## Understanding the “Blue Spot”

### *Sodium Chloride Hot Salt Stress-Corrosion Cracking in Titanium-6246 during fatigue testing at low pressure*

EA Saunders<sup>1</sup>, TP Chapman<sup>2</sup>, ARM Walker<sup>3</sup>, TC Lindley<sup>2</sup>, RJ Chater<sup>2</sup>, VA Vorontsov<sup>2</sup>, D Rugg<sup>3</sup>, D Dye<sup>2</sup>

<sup>1</sup>Rolls-Royce plc., Materials – Failure Investigation, Bristol, BS34 7QE, UK

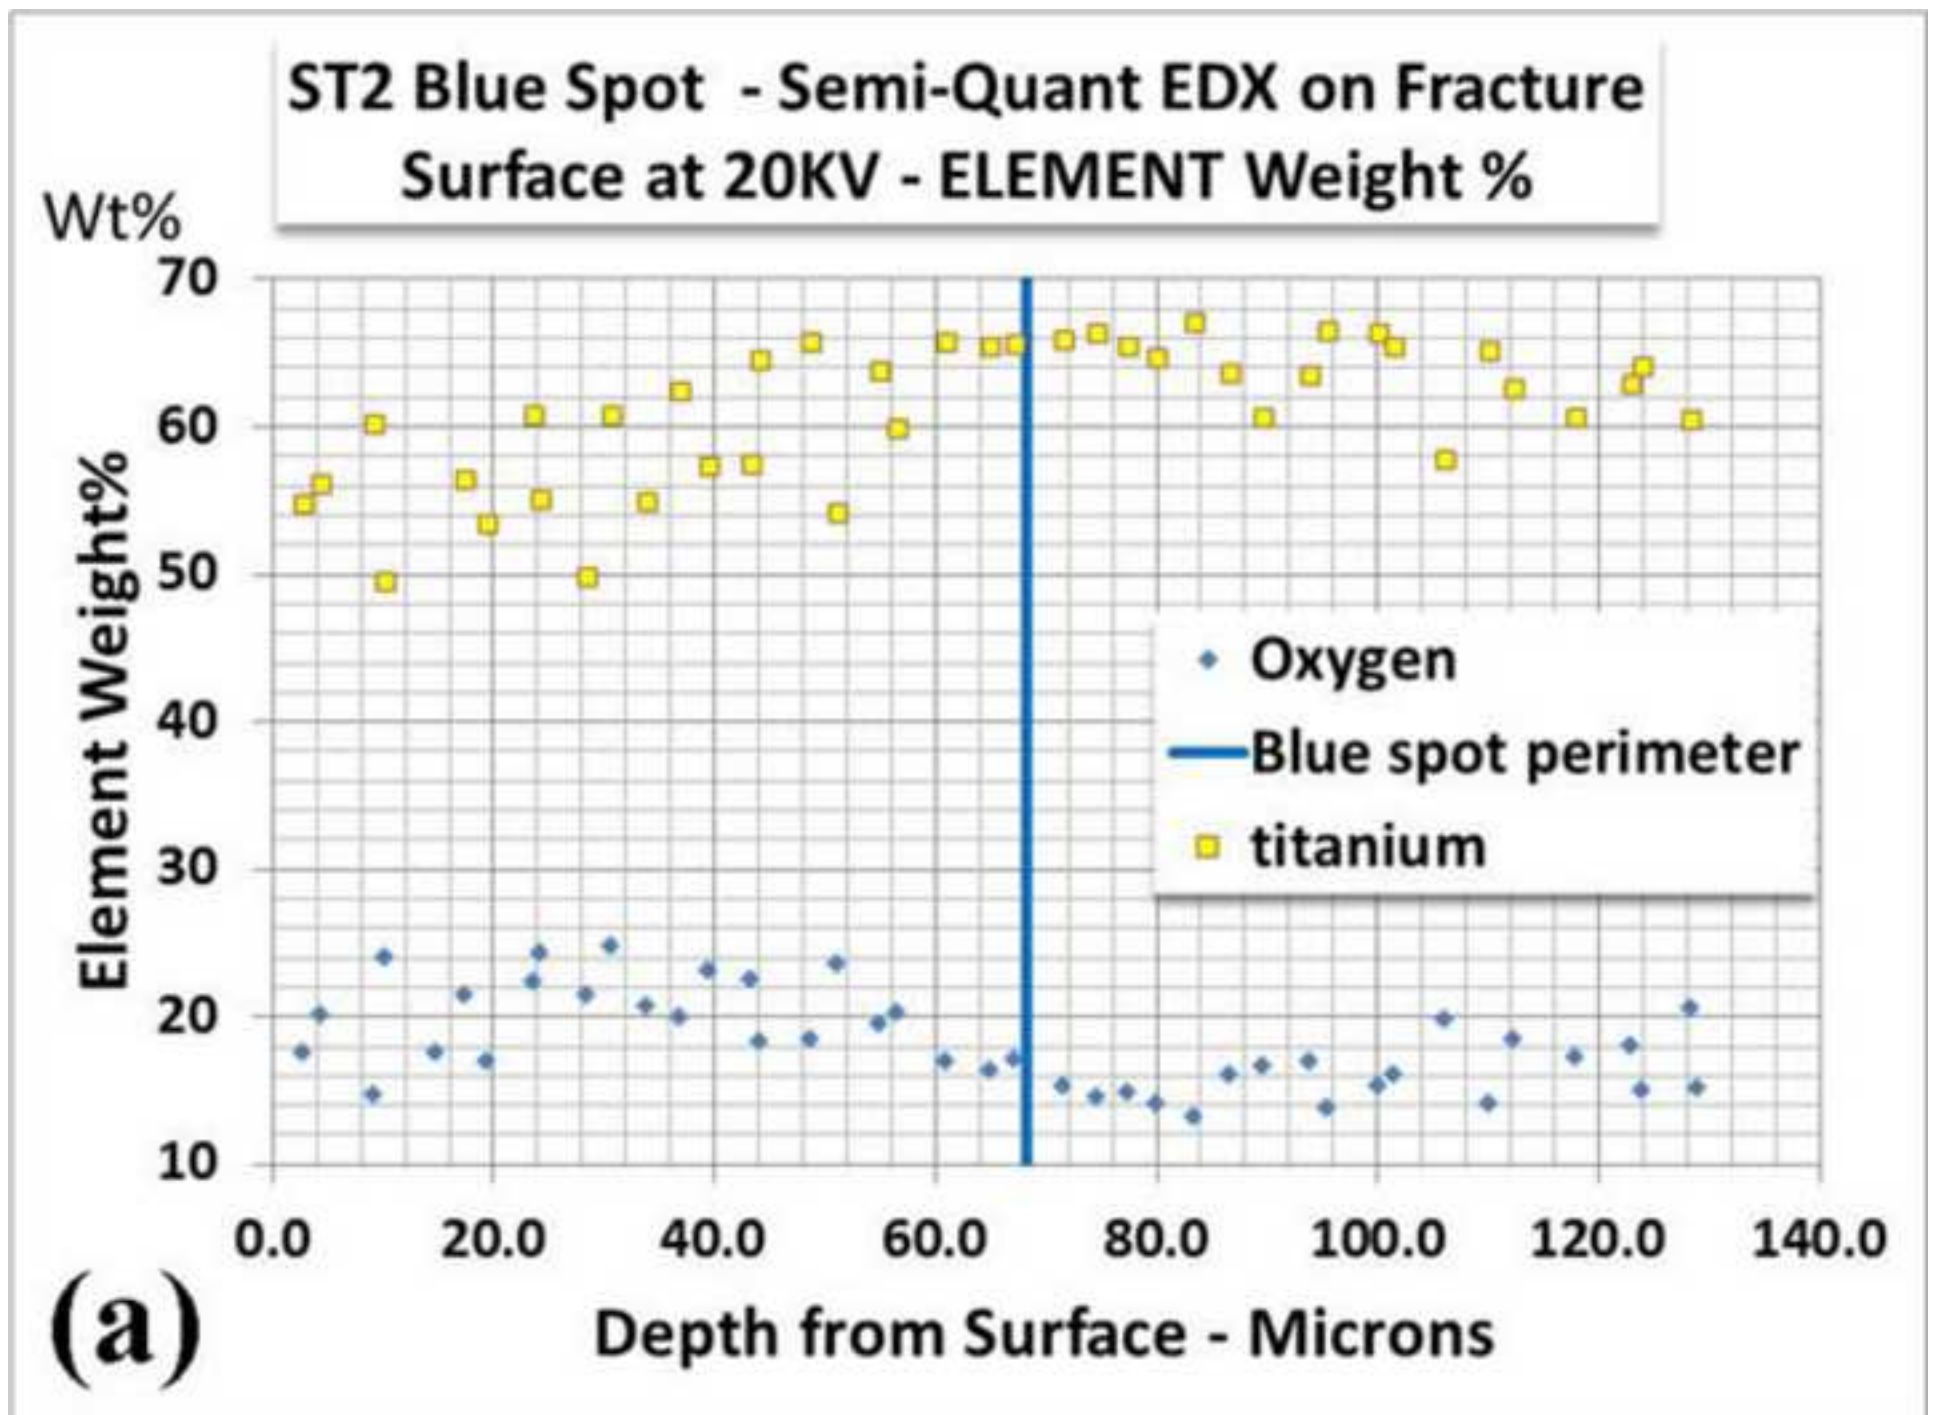
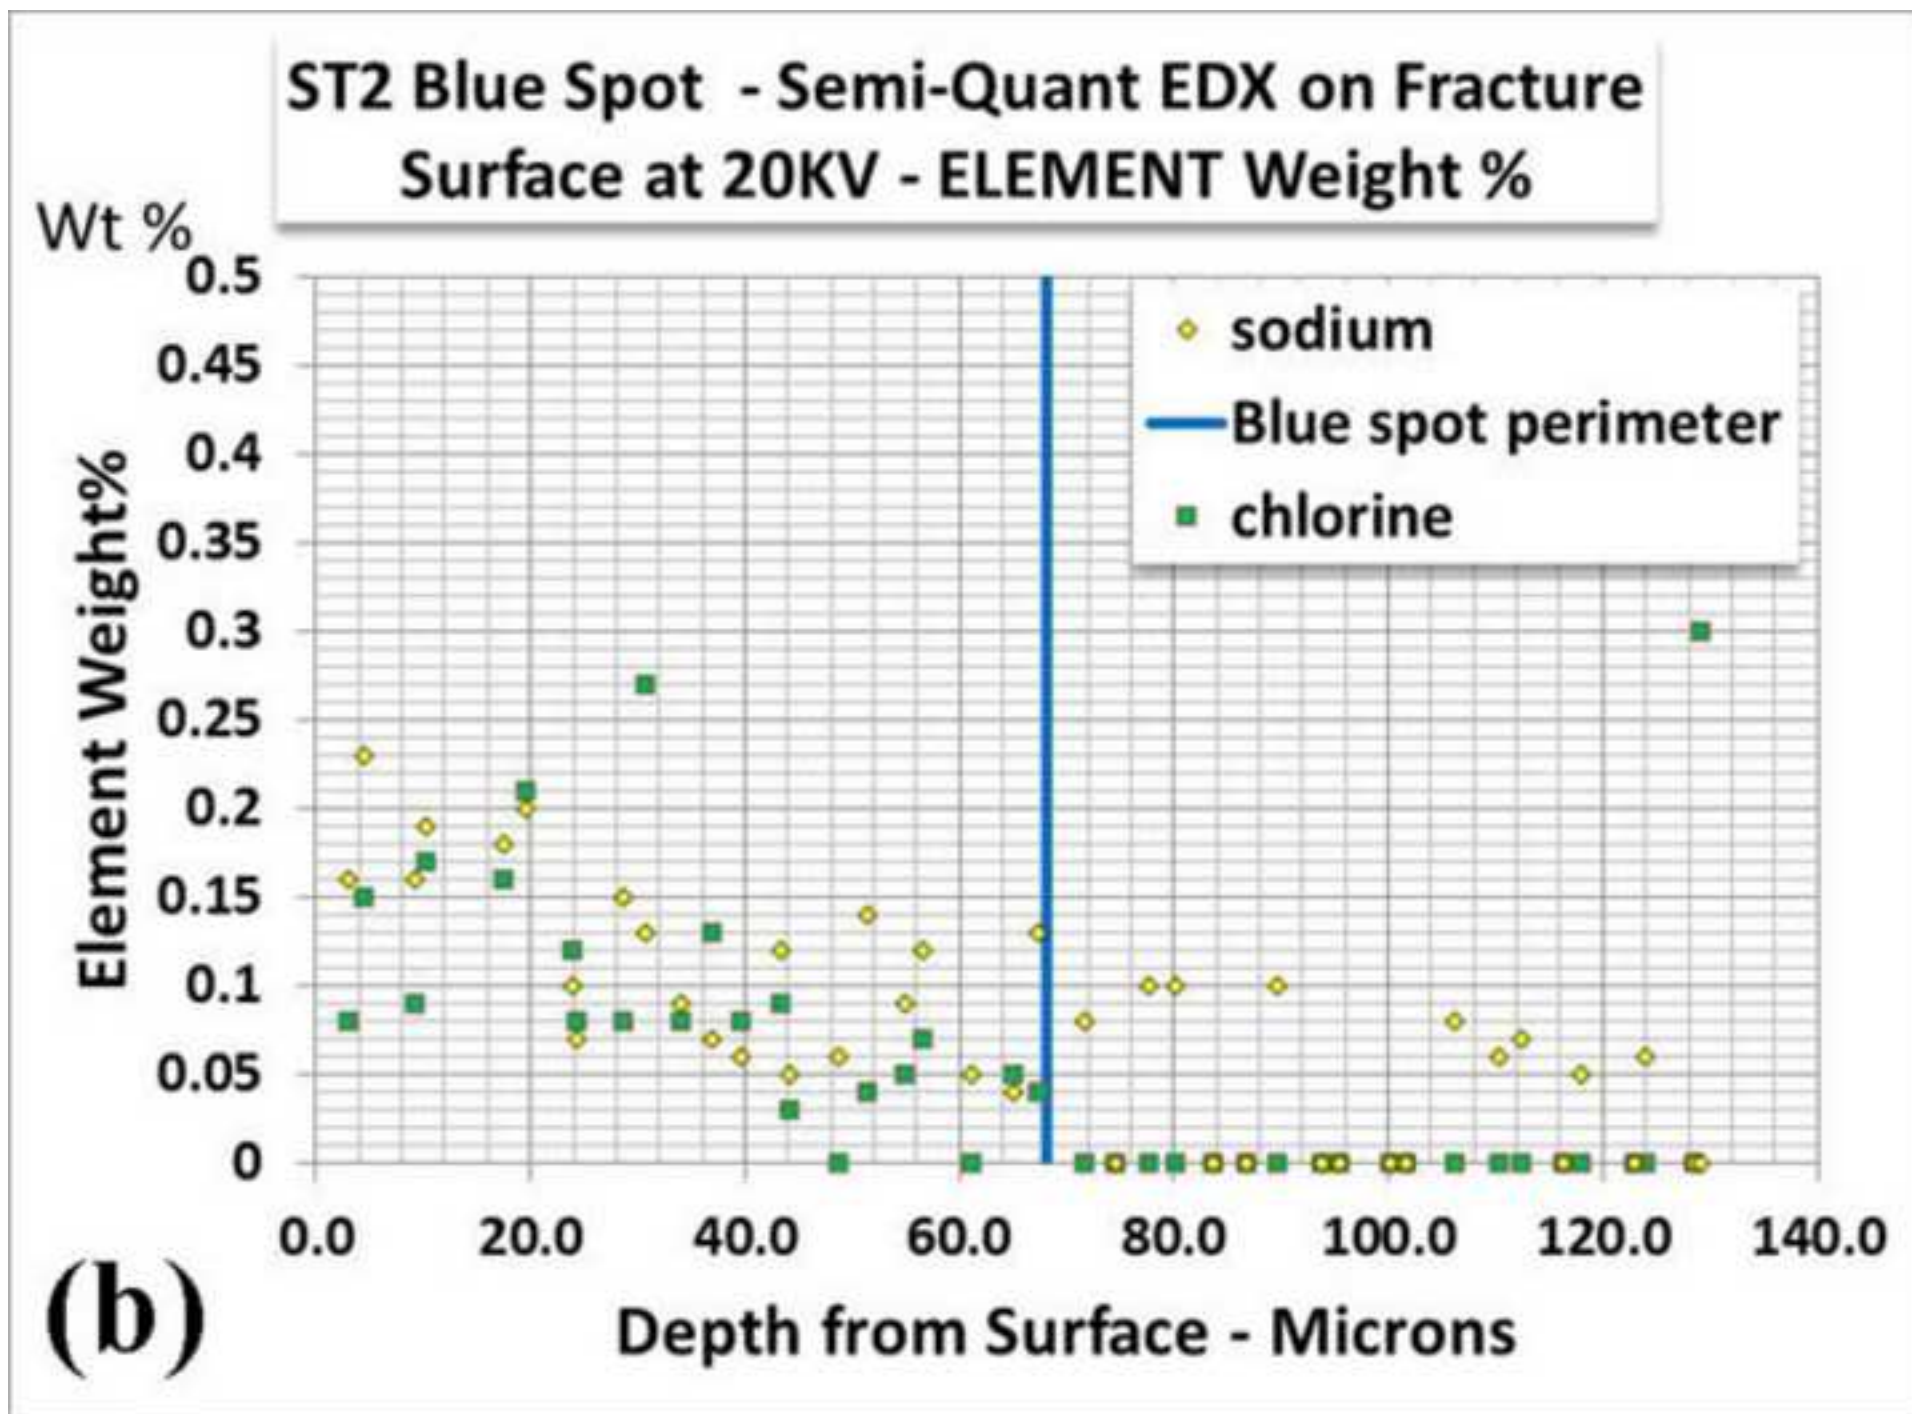
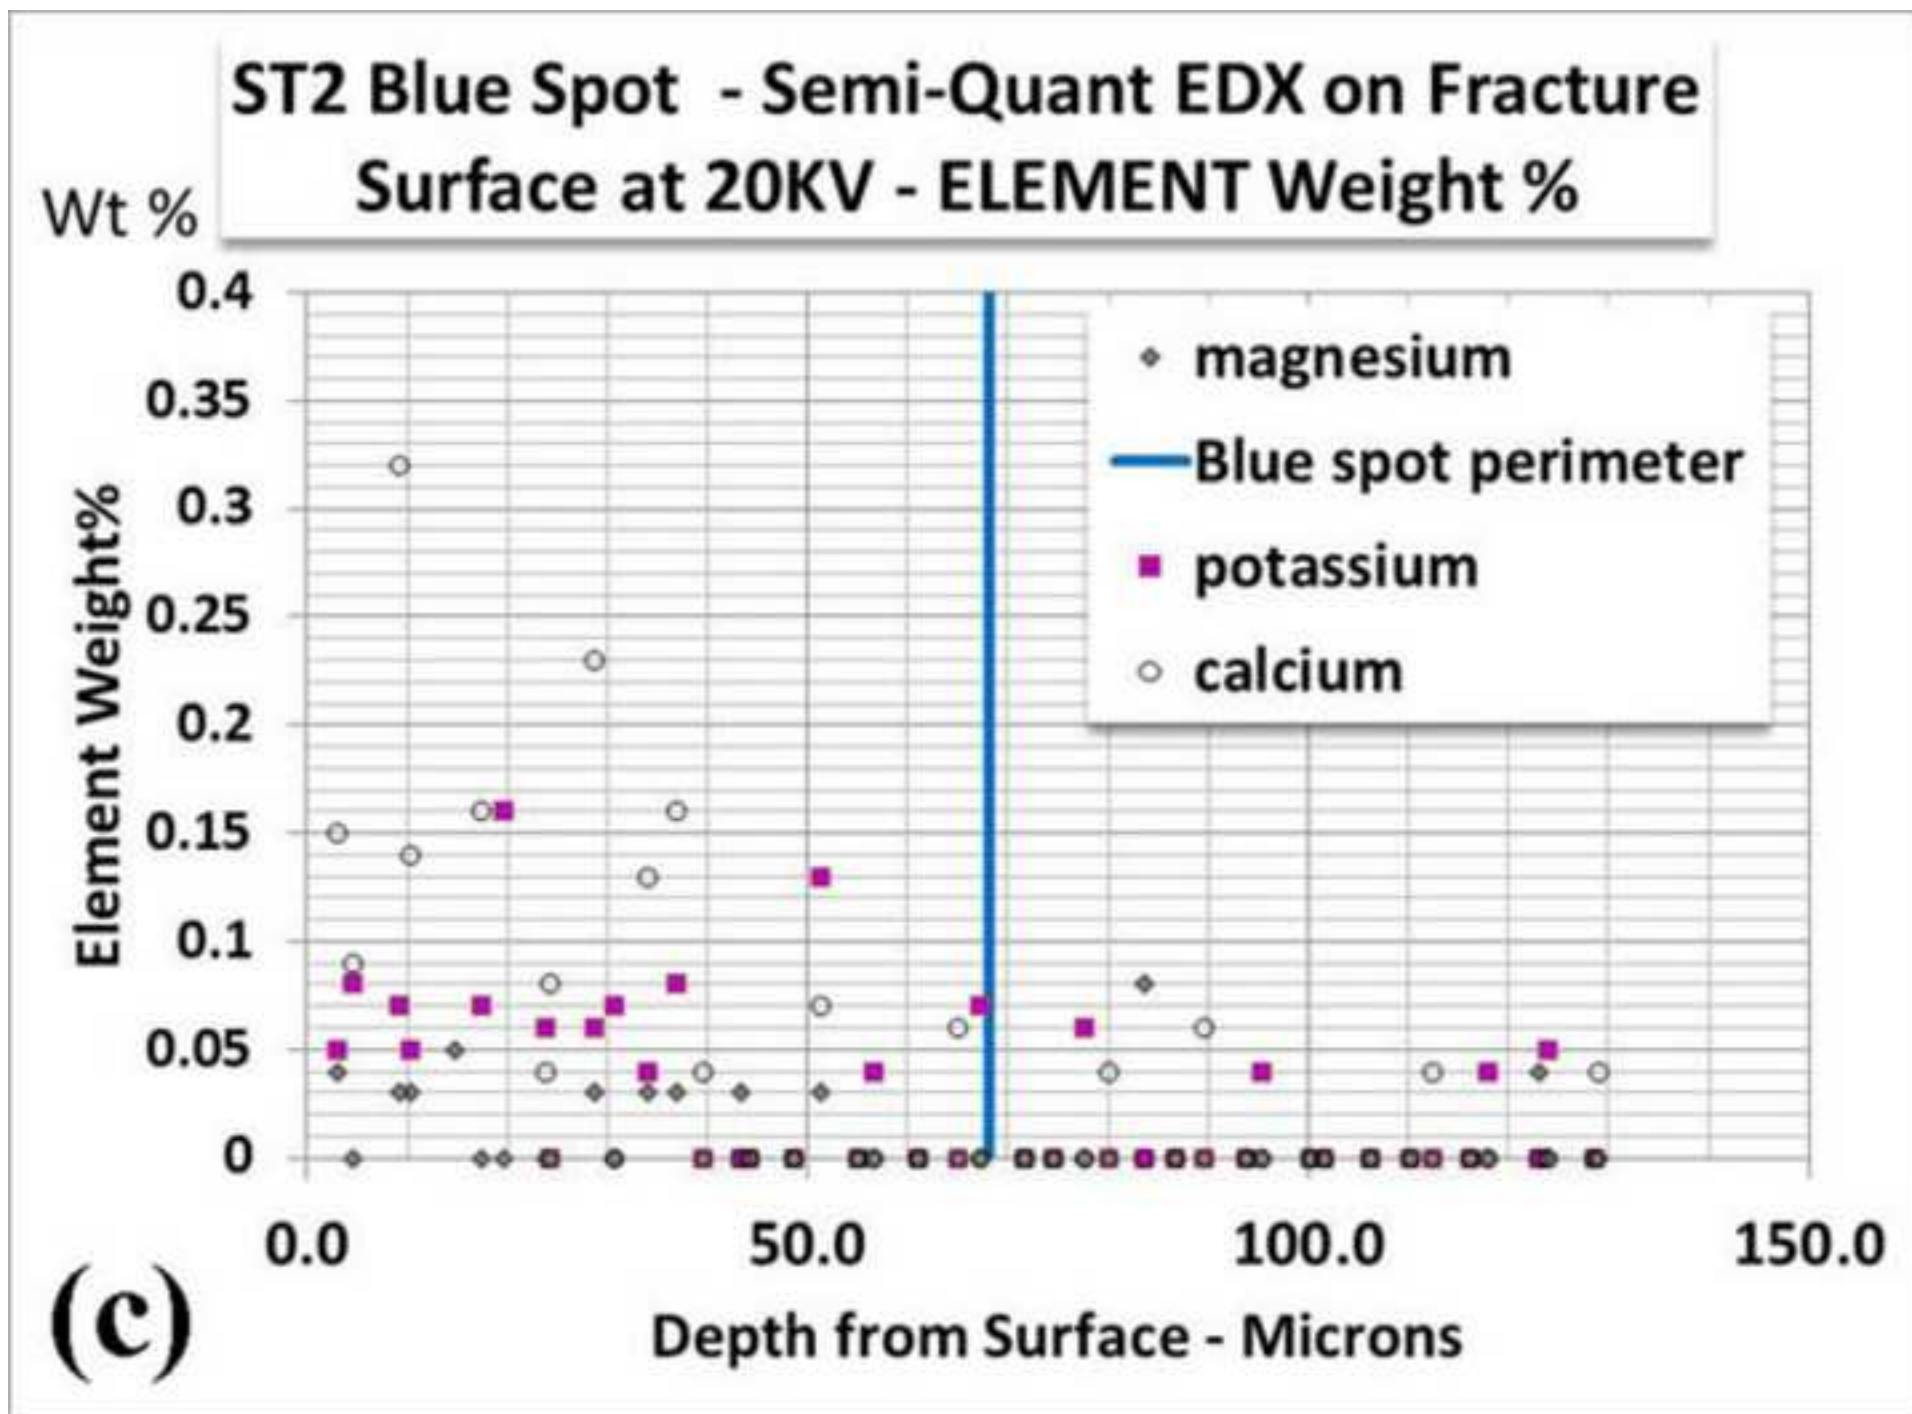
Figure 14a

**Figure 14** - 20KV EDX semi-quantitative analysis line scans through the ST2 blue spot –in weight %. Percentages given are based on numbers of x-rays emitted from the electron beam penetration volume (not a precise interpretation of surface layer composition). Either side of the blue spot periphery, (a) O drops from 15-25% to 12-20%, Ti from 50-60% to 60-70%, (b) Cl and Na drop „dramatically“ from 0.05-0.25% to near 0%, and (c) trace K, Ca and Mg drop to near 0%.

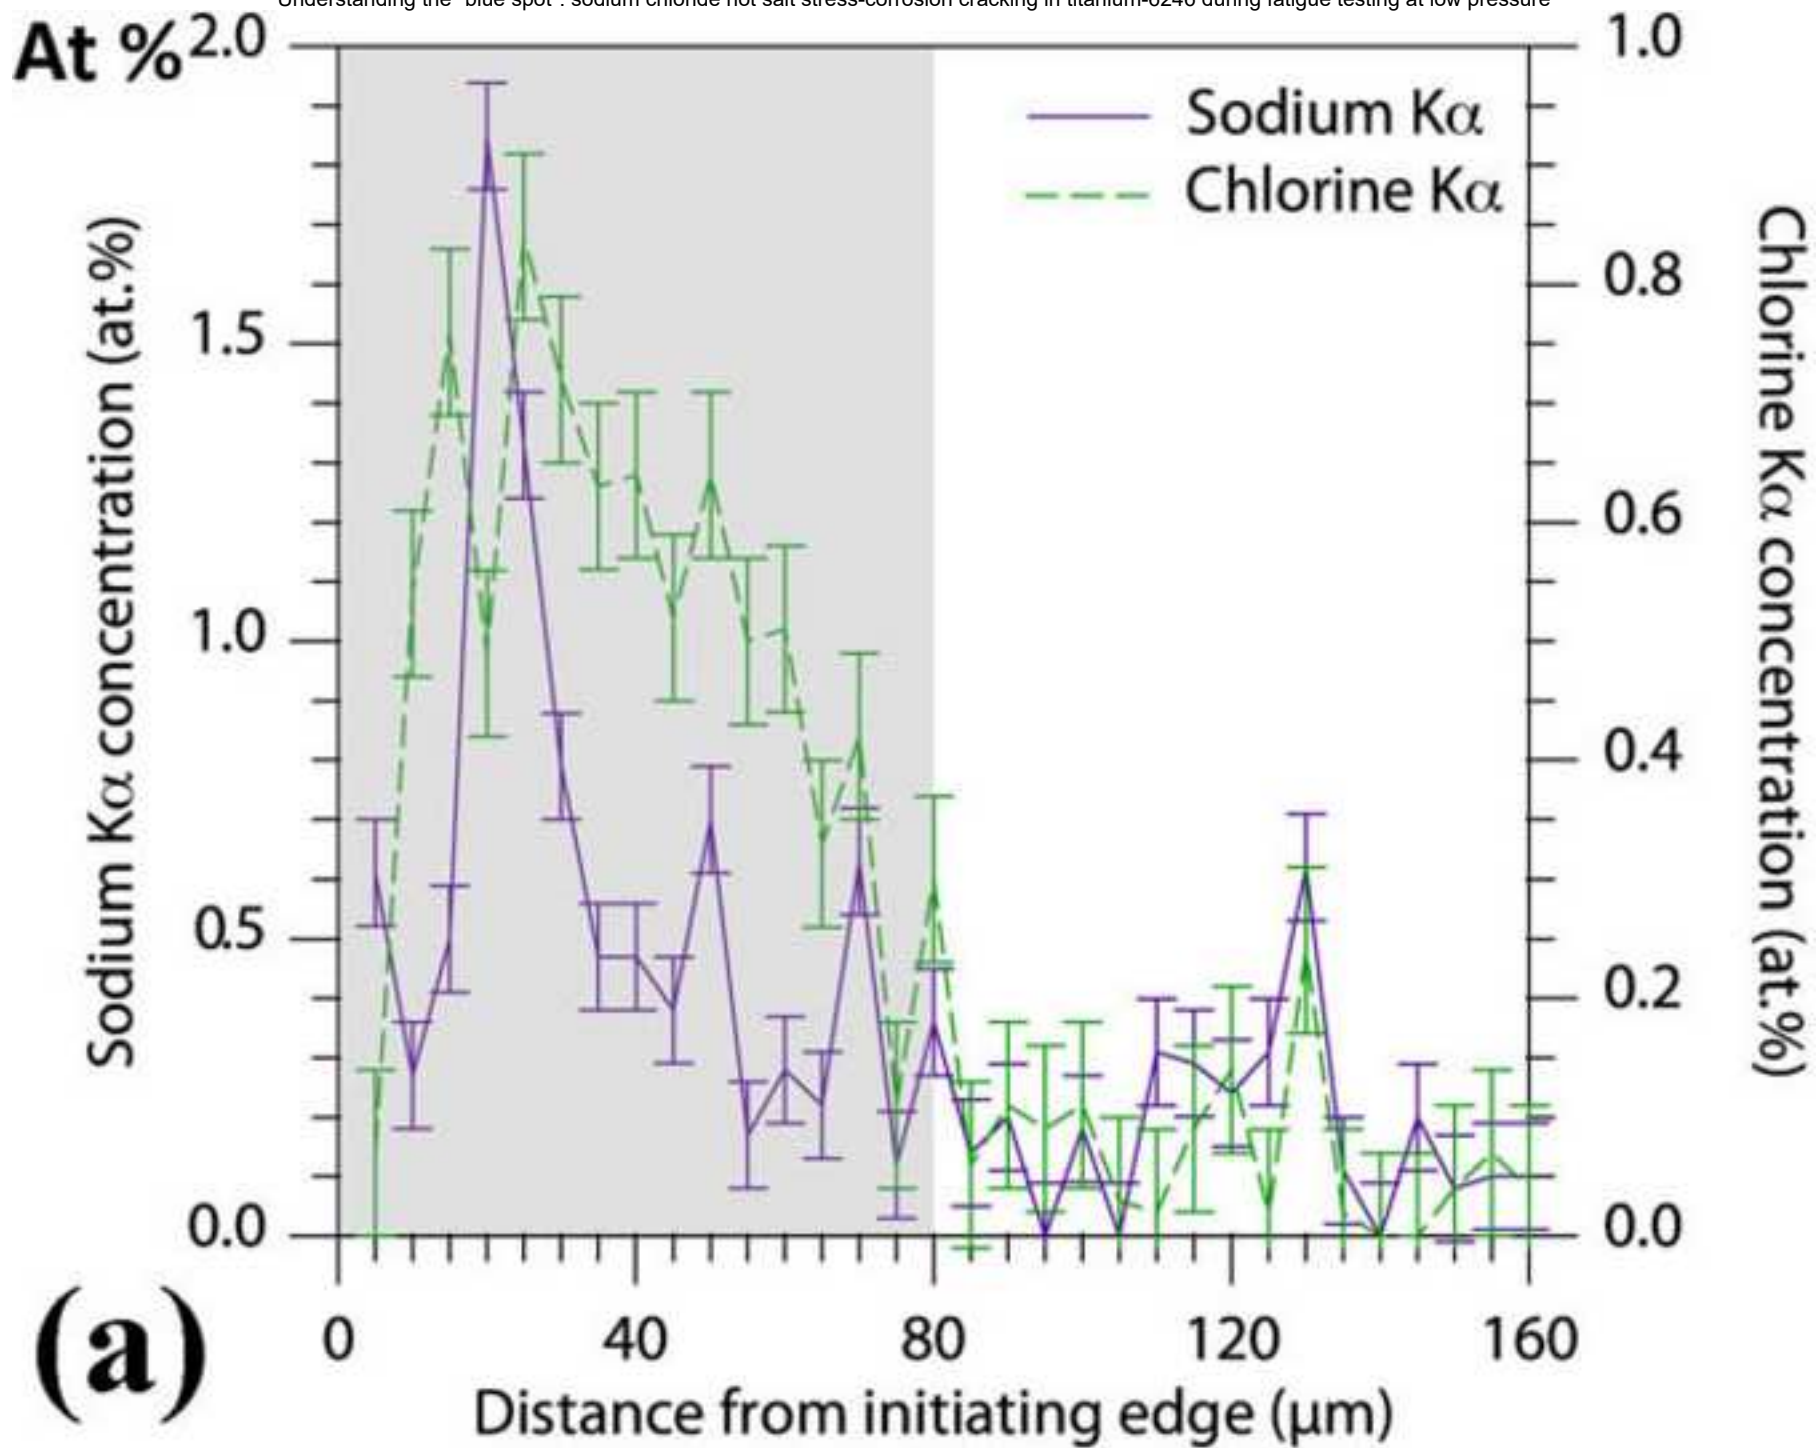
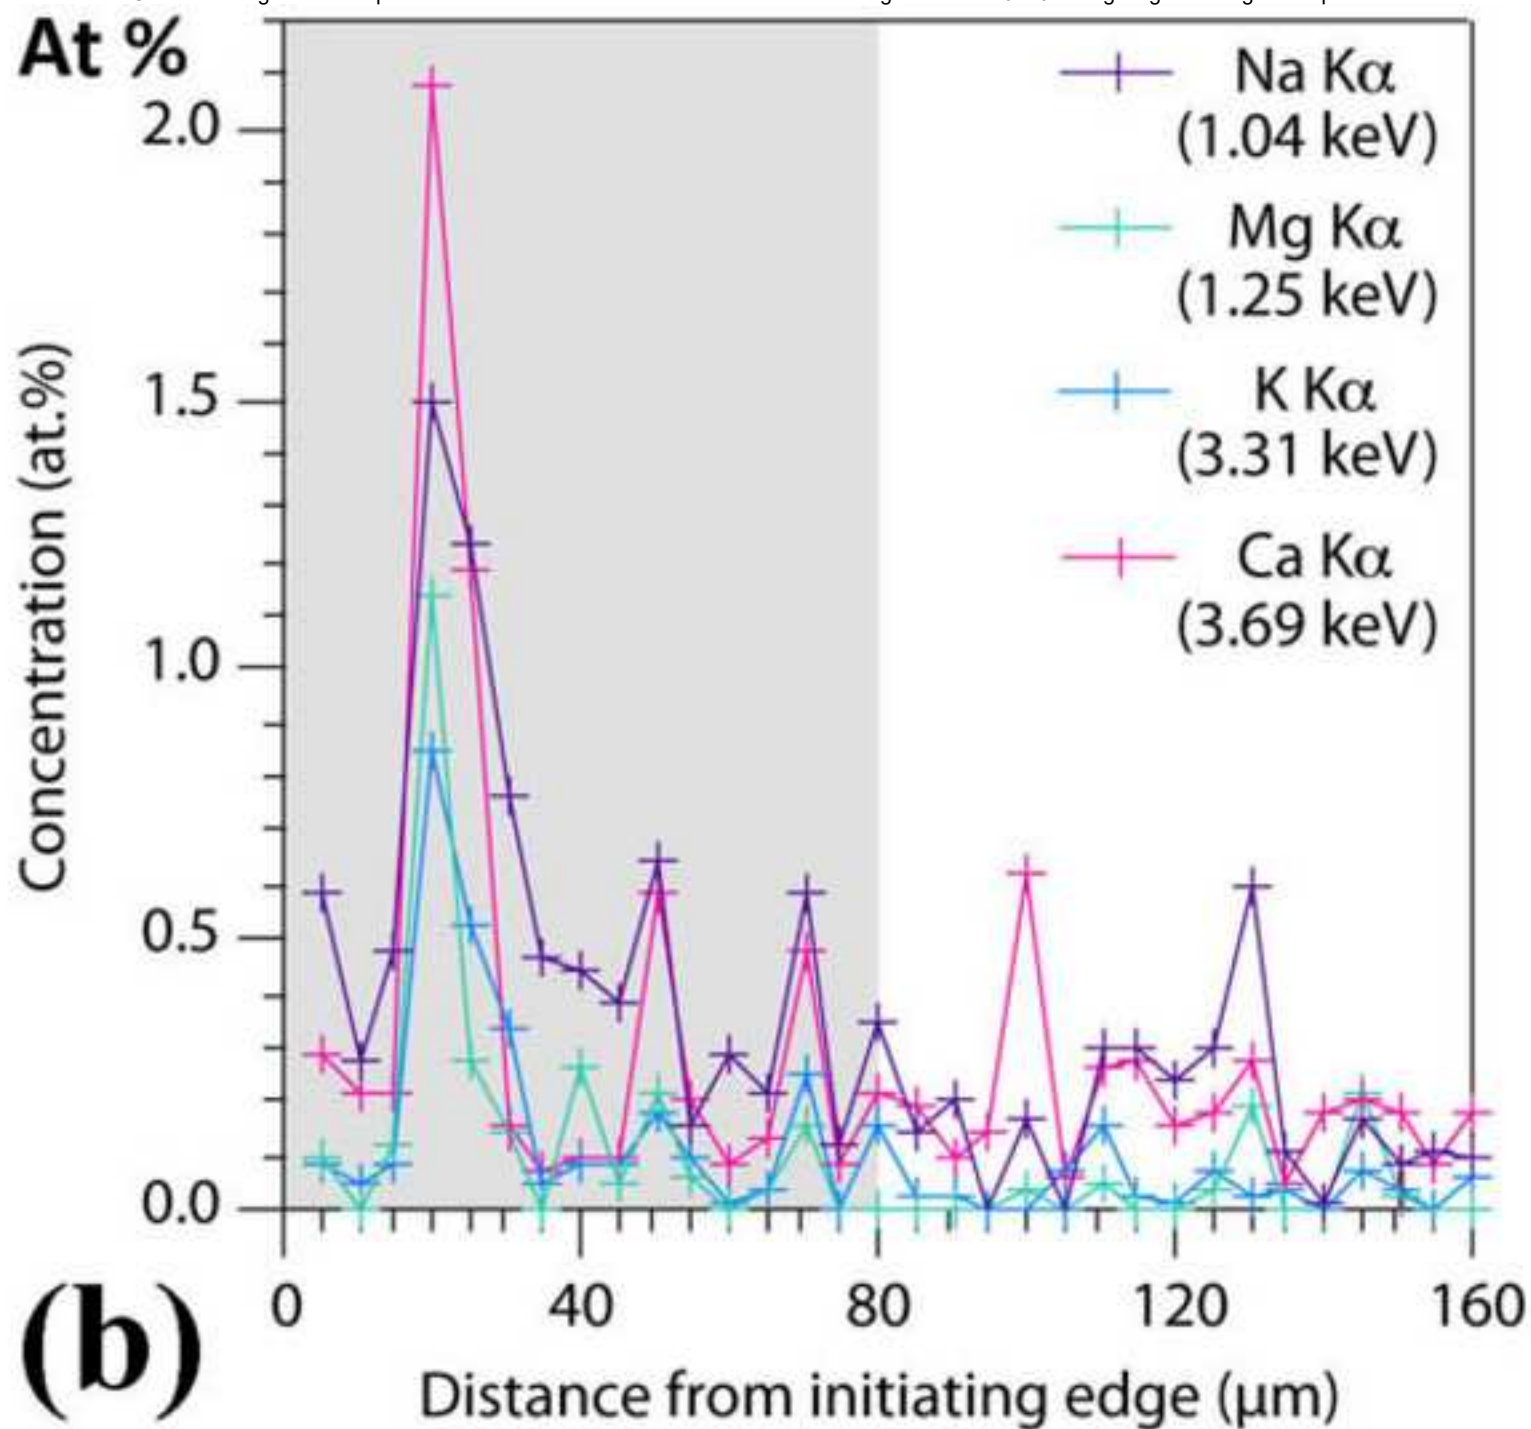
Figure 15a

**Figure 15** - 20KV semi-quantitative EDX line scans through the ST1 „blue spot“ (marked in grey) in atomic %, for (a) Na and Cl, (b) Na, Mg, K and Ca, all existing at low levels in the blue spot, dropping to near-zero after its periphery.

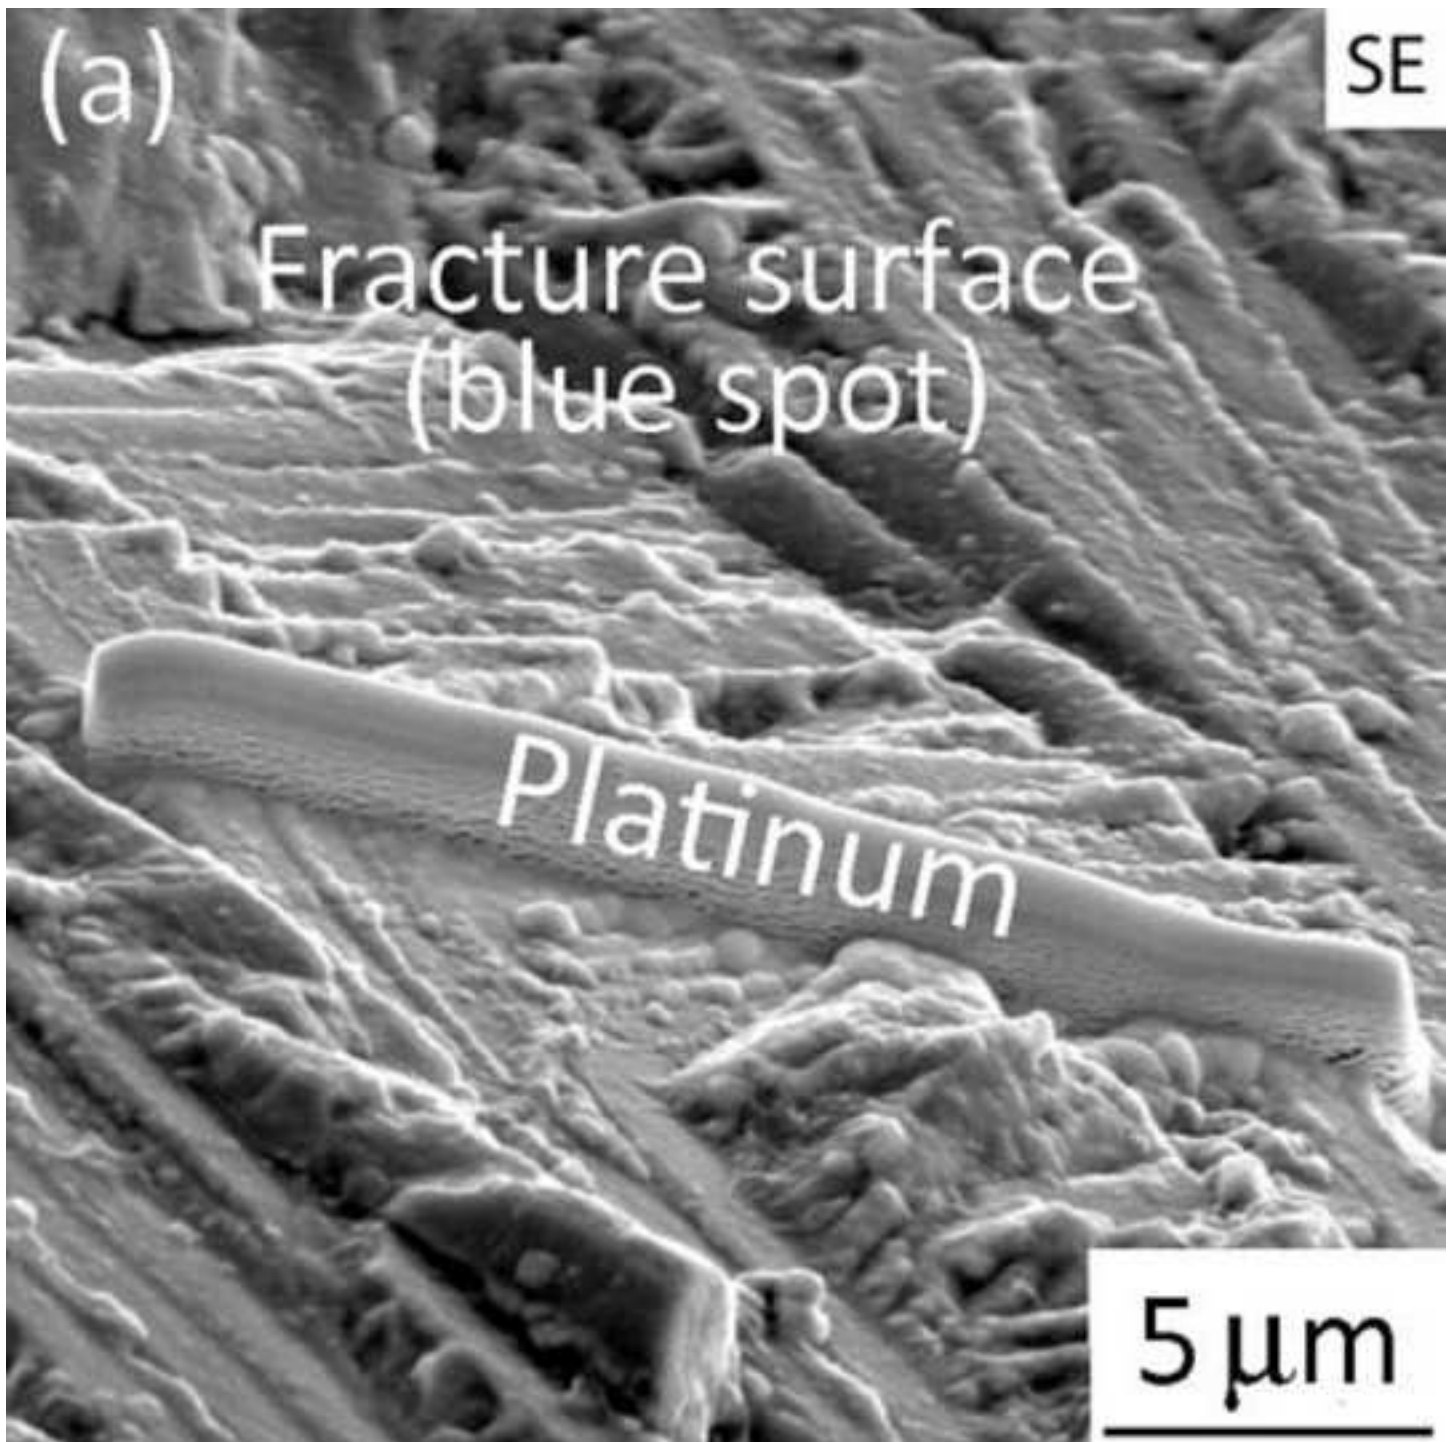
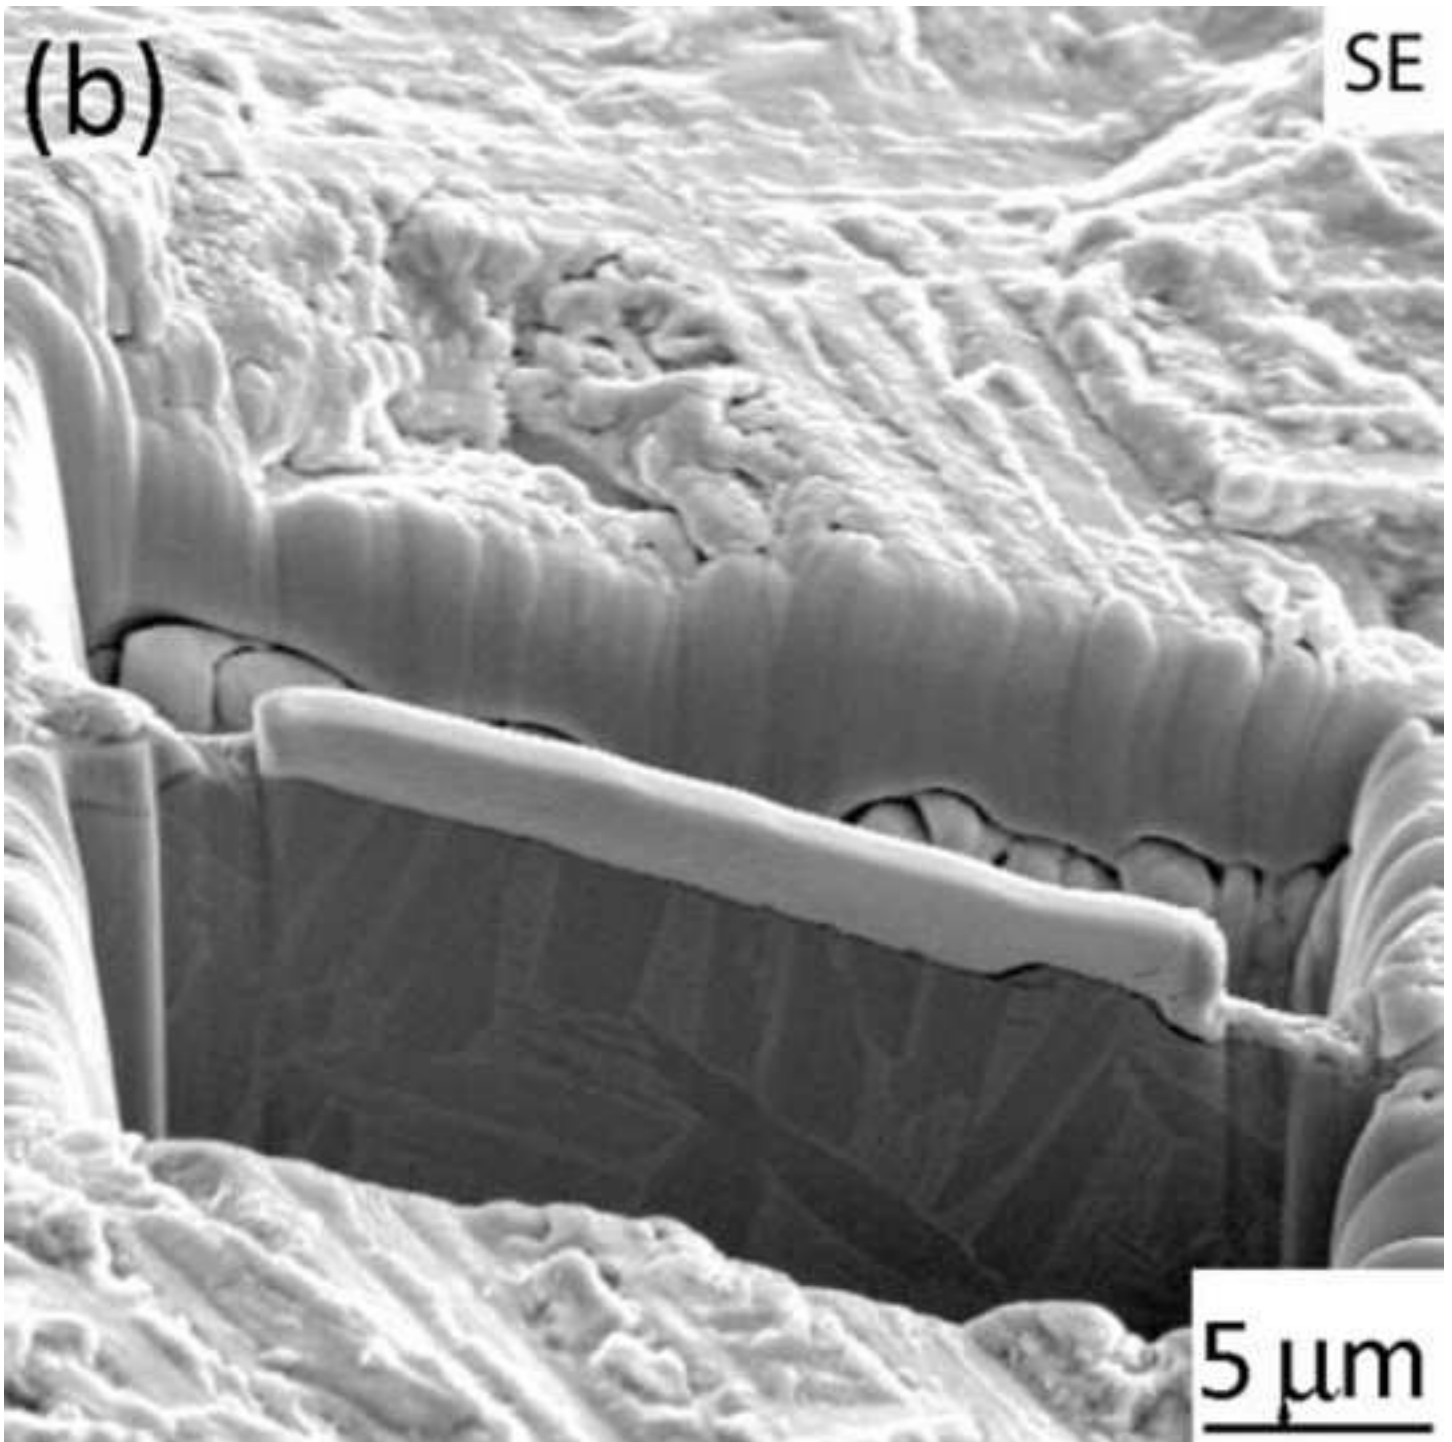
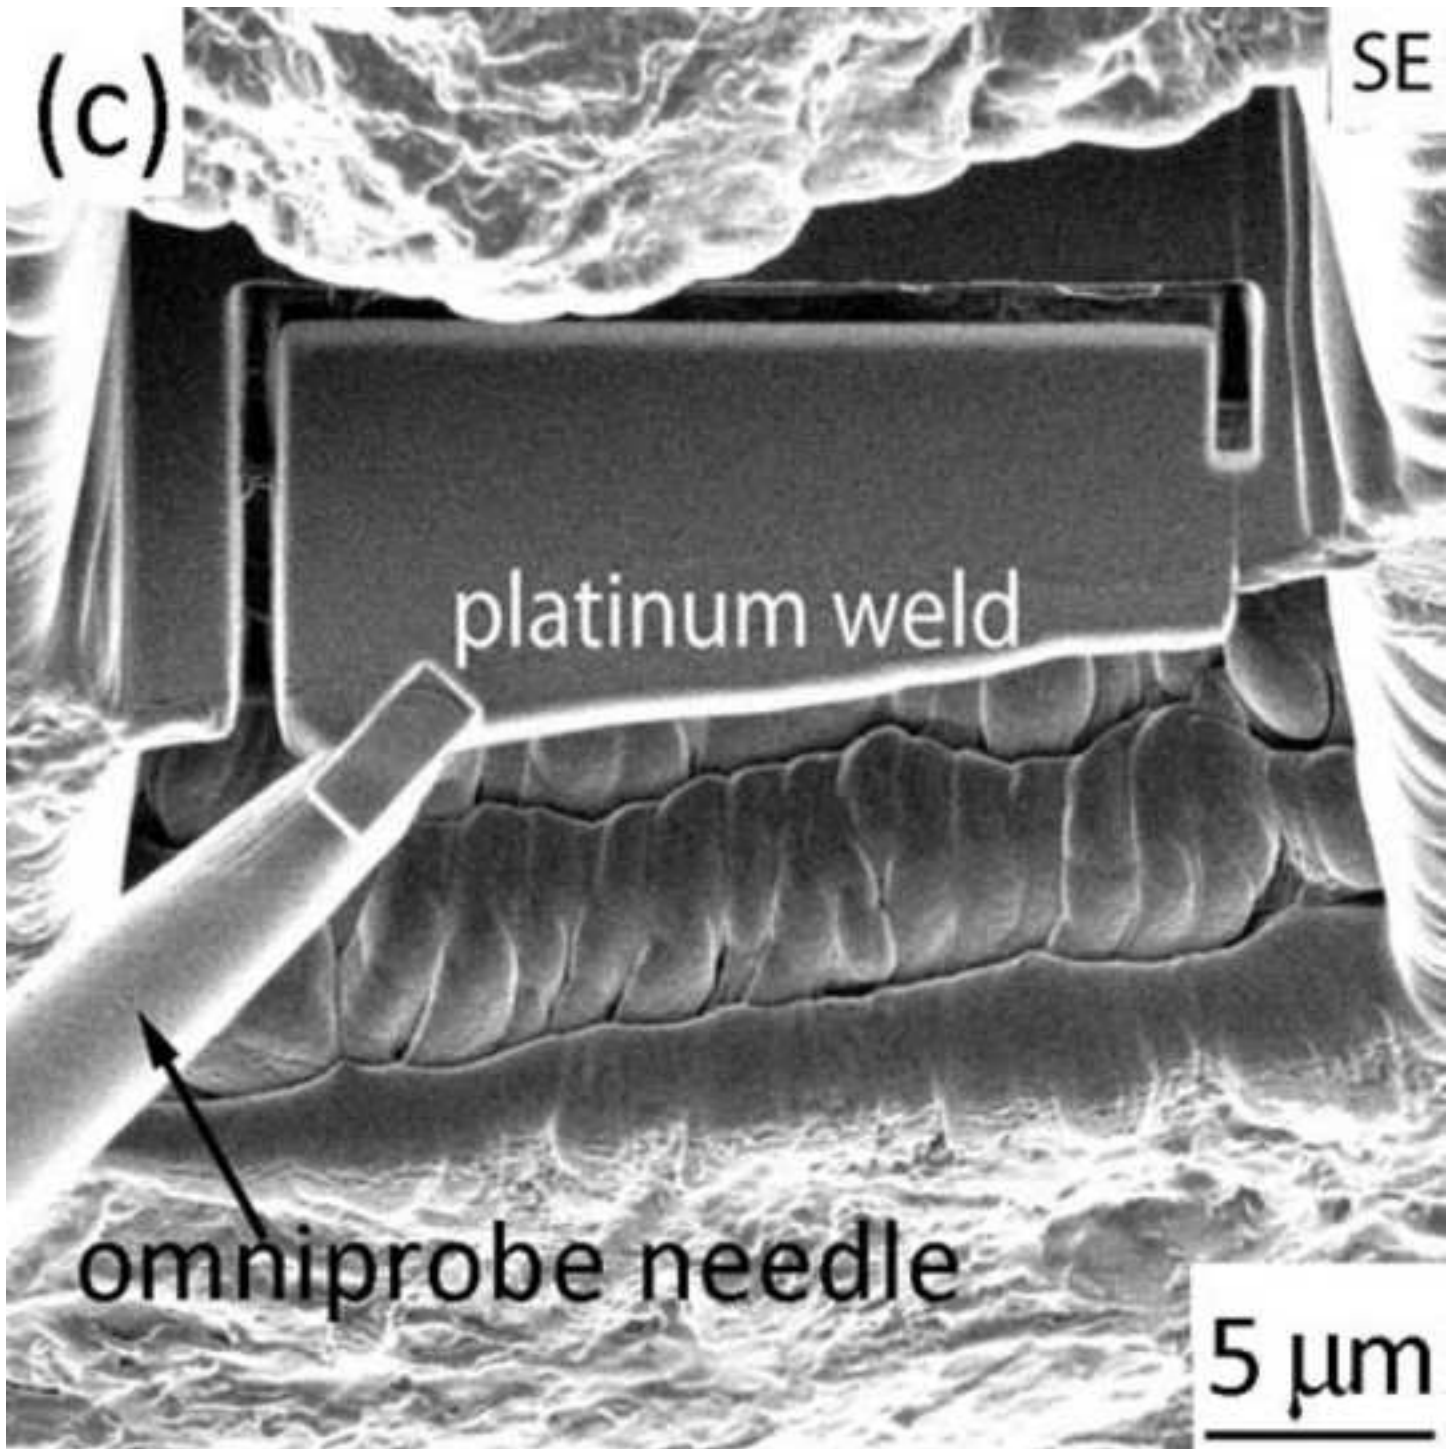
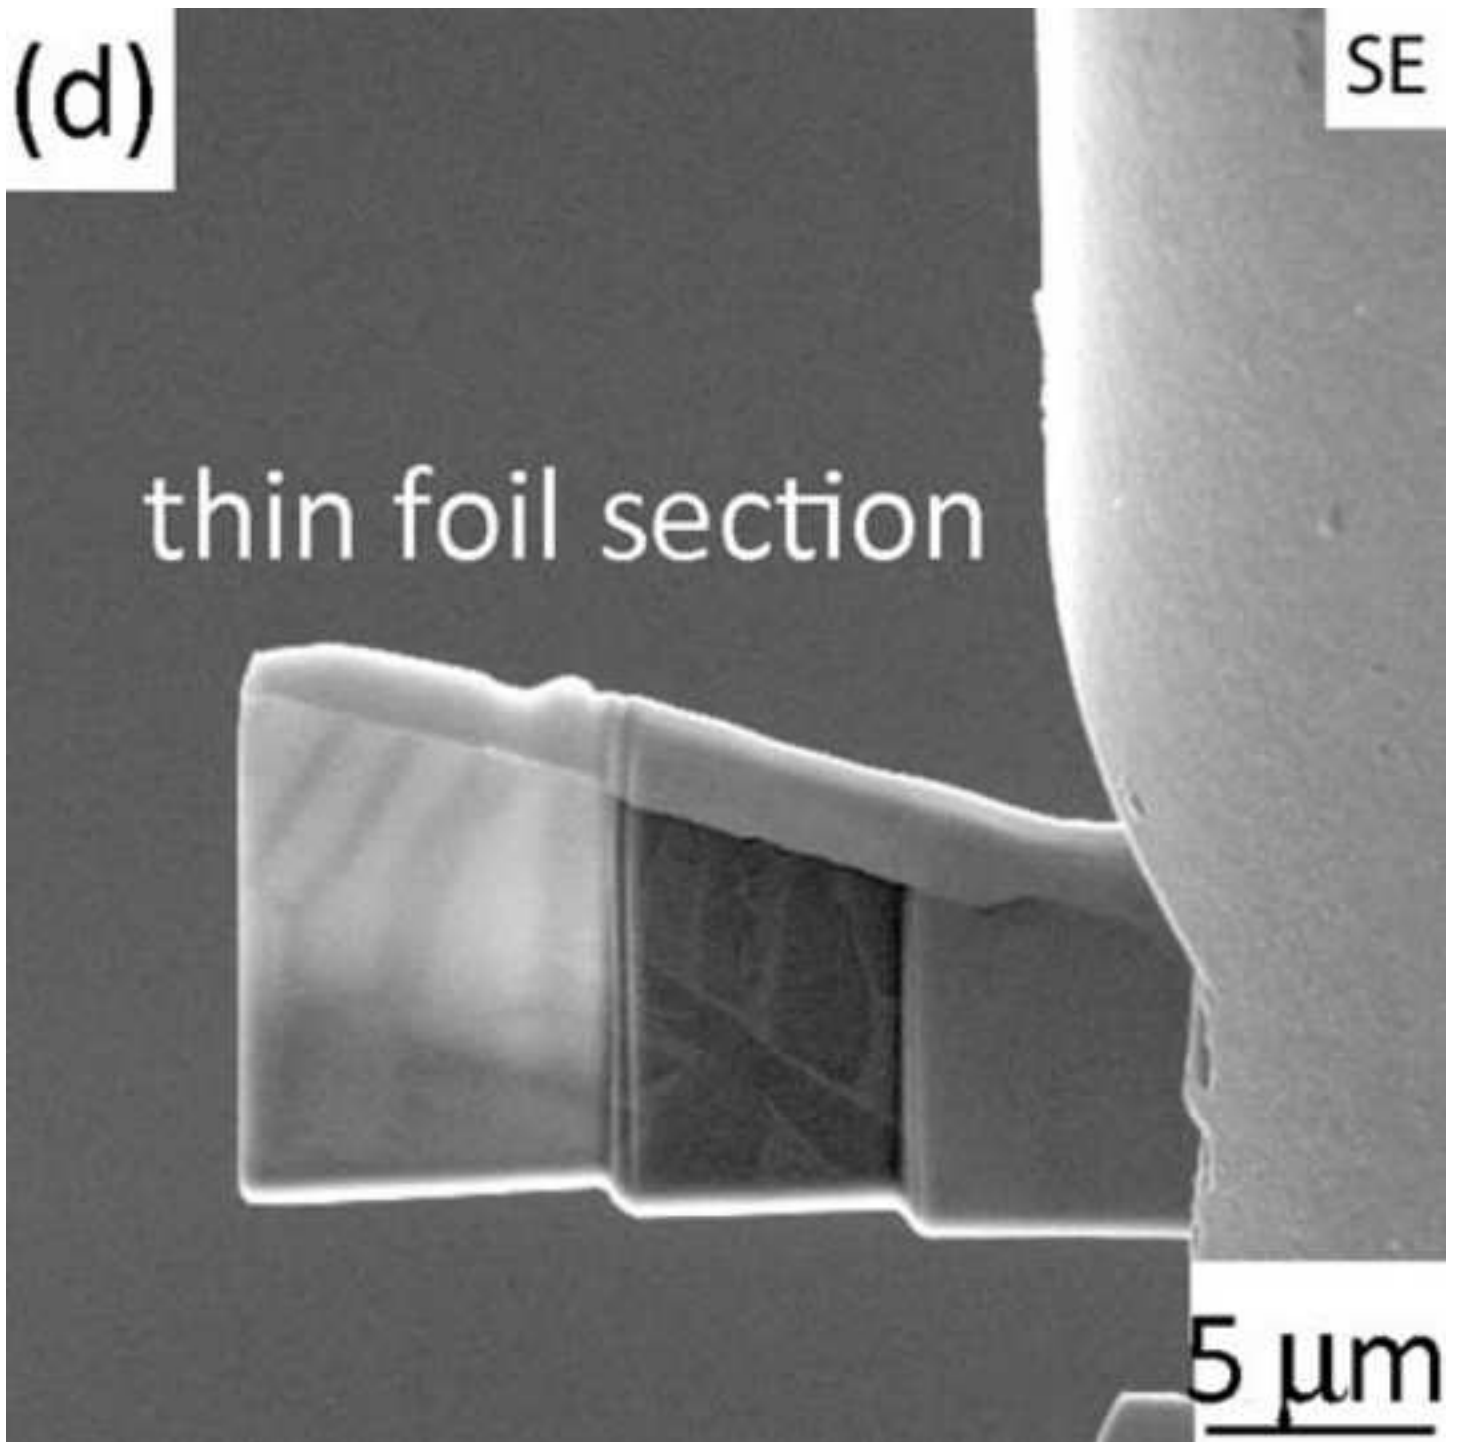
Figure 19a

**Figure 19** - Producing a “lift-out” foil from the blue spot fracture surface: (a) A platinum-containing layer is initially deposited with the FEI Helios NanoLab 600 gas injection system - this protects the area of interest underneath from the FIB beam. (b) Material is FIB-milled around the protected area to a depth of several microns. (c) An omniprobe needle is platinum-welded to the potential foil following FIB milling around the periphery bar a small ligament – which is then cut to allow foil removal. (d) The foil is welded to a TEM omniprobe grid, and then further thinned by FIB milling to allow electron passage (three stages of thinning may be seen - with microstructure visible in the thinnest area (~150nm).
