## Understanding the “Blue Spot”

### *Sodium Chloride Hot Salt Stress-Corrosion Cracking in Titanium-6246 during fatigue testing at low pressure*

EA Saunders<sup>1</sup>, TP Chapman<sup>2</sup>, ARM Walker<sup>3</sup>, TC Lindley<sup>2</sup>, RJ Chater<sup>2</sup>, VA Vorontsov<sup>2</sup>, D Rugg<sup>3</sup>, D Dye<sup>2</sup>

<sup>1</sup>Rolls-Royce plc., Materials – Failure Investigation, Bristol, BS34 7QE, UK

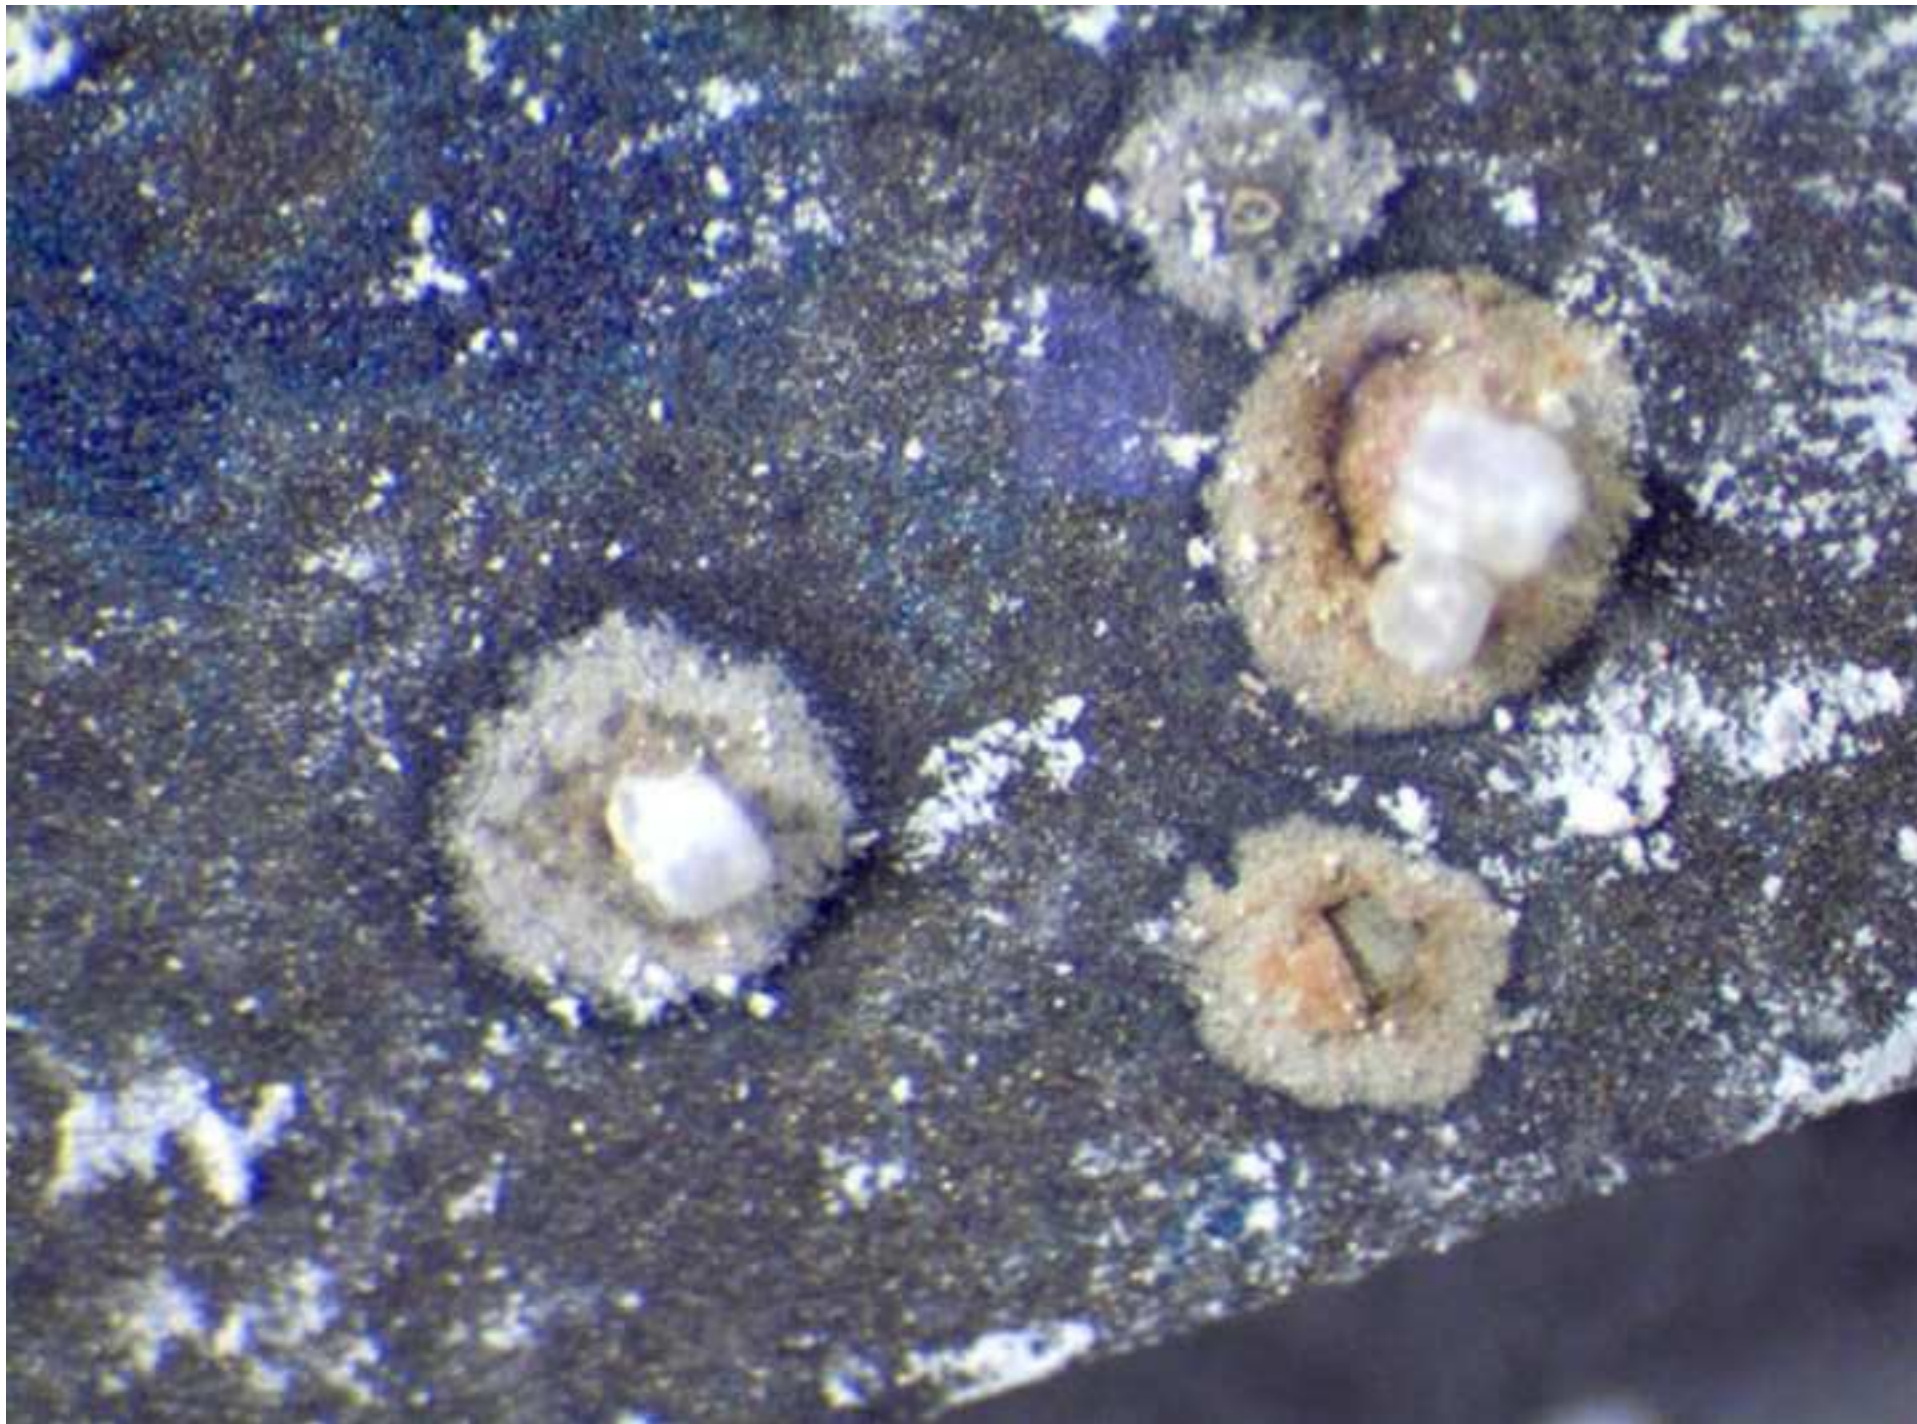
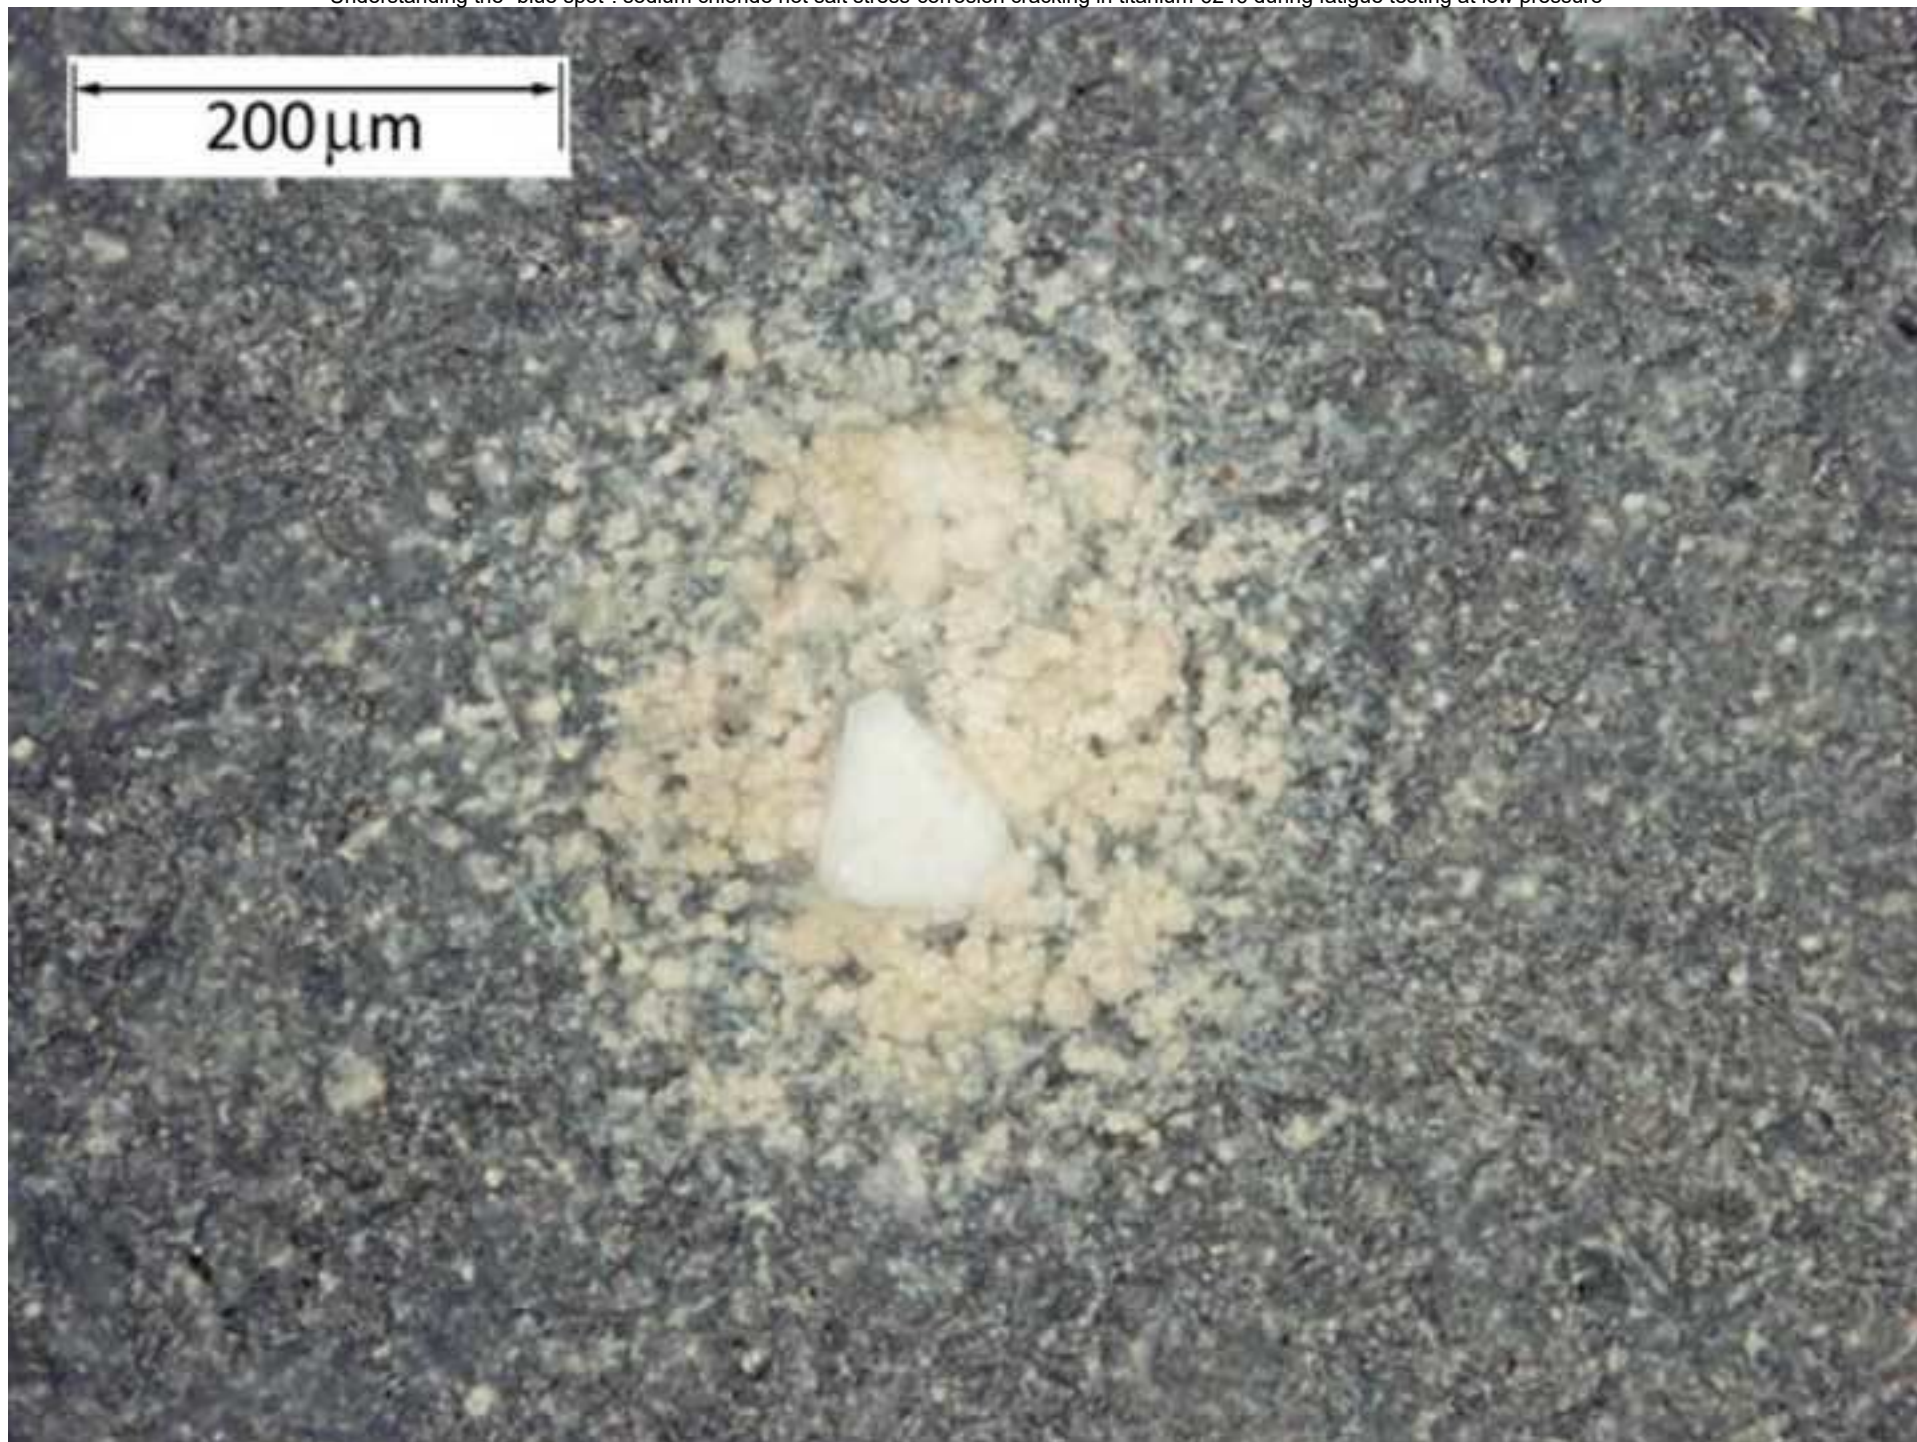
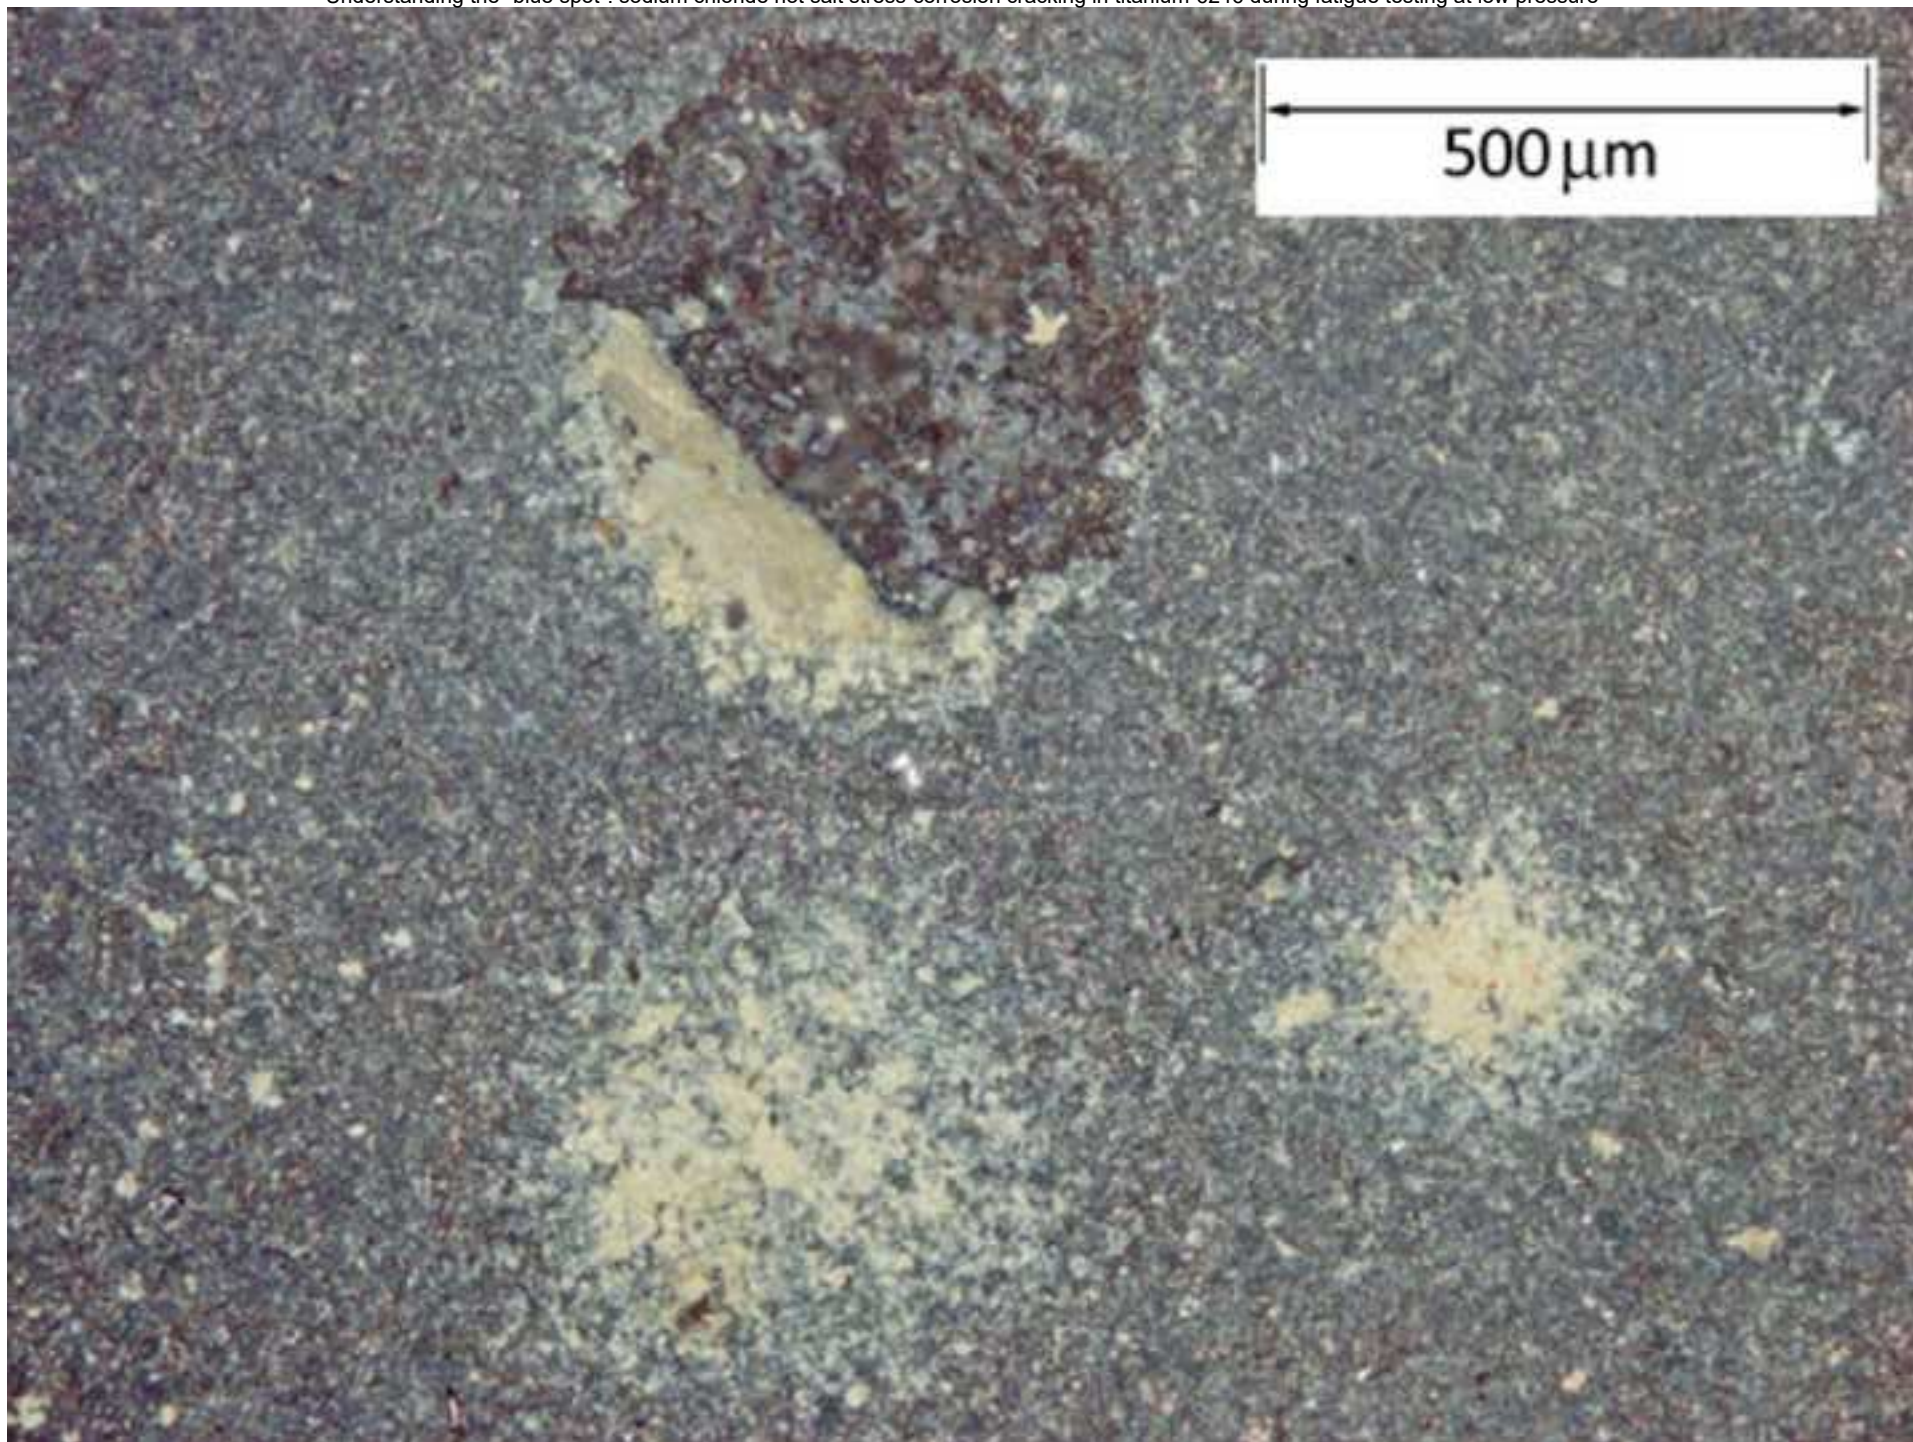
Figure 21a

**Figure 21** - Optical images of yellow-tinged reaction product on Ti-230 alloy plate by NaCl following overnight exposure at 450°C - beneath individual NaCl crystals ((a) and (b)). (c) Also shows a darkened pit in the upper half of the image that formed where the reaction product came away – this was richer in Cl (with very little Na) than the yellow material. Compare ref 35 figure 1.

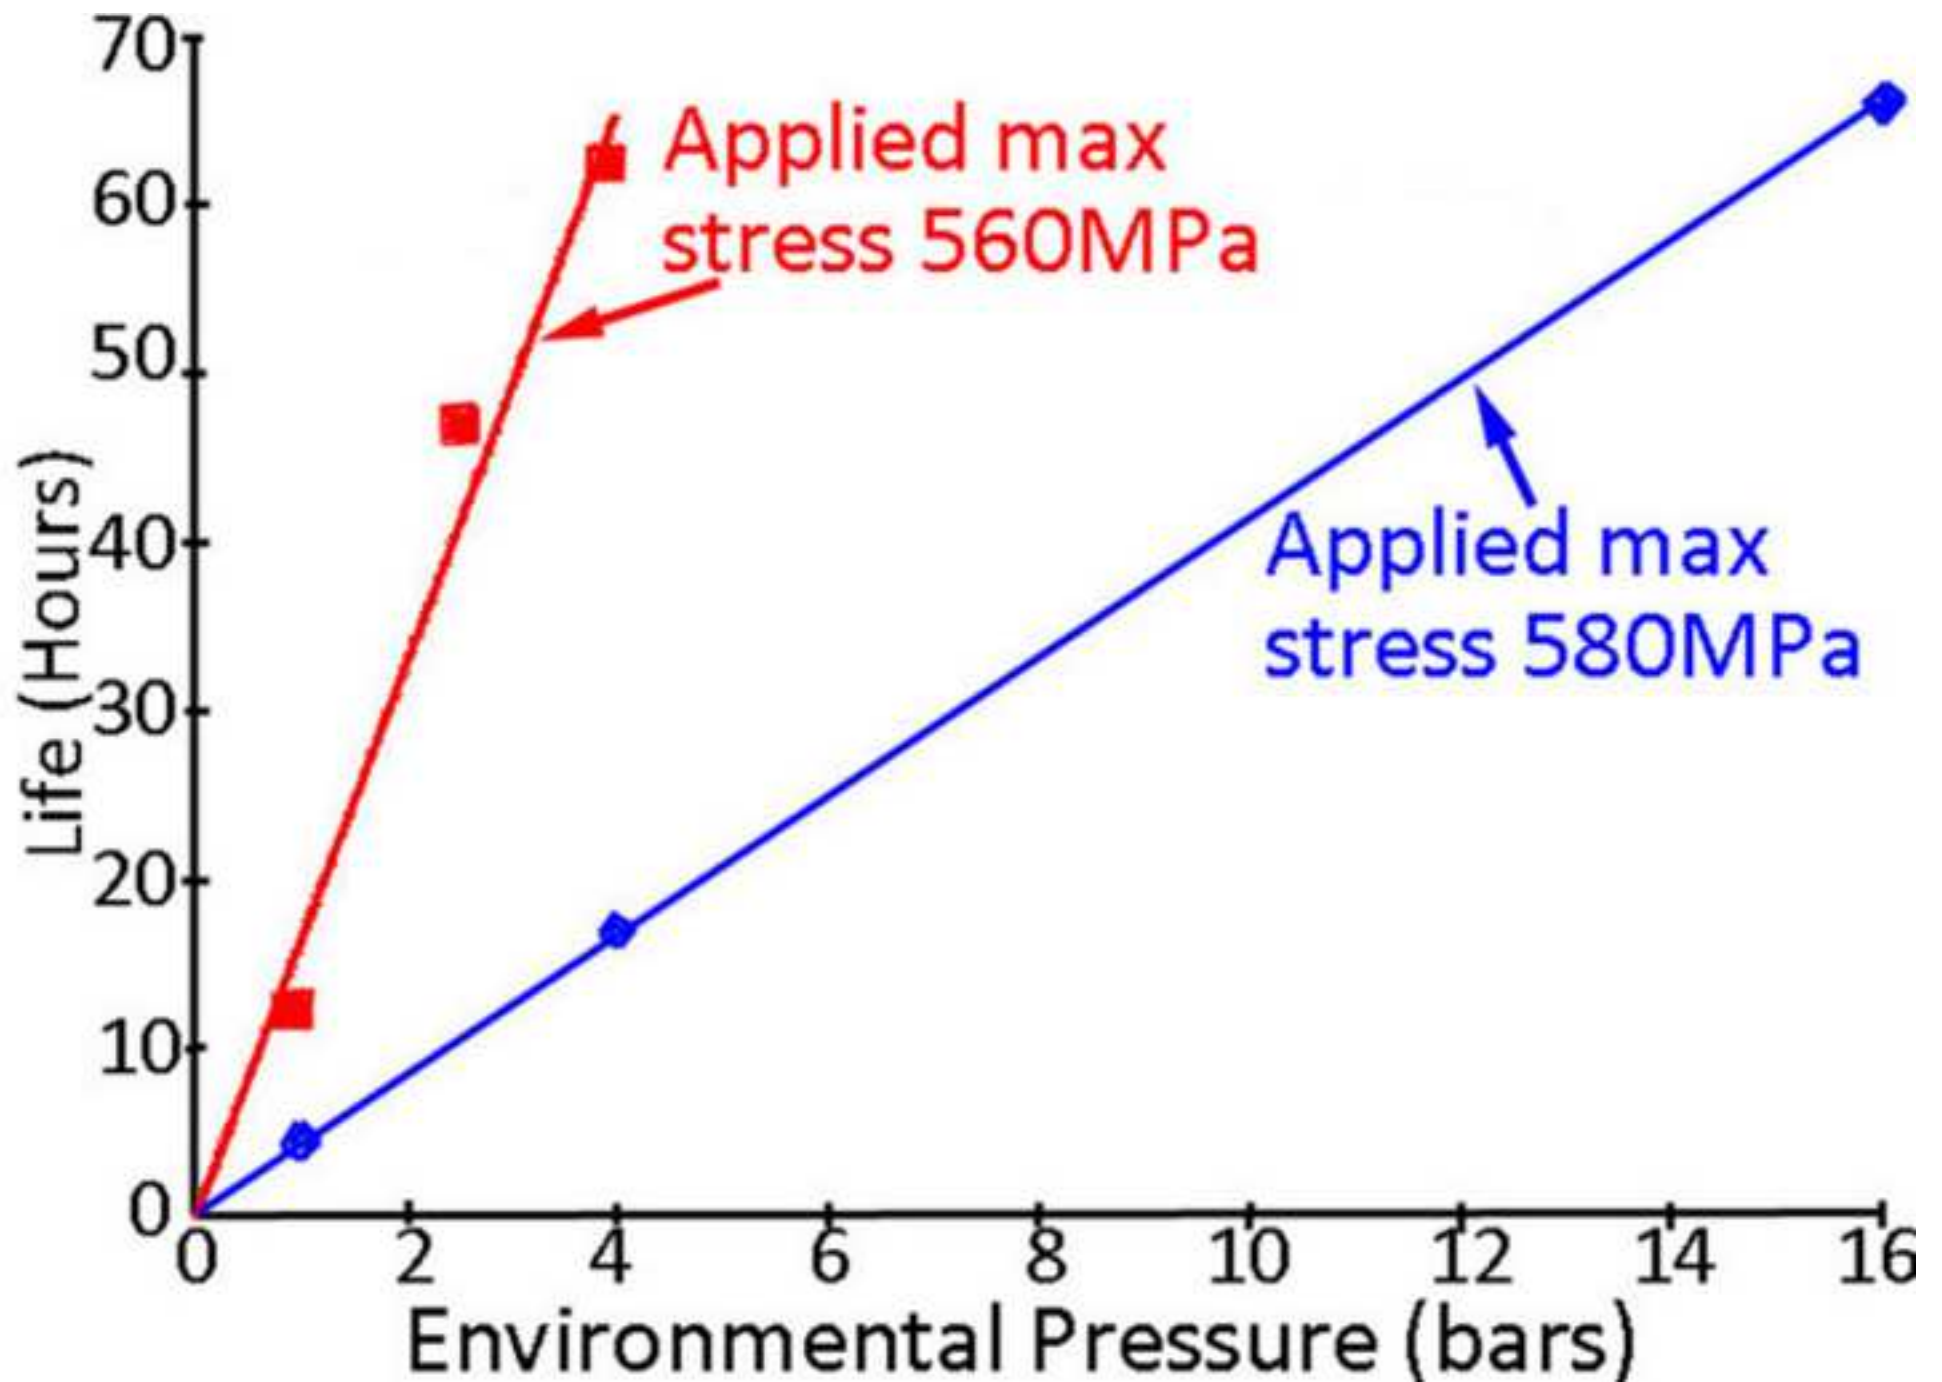
Figure 22

The above is supported by Cranfield University data from 1994 [39], which showed notable improvements in the life of salt-coated Laboratory LCF specimens with increasing pressure [39], depending on applied stress; eg. figure 22.

**Figure 22** - Demonstrating significant improvements in life with pressure for salt-coated LCF specimens (on alloy IMI834 at 500°C) – from work at Cranfield University in 1994 [39]. Two lines for two different applied stress conditions (560 and 580 MPa) are shown.
