# Risk Assessment of Fuel Quantity Indicator Replacement in ATR72 Aircraft

**R. M. Ardito Marretta\***

**J. A. "Drew" Bedson**

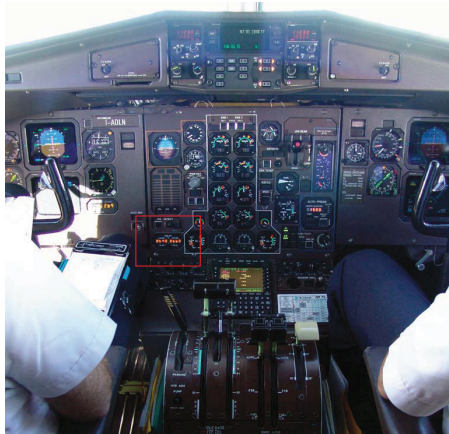
The ATR 42 and 72 aircraft utilize a similar cockpit panel. The FQI is located in the lower left quadrant of the center panel (Fig 5(a)) for both aircraft. The FQIs for both ATR 72 and ATR 42 (Fig 5(b), Fig5(c)) are built up in an exterior cartridge having the same overall dimensions. The faceplate of both the FQI for the ATR 42 and the ATR 72 have two windows with Light Emitting Diode (LED) displays indicating the quantity (in weight) of the stored fuel in each of the respective wing fuel tanks.

(a) Cockpit location of FQI on board of ATR 72

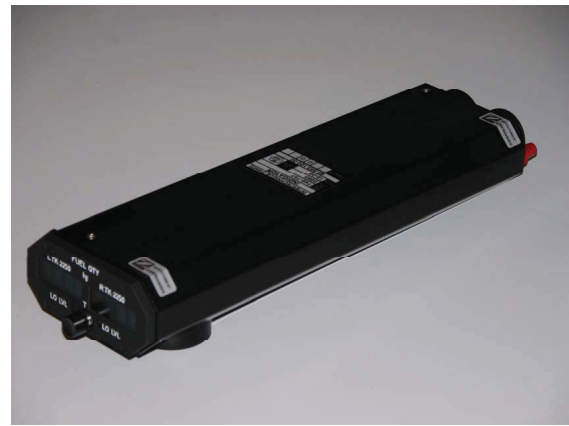
(b) ATR 42/72 fuel quantity indicator (assembly view)

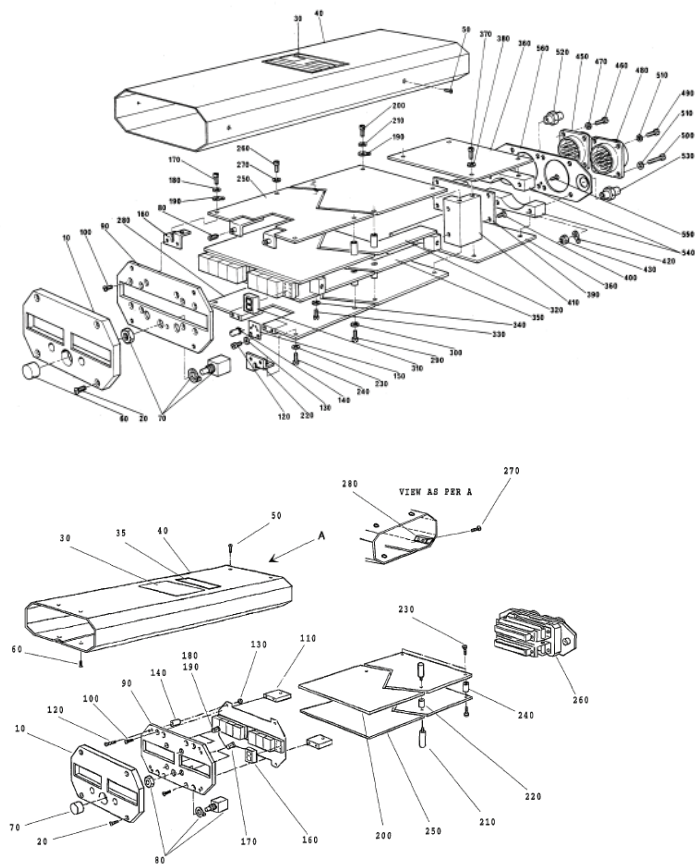
(c) ATR 42/72 fuel quantity indicator (components view)

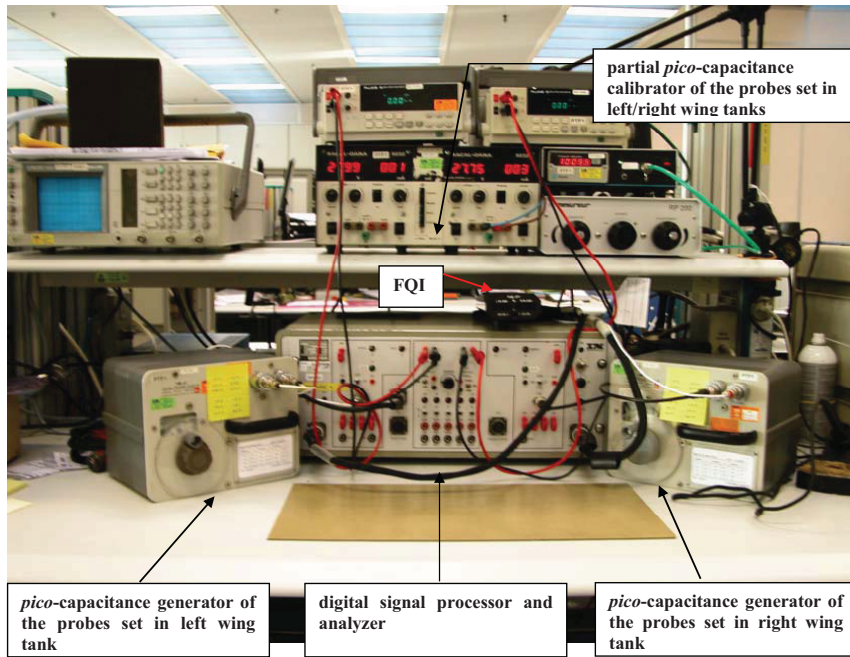
To simulate the behavior of an FQI appropriate to an ATR 42 when incorrectly installed into the cockpit of an ATR 72, the following tests were performed in a devoted test-bench (Fig 12) at the Intertechnique facility near Paris, France.

Eqs (1) and (2) were obtained by the accomplishment of ATP (CR10936 and CR10662) - previously adopted - to both the FQIs (S/N 749-158 (ATR 42) and S/N 748-681-2 (ATR 72)) on the test-bench of Fig 12. These procedures are in compliance with the Joint Aviation Authority (JAA) quality directivities for instrument evaluation (PGQ-1556). In two phases, both of the FQIs were connected to the test-bench equipment. The units were subjected to the calibration tests through a continuous variation of the input capacitance from the fuel probe-set simulators. Roughly speaking, the test-bench is used to process the basic derivation for flux linkages in tubular conductors for finding the flux linkages for both core and sheath of the tank probes according to the formulas:

**Fig. 12.** Test-bench (ATP 03P252) for FQI (ATR 72 and ATR 42) performance and functioning at Intertechnique facility (Paris, France)
