Universidade do Minho
Escola de Engenharia

Seismic behaviour and strengthening of barrel vaults of Augustinian churches in Mexico

Doctoral Thesis
Civil Engineering

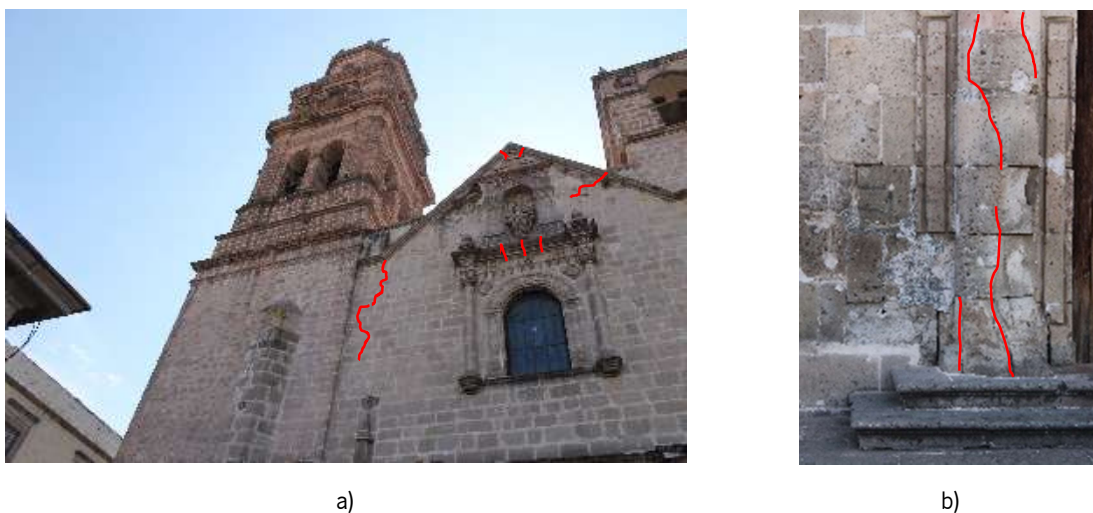
thrust of the barrel vault, since the higher damage is located at the vault's level. The building presents other types of damage, such as cracking at the base of the buttresses (**Figure 4-8a** and **Figure 4-8b**), loss of verticality at the edge of a buttress (**Figure 4-8c**) and vertical cracking (**Figure 4-8d**). Furthermore, some stones have been replaced, as shown in **Figure 4-8e**. The main façade presents two types of damage: 1) cracks due to the interaction with the towers; and 2) damage caused by environmental agents, as the presence of vegetation, the loss of material or deformations on the decorative elements (**Figure 4-9a**). These are worsened by the lack of maintenance or by the interventions using non-compatible materials, for instance, covering the missing parts of the ashlar, as in **Figure 4-9**.

Figure 4-9. Damage in the west façade: a) cracks in the connection tower-façade and at the decorative elements; b) cracks in the frame door, exfoliation at the base of the pilaster and marks of previous interventions.

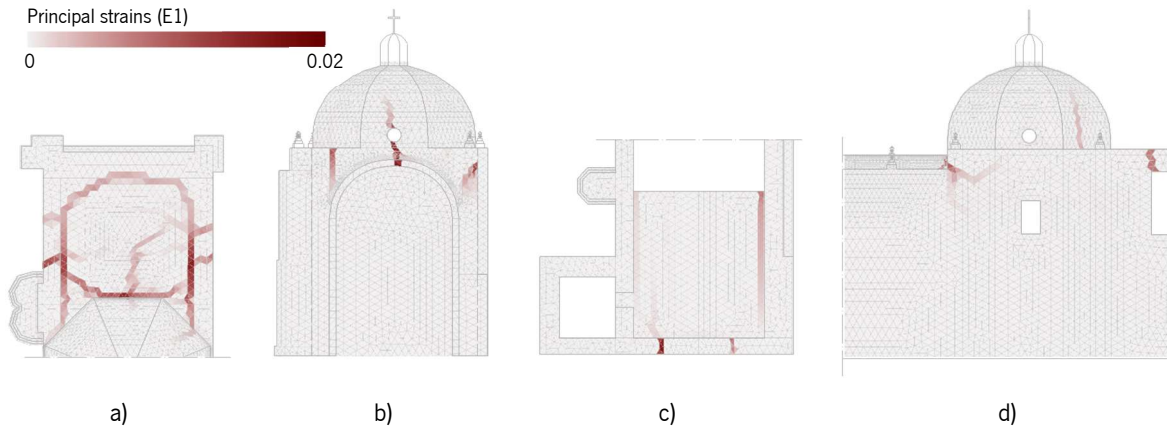
Figure 5-4. Damage in the building due to the action of the signal OAXM: a) groin vault (plan); b) transverse arch and dome (section-elevation); c) choir loft (plan); d) south wall (elevation).

After the self-weight application, the NLDA with OAXM seismic record converged until 5.3 s. The first damage corresponds to Sabouret cracks at the perimeter of the groin vault, only at the extrados (**Figure 5-4a**). Together with the opening of the transverse arches, the dome cracks vertically (east, southeast and west meridional panels) with decreasing crack-width toward the top. A crack parallel to the north wall develops in the northwest corner at the base of the dome (**Figure 5-4b**). In the next time steps, damage appears in the connections between the choir loft and the lateral walls (**Figure 5-4c**) and a longitudinal crack opens in the crown of the groin vault. In the south wall, there is an in-elevation irregularity (due to the different height levels) that causes in-plane horizontal cracks at the top (**Figure 5-4d**). In-plane damage emerges in the façade as a result of the interaction with the towers, namely two vertical cracks running from both the bases of the pediment and growing in direction of the oval windows. In addition, typical shear cracks emerge from the window of the choir loft (**Figure 5-5a**). The response of the tower triggers a vertical crack in the north wall, along the connection with the buttress (**Figure 5-5b**). At the

intrados of the barrel vault damage emerges also from the interaction with the towers, plus longitudinal cracks develop at the crown (**Figure 5-5c**). At the extrados, hinges appear at the springers. The onset of diagonal cracks in the lateral walls of the presbytery, spreading from the corners of the window (**Figure 5-5d and e**), is likely due to the global transverse response of the building.

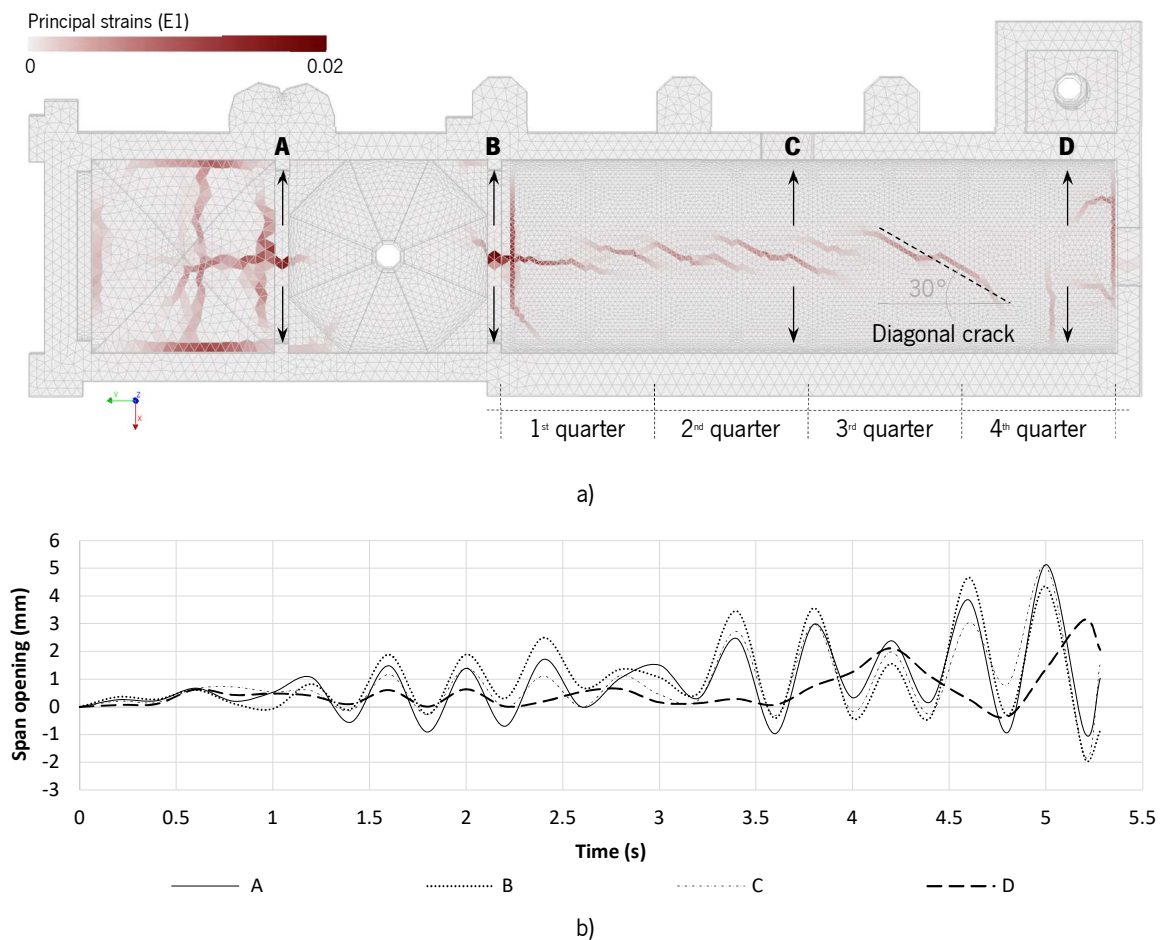
Figure 5-6. a) Damage at the intrados due to the OAXM record (last step converged); b) plot of the span openings A and B (transverse arches) and C and D (barrel vault).

The transverse response of the nave was analysed through the span openings, plotted in **Figure 5-6b**. Outward and inward deformation of the lateral walls causes damage along the building, as shown in **Figure 5-6a**. The groin vault, the transverse arches, the dome and the barrel vault are mainly affected. According to the output parameter, the span openings A, B and C reach the maximum opening at 5 s, before the analysis stops. In the case of the span opening D, the behaviour is different, since at this step no cracks are presented in the crown of the barrel vault (**Figure 5-6a**). The highest span opening suffered at section D occurs at 5.3 s, when a diagonal crack (30°) develops, located between the 3rd and 4th quarter of the barrel vault.

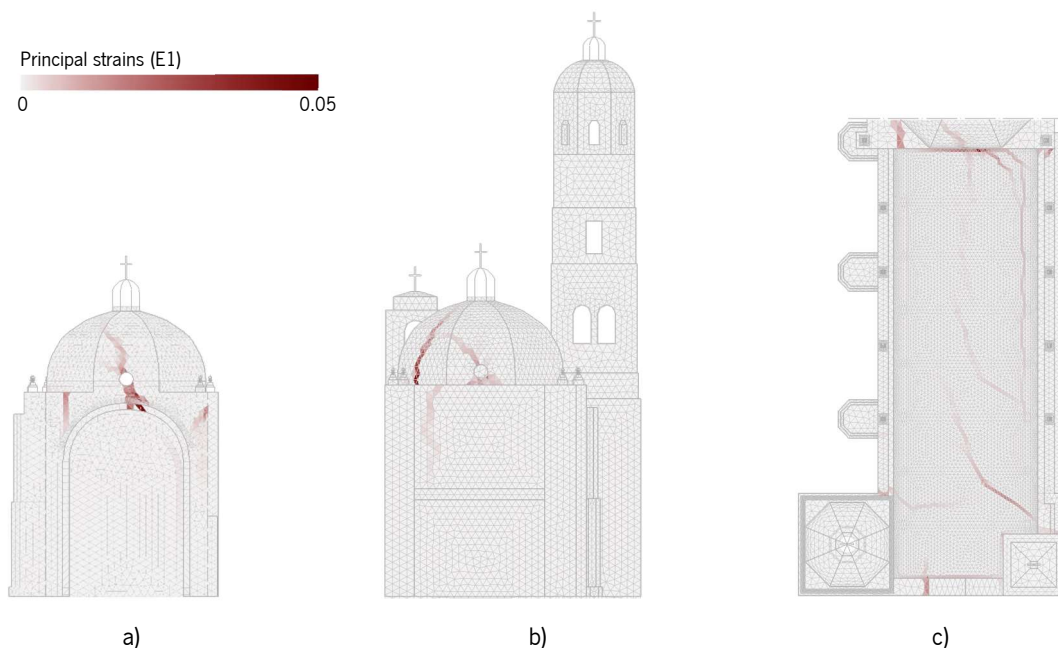
Figure 5-7. Damage in the building due to the action of the signal OXCU: a) transverse arch and dome (section-elevation); b) back wall (elevation); c) extrados barrel vault (plan).

The NLDA performed with the signal OXCU reached 4.1 s of the input. In terms of damage, similarities with the OAXM analysis were found: e.g. the Sabouret cracks in the groin vault, the damage in the northwest corner at the base of the dome; the cracks in the connections between the choir loft and the lateral walls; the compression area from the interaction of the nave and the south wall under the dome; in the façade, only the vertical crack developed from the north base of the pediment; and the diagonal cracks in the lateral walls of the presbytery. Major differences are related to the following aspects. Two hinges were detected at the crown of the transverse arches (**Figure 5-7a**). As consequence, the damage in the dome is higher than caused by the OAXM record, although causing cracks at the same three meridional panels (east, southeast and west) (**Figure 5-7a** and **b**). New damage develops in the back wall of the presbytery: a vertical crack parallel to the connection with the south wall emerges (**Figure 5-7b**). A significant longitudinal crack appears in the south haunch of the barrel vault, at the extrados (**Figure 5-7c**).

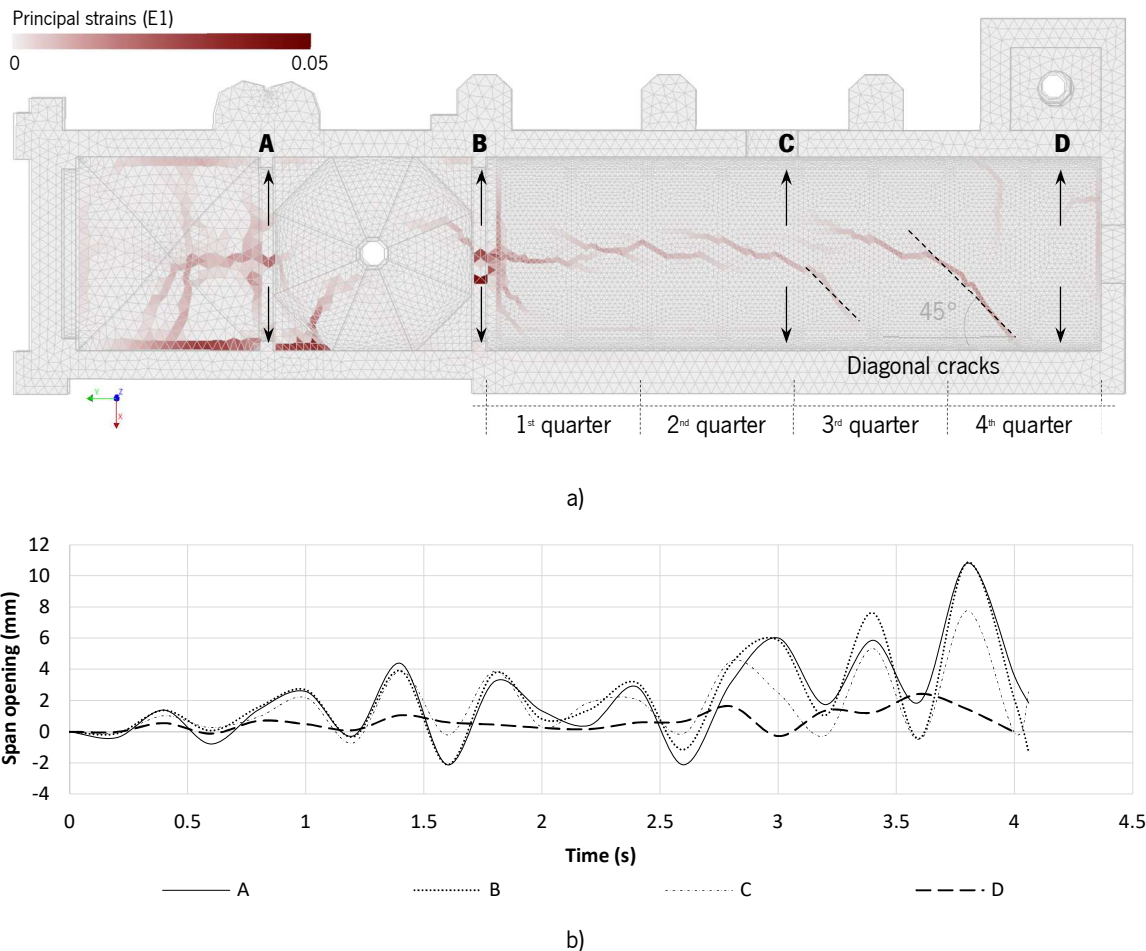
Figure 5-8. a) Damage at the intrados due to the OXCU record (last step converged); b) plot of the span openings A and B (transverse arches) and C and D (barrel vault).

At the intrados of the barrel vault, longitudinal cracks occurred, mainly at the 1st and 2nd quarter. The 3rd and 4th quarter present diagonal cracks of around 45° (**Figure 5-8a**). All the elements of the roofing system present longitudinal cracks, caused by the transverse deformation of the building. **Figure 5-8b**

shows that the maximum span openings for A, B, and C sections occur at 3.8 s. This is related to a longitudinal hinge located at the connection between the roof system and the south wall, mainly in the area of the presbytery and the dome. Regarding section D, the highest opening, detected at 3.6 s, is associated with the evolution of the vertical cracks both in the façade and in the connection between the north wall and the north tower.

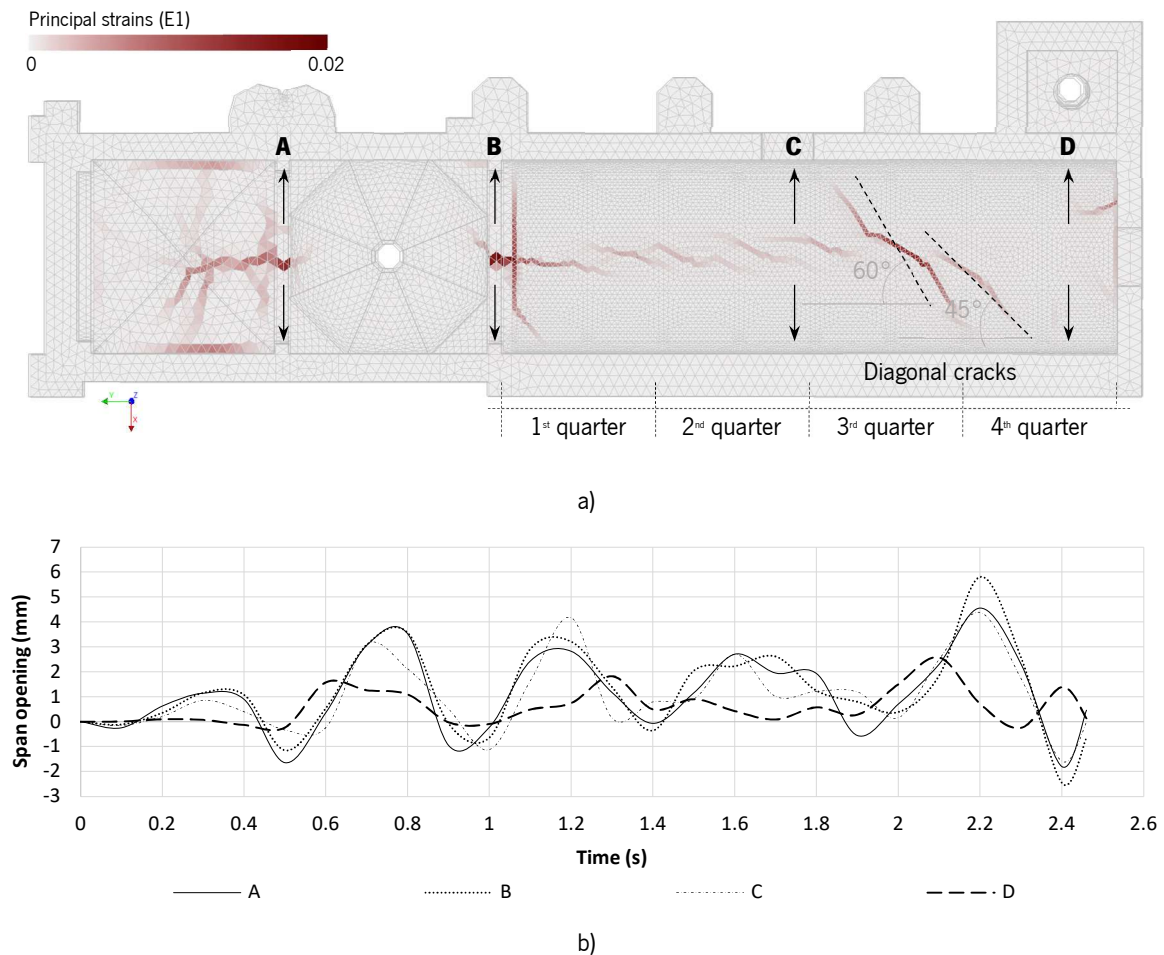
Figure 5-9. a) Damage at the intrados due to OXJM record (last step converged); b) plot of the span openings A and B (transverse arches) and C and D (barrel vault).

This analysis was performed for 5 s of the input. The damage obtained is comparable to the previous analyses (OAXM and OXCU). The groin vault suffers the Sabouret cracks; the transverse arches present hinges at the crown; the dome is damaged in the east and west meridionals; the vertical crack in the

façade runs from the north base of the pediment; in the connection between the north wall and the tower presents a vertical crack; in the south wall, the interaction between the nave and the dome presents the same type of in-plane damage; the choir loft shows cracks in the connection with the lateral walls; the lateral walls of the presbytery present as well diagonal cracks. However, this analysis presents some differences: the east transverse arch presents two hinges at the crown while the east only one; the damage at the dome is lower than the damage observed in the two previous analyses; the diagonal crack at the south wall of the presbytery is larger than the damage emerged in the north side. **Figure 5-9a** shows the damage at the intrados of the roofing system due to the OXJM signal. The longitudinal damage in the 1st and 2nd quarter of the barrel vault consists of parallel cracks more similar to the ones caused by OAXM analysis, while the diagonal cracks seem to be different from both previous analyses (OAXM and OXCU).

In **Figure 5-9b**, the plot of the span openings indicates a large opening around the 0.8 s, which corresponds to an evolution of the damage in the crown of the transverse arches, affecting mainly sections

A and B, but still detected at section C. Regarding section D, the first opening (0.6 s) is associated with the enlargement of the vertical crack located at the façade, increasing (0.7 s) due to the vertical crack at the connection between the north wall and the north wall. However, the highest openings for sections A, B, and C occurs at 2.2 s. This damage is related to the diagonal crack located in the 3rd and 4th quarter. At 2.1 s, section D shows a high value (smaller than the maximum for the other sections) related to the evolution of damage at the barrel vault and interaction with the south tower.

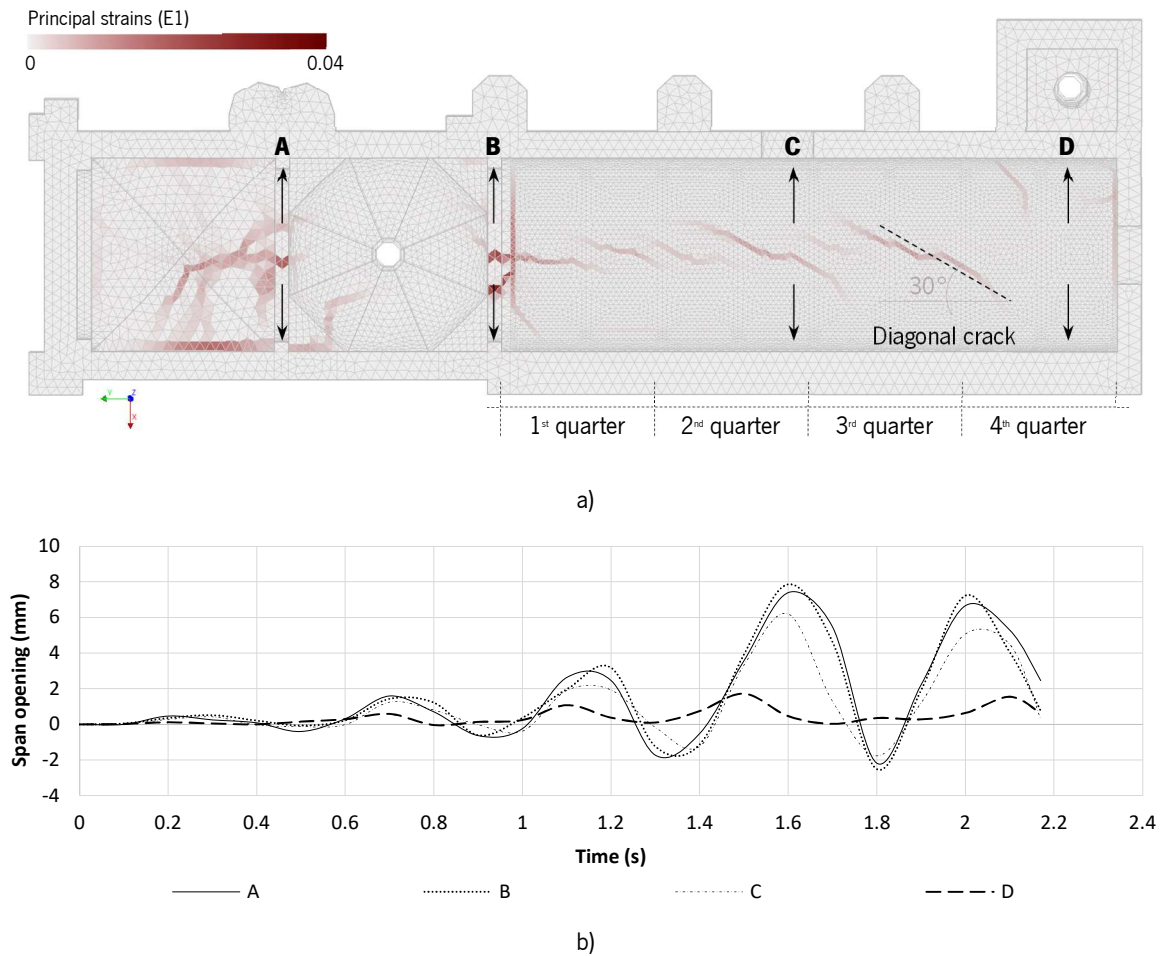
Figure 5-10. a) Damage at the intrados due to OXXO record (last step converged); b) plot of the span openings A and B (transverse arches) and C and D (barrel vault).

The OXXO earthquake was the fourth applied signal that caused a similar crack pattern. The main similarities are associated with the main damages described in the previous Sections, such as the cracks at the presbytery (groin vault and lateral walls), transverse arches and dome, façade, choir loft and barrel vault. Although differences exist, this Section (and the following ones) will focus on relating the damages with the span opening. **Figure 5-10a** presents a view of the final damage state for the seismic action OXXO while **Figure 5-10b** shows the plot of the span openings for the known indicators. At 1.2 s, the damage develops along the roofing system, and the span opening in sections A, B and C are affected by longitudinal cracks of the 1st and 2nd quarter of the nave and the cracks located at the crown of the transverse arches. At 1.6 s, sections A, B and C openings are in a range from 6 to 8 mm and damage occurs: 1) a diagonal crack appears, mainly in the 3rd quarter of the vault; 2) new hinges develop in the transverse arches; and 3) a diagonal crack opens at the south wall on the presbytery. At 2 s, a continuum hinge is developed in the longitudinal direction, namely at the connection of the groin vault with the south wall. This crack develops from there to the east-west meridional panel. Finally, in the crown of the west arch, a new hinge is also developed at this stage. Regarding the span opening at section D, the maximum values are lower than 2 mm. Two aspects identified in section D can be highlighted: around 1.5 s, a vertical crack develops at the connection of the north tower with the lateral wall; at 2.1 s, damage at the barrel vault increases and is connected to the crack of the north wall.

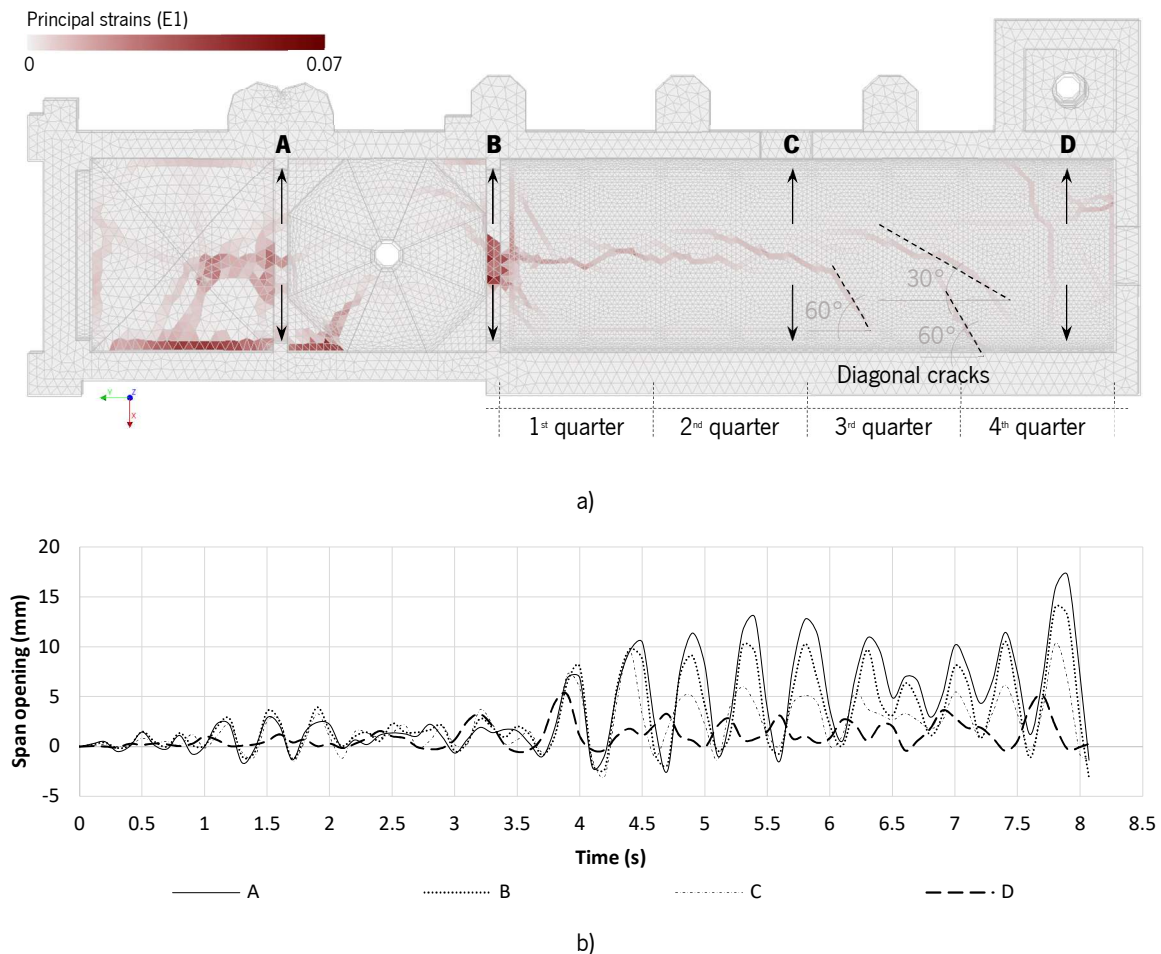
Figure 5-11. a) Damage at the intrados due to SAPP record (last step converged); b) plot of the span openings A and B (transverse arches) and C and D (barrel vault).

In the analysis performed with the record SAPP, a total duration of 8 s was reached. The maximum principal strains (E1) are higher than the ones obtained in the previous analyses. Around 4 s, all the span openings are almost synchronised, namely the peaks of the response. This is related to a sudden development of damage along the roofing system, creating longitudinal cracks at the barrel vault and the groin vault. At the same time, the hinges located at the crown of the arches increase their opening and damage appears at the dome, namely at the southeast meridian panel. A vertical crack at the connection of the north tower and the north wall appears, mainly affecting the span opening at section D. At this stage of the analysis, the principal strains (E1) reached maximum values of 0.03. From then on, the

analysis continues by opening and closing the same cracks, incrementing the principal strains to 0.07, as shown in **Figure 5-11a**.

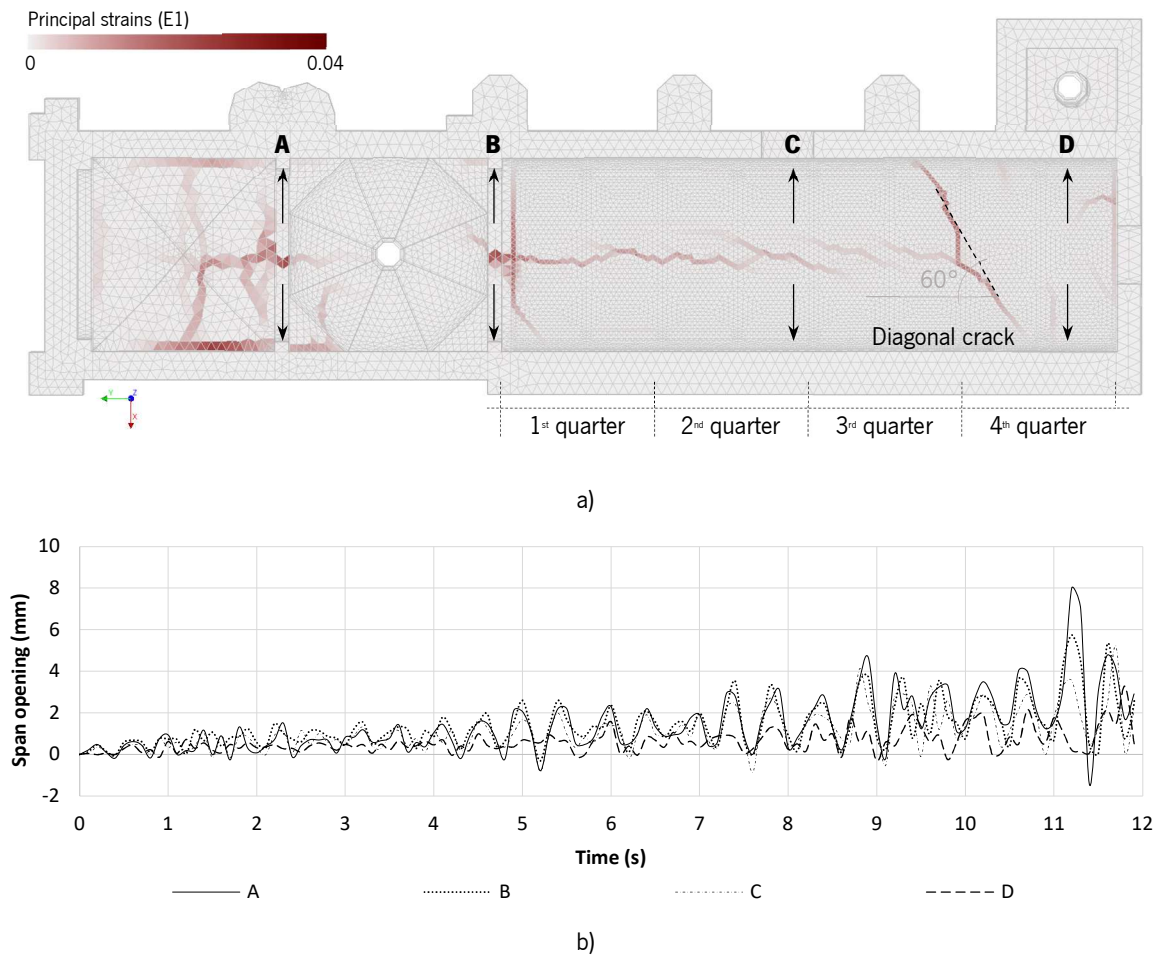
Figure 5-12. a) Damage at the intrados due to SCRU record (last step converged); b) plot of the span openings A and B (transverse arches) and C and D (barrel vault).

The analysis with the record SCR converged until almost 12 s of the earthquake duration. According to the plot in **Figure 5-12b**, in the first 4.5 s of the analysis, the openings stay within a range of 2 mm. At this point, an early stage of damage is developed along the roofing system, namely, Sabouret cracks at the groin vault, hinges at the crown of the transverse arches that extend to the dome, and longitudinal cracks in the barrel vault. After 11 s, the highest opening is equal to 8 mm at section A, 6 mm at section B and almost 4 mm at section C. This is related to a sudden evolution of the damage: 1) a longitudinal

crack, located at the connection between the groin vault and the south wall; 2) a diagonal crack (located at the same wall); and 3) cracks at the southeast meridional panel of the dome. In addition, an evolution of the diagonal crack located within the 3rd and 4th quarter of the barrel vault is also observed. Regarding the span opening at section D, the maximum value is reached almost at the end of the plot, at around 11.8 s. At this point, the diagonal damage of the barrel vault reaches its ultimate state, developing vertical cracks in the north wall, at the connections with the buttress and the tower. A meaningful difference to the previous results is worth mentioning: the duration of the analysis is longer; therefore, the severity of the damage is not just due to a sudden deformation but, it is also a consequence of constant and continuous evolution.

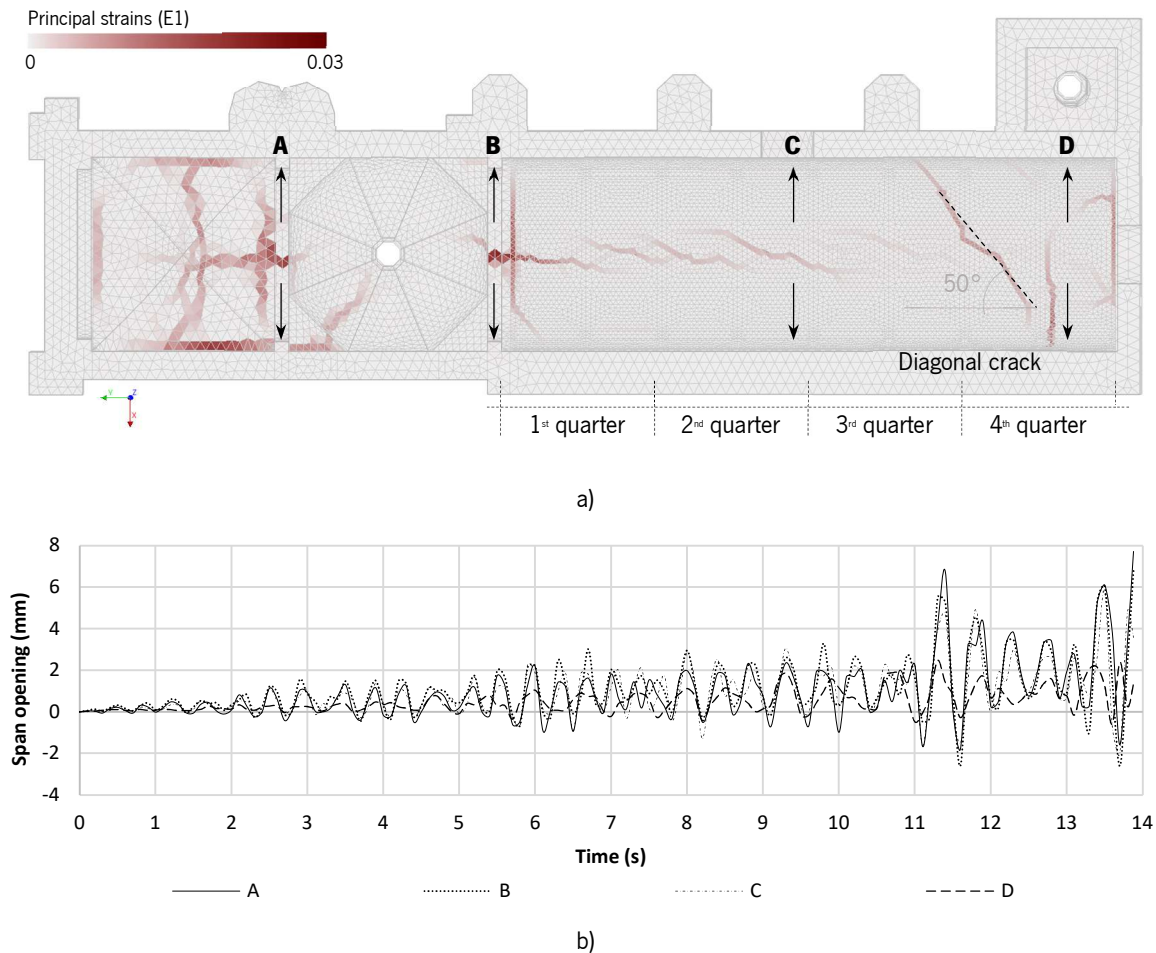
Figure 5-13. a) Damage at the intrados due to RFPP record (last step converged); b) plot of the span openings A and B (transverse arches) and C and D (barrel vault).

The results obtained for the analysis with the RFPP earthquake are similar to the ones obtained with the SCRU earthquake. For this analysis, the span openings stay lower than 2 mm until 5.5 s. After that, the oscillations reach values around 3 mm until at 11 s. During this part of the analysis, the damage evolves smoothly. It is at around 11.5 s that one of the maximum openings occurs, presenting a maximum value of almost 7 mm. This deformation results of the evolution of the damage located at the groin vault and the development of the diagonal crack located between the 3rd and 4th quarter of the barrel vault. The opening at section D, which occurred at 11.3 s, is related to damage at the barrel vault and its interaction with the south tower.

At 13.5 s, sections A, B and C reach values around 6 mm, which is associated with the development of the diagonal crack at the south wall of the presbytery, the damage emerging at the southeast meridional panel of the dome, and the evolution of the damage in the transverse arches and barrel vault. In the last step of the analysis, a second hinge appears at the crown of the east transverse arch causing an increase of the span opening at section A.

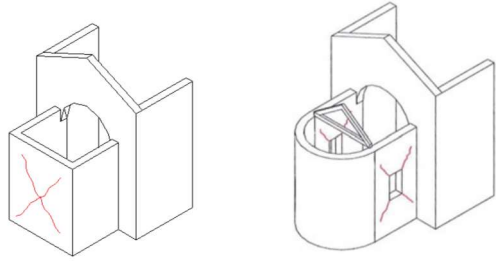
Figure D - 17. M.17 Shear mechanisms in the walls of the presbytery or apse (DPCM, 2015).

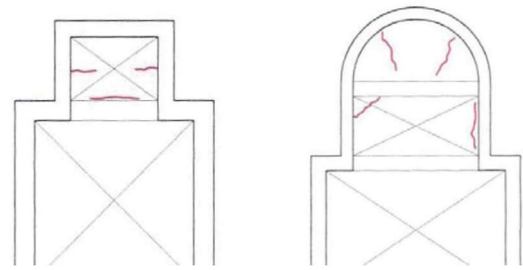
Figure D - 18. M.18 Vaults of the presbytery or apse (DPCM, 2015).

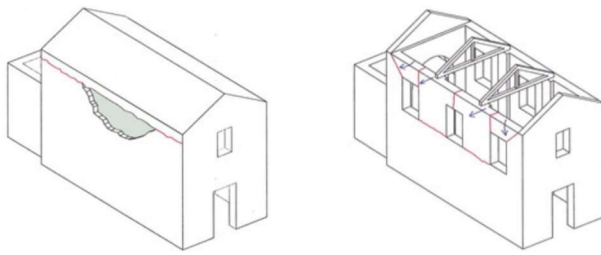
Figure D - 19. M.19 Roof elements: nave (DPCM, 2015).

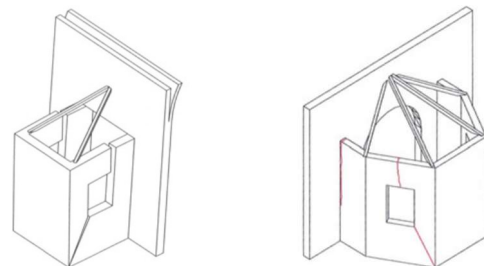
Figure D - 22. M.22 Overturning of the chapels (DPCM, 2015).

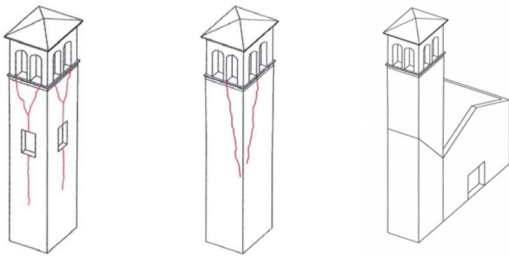
Figure D - 27. M.27 Bell tower (DPCM, 2015).

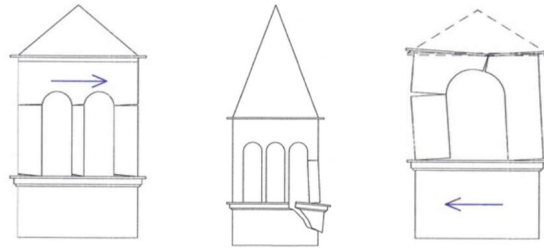
Figure D - 28. M.28 Belfry (DPCM, 2015).

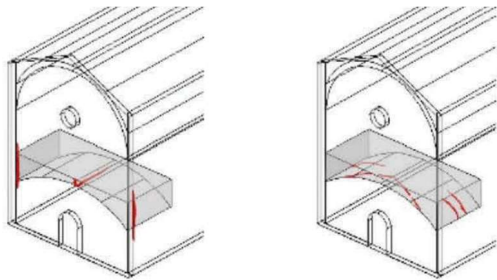
Figure D - 29. M.29 Choir loft (Fuentes et al., 2019)

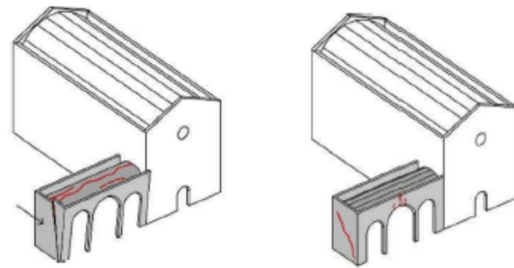
Figure D - 30. M.30 Open chapel (Fuentes et al., 2019).
