The Carmine Maggiore Bell Tower: An Inclusive and Sustainable Restoration Experience

Mariano Nuzzo ¹

and Giuseppe Faella ^{2,*}

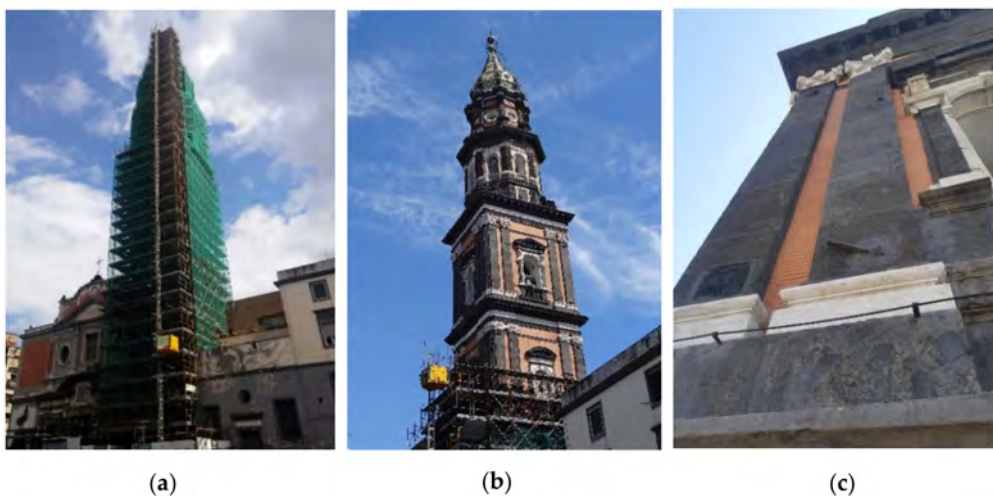
Figure 2. The bell tower with the scaffolding (a), during the dismantling of the scaffolding (b) and after completion of works (c).

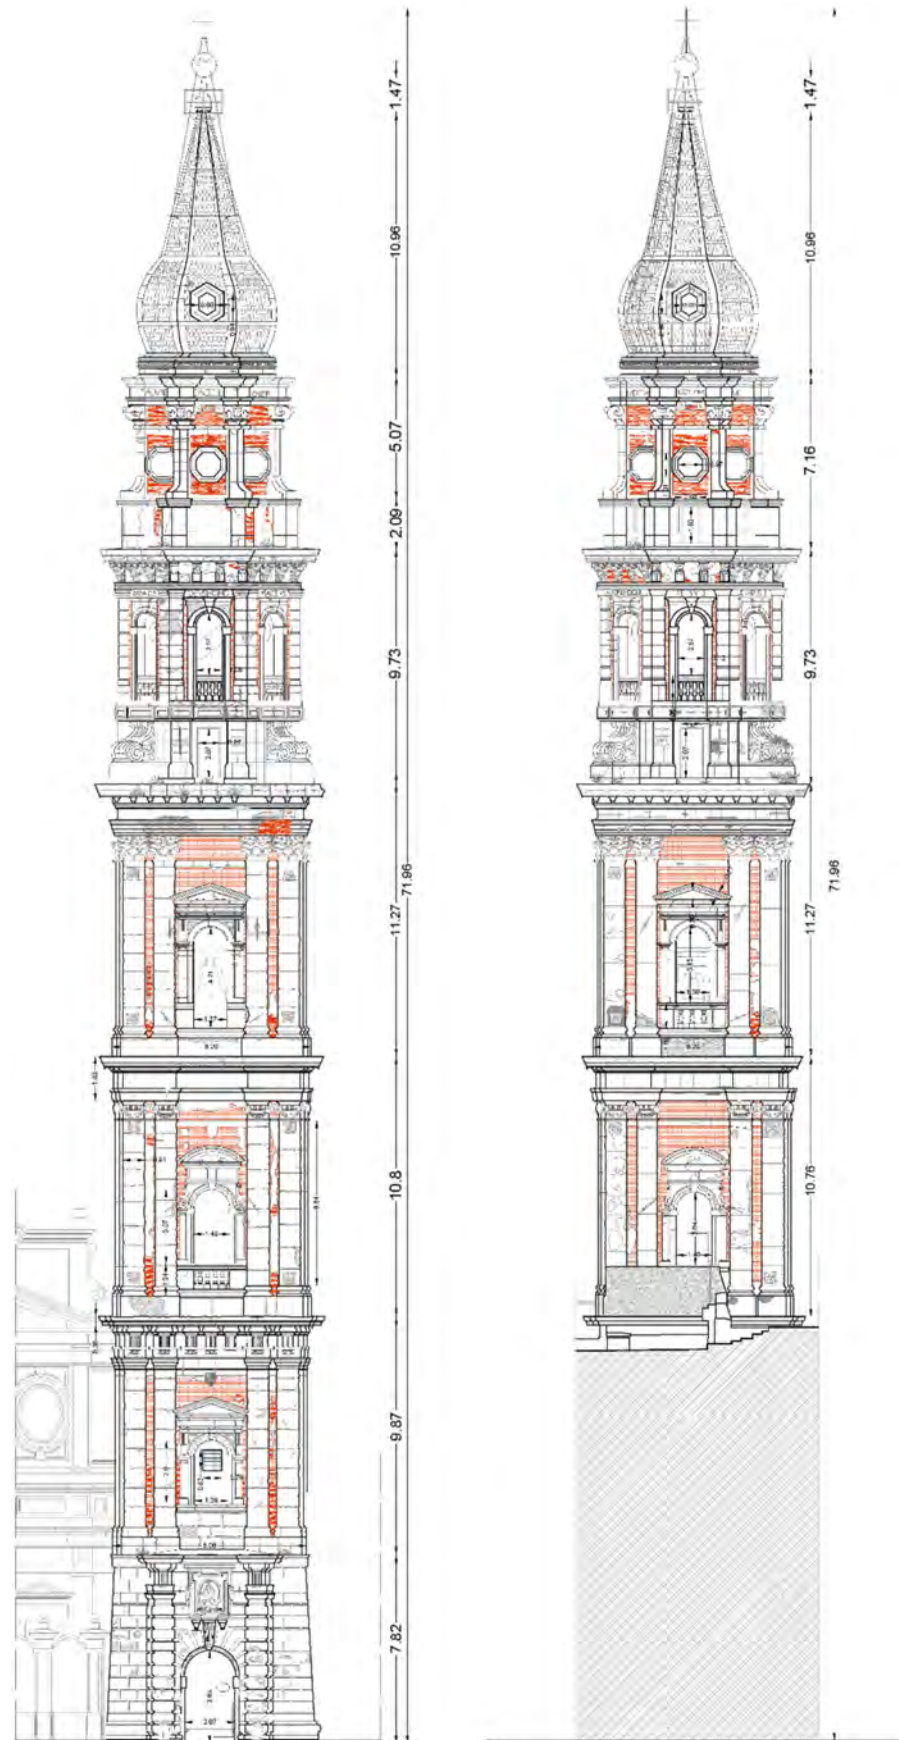
This traditional construction technique, which arranges more resistant and heavier materials at the base, can also be found in later structures. In particular, an extraordinary example of this “Vanvitellian School” is the bell tower of the Corpus Christi Basilica of Maddaloni: it was built using increasingly lighter materials from the base to the roofing pear [34], providing a pyramidal structural behavior to the bell tower [18]. It cannot be excluded that the original building typology of the “Carmine Maggiore” bell tower had similar characteristics to the Maddaloni bell tower, considering the numerous tampering that it underwent over time (Figures 3 and 4).

Figure 3. Bell-tower: west and east façade.

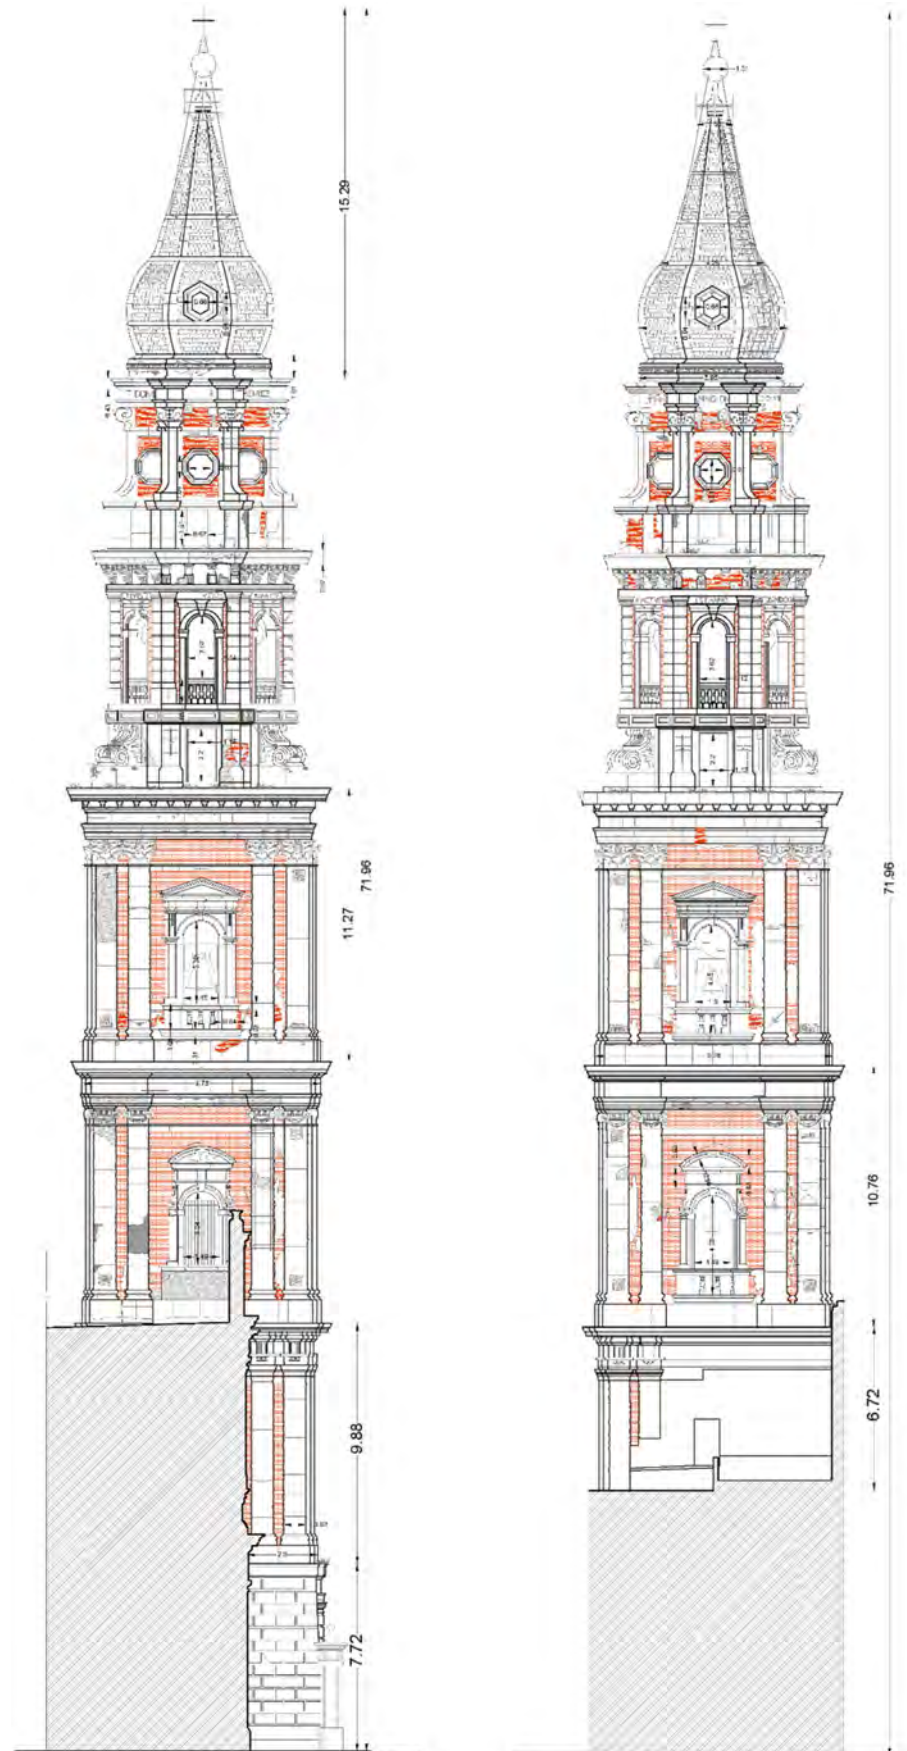
Figure 4. Bell-tower: north and south façade.

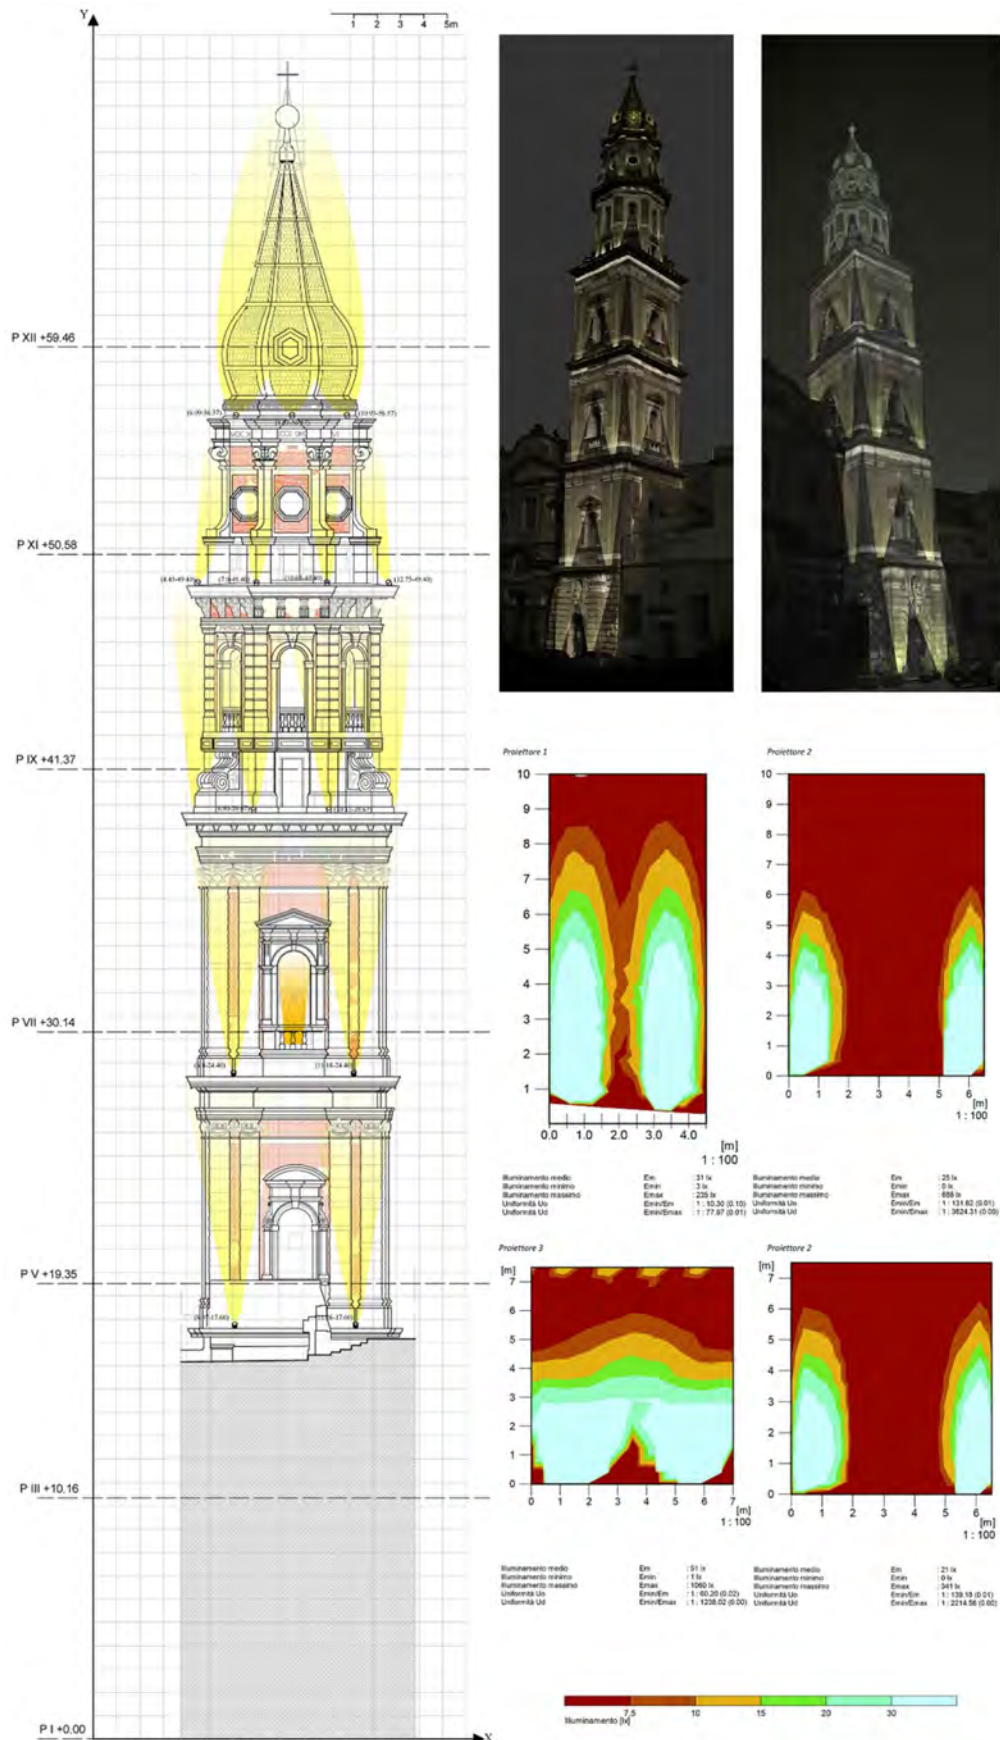
The lighting of the upper part of the bell tower was divided into three zones: the belfry is illuminated by spotlights placed on the projecting cornices, while the friezes above are illuminated by lights placed on the cornices of the floors. The pear-shaped top is illuminated by projectors located on the drum cornices (Figure 11).

Figure 11. East façade: The lighting project.

All lighting fixtures are LED, with low energy consumption, as a sustainable design requires. Moreover, particular attention was paid to the reduction of light pollution: in fact, both the lighthouses positioned outside and inside the bell tower almost exclusively affect the bell tower itself, except for the lighthouse that illuminates the top cross. The projectors were installed by stainless steel brackets, fixed to the cornices.
