NON DESTRUCTIVE TESTING OF STRUCTURES

Part1: Masonry Arch Bridges

Zoltan Orban

APPENDIX 2: Case studies **47**

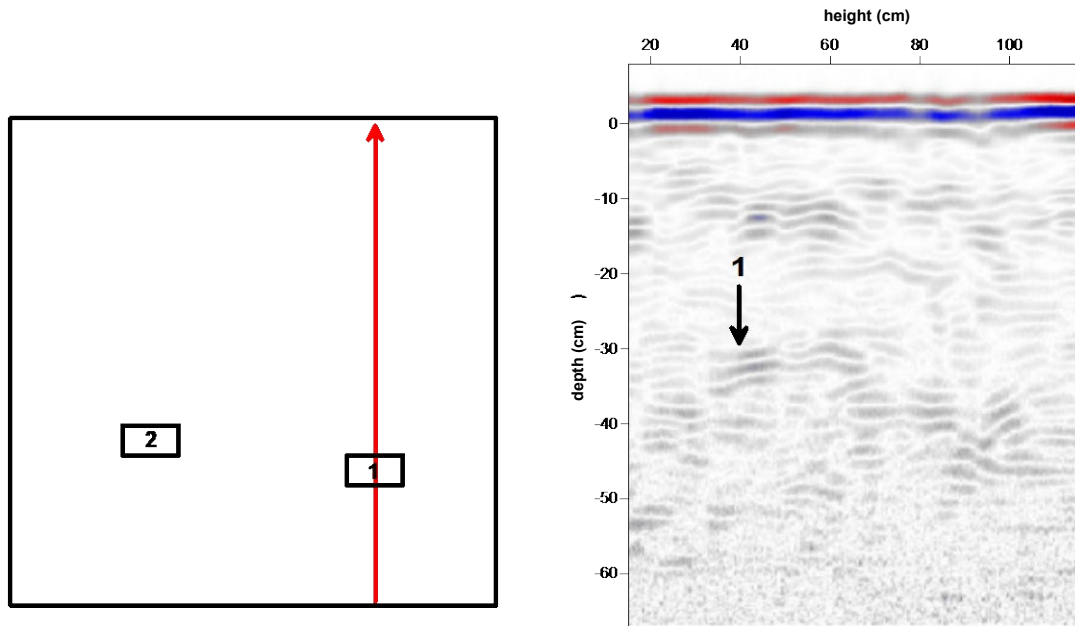
Figure 13. The effect of the 1st anomaly on the radargram of F2 wall

Although the missing brick is visible in *Figure 13*, there are also other signals with similar amplitudes in the section. The greatest reflection is located at the 44th cm of the section in the depth of 12.4 cm. The fact that this has a higher amplitude than that coming from the surveyed anomaly can be considered normal, since the signal attenuates significantly in the wall, therefore the effect of the closer smaller parameter contrast could as well be higher than that of the greater change further away. However, we cannot account for the phenomenon that in the same depth the extent of the reflection located right from the arrow is nearly similar to that of the signal reflected from the part that lacks bricks.

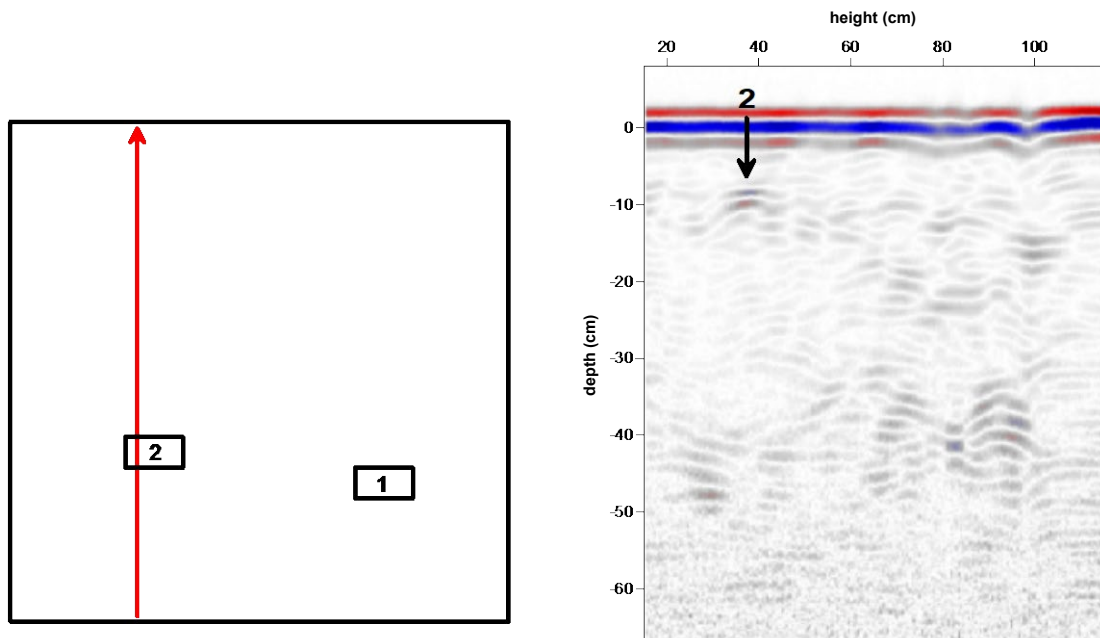
Figure 14. The effect of the 2nd anomaly on the radargram of F2 wall

In Figure 14 the 2nd anomaly can be seen clearly with high amplitude. Despite the high attenuation in the wall there is a surprisingly strong reflection at the 92.5th cm of the section in a depth of 35 cm. The origin of this is unknown. There are significant reflections in the depth

ranges of 8-15 cm and 18-25 cm, although they are lower than that of the 2nd anomaly. These are not artificial defects, these inhomogeneities created during the building of the wall which result in significant reflections whose amplitudes can be compared to those from the cavity, although they are somewhat lower.

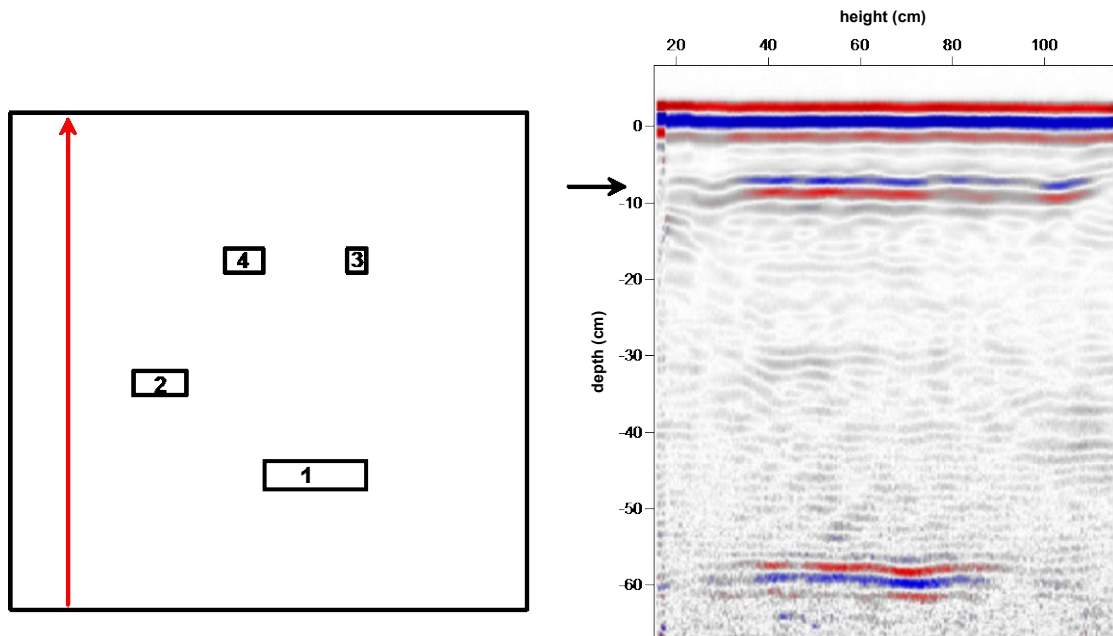
Figure 16. Radargram of the undisturbed part of F3 wall

Figure 16 shows a section that was recorded on the defect-free part of the 1-brick-thick test wall. A strong reflection arrived at the receiver from the back side of the wall that was marked by a black arrow. The amplitude of the signal is much higher than those that we have seen during the previous measurements due to the high parameter contrast and small thickness of the wall. It is clearly visible that the strength of the reflections changes along the wall, there is an edge effect at the top and bottom edges of the wall, while the lower amplitudes over the middle part are presumably due to moisture.

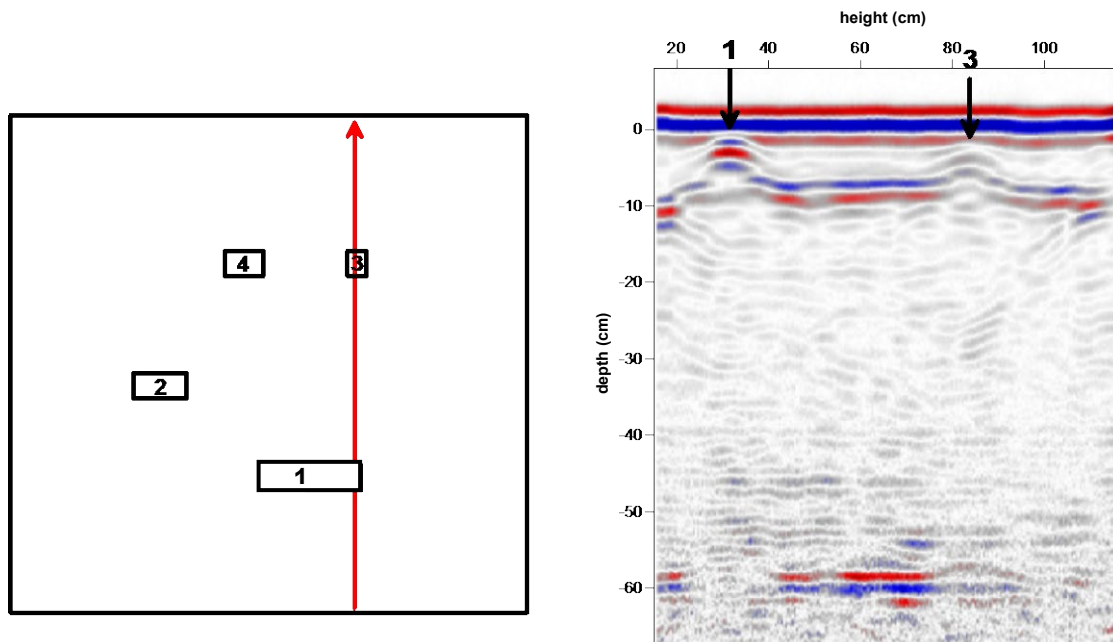
Figure 17. The effect of the 1st and 3rd anomalies on the radargram of F3 wall

Both of these anomalies can be seen well in the recorded section shown in *Figure 17*. This is due to the fact that they are located not too deep in the 1-brick-course thick test wall. The 3rd anomaly is so strong that it screens the wall behind it in a bigger area, and the smaller one also covers the air-brick boundary behind it. The reflection coming from the bigger cavity is much stronger than the one coming from the smaller one.

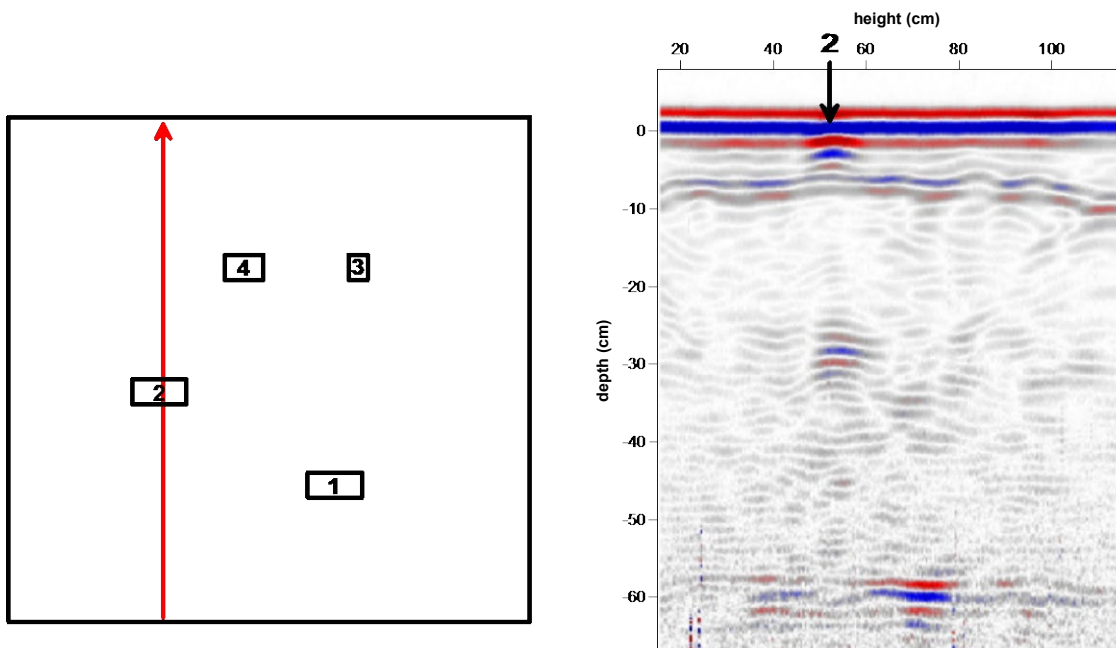
Figure 18. The effect of the 2nd anomaly on the radargram of F3 wall

The 2nd anomaly is clearly visible in Figure 18. Due to the small depth, the first phase of the wave interferes with the first arrival, but due to its high amplitude the reflection coming from the cavity is clearly visible. Under this, at the depth of about 26 cm there is another anomaly. This, however, is not coming from the wall, since its thickness is smaller. Most probably, the wave got reflected from another object behind the wall.

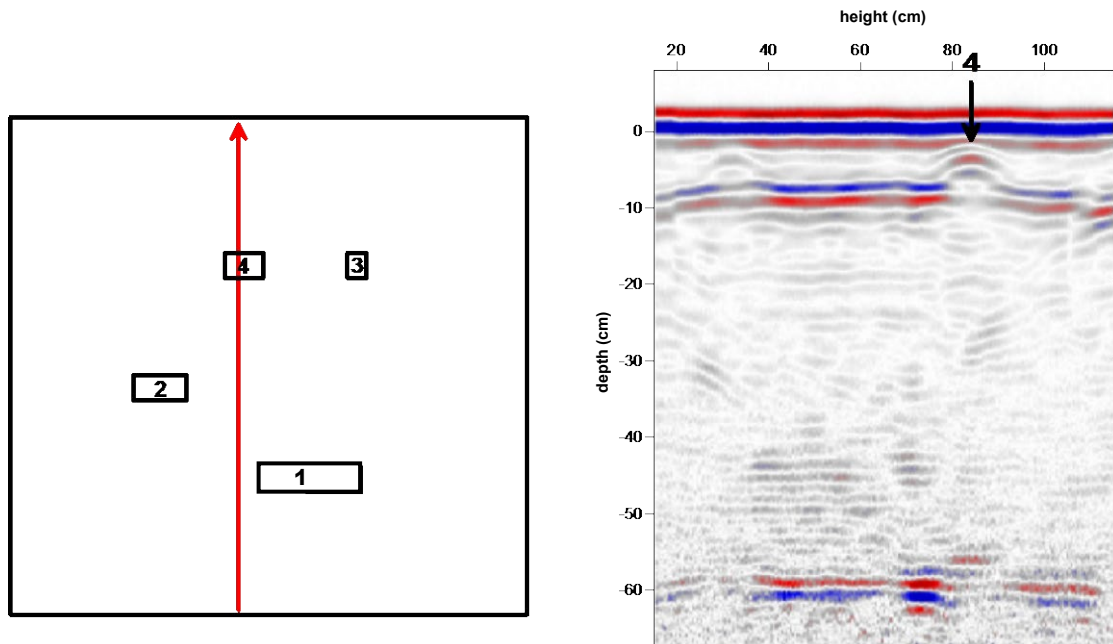
Figure 19. The effect of the 4th anomaly on the radargram of F3 wall

Figure 19 shows the recorded section in which the 4th anomaly can be seen. The reflection of the cavity marked by a black arrow is so strong that it screens the part of the wall behind it. There is another anomaly visible in the recorded section, at the same depth with the 4th anomaly, at the height of about 30 cm. This is weaker than the previous one, but it is clearly visible, with slightly lower amplitudes. The reason for the second reflection is unknown but it is possible that it is due to a natural inhomogeneity produced during construction.

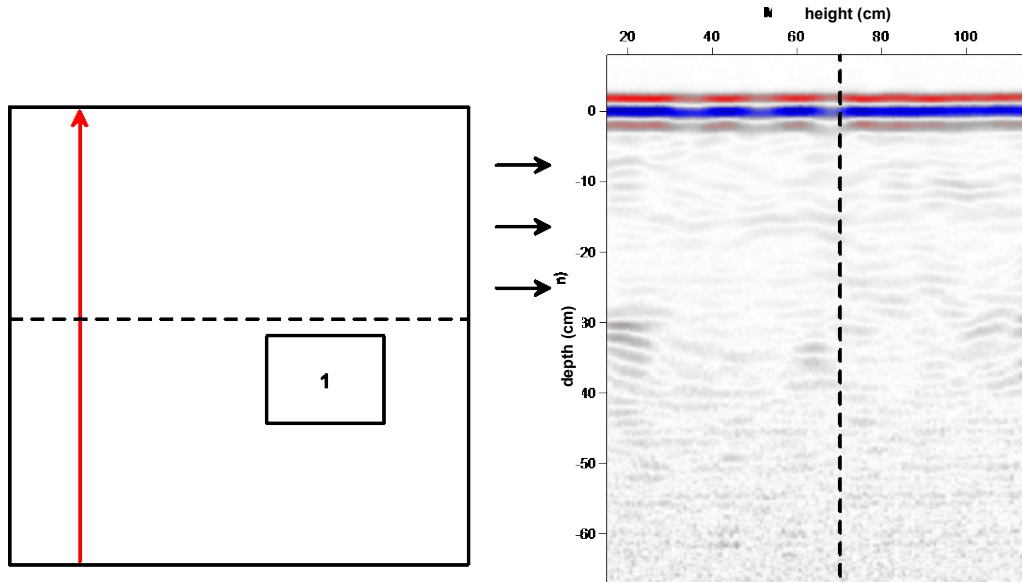
Figure 21. Radargram of the undisturbed part of F4 wall

In *Figure 21*, the identified brick courses are marked by a black arrow. The effect of the air gap is significant both in terms of amplitude and phase. The amplitudes of the signals coming from the joints filled with binding material are smaller than those of the ones coming from the air gap. In theory the expected reflection from the brick-air boundary is higher by a magnitude order. This, however, is not obvious in the section due to the destructive interference of the signal coming shortly after from the air-brick boundary.

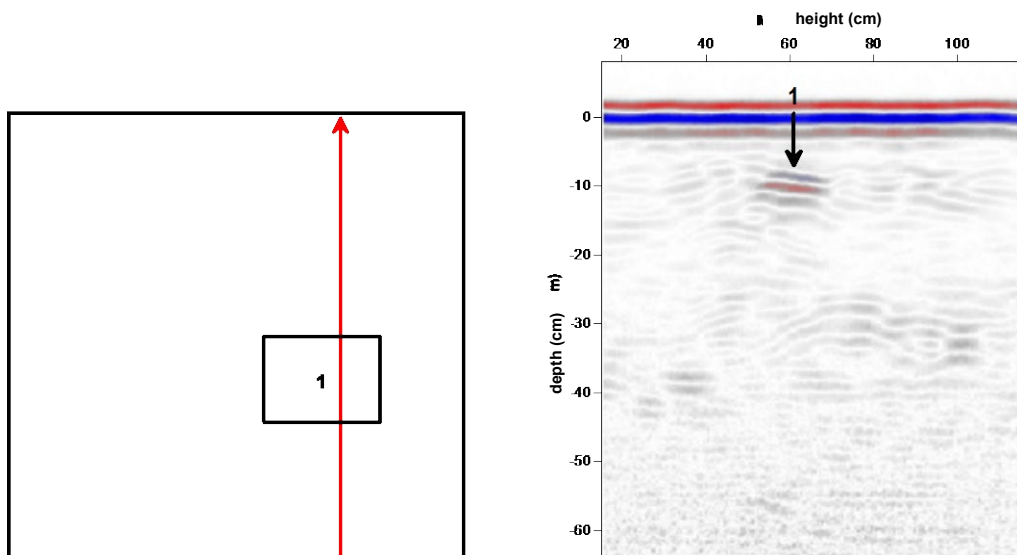
Figure 22. The effect of the 1st anomaly on the radargram of F4 wall

In *Figure 22*, the cavity that is much bigger than the previous ones is marked by a black arrow. The reflection is very strong and clearly visible.

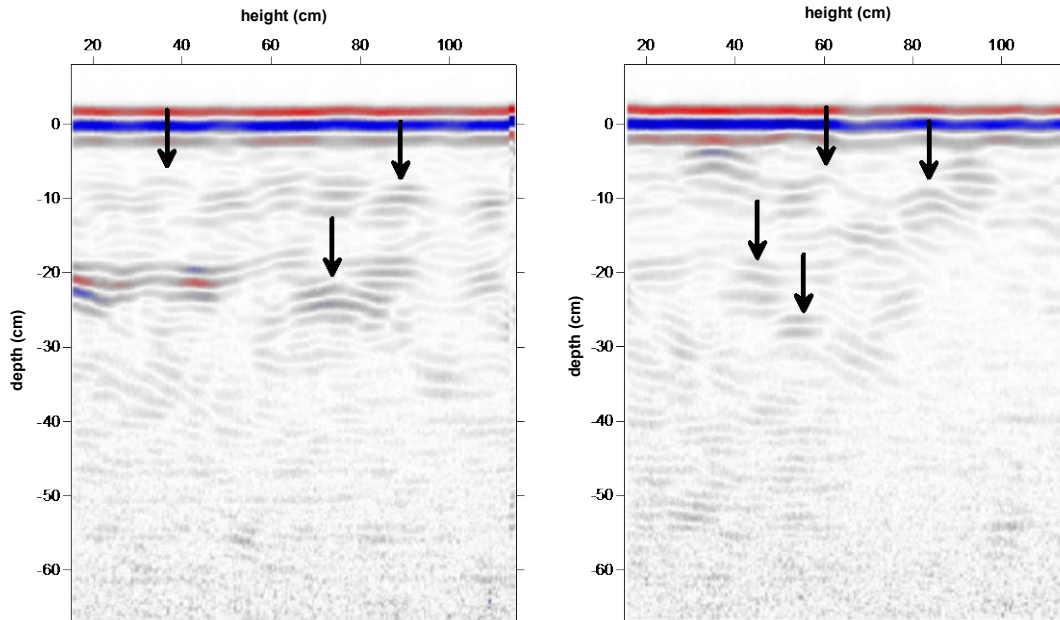
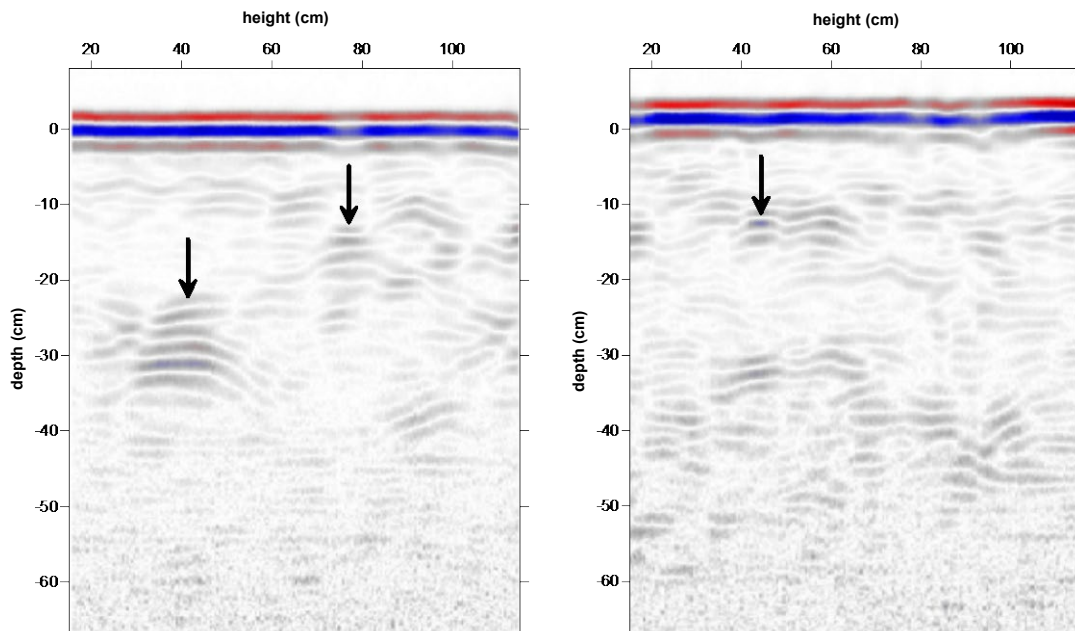
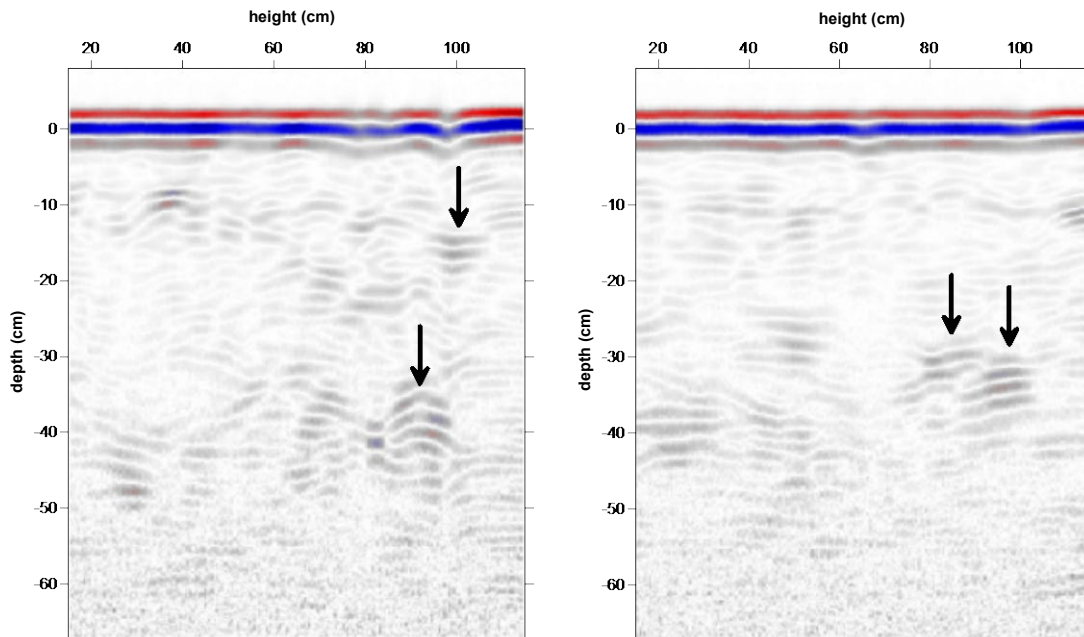
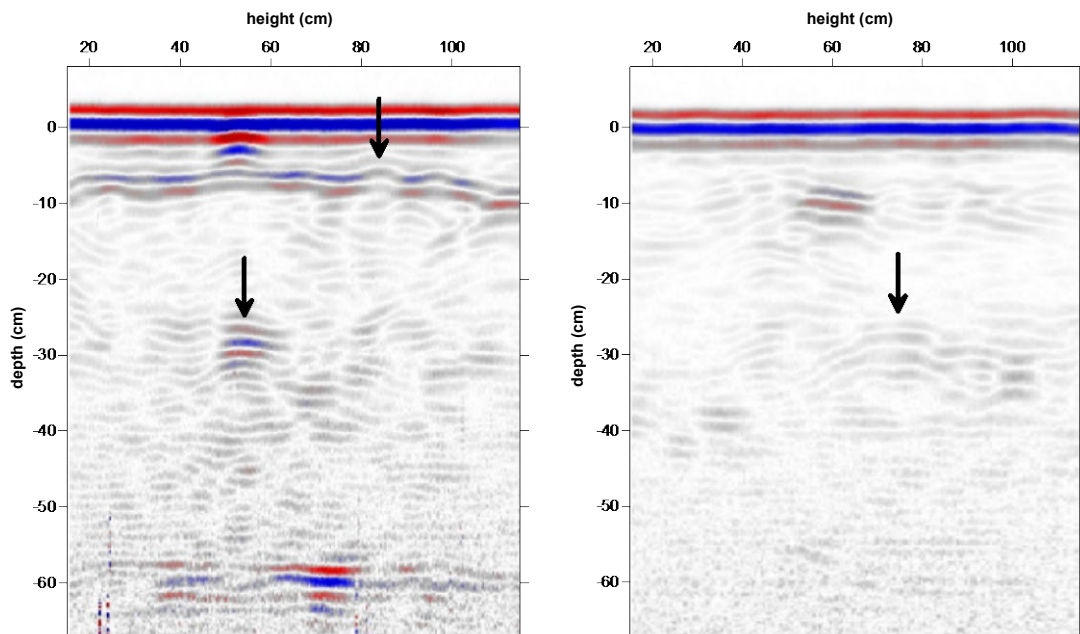
The anomalies shown in *Figures 23-26* are natural anomalies (i.e. anomalies that were accidentally introduced during the construction of the walls or appeared as a result of various environmental effects).

The sources of the phenomena marked by arrows above are not exactly known. All of them provided amplitudes that are comparable to those generated by those of artificial origin, therefore they can be misleading in the interpretation.

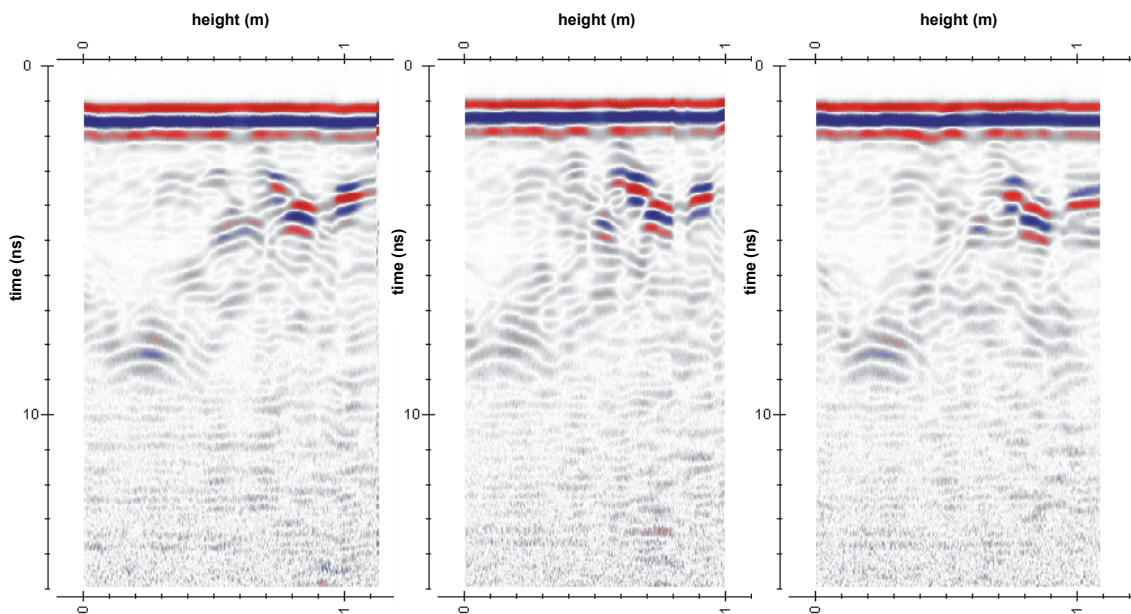
Figure 27. The effect of wettness on the radargrams of F1 wall

Figure 27 presents the effects of water on the first test wall. The sections were recorded by using the GSSI device with the 1.5 GHz antenna. When the left hand side section was recorded the wall was dry. The section in the middle was recorded after pouring in 5 litre of water into the gap between the courses, while the one on the right was made after pouring 10 litre of water.

The effects of the water appear by changes in the amplitude and by time delay. The reason for the time delay is that the speed of the electromagnetic waves is about one-third of the speed in bricks. The change in amplitude size usually means lower amplitudes due to the electric conductivity of the water. It is clearly visible in the section that a larger amount of water caused stronger attenuation. In walls that are exposed to water for a longer period of time and are totally damp the signals can be significantly absorbed.

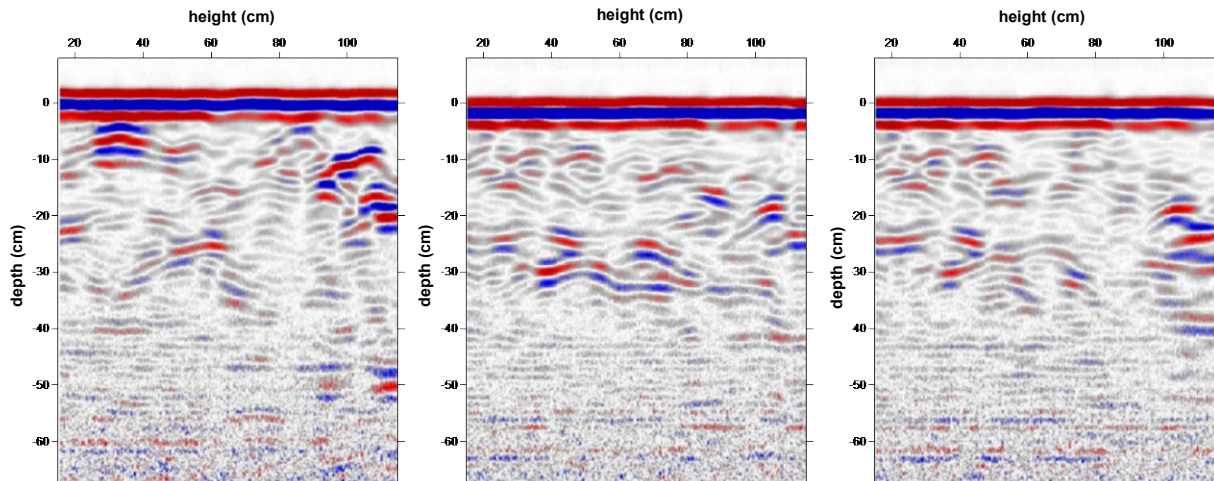
Figure 28. The effect of sand filling and wetness on the radargrams of F1 wall

On the left hand side of *Figure 28* one can see the original state of the first test wall (F1). In the middle part the gap between the brick courses is filled with dry sand, while on the right the sand had been dampened (*Photo 8*). The original state was recorded earlier and unfortunately the changes can partly be accounted for the fact that the weather conditions were different during the first and the next two measurements. In spite of this it is clearly visible that filling the gap with sand caused significant changes. At the height of 95-110 cm and the depth of about 9 cm the reflections nearly disappear due to the decreased parameter contrast. On the right hand side of the section, the amplitudes are lower due to the higher conductivity in the water.

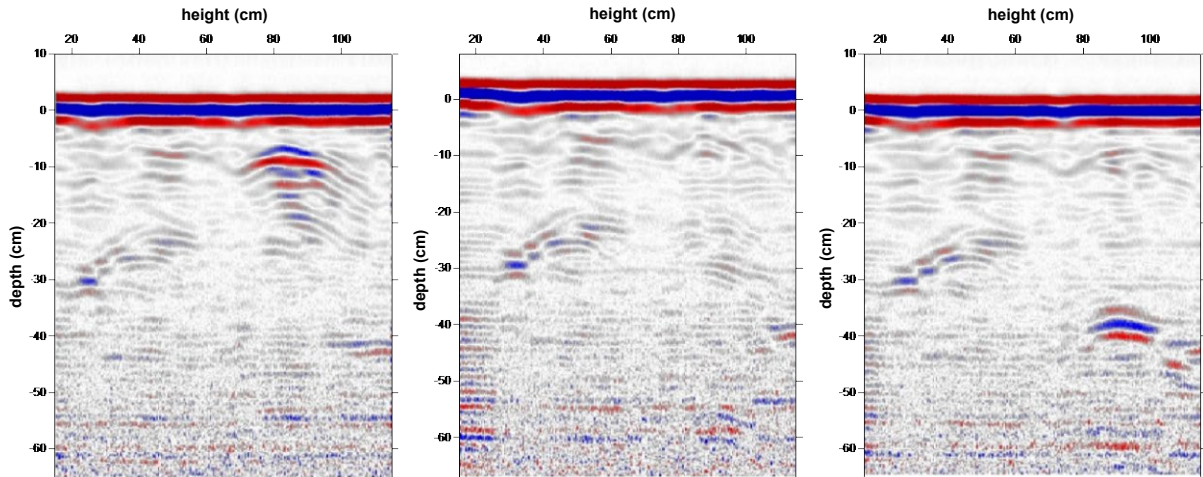
Figure 29. The effect of various type of filling and wetness on the radargrams of F2 wall

In *Figure 29* the effect of various types of filling can be observed that were filled in the gap between the two outer courses of the upper part of the second wall (F2). The left hand side radargram shows the effect of debris filling, on the middle radargram dry gravel and sand were used, while the gravel and sand filling was wetted on the right hand side radargram (*Photo 9*). The radargrams recorded in the debris and gravel show significant differences, which is possibly caused by the significant amount of air in the debris. Surprisingly, the sections recorded in the dry and wet gravel are more or less similar, although based on previous experiences, a more significant difference was expected.

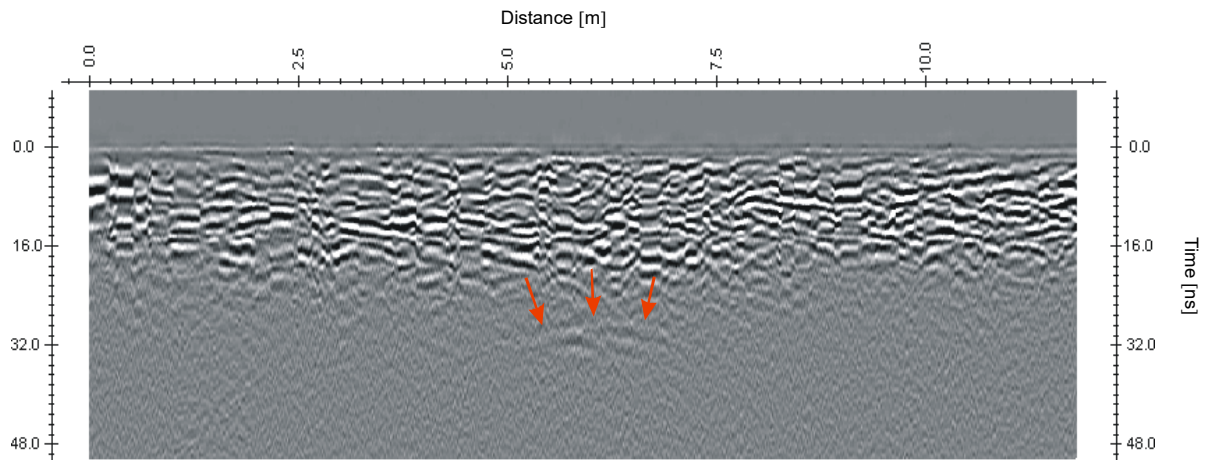
Image 5: Radargram taken parallel to the rails on track level

Measurements were also made with 450MHz antennae on track level parallel to the rails. The purpose of this measurement was to check the ability of the system to survey the geometry of the structure from above the arch on track level. Red arrows indicate reflections

received from the extrados of the arch (Image 5). As proper penetration depth could not be achieved with the used antennae the measurement was unable to provide valuable information regarding the dimensions of the structure.

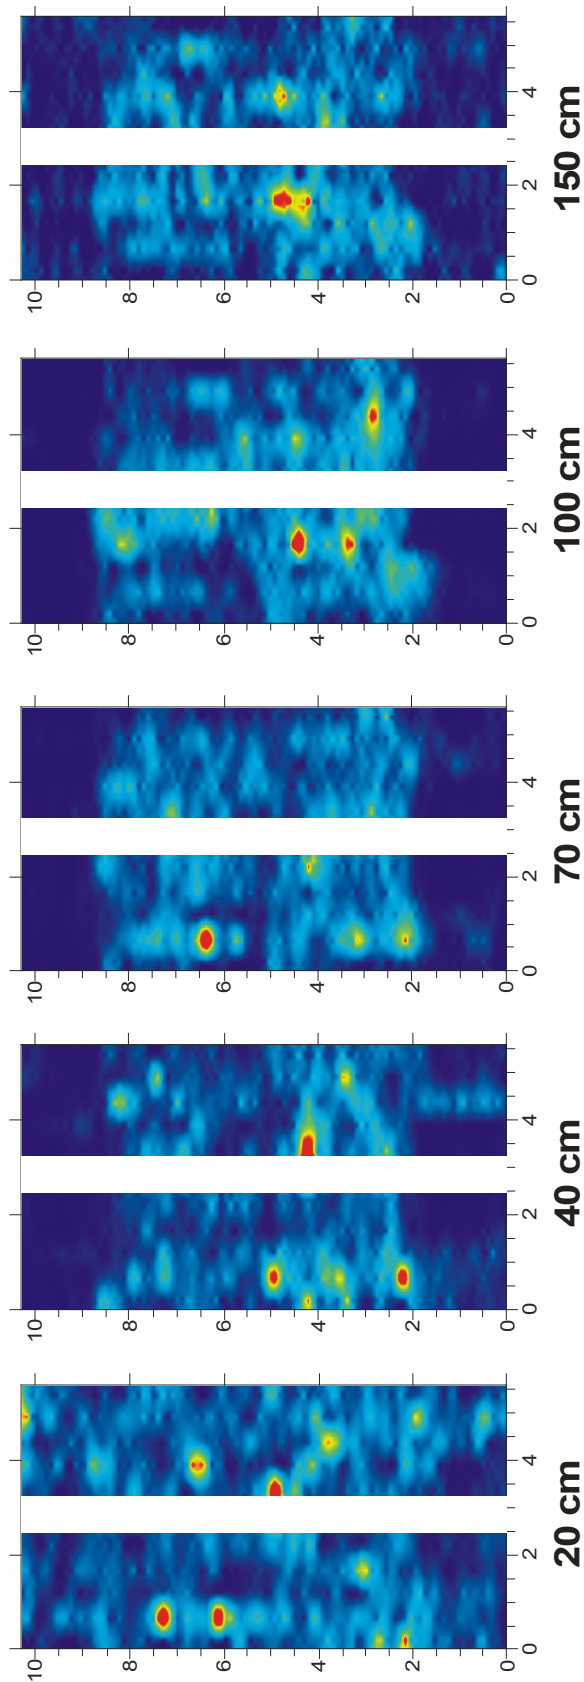
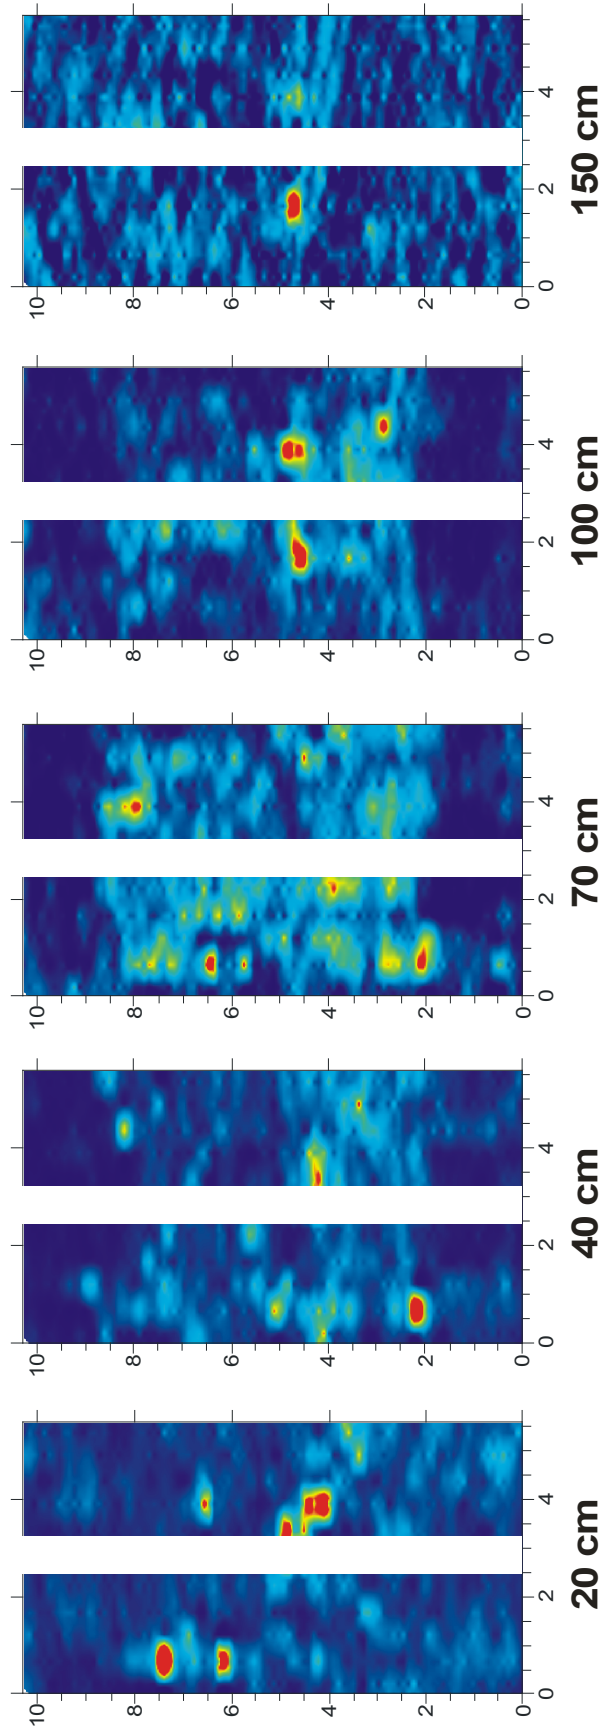
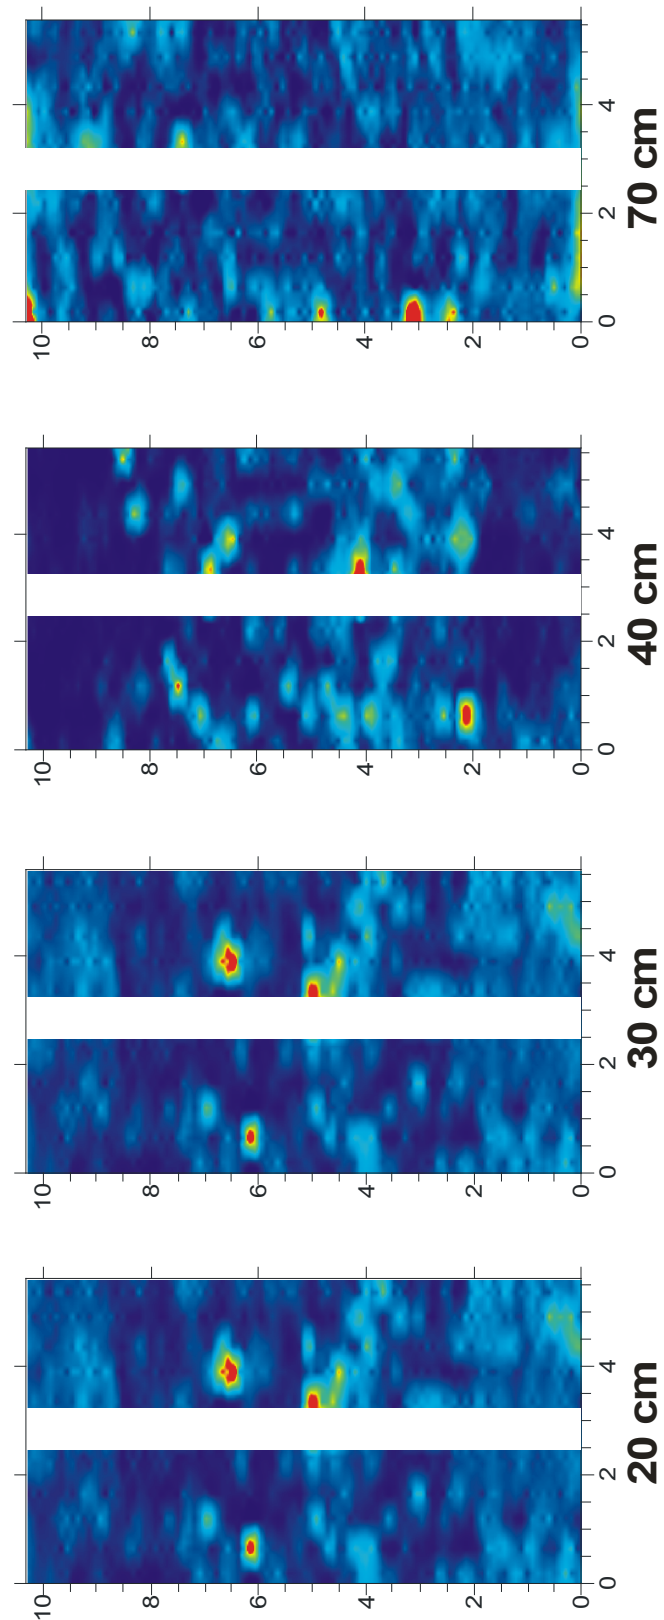
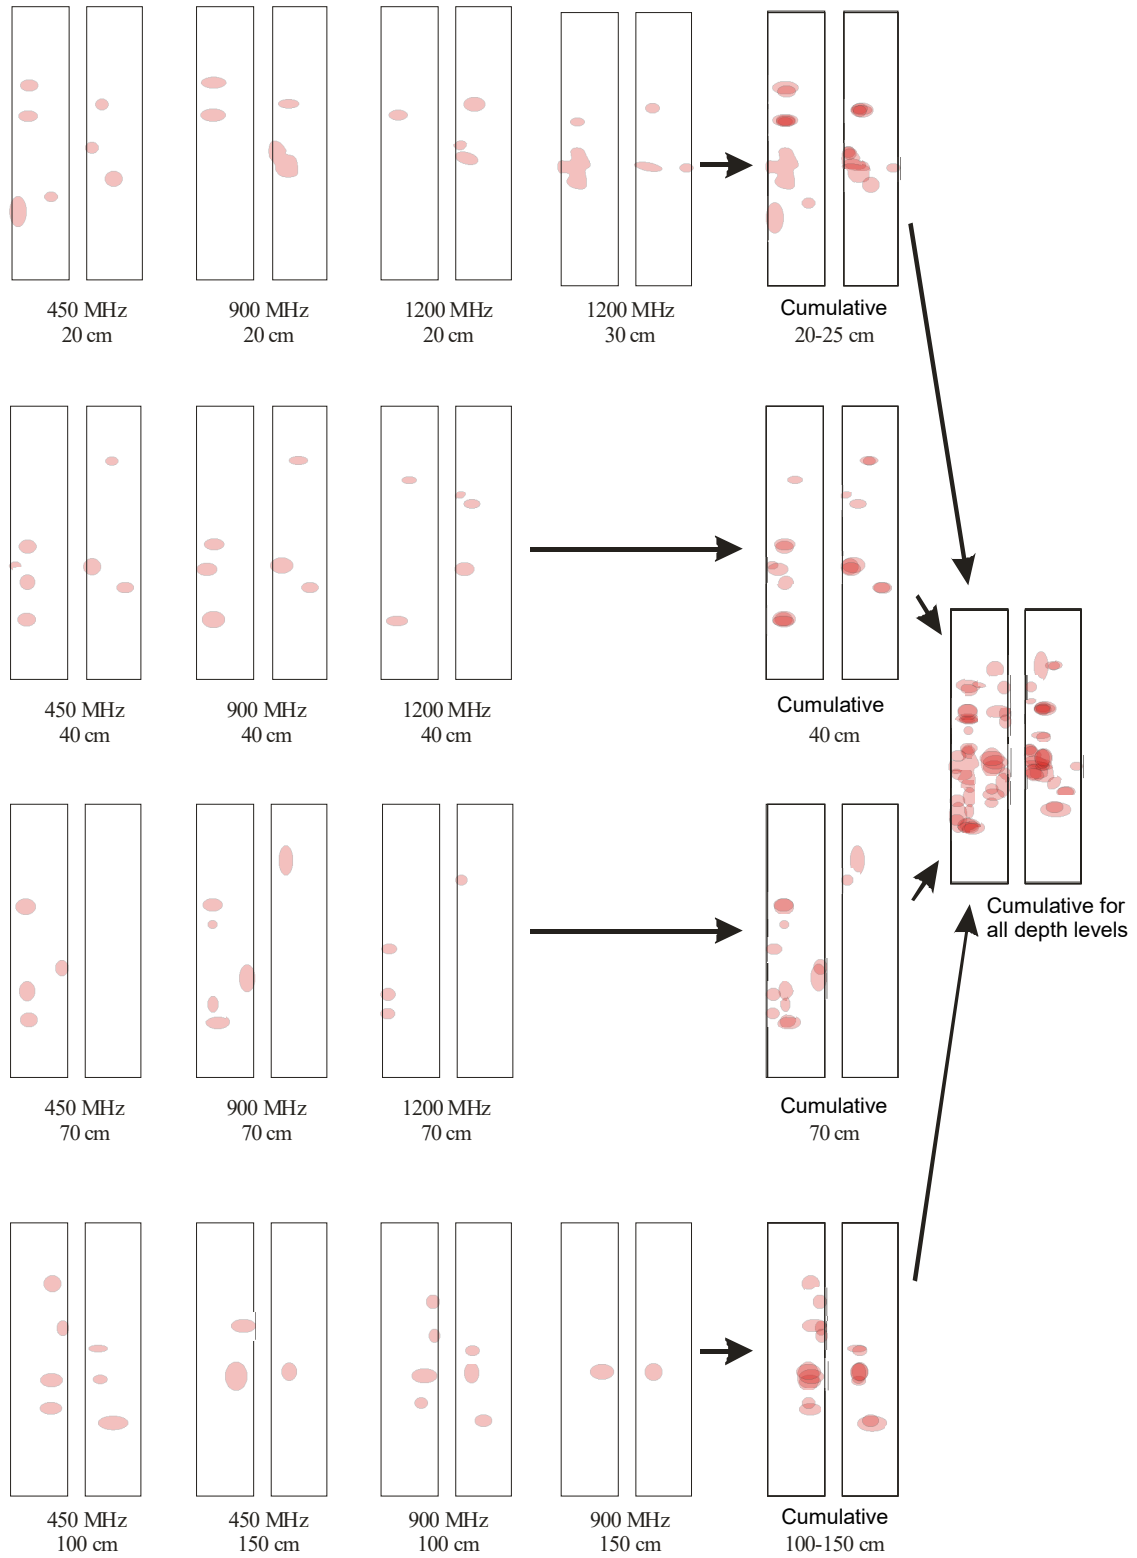
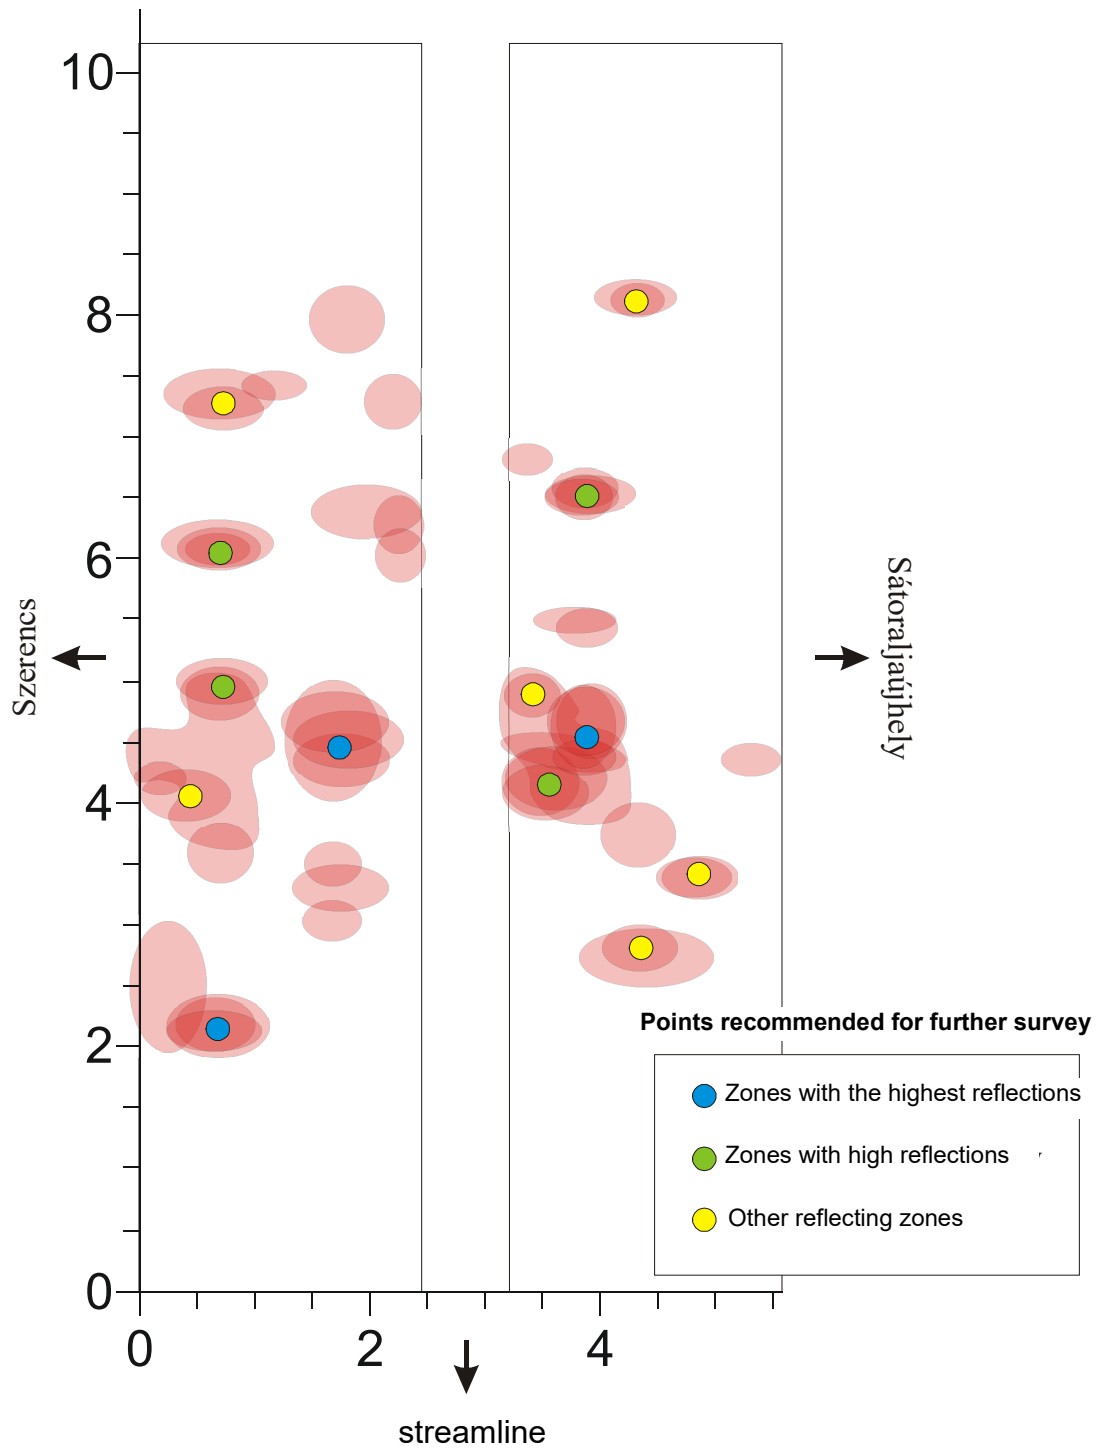
Many individual diffractions were found however on the radargrams. It is very likely that these diffractions were received from point-like objects. After processing of the recordings anomaly maps were constructed. The anomaly maps show, at a given depth level, the changes in the amplitude values. These anomalies mark the areas from where the electro-magnetic waves are reflected differently. Appendix 1 shows the anomaly maps of the arch measured at three different frequencies (450MHz, 90MHz, 1200MHz) and at five different depth levels (20cm, 40cm, 70cm, 100cm, 150cm) for each frequency. The maps are plotted against the penetration depth of the waves on a flat sheet. As the arch soffit was left out from the measurement this area is represented on the anomaly maps with a 1 meter wide white strip. The higher amplitudes on the maps (seen in reddish colours) refer to cavity or other highly reflecting material, while areas with lower amplitudes (seen in bluish colours) refer to increase in moisture level or to material with smaller compactness.

The individual radargrams and the anomaly maps suggest that there is no continuous gap or large size cavity is found inside and behind the stonework. The anomaly maps pointed to smaller areas where the reflections are higher than at other parts of the structure, these areas are considered potential zones of cavities.

The recorded data have been represented in a demonstrative form (cumulative anomaly map) that highlights all potential zones of irregularities and helps to appoint areas for further survey.

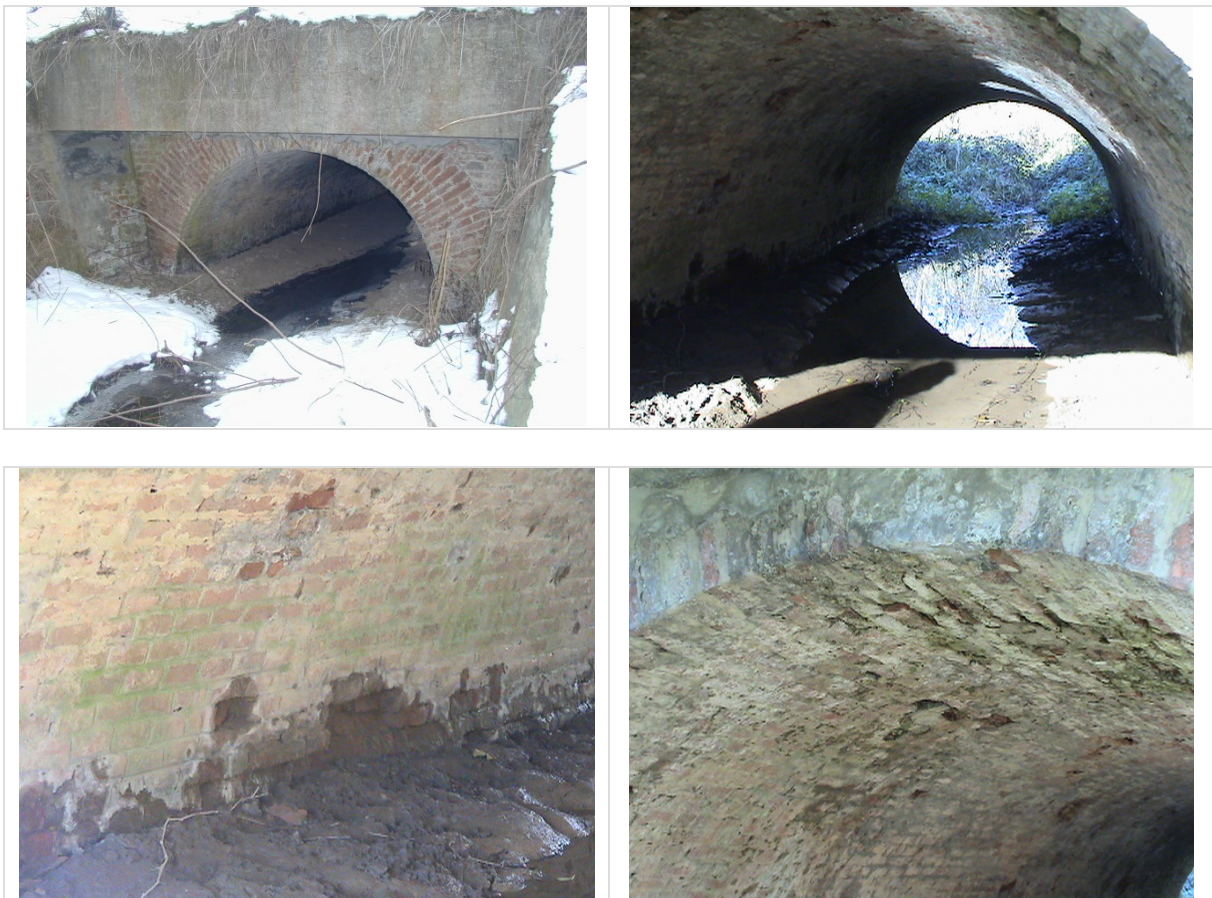
Image 1: Photos demonstrating the condition of the bridge

- Wet and weathered masonry surface due to the lack of proper waterproofing. Considerable wetness was observed at the abutments near the ground level and at some parts of the barrel.
- Loss of bricks and joint material due to freeze and wetness.
- Transversal cracks at the arch soffit. These cracks are thin and are not extensive.
- The bed is filled up with mud.

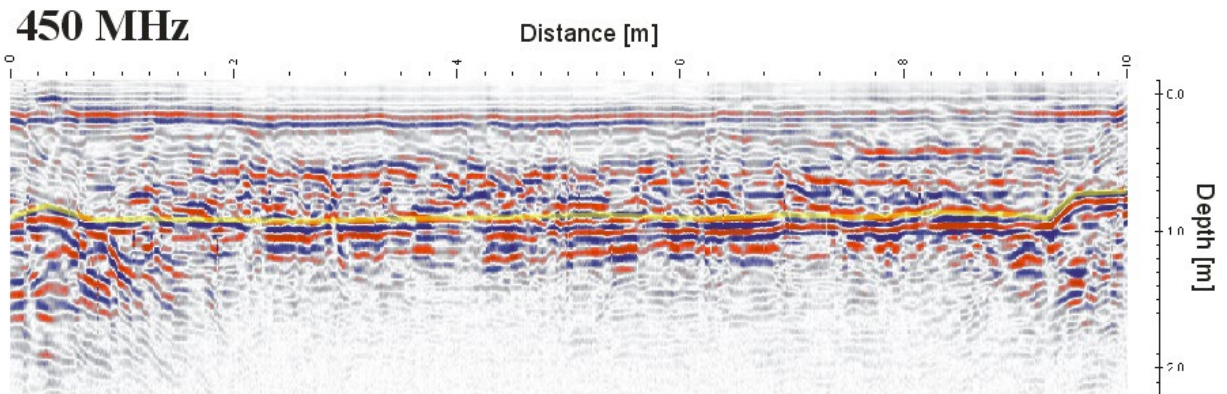
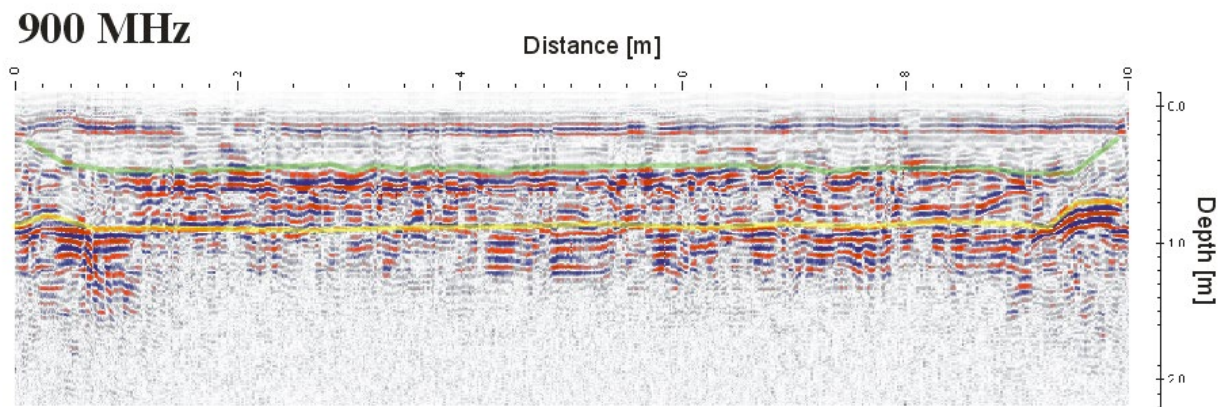
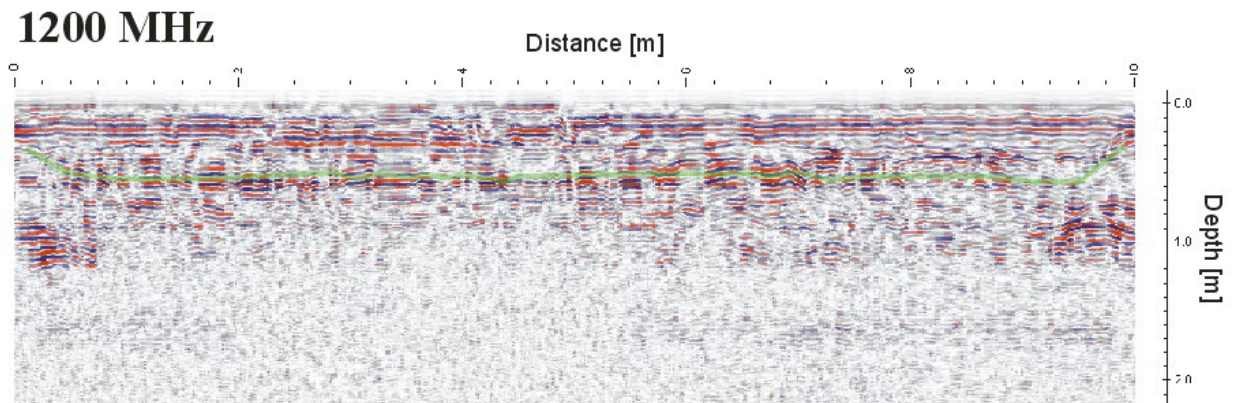
Radargrams taken with various frequency antennas along longitudinal line (C2) on the arch barrel.
