NON DESTRUCTIVE TESTING OF STRUCTURES

Part1: Masonry Arch Bridges

Zoltan Orban

APPENDIX 2: Case studies **47**

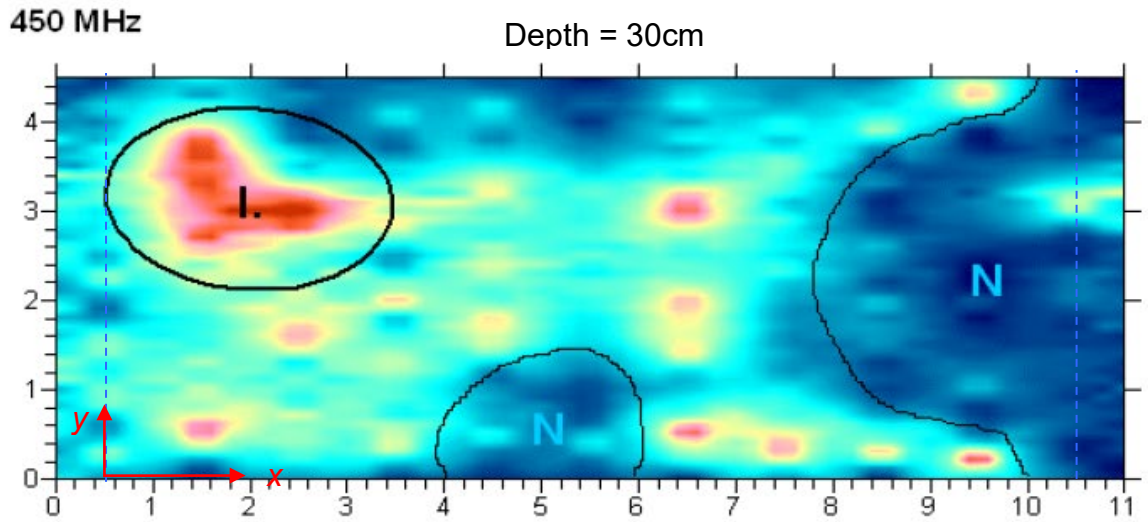
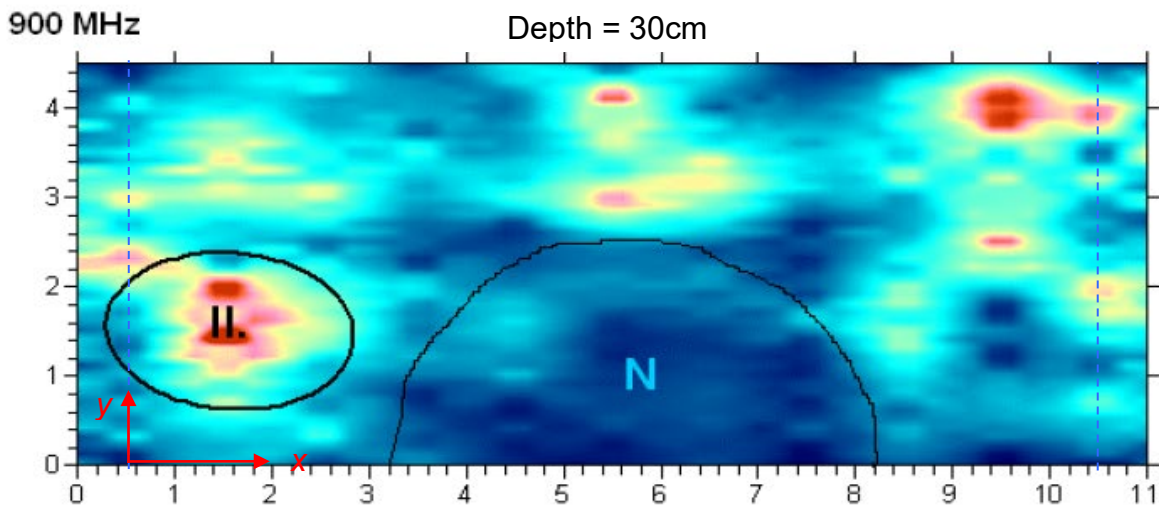
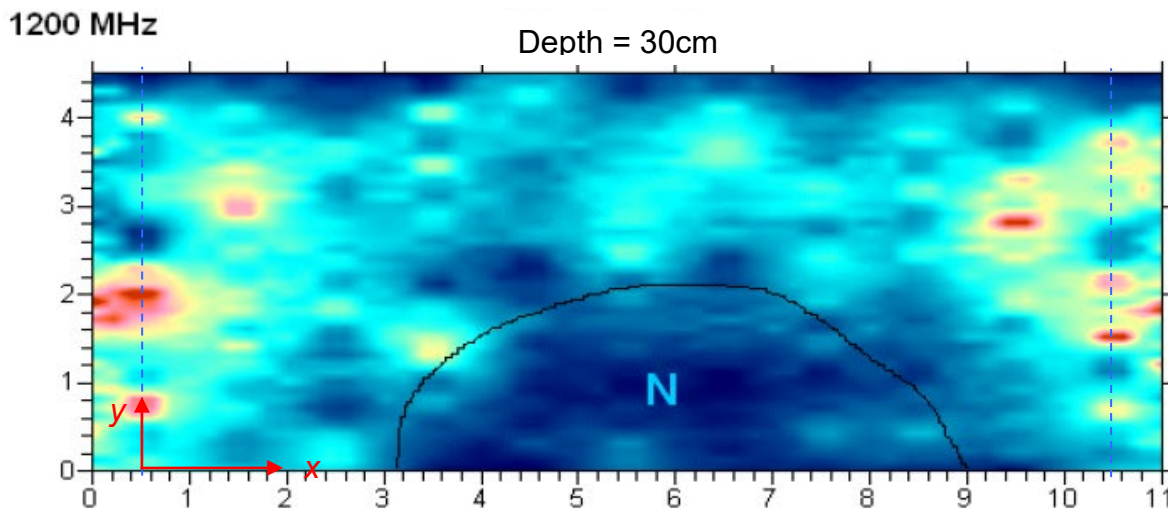
Anomaly maps of the arch barrel with various frequencies at 30cm depth segment, represented on flat sheets (horizontal: longitudinal profiles, vertical: transversal profiles)

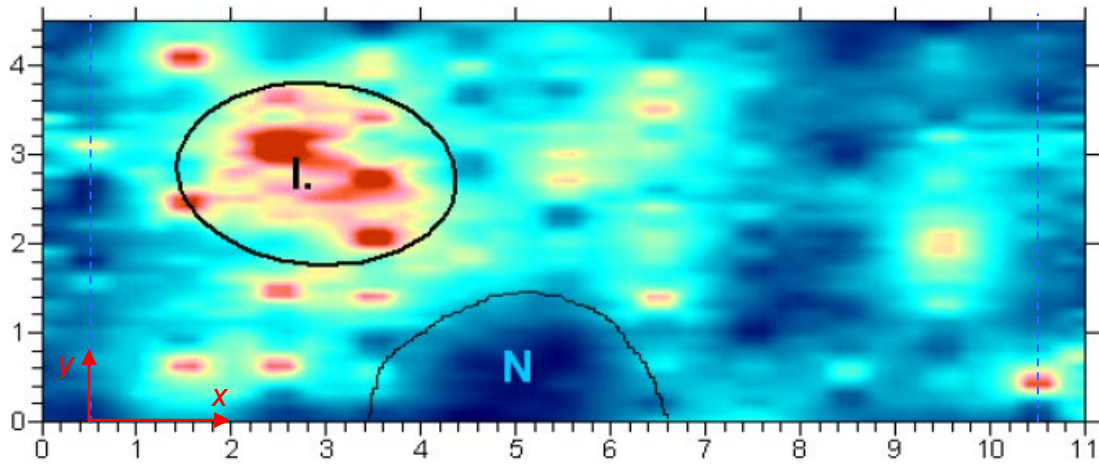
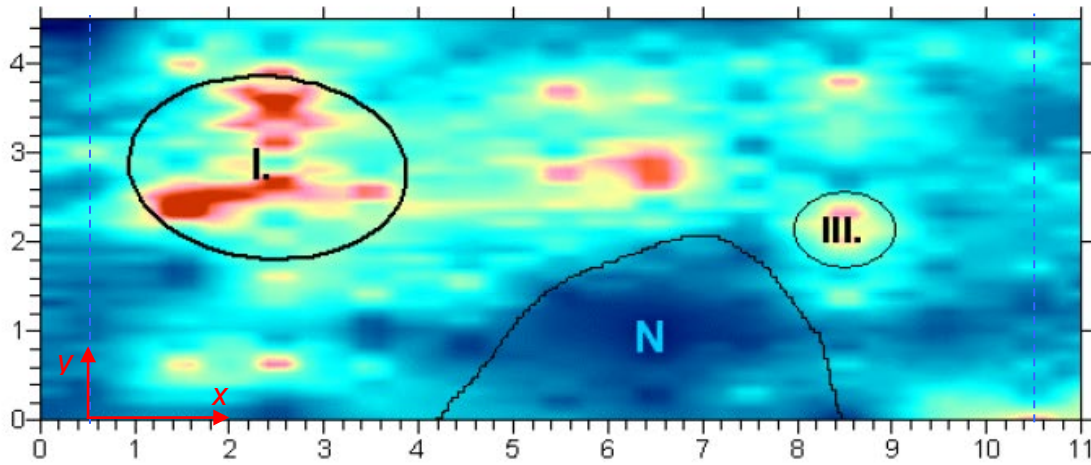
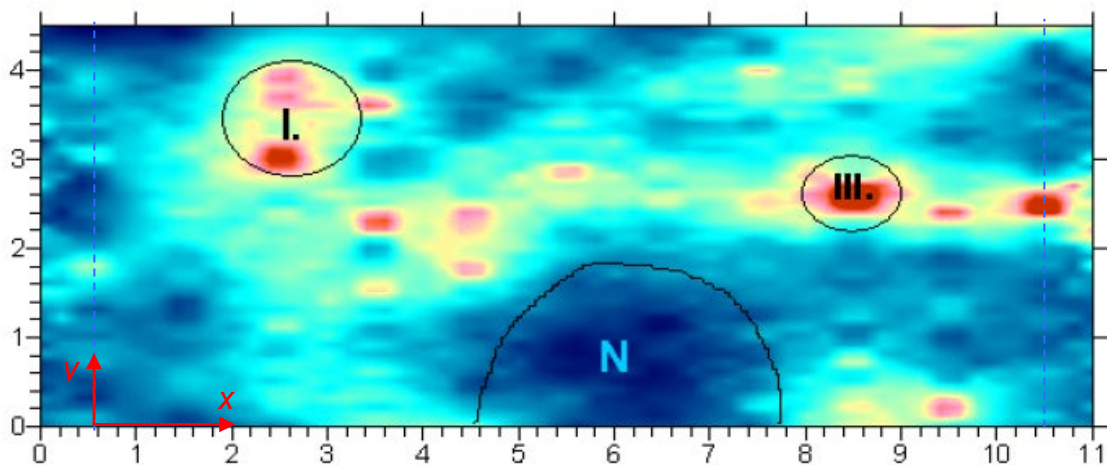
Anomaly maps of the arch barrel with various frequencies at 50cm depth segment, represented on flat sheets (horizontal: longitudinal profiles, vertical: transversal profiles)

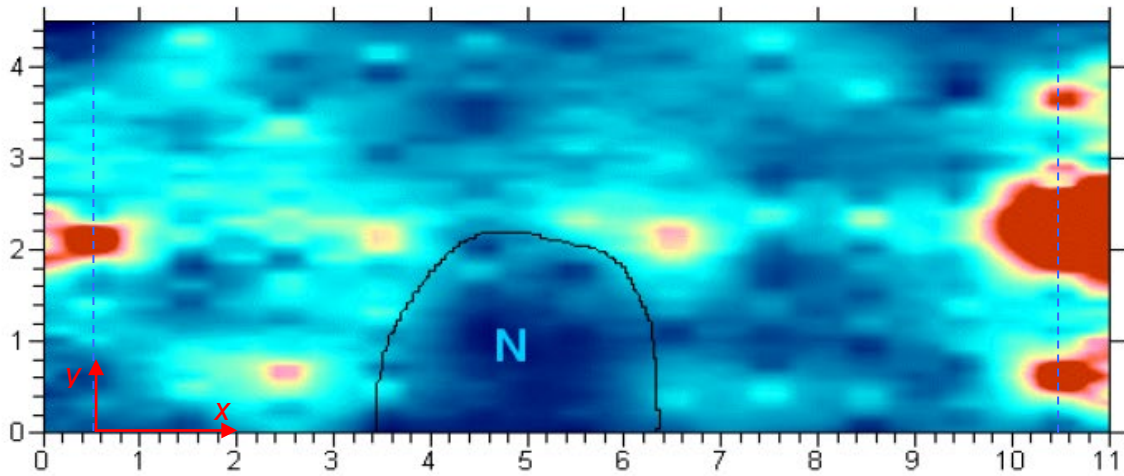
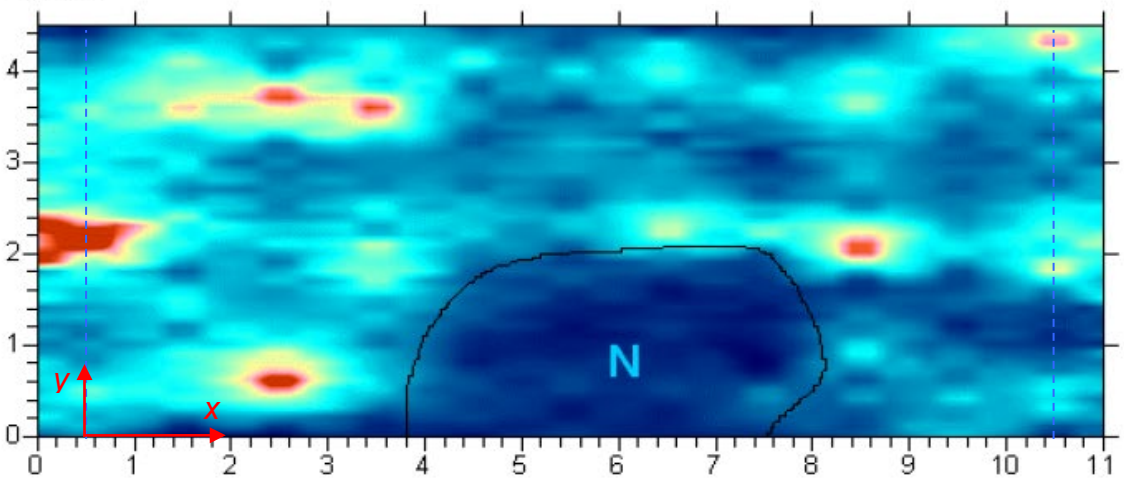
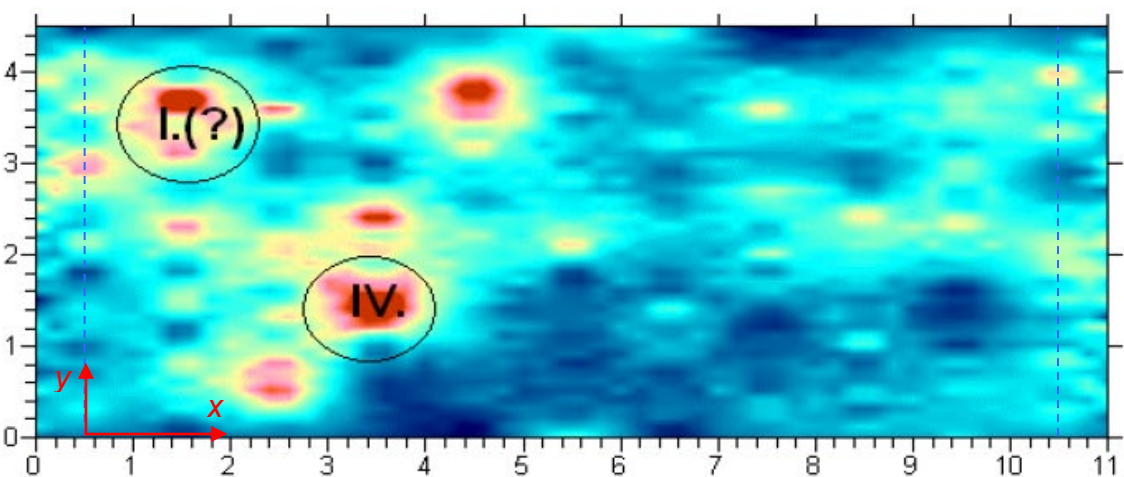
Anomaly maps of the arch barrel with various frequencies at 70cm depth segment, represented on flat sheets (horizontal: longitudinal profiles, vertical: transversal profiles)

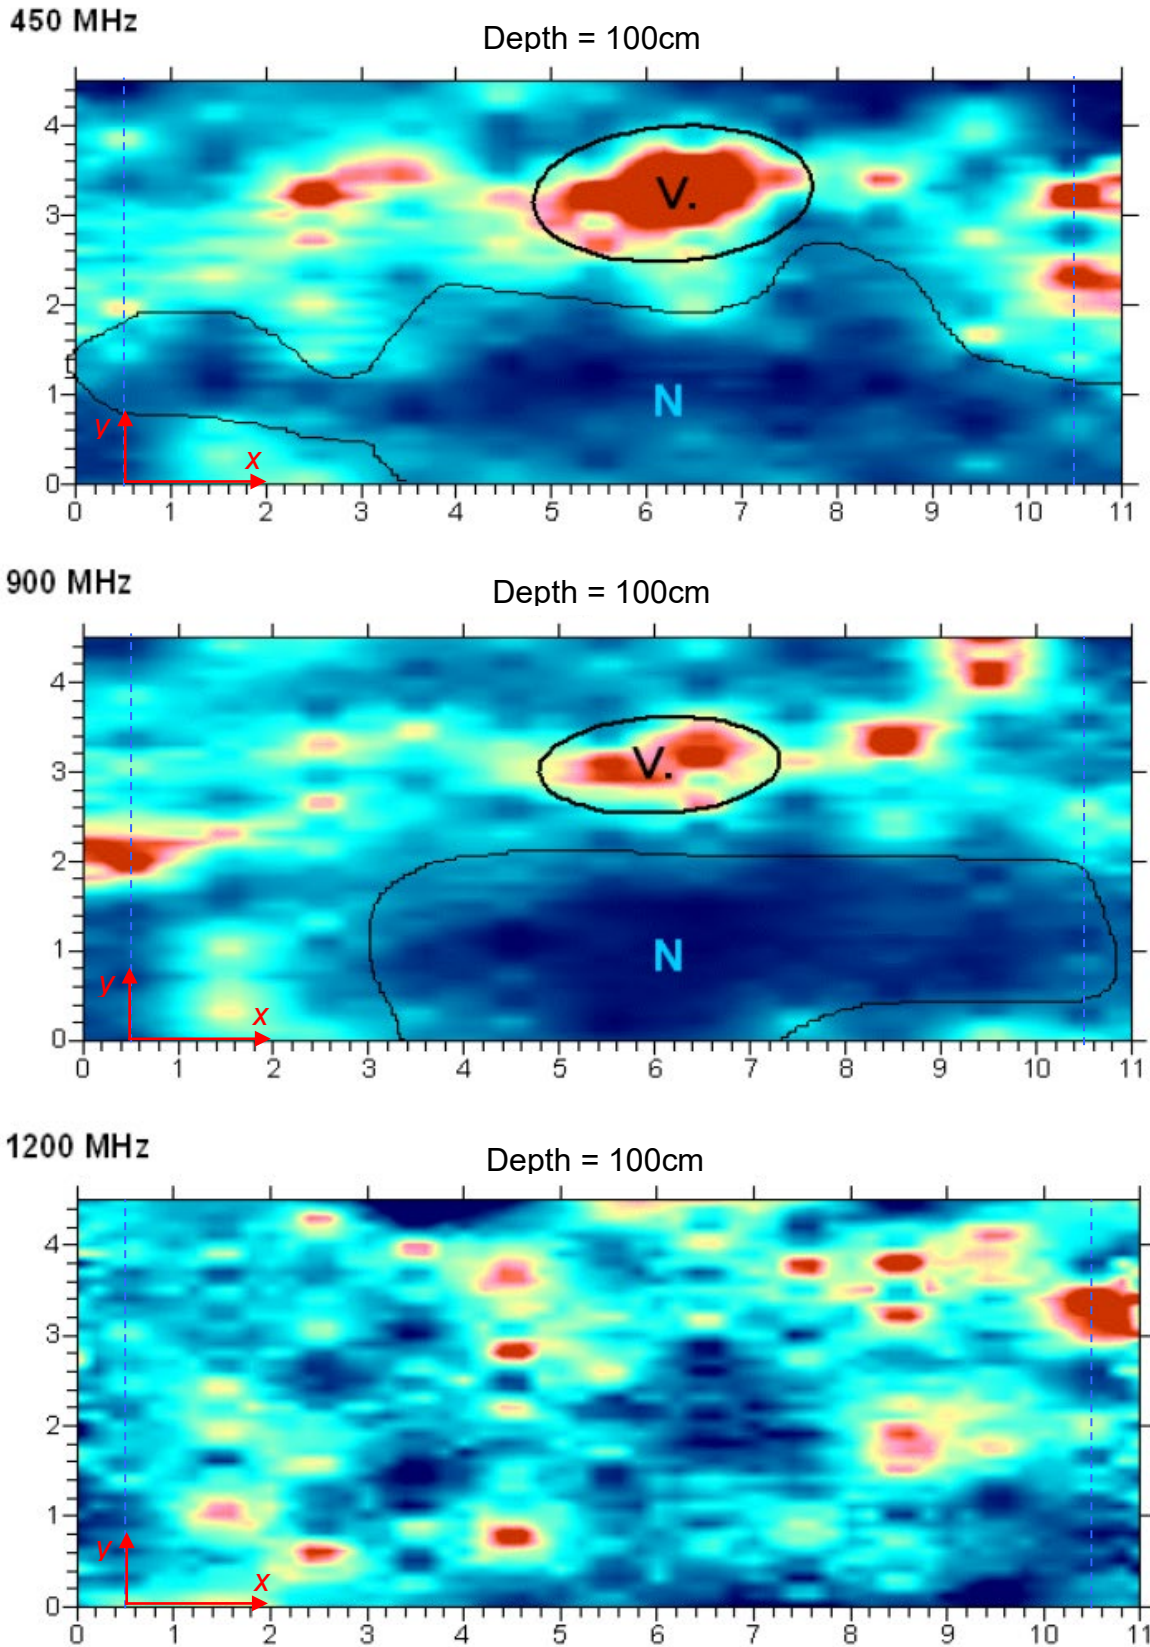
Anomaly maps of the arch barrel with various frequencies at 100cm depth segment, represented on flat sheets (horizontal: longitudinal profiles, vertical: transversal profiles)

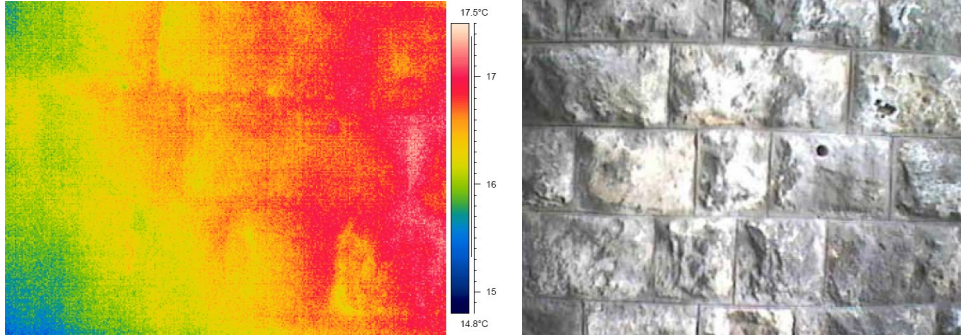
Image	Location
B1-03	Eastern abutment at middle level
<u>Comments:</u> No inhomogeneity was found on the stonework. Different construction materials can be identified (stone, mortar). The right side of the surveyed area is warmer due to the side effect.

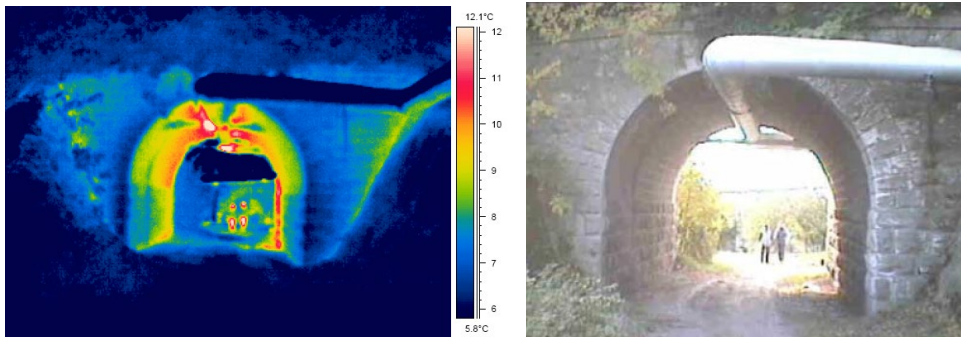
Image	Location
B1-04	Bridge front view (northern side)
<u>Comments:</u> No inhomogeneity was found on the stonework. The structural parts (barrel and spandrel wall) and the different structural material cannot be distinguished. The hot parts on the thermal image are originated from the effect of the heat pipe and the direct solar radiation on the surface.

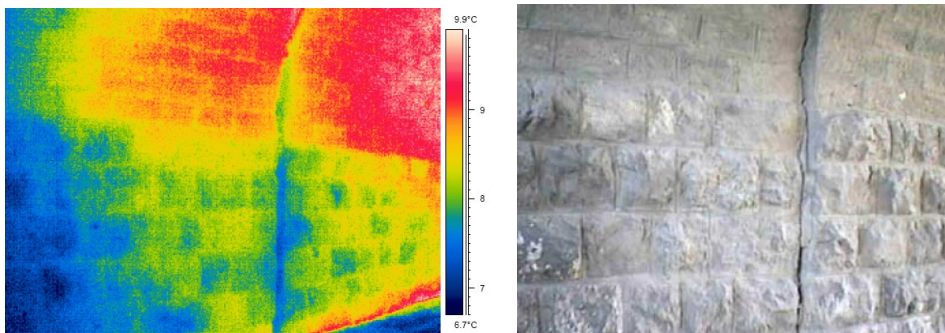
Image	Location
B1-07	Abutment and arch barrel –(eastern side, middle of the bridge)
<p><u>Comments:</u> No inhomogeneity is seen on the surface. Different construction materials can hardly be identified (stone, mortar). The surface is more or less in thermal equilibrium. Separation between the two bridge segments is clearly seen on the thermal image.</p>

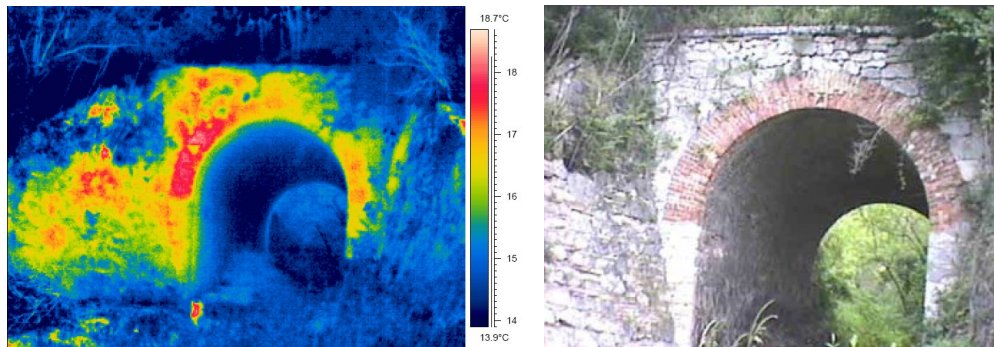
Image	Location
B2-01	Front view of the bridge (south-west)
<u>Comments:</u> The left side of the spandrel wall was subjected to sunshine for a few minutes prior to the measurement. This surface is therefore warmer than the other side with approximately 2°C. Presence of vegetation can be identified at both parts of the structure.

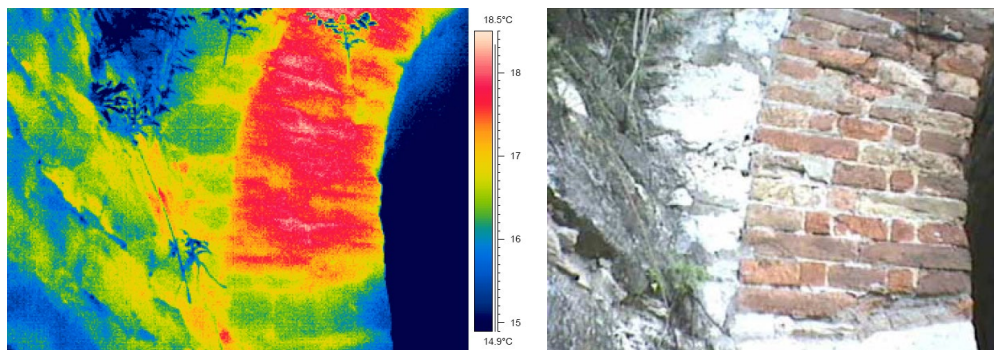
Image	Location
B2-02	Front view of the bridge (left side of the barrel near springing)
<u>Comments:</u> The barrel can be distinguished from the spandrel wall (i.e. brick surface from stone surface). Presence of vegetation is more striking on the thermal image than on the photo. Parts with loss of material (brick or mortar) can be identified on the thermal image.

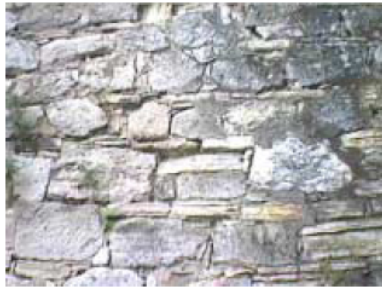
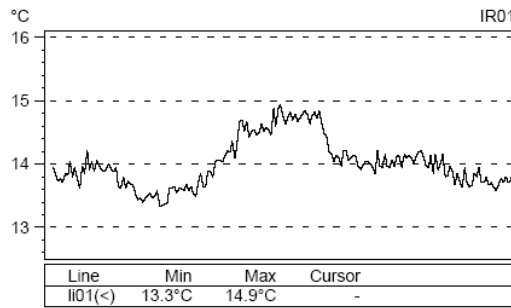
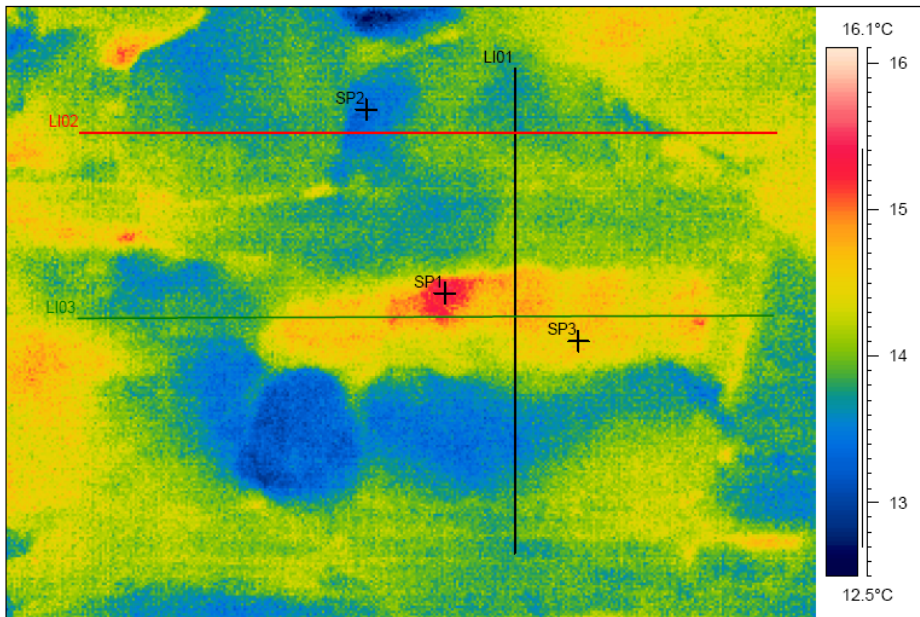
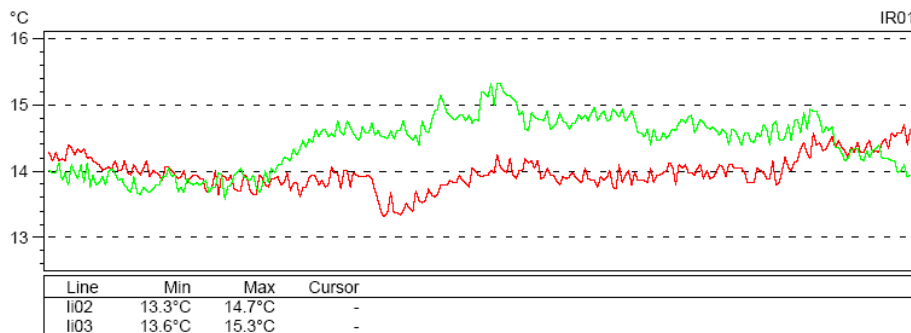
Image	Location
B2-03	Wing wall
<p>Comments: Different type of stones can be identified on the thermal image by using the same emissivity coefficient (ϵ). Temperatures of selected points (SP1, SP2, SP3) are given in Table (the temperature values were calculated with $\epsilon=0.8$). The temperature variation along horizontal and vertical segments can be followed on the given charts.</p>

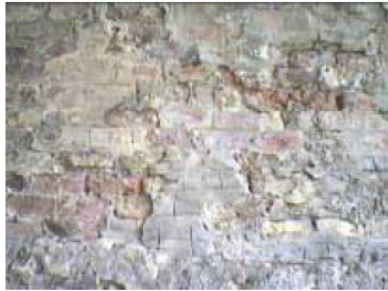
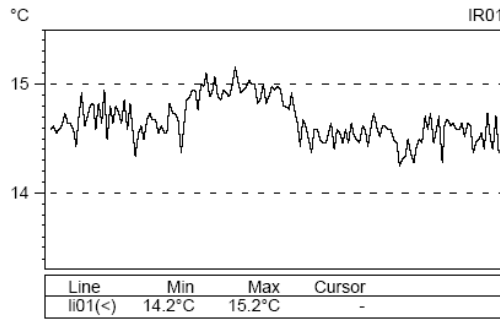
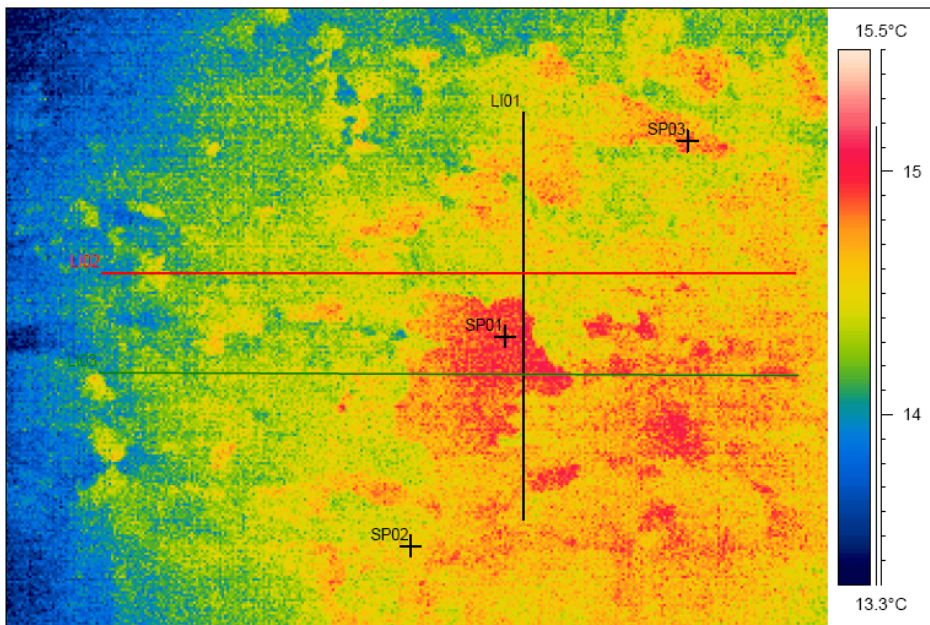
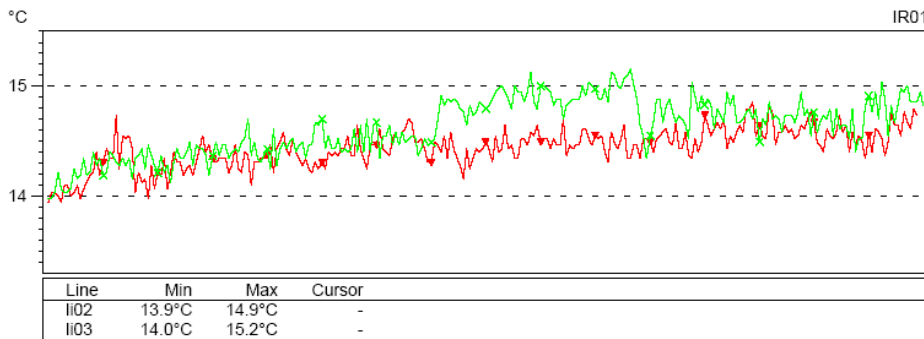
Image	Location
B2-04	Arch barrel (at the middle of the bridge)
<p>Comments: Areas covered with cement mortar (as a result of an improper repair) can be distinguished from others. Delaminated mortar cover from the surface and weathered bricks can clearly be seen on the thermal image. Temperatures of selected points (SP1, SP2, SP3) are given in Table (the temperature values were calculated with $\epsilon=0.8$). The temperature variation along horizontal and vertical segments can be followed on the given charts.</p>

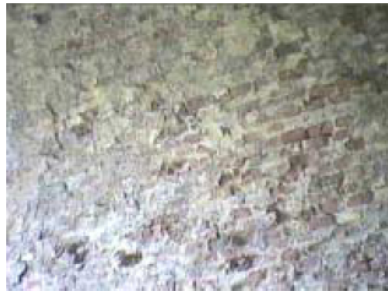
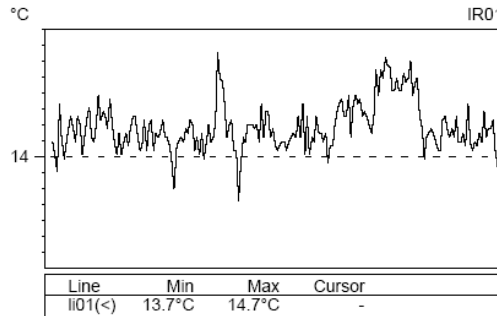
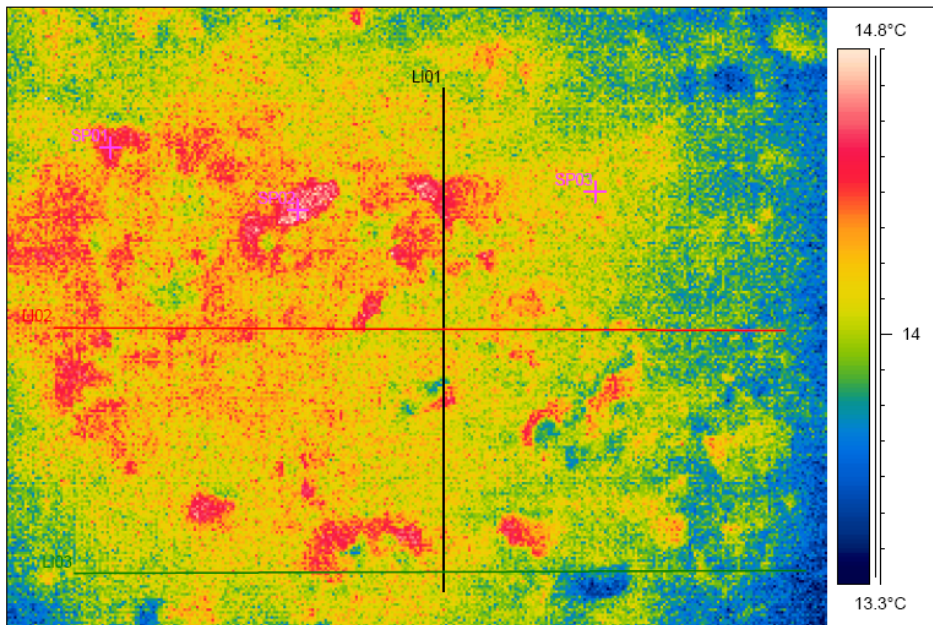
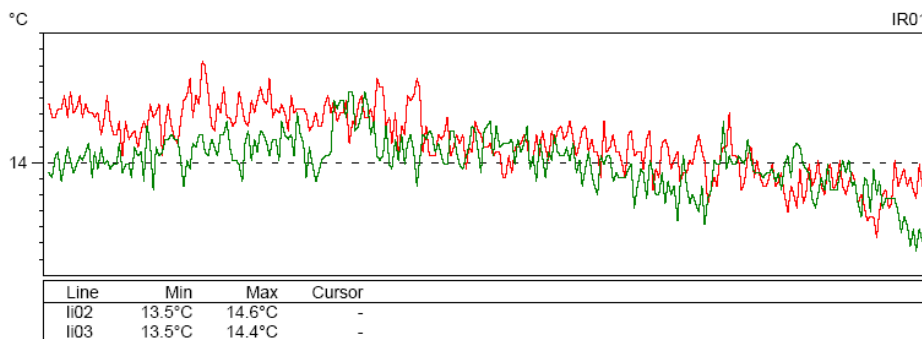
Image	Location
B2-05	Arch barrel (at the middle of the bridge)
<p>Comments: Extensive temperature variations can be observed both on the thermal image and the segments. These refer to largely weathered brick surface and loss of material. Temperatures of selected points (SP1, SP2, SP3) are given in Table (the temperature values were calculated with $\epsilon=0.8$). The temperature variation along horizontal and vertical segments can be followed on the given charts.</p>

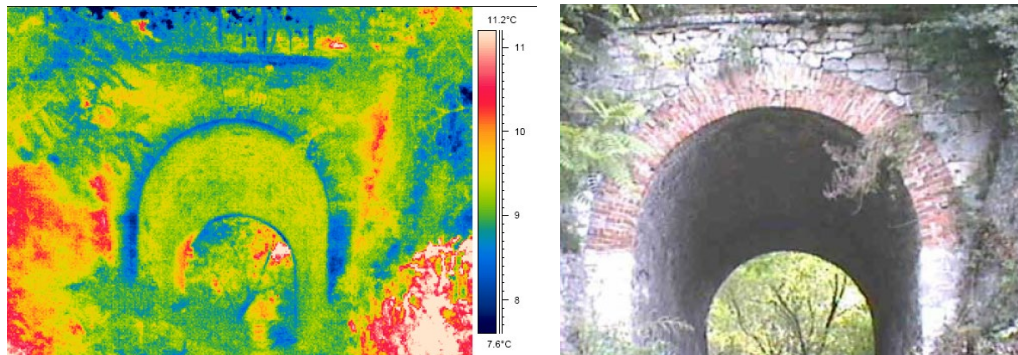
Image	Location
B2-06	Front view of the bridge (south-west)
<p><u>Comments:</u> The left wing wall was subjected to direct sunshine prior to the measurement. This surface is therefore warmer than other parts. The spandrel wall and the arch barrel was virtually in thermal equilibrium, the range of surface temperature differences is very narrow. Even the basic construction materials can hardly be distinguished. The presence of vegetation can easily be identified.</p>

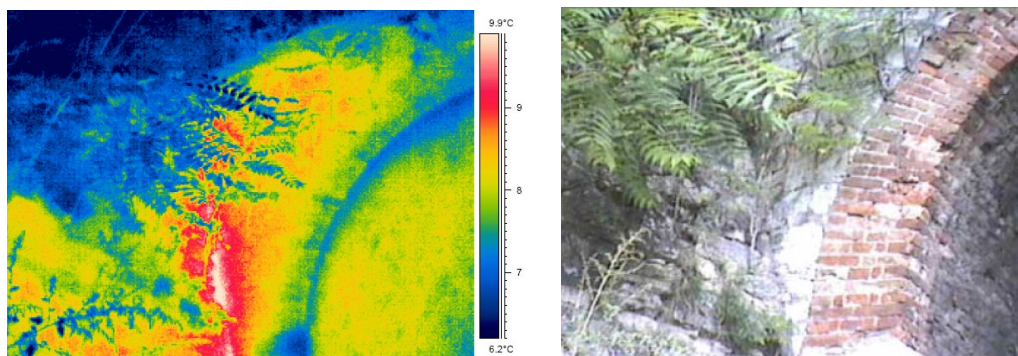
Image	Location
B2-07	Front view of the bridge (left side of the barrel near springing)
<p><u>Comments:</u> The exposed surface of the spandrel wall and the wing wall was subjected to direct sunshine before the measurement (hot region). The barrel cannot even be distinguished from the spandrel wall on the thermal image. Vegetation can clearly be seen. Other anomalies and damages on the brickwork surface cannot be identified on the thermal image, although they are noticeable on the photo.</p>

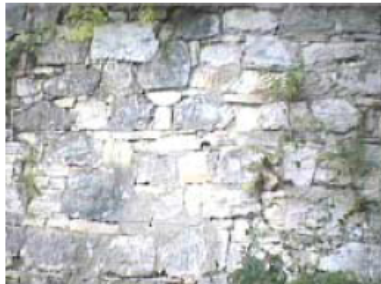
Image	Location
B2-08	Wing wall

Comments: The surface was subjected to direct sunshine before the measurement. Different type of stones can be identified on the thermal image, even with a small range of temperature variations, by using the same emissivity coefficient (ϵ). Temperatures of selected points (SP1, SP2, SP3) are given in Table (the temperature values were calculated with $\epsilon=0.9$). The temperature variation along horizontal and vertical segments can be followed on the provided charts. Vegetation can clearly be seen on the thermal image.

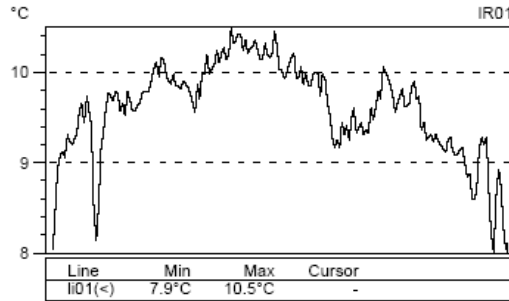
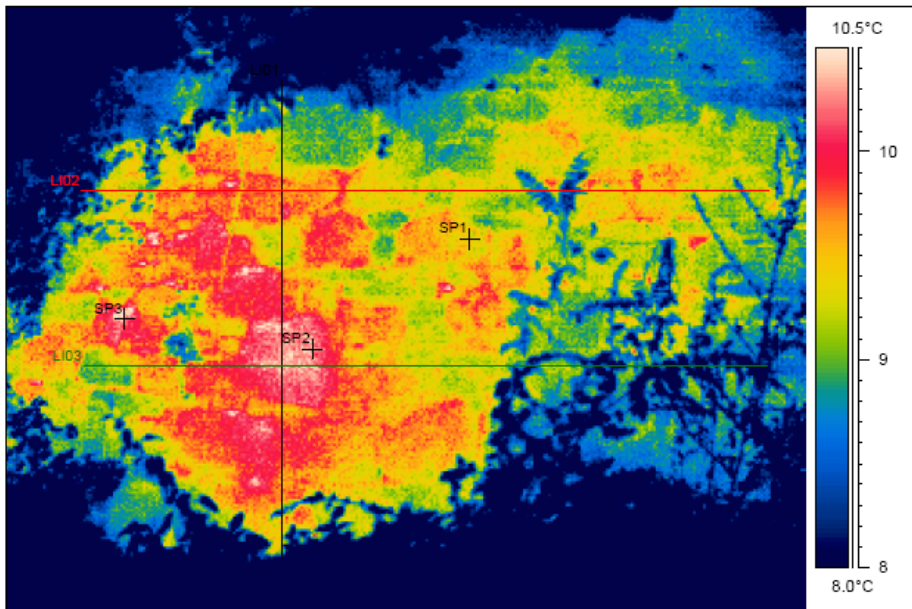
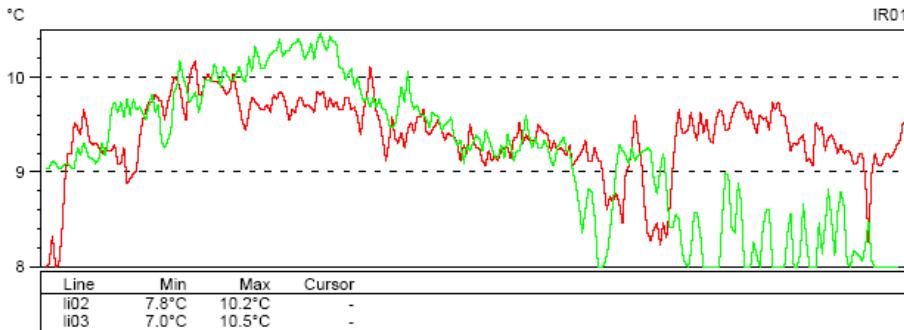
SP1	SP2	SP3
hőm. (°C)	9.3°C	10.3°C	10.2°C

Thermal distribution along vertical segments (L01)

Thermal distribution along horizontal segments (L02, L03)

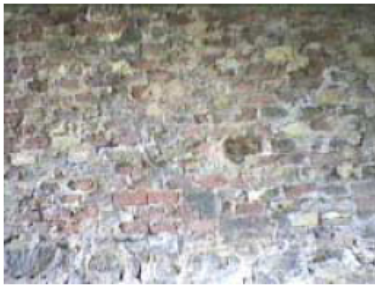
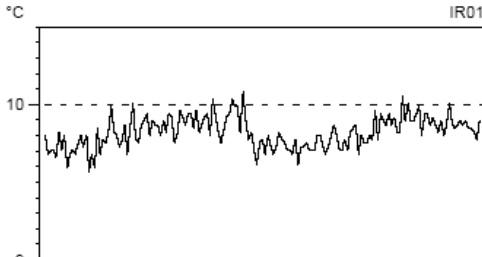
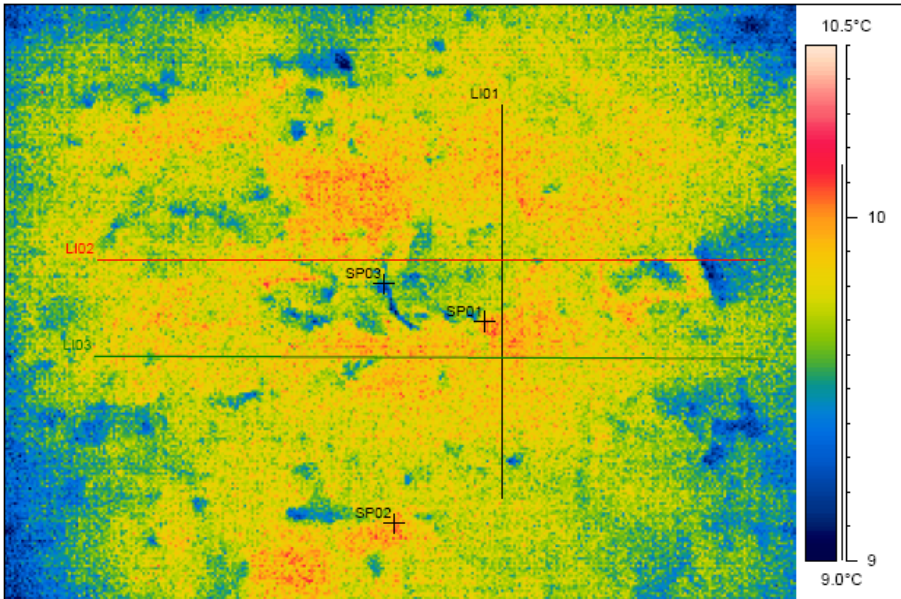
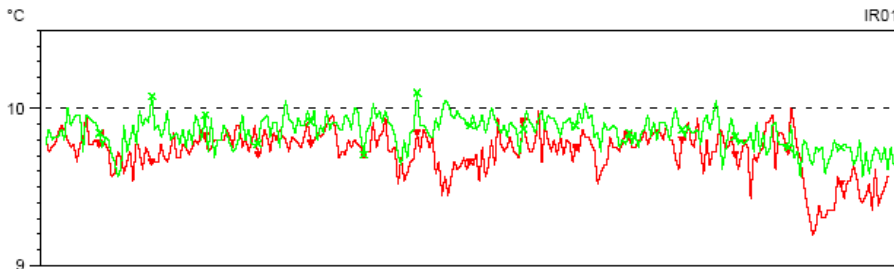
Image	Location
B2-09	Arch barrel (middle of the bridge)

Comments: The same area was surveyed as at Image B2-05. This area has weathered brick surface and suffers loss of brick material.

Temperatures of selected points (SP1, SP2, SP3) are given in Table. The temperature variation along horizontal and vertical segments can be followed on the provided charts. The thermal image suggests the variation in quality of the masonry surface but the range of temperature changes is much less than that of the previous measurement (see Image B2-05 and the corresponding thermal distribution charts). The thermal distribution of the surface is rather uniform as such the detection of surface anomalies is less effective.

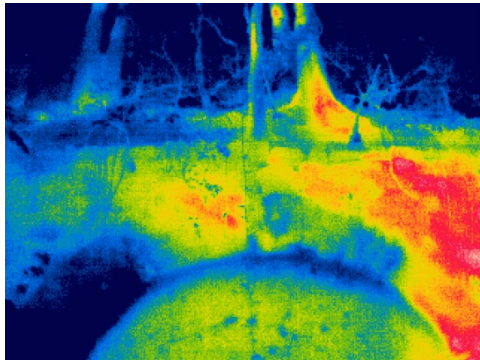
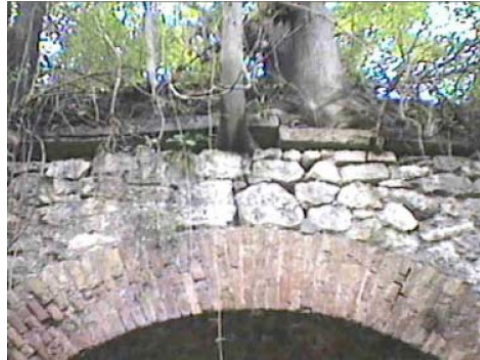
Image	Location
B2-10	Front view of the bridge (north-east)

Comments: The right part of the spandrel wall was subjected to diffused sunshine prior to the measurement. This surface is therefore warmer than other parts. Areas affected by the invasion of vegetation can be identified.

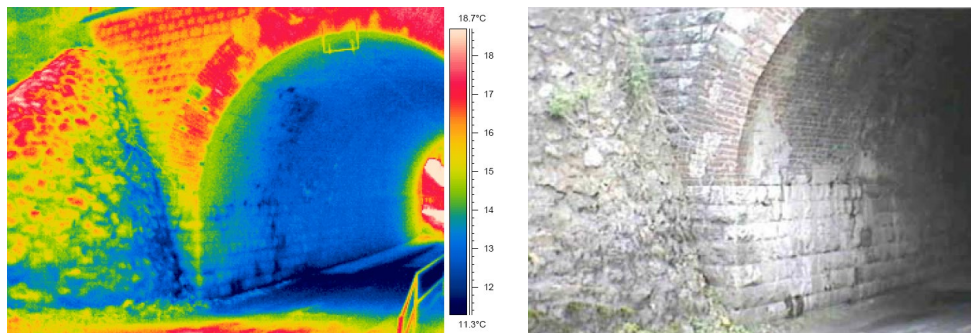
Image	Location
B3-02	Bridge front view (eastern side)
<p><u>Comments:</u> The front side of the bridge was not subjected to sunshine before and during the measurement but difference between the temperatures at the upper side and lower side can be observed. The barrel (brick material) can be distinguished from the spandrel wall (quarry stone) on the thermal image. Spots with lower temperatures on the thermal image of the barrel refer to locations of patch repairs. The area with lower temperature (deep blue spots) on the barrel and the abutment refers to the presence of wetness around a crack. This anomaly can be observed even at a distance of 15m.</p>

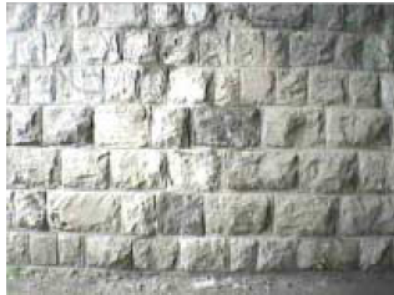
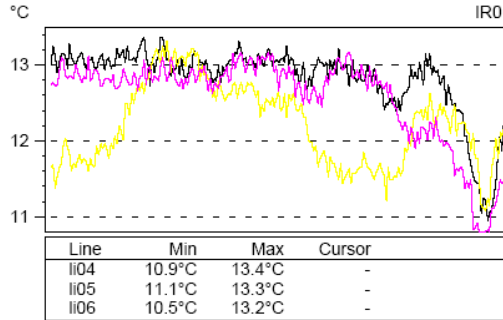
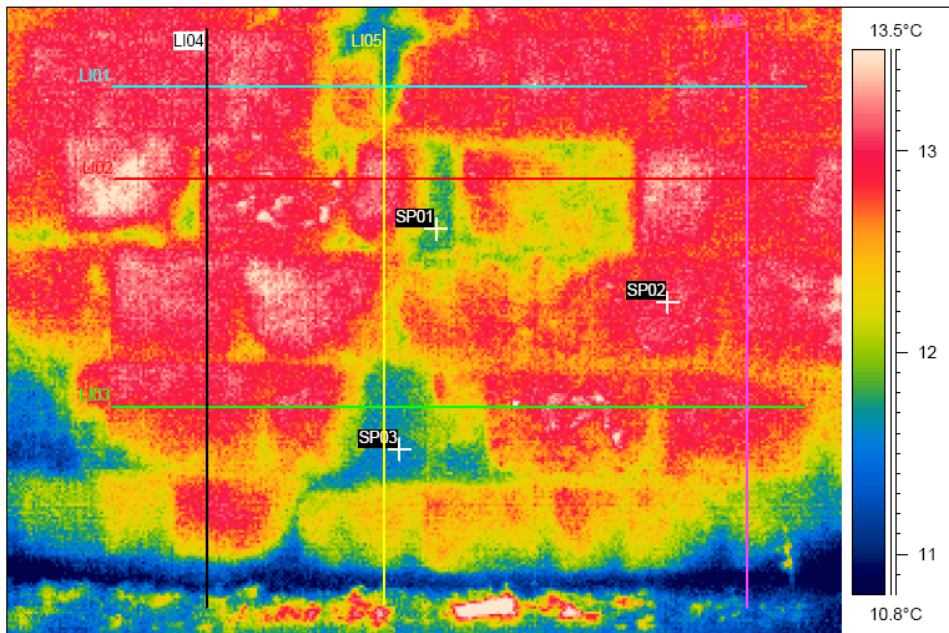
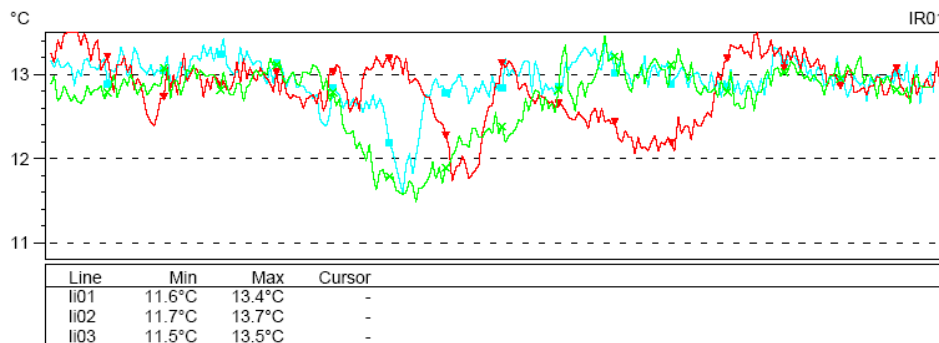
Image	Location
B3-03	Abutment (3m from the eastern end)

Comments: The cold parts on the thermal image refer to a vertical crack on the abutment stonework. More moisture is found near the crack therefore the surface here is colder than elsewhere. The moisture distribution around the crack cannot be seen by pure visual observation. The blue strip above the ground level may also refer to stones with a higher moisture content. Mortar joints can also be distinguished from stones especially in the wet area as the moisture content of mortar differ from that of the stone material. The extent of the moisturised zone can be more accurately determined on the charts showing the thermal distribution along horizontal and vertical segments.

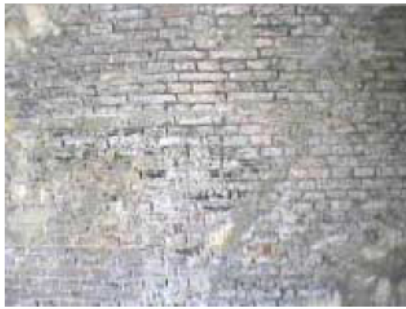
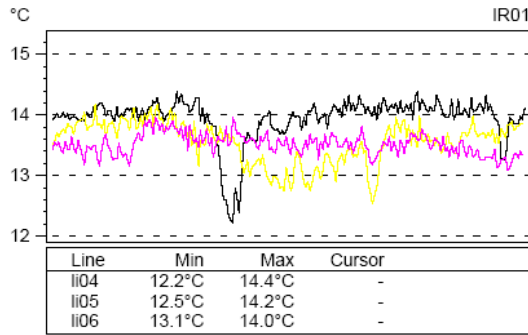
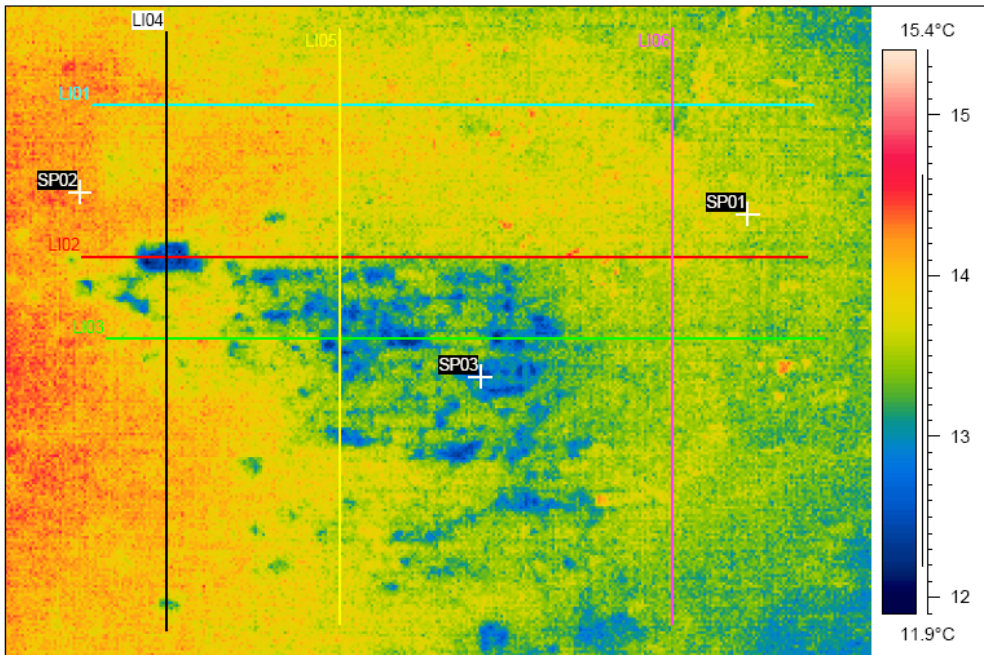
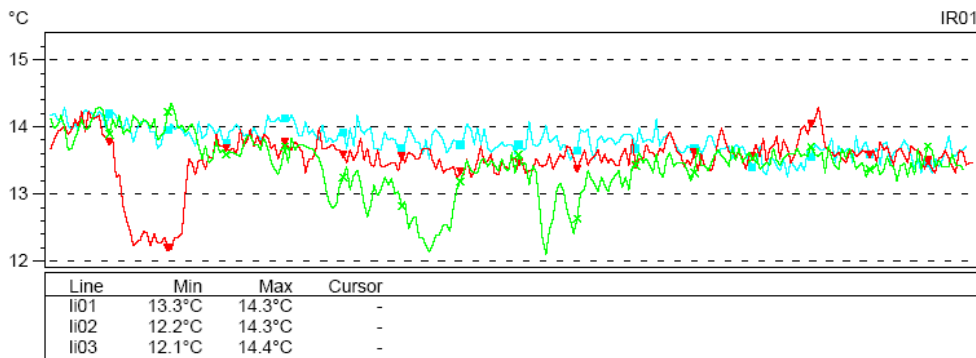
Image	Location
B3-04	Arch barrel (middle of the bridge)

Comments: The middle part of the analysed area is covered by moss. It is assumed that this area is more wet than its surrounding resulting in lower surface temperature. Temperatures of selected points (SP1, SP2, SP3) are given in Table. The temperature variation along horizontal and vertical segments can be followed on the given charts.

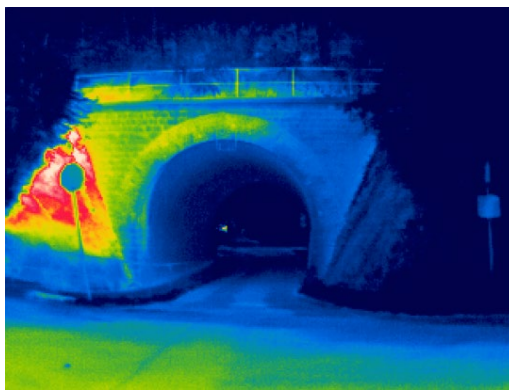
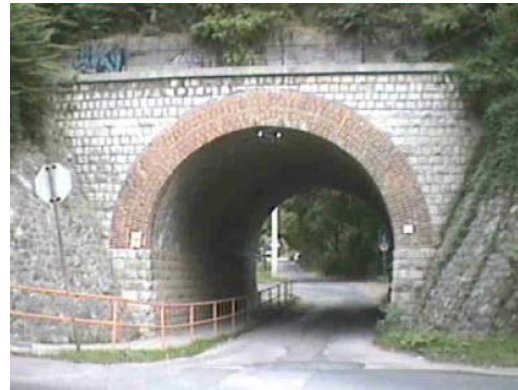
Image	Location
B3-05	Bridge front view (western side)
<u>Comments:</u> The left wing wall was subjected to diffused sunshine prior to the measurement therefore this area is much warmer than the other parts. The various structural parts and materials can hardly be distinguished from each other. The large surface temperature difference between the left wing wall and the other parts prevents observing less striking anomalies.

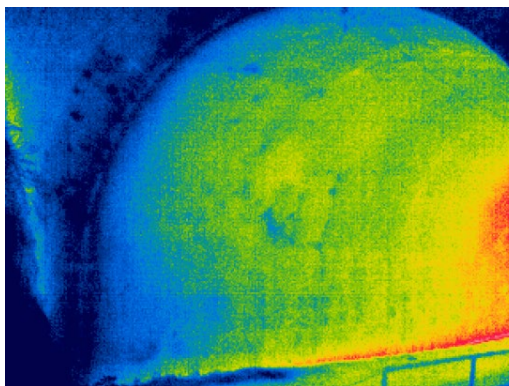
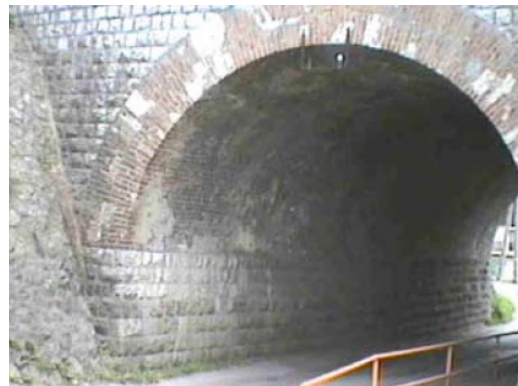
Image	Location
B3-06	Bridge front view and arch barrel (eastern side)
<u>Comments:</u> The front side of the bridge and the arch surface were almost in thermal equilibrium during the measurement. No anomaly can be observed on the thermal image. The wet area around a longitudinal crack, that was well seen on Image B3-02 (recorded at the previous measurement), is still noticeable, although the measurement was preceded by a long dry period.

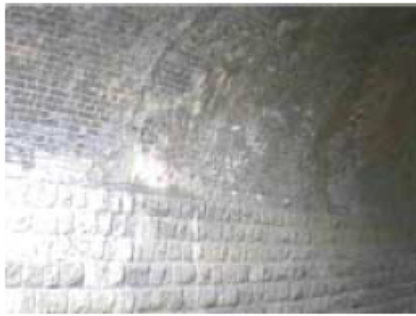
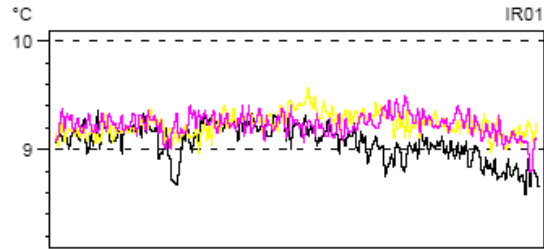
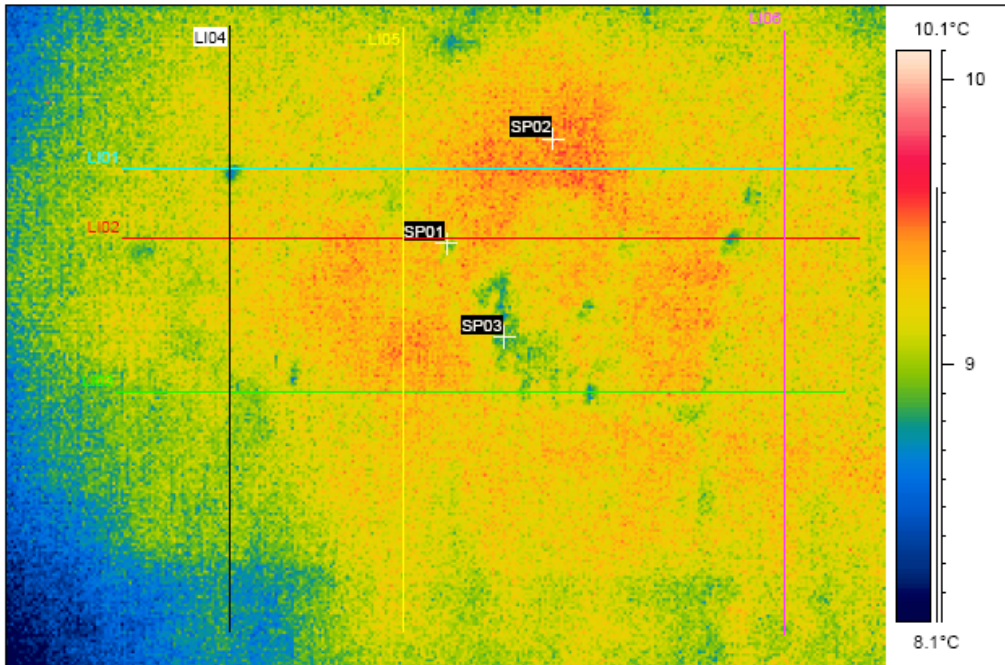
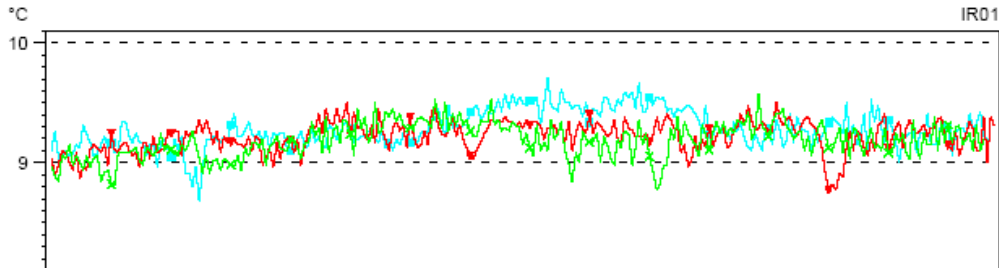
Image	Location
B3-07	Abutment and arch barrel (3m from the eastern end)

Comments: The image shows a closer view from the longitudinal crack. Now the thermal distribution of the surface is rather uniform (the temperature variation along the segments is in the range of only 0.3 °C) as such the identification of the crack is rather difficult.
