NON DESTRUCTIVE TESTING OF STRUCTURES

Part1: Masonry Arch Bridges

Zoltan Orban

APPENDIX 2: Case studies **47**

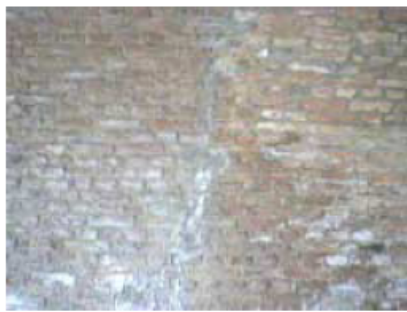
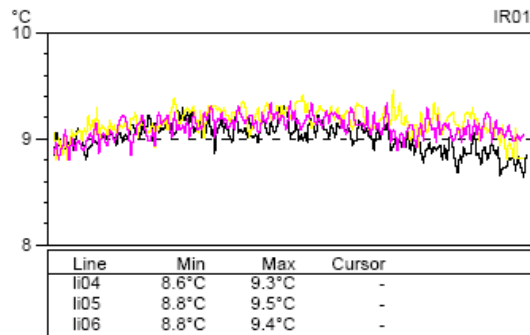
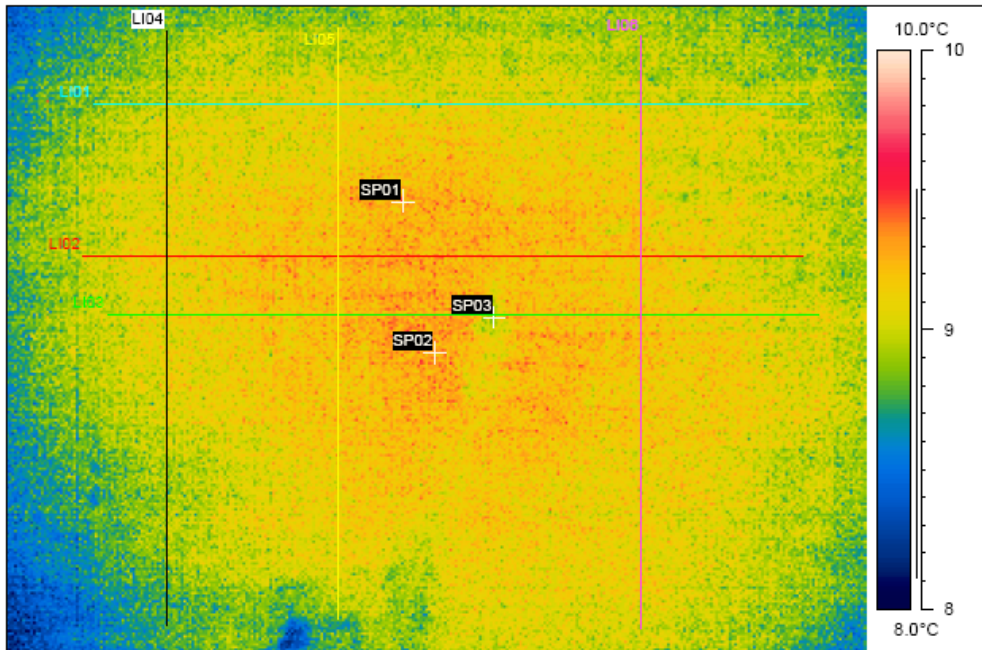
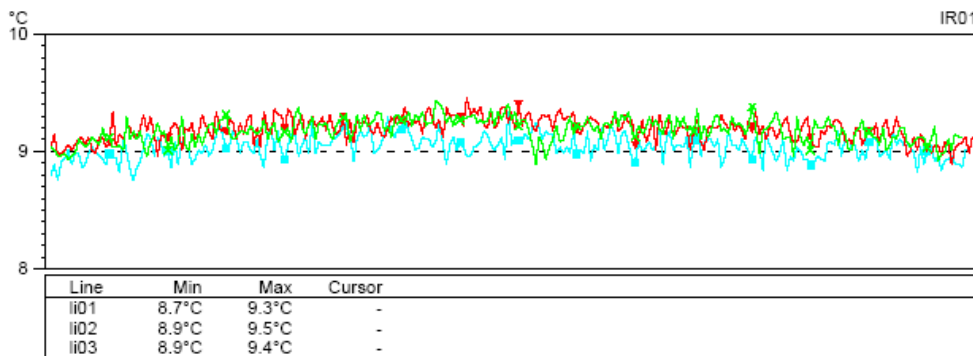
Image	Location
B3-08	Arch barrel (middle of the bridge)

Comments: The image shows a closer view from another longitudinal crack in the middle of the bridge. The thermal distribution of the surface is uniform (the temperature variation along the segments is in the range of only 0.3 °C) as such the identification of the crack is rather difficult even on the segments.

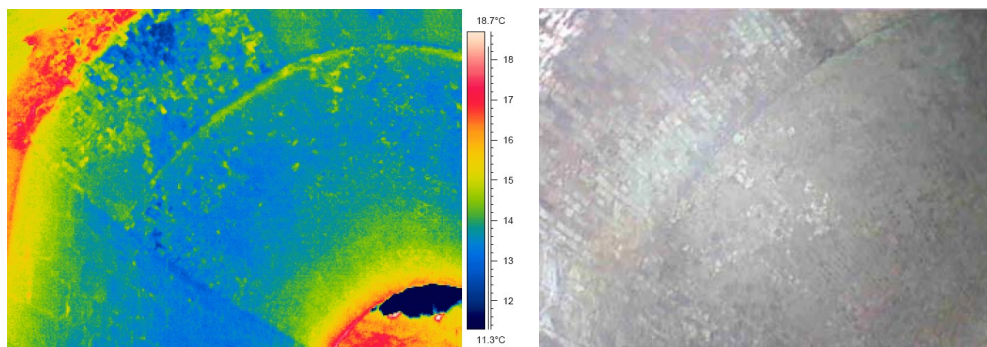
Image	Location
B4-02	Arch barrel (eastern side, at the extension of the bridge)
<u>Comments:</u> Longitudinal crack at the barrel can be identified at the thermal image.

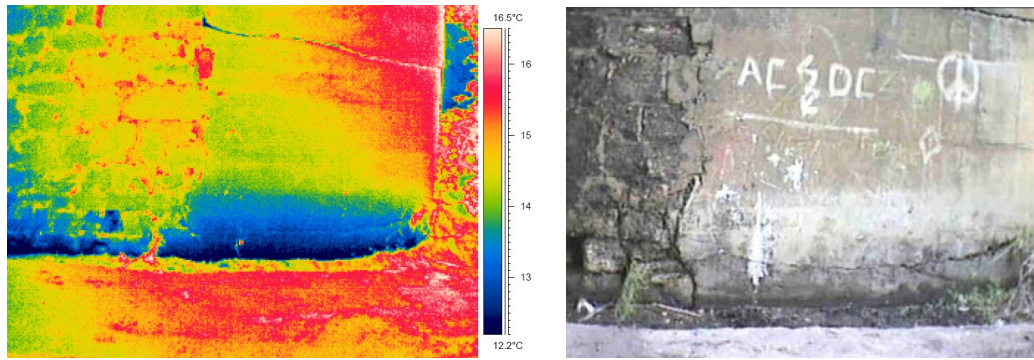
Image	Location
B4-04	Abutment (at the extension of the bridge)
<u>Comments:</u> The right part of the surveyed area on the image is covered by plaster while the left part is a stonework masonry with a highly weathered surface. The difference between the two parts can clearly be seen on the thermal image and the various construction materials can be identified. The lower part of the surface is wet that is seen on the thermal image.

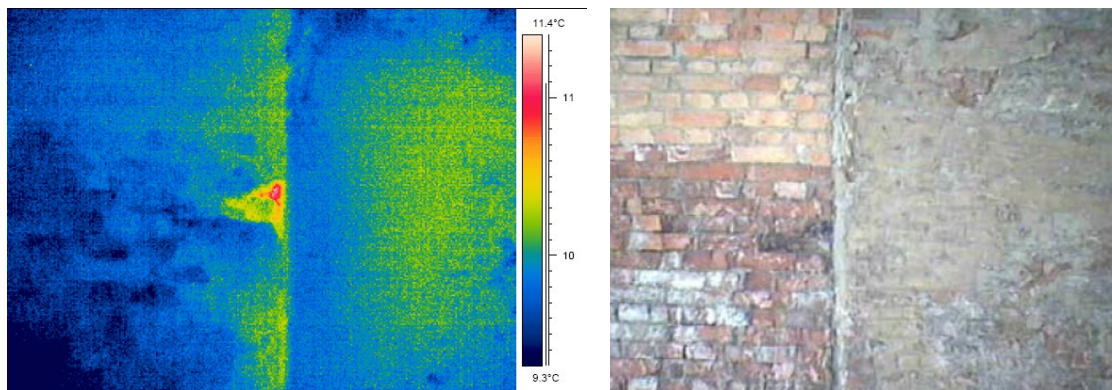
Image	Location
B4-06	Arch barrel (at the extension of the bridge)
<p><u>Comments:</u> Longitudinal crack (separation at the extension) at the barrel can be seen on the thermal image. The right part of the surveyed area on the image is covered by plaster while the left part is brickwork masonry with a highly weathered surface. However this difference between the two parts cannot be identified on the thermal image. No other anomaly can be identified.</p>

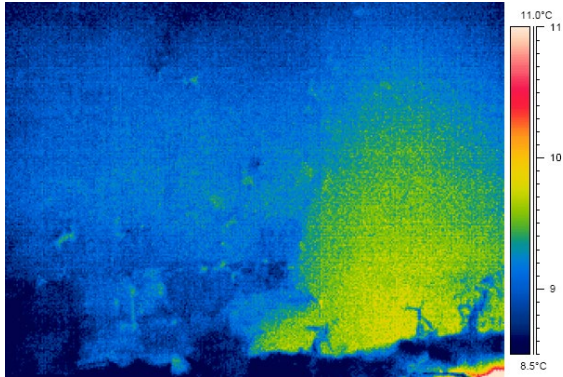
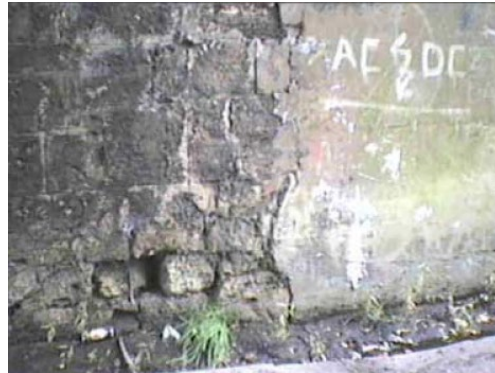
B4-07	Abutment (at the extension of the bridge)
-------	---

Comments: The right part of the surveyed area on the image is covered by plaster while the left part is a stonework masonry with a highly weathered surface. However this difference between the two parts can hardly be identified on the thermal image. No other anomaly can be identified.

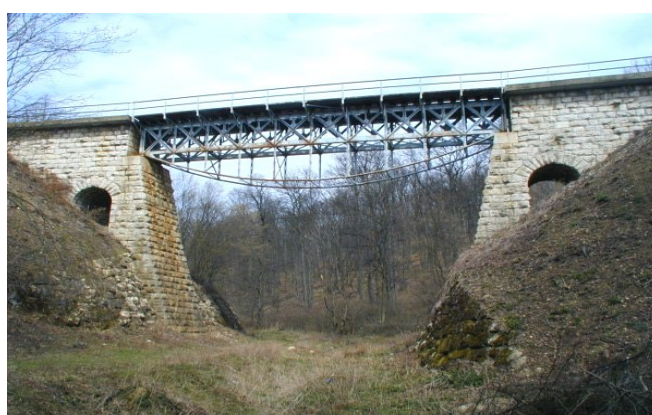
Image 2. The view of the viaduct

The structure is exempt from serious defects. Only the following damages were observed during the visual inspection:

- Cracks at some of the stone blocks. These cracks are thin and are not extensive.
- Waterproofing damage and wet surface at the internal arches.
- Loss of joint material. This defect concentrates mainly at those regions where the surface is wet.
- Weathered stones. Found especially at regions of wetness.

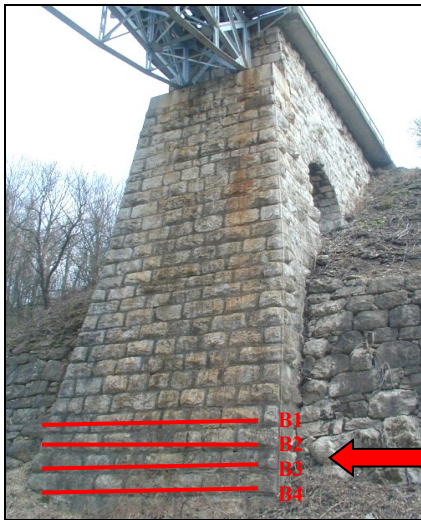
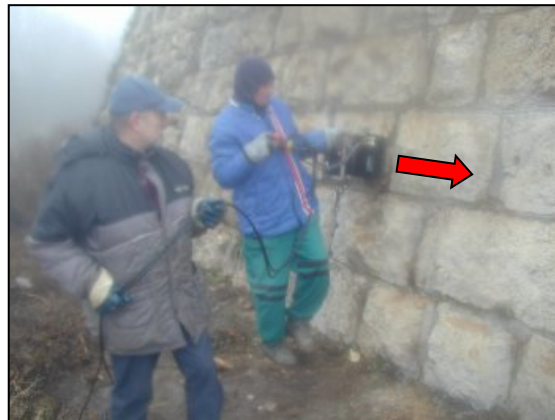
Image 3-4. Location of the GPR survey at the front wall of the left side abutment (B1-B4)

A pulseEKKO-1000 system by Sensors & Software Inc. from Canada was used for the radar tests. The survey was carried out at 450 MHz along horizontal lines at four different heights on the front wall of each abutment (Image 3-4) and on the entire surface of one of the exposed internal arches with frequent horizontal profiling (Image 5-6).

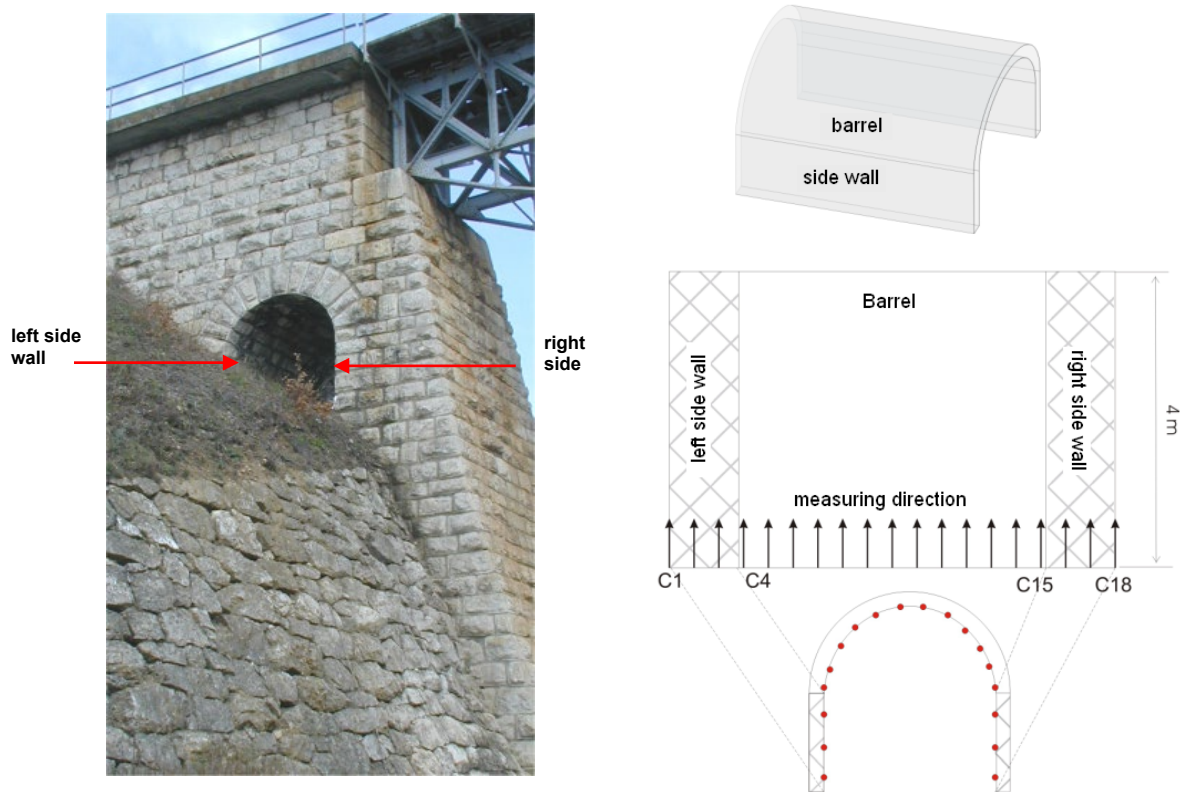
Image 7. Profiles recorded on the surface of the internal arch (demonstration on flat sheet)

Figure 3 shows the location of the GPR recordings on the internal arch. The horizontal profiles are 4 m long and are spaced approximately 30 cm from each other. The numbering of the profiles starts at the left side wall, go along the arch and end at the bottom of the right side wall. The entire surface of the arch and the side walls is 400 cm x 520 cm. The recorded radargrams are shown in Appendix 2, showing side by side the profiles symmetrically facing each other. Profiles C1-C4 were recorded on the left side wall, while profiles C18-C15 were recorded on the right side wall, followed by the profiles recorded on the arch barrel.

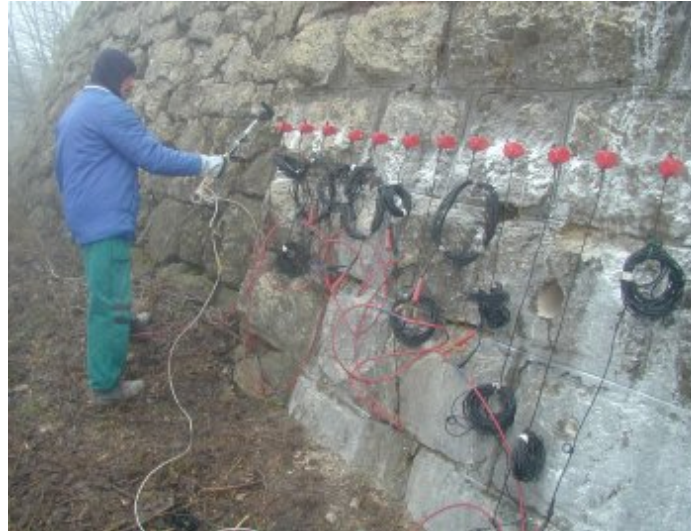
Image 8. Test configuration for the seismic investigation

The seismic measurements were made on the front wall of the left abutment along a straight line at 150 cm height. An ESS 03-48 type computer-controlled seismic measuring system was used, that was developed by ELGI. The distance between the geophones was 20 cm, and a hammer was used as a signal source (Image 8).

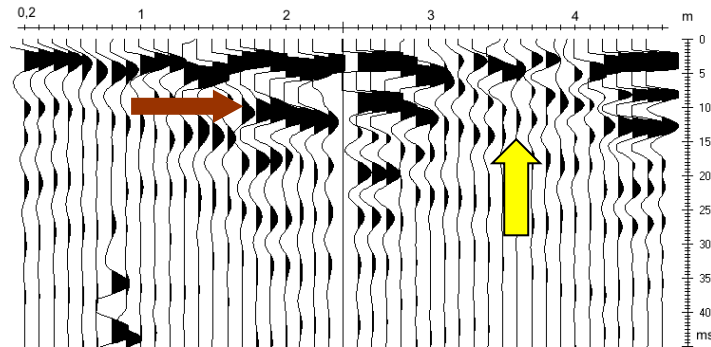
Image 9. Seismic recording on the left side abutment front wall (profile B2)

Image 9 shows the recordings of seismic reflections. The resolution of the seismic reflections from the area behind the rubble stone layer is not so good as the GPR reflections but the penetration is deeper. The image shows two distinctive anomalies. The first anomaly, a lack of signals at the first reflection between 0-5 ms (see the yellow arrow), could either be caused by a measuring error or by the uneven joints of the rubble stones. The “second anomaly” (brown arrow) was possibly caused by the reflection from the other end of the wall. This anomaly, however, cannot be seen on the first part of the profile, but no serious

conclusion should be drawn because the events of interference are very complex in this system and the actual velocity of the seismic waves is not known. (It should be noted here that the propagation velocity of the seismic waves is more difficult to assess than that of the GPR. In the analysed case, calculating with 1000-1500 m/s, the other side of the abutment wall could be at 4-6 m depth.)

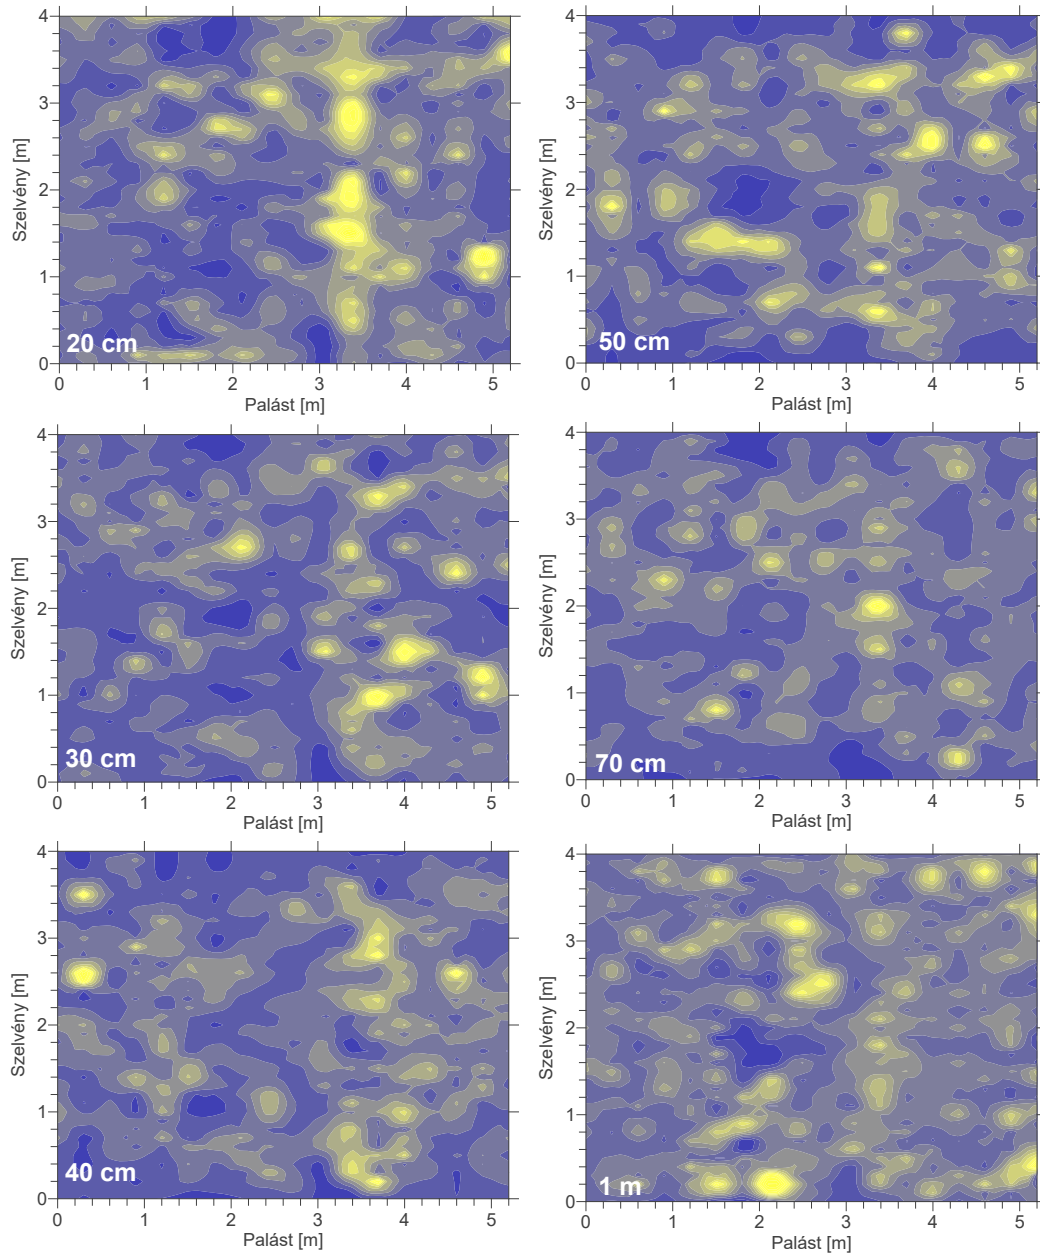
Anomaly map. 3D representation of measured data with slice technique.

The images show anomalies in masonry interior at various depths.

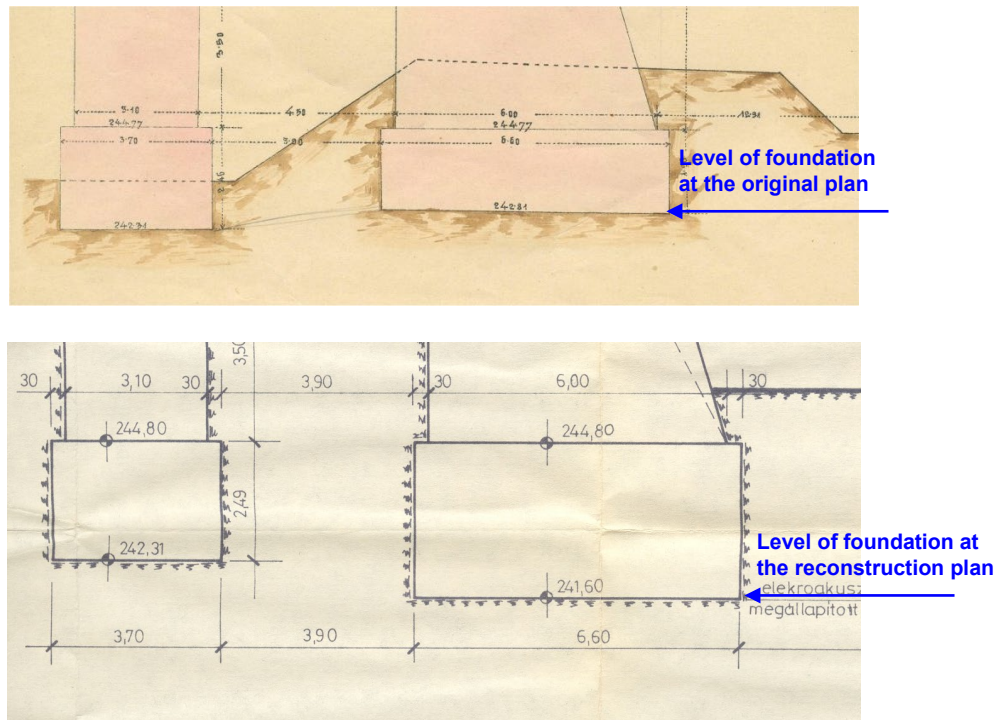
Fig.4: Existing information on the foundation of the Rátót viaduct.
top) original plan bottom) reconstruction plan

Fig. 4. shows that there were controversial informations on the depth of the foundations of the Rátót viaduct. The original plan suggested 242,82m while on the reconstruction plan 241,60m was indicated. The latter was determined by an electro-acoustic technique many years ago.

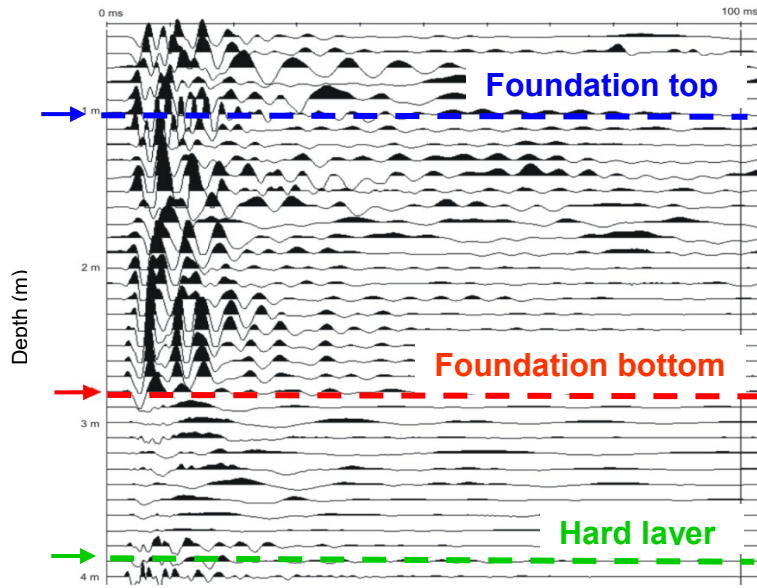
Fig.5: Interpretation of PS recording of the 1st borehole (Rátót viaduct)

A plot of the arrival times -versus-depth has been prepared for both structures (Fig. 5 and Fig. 7). Changes in the physical properties of the medium lead to changes of the characteristics of the plot (e.g. changes of the first arrival times result change of the slope of the curve) The top and bottom of the foundation and the hard rock layer are clearly noticeable on the 'time-depth' plots received from the abutment of the Rátót viaduct (Fig. 5).

Surprisingly the bottom of the foundation is approximately 1m above the hard rock layer according to the PS measurements. Measurements on the second borehole suggests the same level of foundation bottom, but the hard rock layer is found at lower depth. The PS tests confirm the correctness of the foundation data at original plan (Fig. 6).

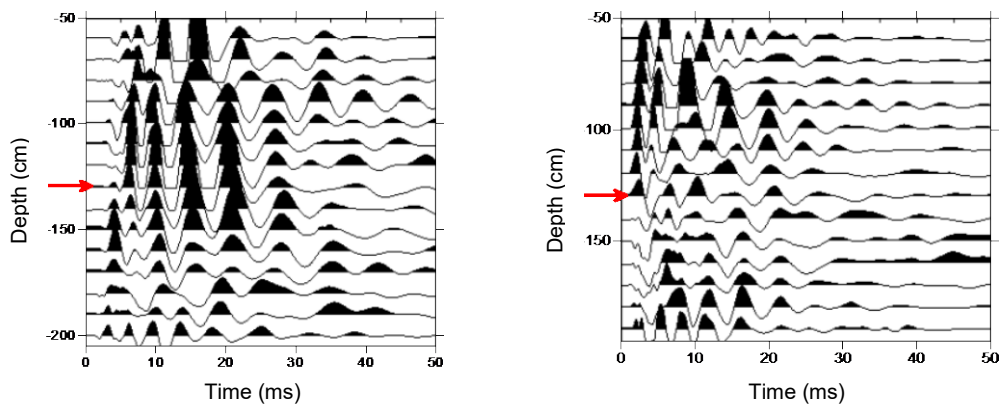
Fig.7: PS recordings at Eplény arch bridge

Red arrows on the recordings received from the two boreholes drilled at the Eplény arch bridge (Fig. 7) point at the level of foundation bottom.
