International Journal of Disaster Risk Reduction

A cascading risk model for the failure of the concrete spillway of the Toddbrook dam, England during the August 2019 flooding

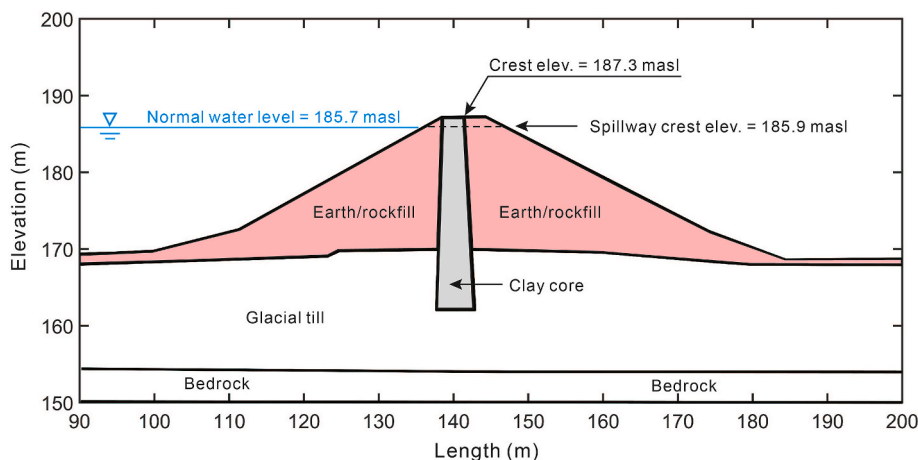
The Toddbrook dam is a zoned earth-fill dam with a clay core acting as its water sealing element (Fig. 2). The height of the dam is approximately 24 m, its crest length is 310 m, the reservoir capacity is 1.29 million m³, and the slope of the upper part of its embankment is 2 (horizontal):1 (vertical) [16]. The dam construction was completed in 1840 and its purpose was to supply water to a nearby navigation canal [17]. The dam was originally equipped with a side channel as its spillway, which is called spillway-1 throughout this report (Fig. 3). These types of spillways usually have limited discharge capacities and are susceptible to blockage by flood debris as they are located at a side of the dam and are usually narrow. Therefore, it was concluded that the original spillway does not have enough capacity and a new spillway, called as spillway-2 hereafter (Fig. 3), was built in 1970. The new spillway is of chute type with an entrance width of 76 m that extends from the dam crest to the downstream channel connected to spillway-1 (Fig. 3) and with 15-cm thick concrete slabs [17]. The crest elevation of spillway-2 is 1.4 m below the dam crest elevation. With the combined discharge capacities from the two spillways, it is expected that the dam has been provided with sufficient protection during severe flooding in the area.

Fig. 2. A cross section of the Toddbrook dam showing different soil elements of the embankment. This section is produced based on a sketch published by Balmforth [16]. “Elev.” is the abbreviated form of elevation. “masl” stands for meters above sea level.

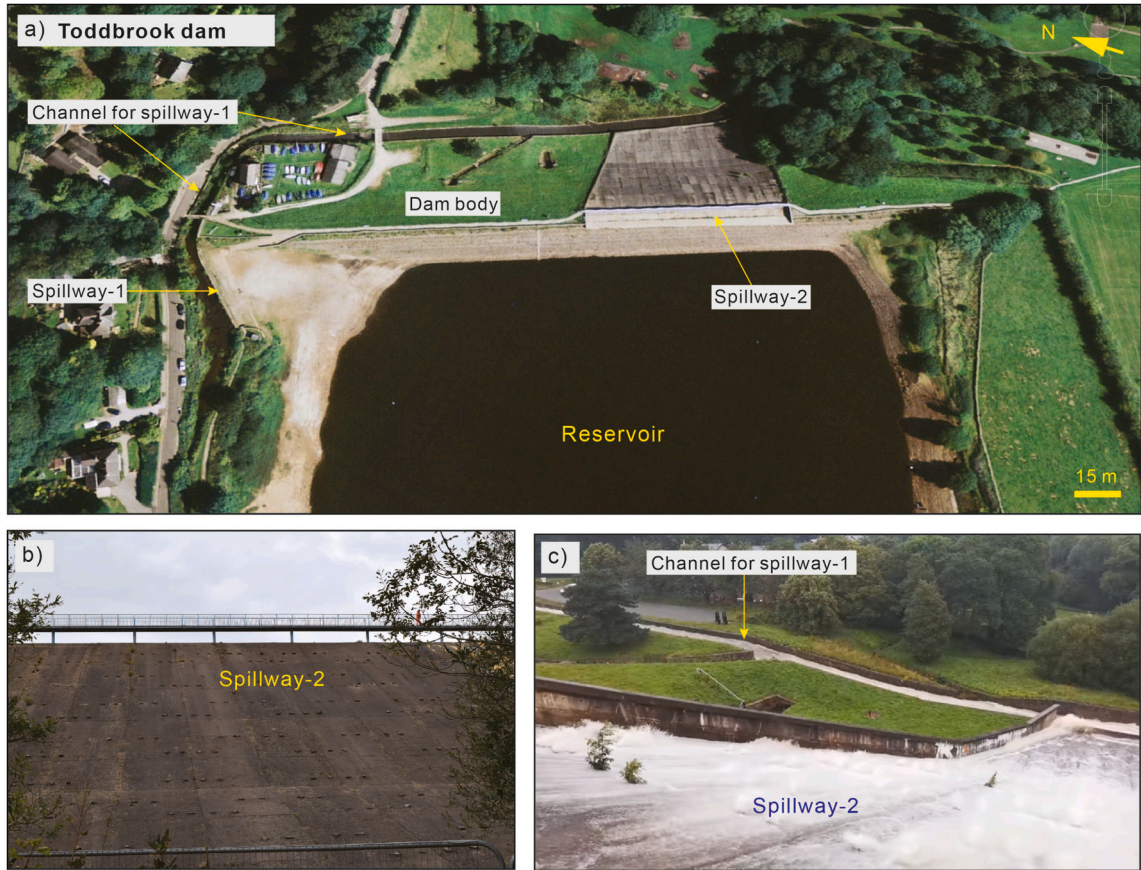
Fig. 3. The two spillways of the Toddbrook dam named as spillway-1 and spillway-2. Panel “c” is a snapshot from the video at: www.youtube.com/watch?v=-5I-t7YTkec (YouTube channel of Matthew P. E. Forrest).

Analysis of photos and videos from the Toddbrook dam incident reveals that the concrete surface of the spillway-2 was in a poor condition at the time of the incident. Dense vegetation including a few trees were present on the surface of spillway-2 when high-speed flow was passing over it during the incident (Fig. 6a). It is noted that at least three trees, one of them approximately 1.7 m tall, are seen at the damaged part of the spillway during the incident. A review of satellite images of spillway-2 over the period of 1999–2020 (Fig. 7) reveals that the spillway surface was cleaned up of vegetations and trees from time to time. For example, the surface appears to be in a good condition in December 1999 (Fig. 7f) and December 2005 (Fig. 7b), but it is covered with vegetation and trees in other times (Fig. 7b,c,e). It is most likely that the foundation of spillway-2 has been seriously undermined due to the extensive growth of vegetation and trees over years; therefore, the concrete slabs were not resting on a solid foundation. As a result, any water injection beneath the slabs could lead to erosion of the foundation and settlements of the slabs (Fig. 8).

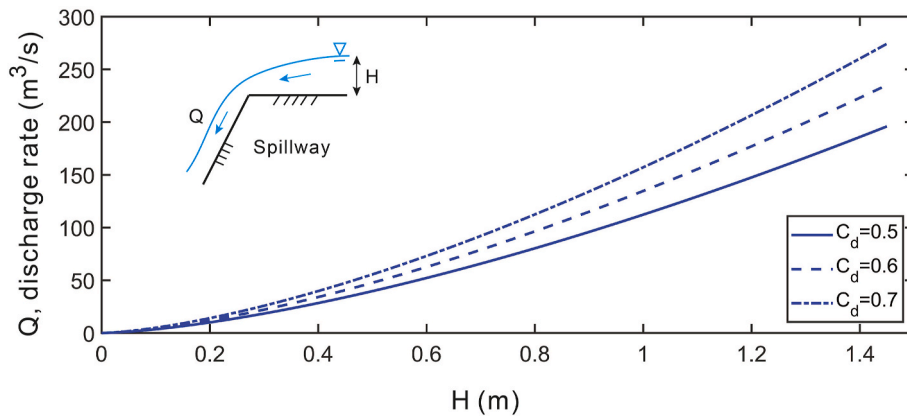
Fig. 4. The discharge capacity of the Toddbrook dam spillway-2 at different water heights above the spillway crest level (H) as a function of C_d (discharge coefficient).

gravitational acceleration, b is spillway width ($b = 76$ m), and H is water elevation difference between water surface in the reservoir and the crest elevation of the spillway (Fig. 4). The result of discharge calculations is shown in Fig. 4 indicating that the spillway-2's discharge rates are $177.0 \text{ m}^3/\text{s}$, $134.7 \text{ m}^3/\text{s}$, and $96.4 \text{ m}^3/\text{s}$ for the H values of 1.2 m, 1.0 m and 0.8 m, respectively (assuming $C_d = 0.6$ in Fig. 4). The Probable Maximum Flood (PMF) for the design of the Toddbrook dam is reported as being $164.0 \text{ m}^3/\text{s}$ at the reservoir level of 187.1 m (equivalent to $H = 1.2$ m) [17]. We note that Eq. (1) results in a discharge rate of $177.0 \text{ m}^3/\text{s}$ for $H = 1.2$ m; therefore, we assume a PMF of $Q_{PMF} = 177.0 \text{ m}^3/\text{s}$ in this study, which is slightly higher than the PMF reported by Hughes [17].

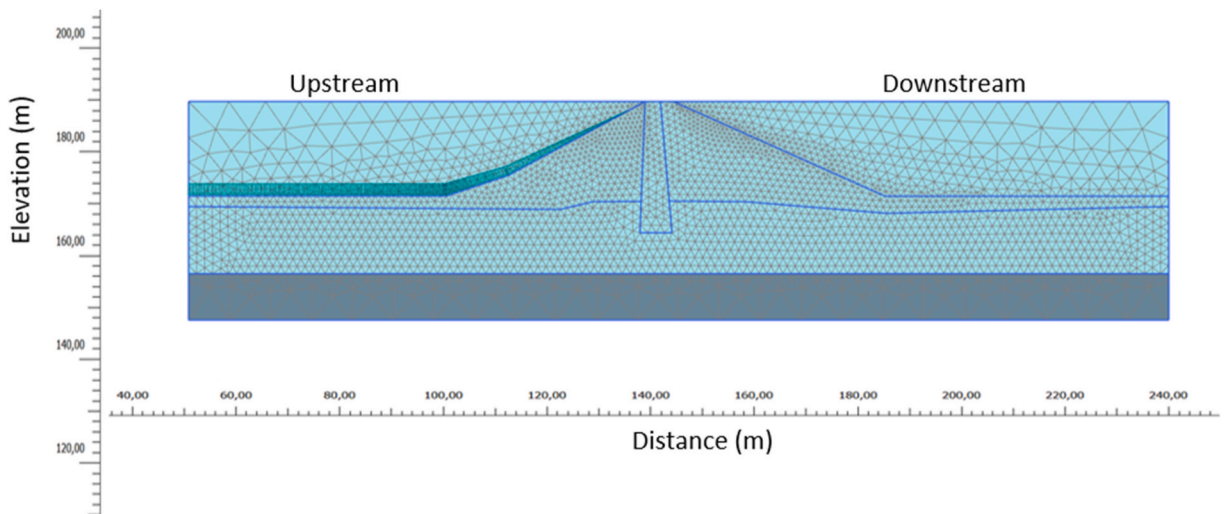
To develop a better understanding of risk posed by rapid drawdown, here we model the situation using a modelling package called PLAXIS (Plane strain and axial symmetry; [35], which is widely used in Geotechnical Engineering (<https://www.bentley.com/en>). PLAXIS is based on Finite Element Method with an implicit numerical scheme. For our modelling, we use a 2D section of the dam body with fine meshing having approximately 44,000 nodes (Fig. 11). In order to find an optimum mesh size for modelling the dam, a few sensitivity analyses were carried out prior to the main analyses. Such sensitivity analyses resulted in a computational mesh with varying grid sizes at different parts of the dam. The mesh sizes are in the range of 0.2–5.0 m with an average element size of 1.7 m (Fig. 11). Soil properties for different layers of the dam (Fig. 2) are presented in Table 2. It is noted that the material properties in Table 2 are based on our geotechnical engineering judgments as there are no available documents for the dam's soil properties. The water is modeled at the level 186.0 masl based on the observations of the dam's water level before the incident.

Fig. 11. An overview of the meshing system with varying grid sizes at different parts of the dam used for modelling the Toddbrook dam using the PLAXIS modelling package.
