Dynamic Behavior of Connected Structures

Ahmad Fahmy Kamarudin^{1*}, Shahrul Niza Mokhtar¹, Seyed Jamalaldin Seyed Hakim¹, Zainah Ibrahim², Azmi Ibrahim³, Ade Faisal⁴

Abstract: The effect of connected structure on SMK Bukit Tinggi building was investigated based on their dynamic behaviour. The structure was constructed with four main buildings are interconnected. Ambient vibration testing (AVT) was used to predict the dynamic response and characteristics by using triaxial 1Hz seismometer and CityShark data logger. The AVT signals were analysed using GEOPSY software for Fourier Amplitude Spectral (FAS). All predominant frequencies (f_0) and mode shapes were identified and verified with previous research finding using similar testing approach on the same building, but with different instrument of accelerometer sensor and ARTeMIS software processing tool. Five modes of f_0 were found from the FAS curves from this research, but only four f_0 were obtained from ARTeMIS analysis. The highest deviation percentage was indicated at the 5th mode of building frequency at 9.5 %, but 0 to 2.5% to the rest frequencies mode (1st to 4th frequencies mode). Ununiformed buildings response behaviour

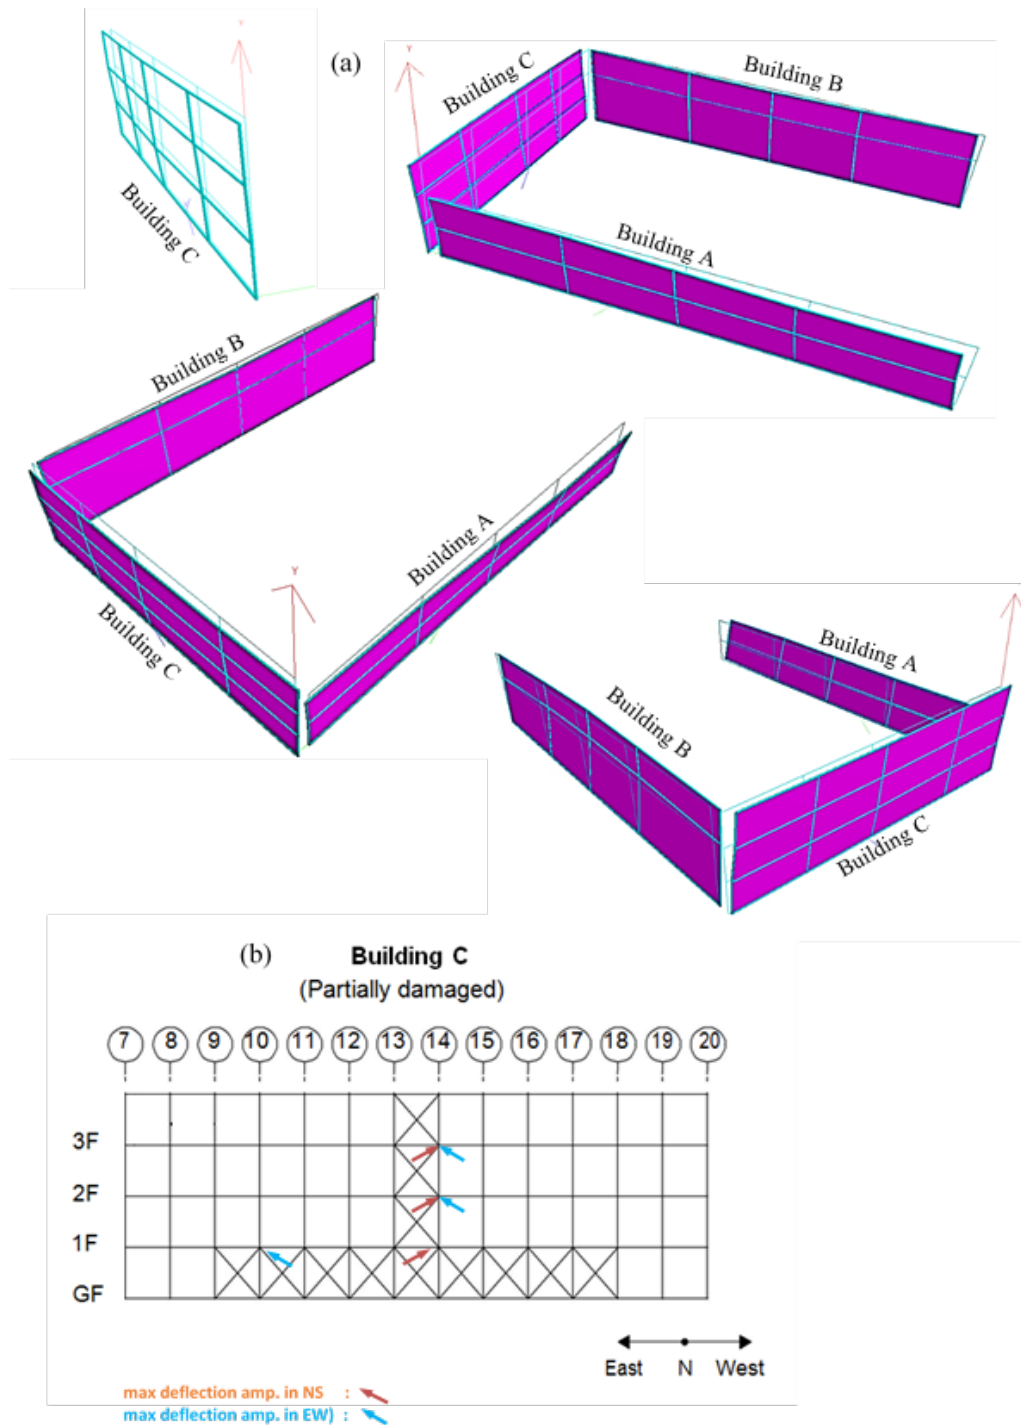
Fig. 9 - Illustrations of (a) 3-dimensional mode shape of SMK Bukit Tinggi at the 1st and 2nd predominant building frequency of 4.21 Hz, and (b) positions of the maximum deflection amplitude

The first modes of vibration (translational) for Building C was found at 4.21 Hz in both transverse (NS) and longitudinal (EW) directions. The translational mode shapes at 4.21 Hz indicated maximum deflection amplitudes mostly concentrating at the mid span (at column C14) for every floor. This is due to the influences of concentration of storey mass, unrestrained condition by adjacent building, existence of soft storey area on ground floor and corridor access with the void compartment at every floor. Uniform mass orientation produces the least relative displacement amplitude compared to the other mass irregularities [16].

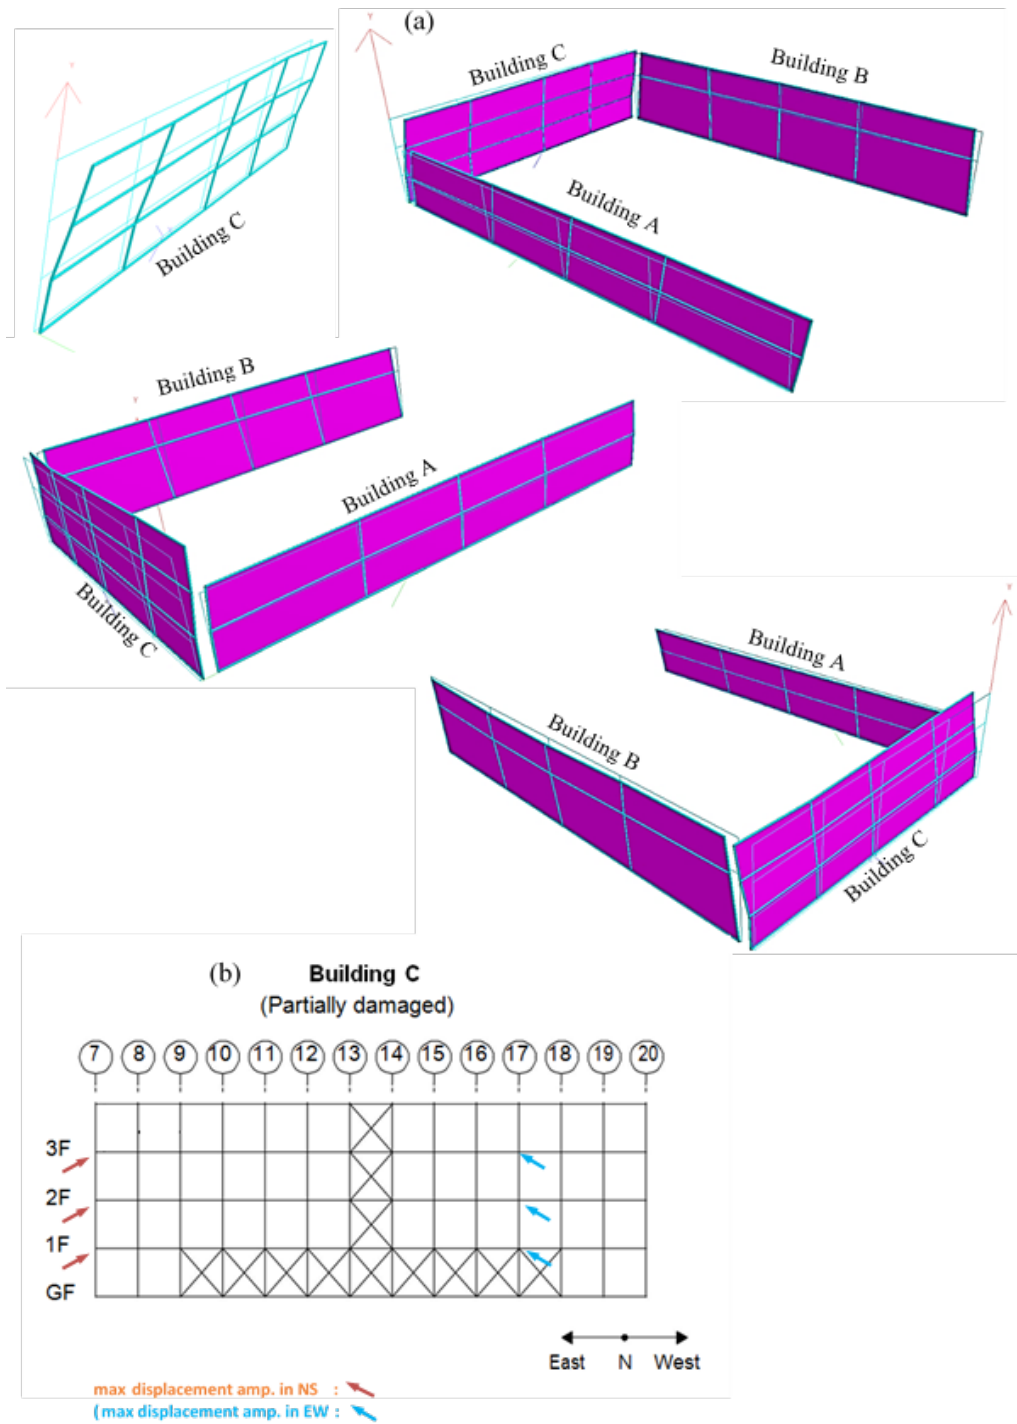
Fig. 10 - Illustrations of, (a) 3-dimensional mode shape of SMK Bukit Tinggi at the 3rd predominant building frequency of 5.17 Hz and, (b) positions of the maximum deflection amplitude.

Meanwhile, the torsional behaviours of Building C were showed at 5.17 Hz and 6.35 Hz. It was observed that the fifth f_0 was also found at 8.66 Hz. The torsional mode shape is clearly observed on the third f_0 of 6.35 Hz at Building C. When Building A and Building B experience translational deformation at 6.35 Hz along respective longitudinal axis
