JRC2015-5793

TRACKING OF SPALL DETERIORATION ON TAPERED ROLLER BEARINGS

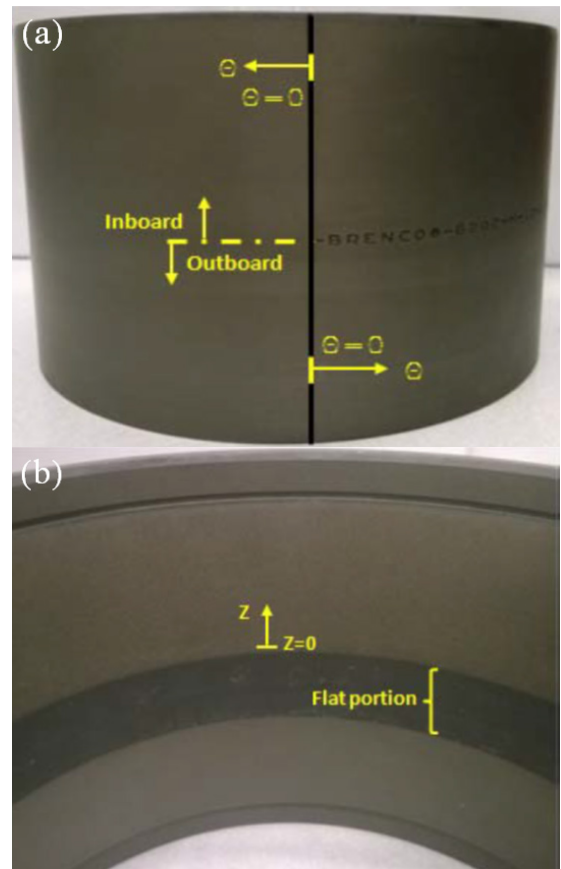
Figure 1: (a) Orientation of the cup raceways (IB and OB) and their respective positive θ rotations, and (b) origin z -coordinate and its positive direction for both IB and OB raceways for the third cup service life test
