Failure Analysis of Steam Generator Tubes

Gonzalo Diego and Susana Merino

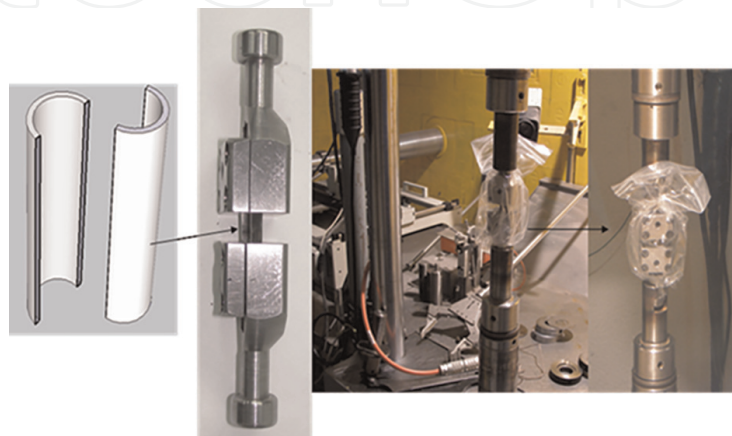
The characterization of the fracture surface was performed by longitudinally cutting the tube into two equal half parts. One of them was tested for fatigue to obtain the fracture surfaces (**Figure 3**).

Figure 3.
Devices used to obtain the fracture surface.

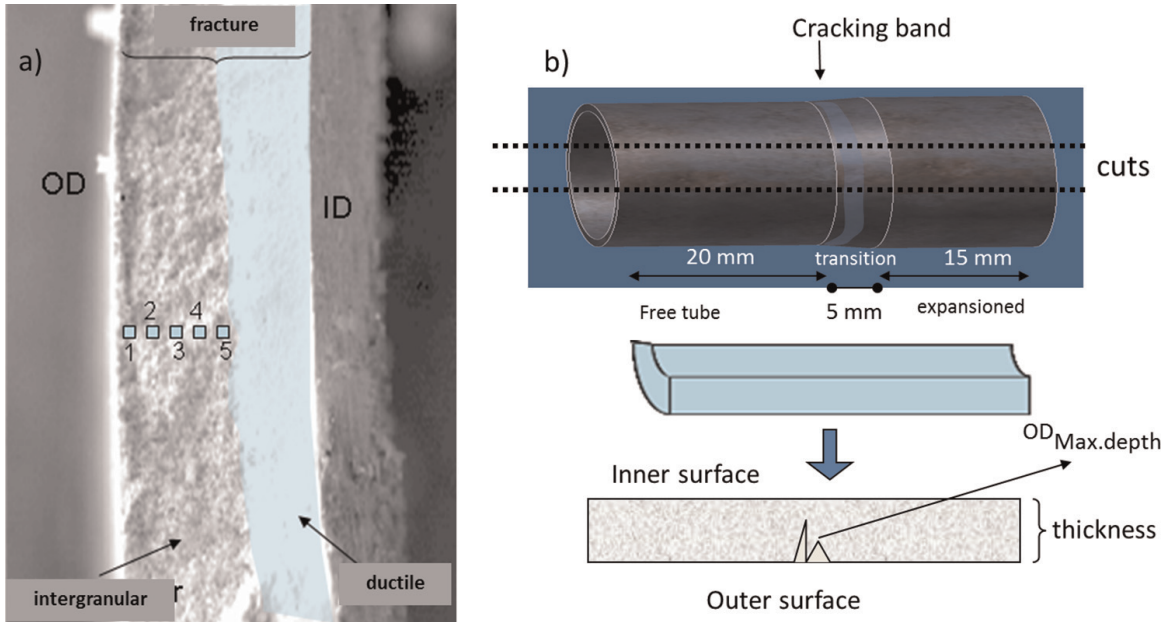
The fracture surface was examined on SEM to quantify the length and depth of existing cracks. The deposits found on the fracture surface of the two cracks were analyzed by EDX and by Auger spectroscopy, five zones of each crack from OD, (point 1) to inside the crack (point 5) (**Figure 4a**).

Metallographic characterization of the axial sections was carried out on the other half of the tube piece as shown in **Figure 4b**.

Figure 4. a) Points analyzed on the fracture surface by Auger spectroscopy. b) Metallographic specimens from the other half of the tube in the area of interest.

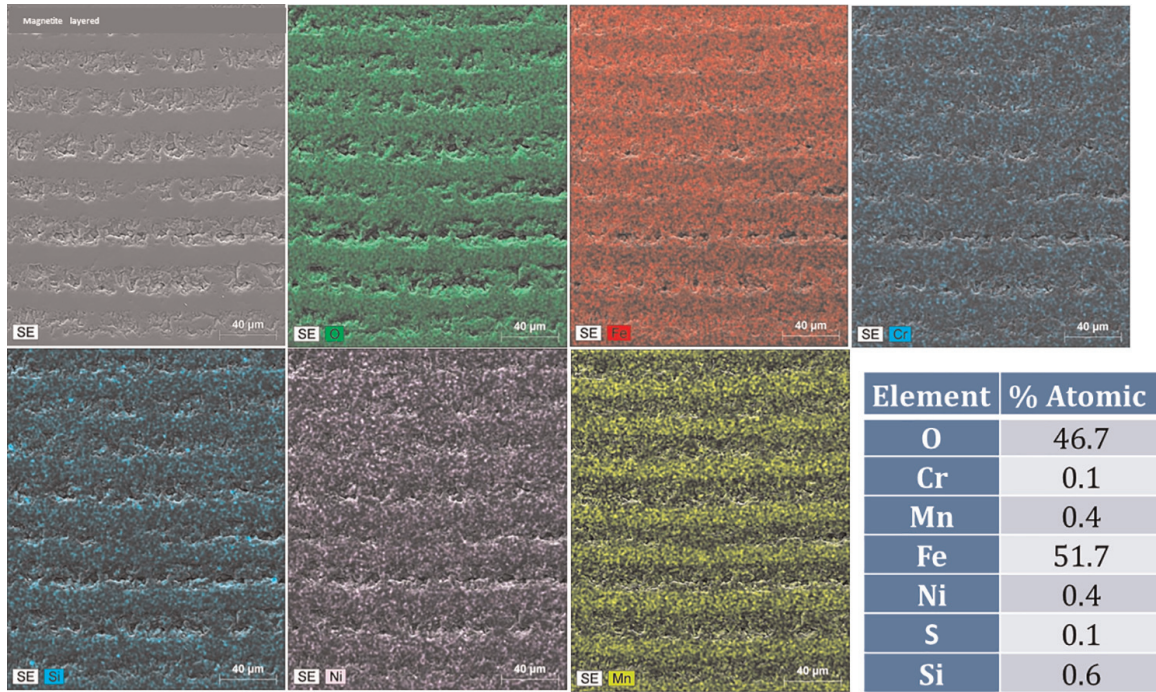
Figure 14 shows the elemental distribution on the magnetite layers with enriched bands in Mn. Dot analysis shows only Fe and O in the compact layers while in the porous layers exists an enrichment of Mn, Ni, Si, and other elements in a lower concentration (**Figure 15**).

Figure 14.
Mapping of elements distribution in the cross-section of magnetite layered.

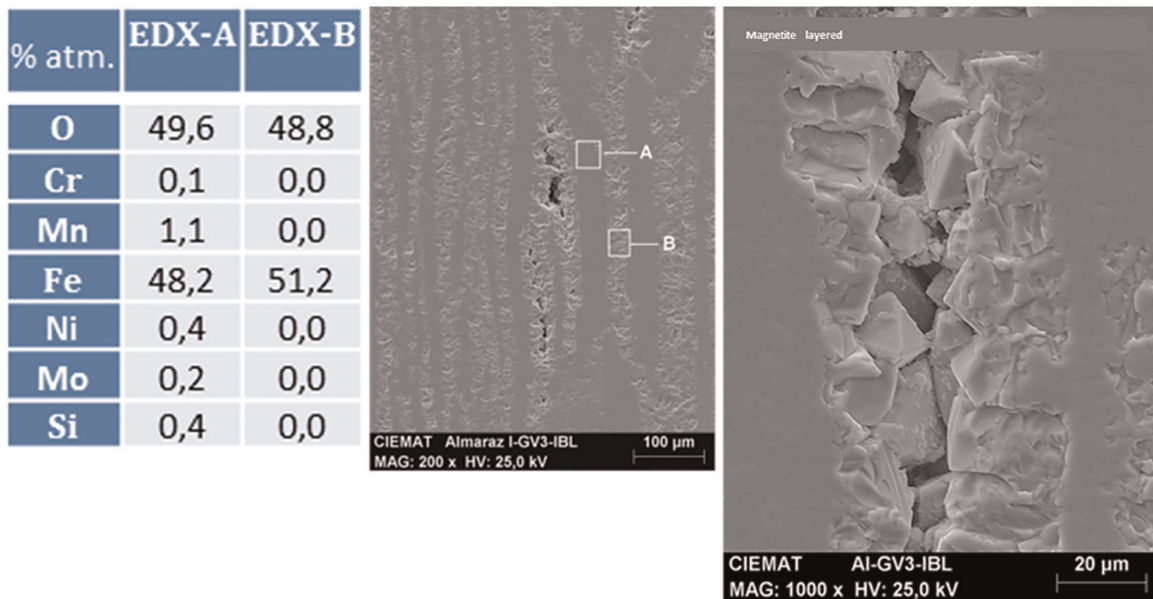
Figure 15.
Dot EDX analysis in the cross-section of magnetite layered sample.

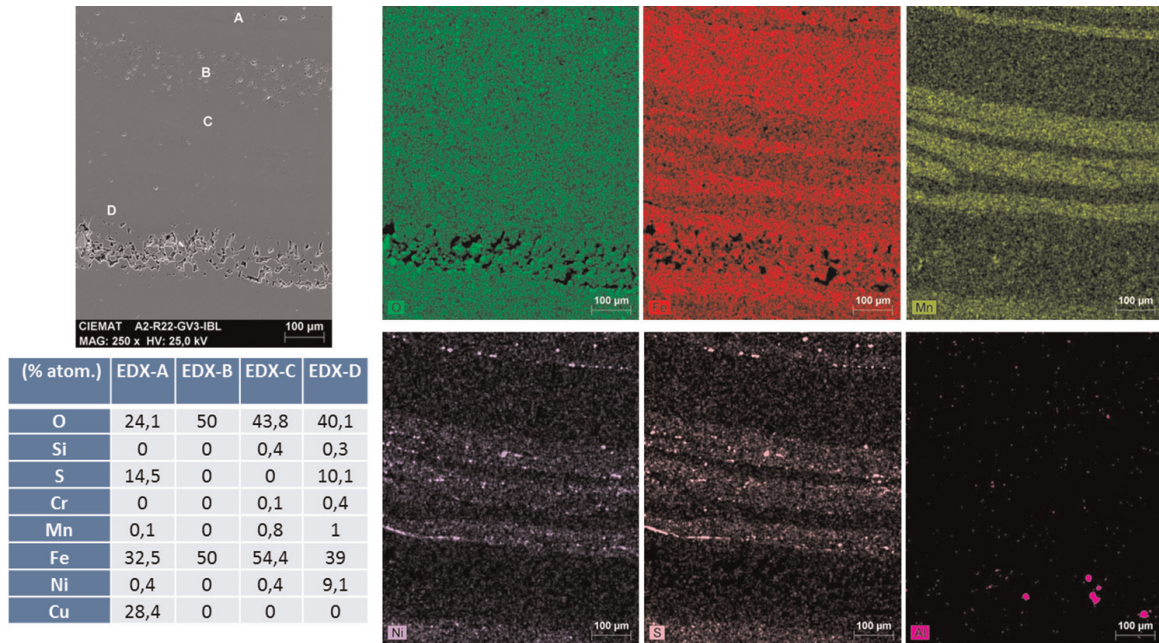
The total of these elements forming the enriched bands is only 2%, the rest is Fe and O. Additional analyses performed detected an increase in S and Ni with isolated precipitates of Cu (**Figure 16**).

Figure 16.
 Mapping of elements distribution in the cross-section of Magnetite layered.

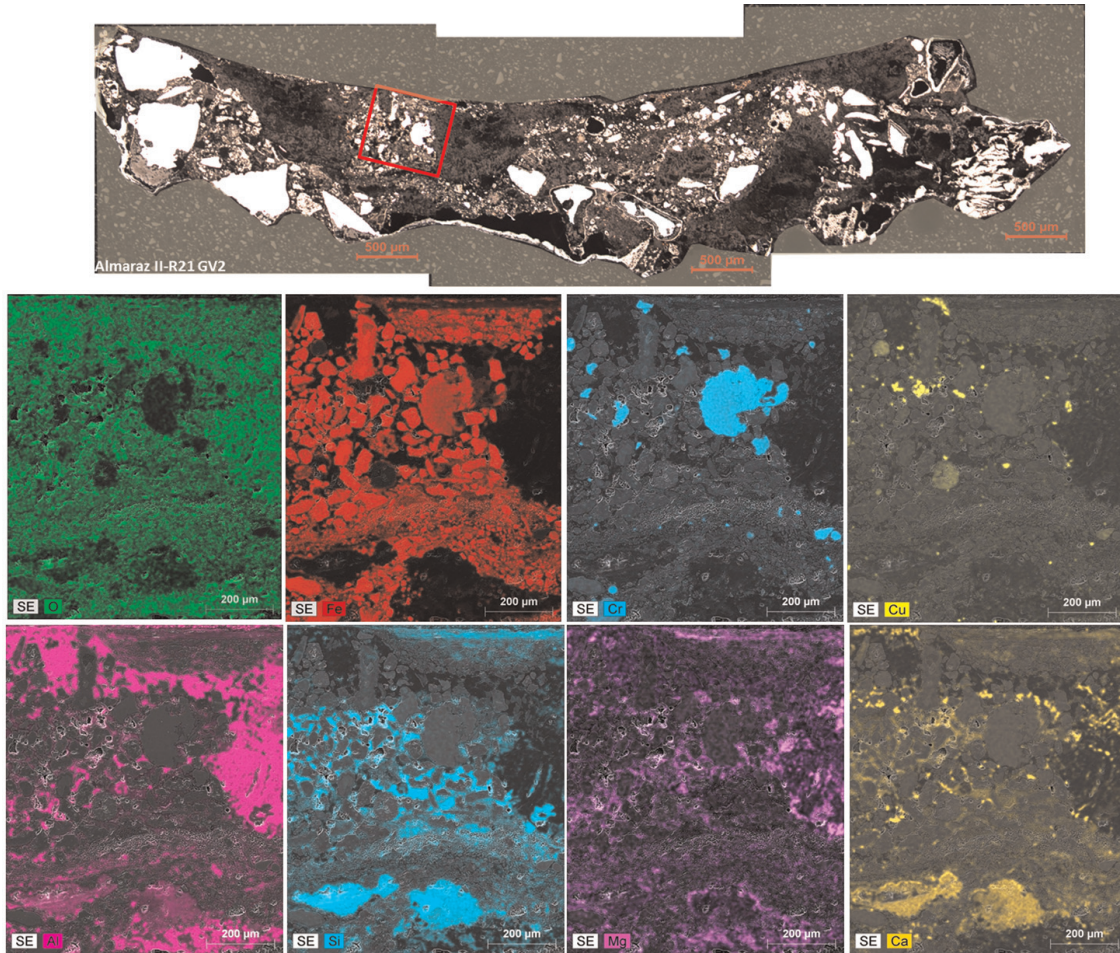
As discussed at the start of this section, “collars” pieces were detected Spanish NPPs (**Figure 17**). Cross-sections of these samples are formed by a number of metallic inclusions embedded in a matrix of Al and Si species (**Figure 18** and **19**). These last elements were enriched preferably near the interface with SG tube surface. Si/Al ratio is higher when the silicates are the binding agents.

Figure 18.
Cross-section collar. Spatial distribution of chemical elements by SEM-EDX.

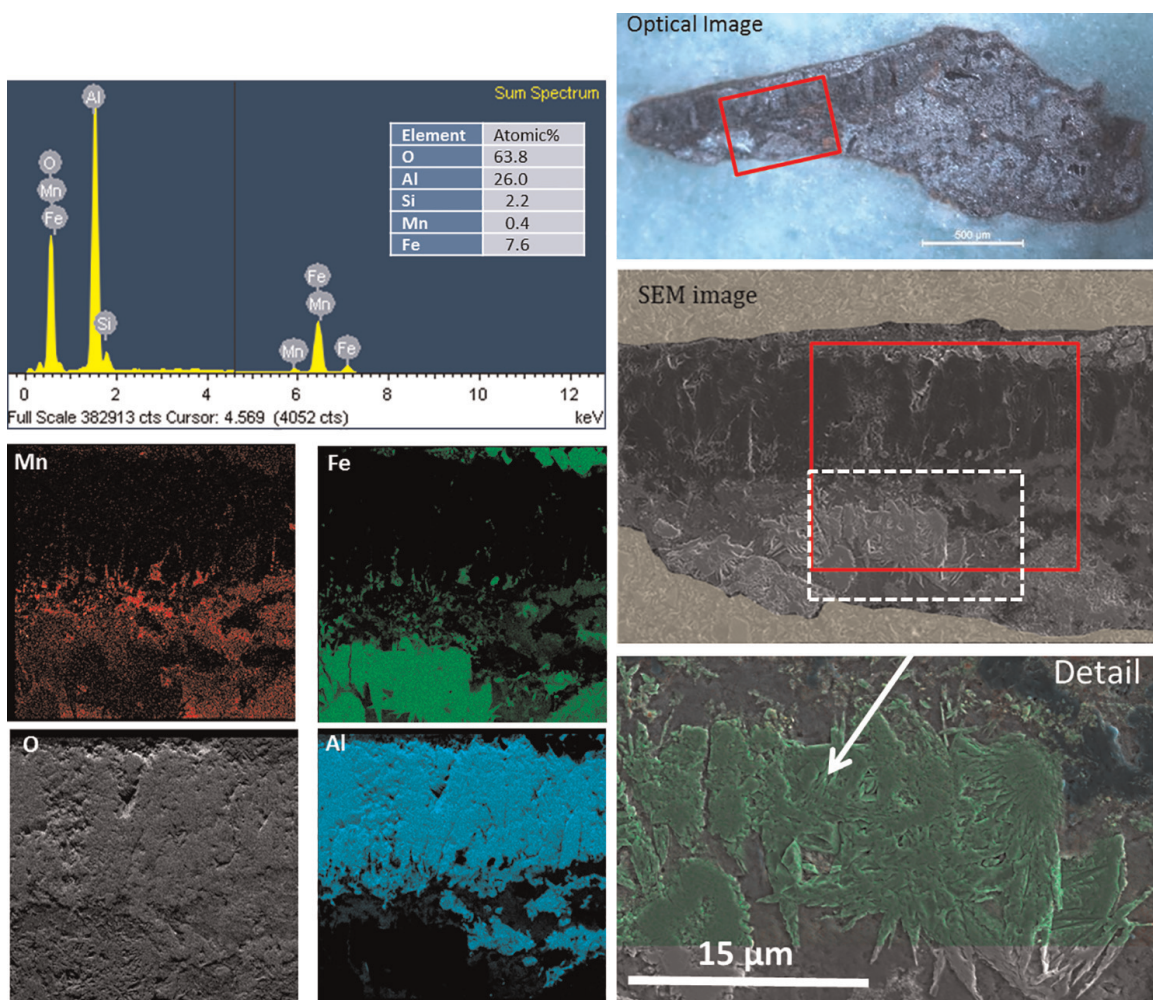
Figure 19.
 Cross-section collar. Spatial distribution of chemical elements by SEM-EDX.

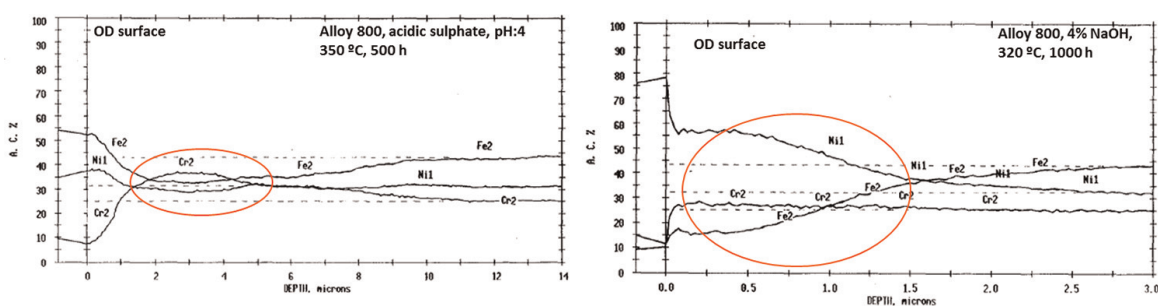
The results of the EDX analyses and Auger analyses carried out on the fracture surfaces of cracks A and B allow us to infer the medium in which the cracks have been formed. For this purpose, the concentration profiles obtained on cracks A and B with those obtained on samples tested in the laboratory were compared (**Figure 21**). In acidic media, a first layer rich in iron and nickel is observed, which is identified as a layer deposited on the specimen during cooling, and below it a layer with enrichment in chromium and depletion in nickel and iron is visible. In caustic media, an oxide

Figure 21. Auger analyses. Concentration profile of deposits formed on the external surface of a C-ring specimen tested in acid sulfates at pH =4 at room temperature and in caustic media.

layer with clear nickel enrichment, slight chromium enrichment in its outermost part, and iron impoverishment is observed.

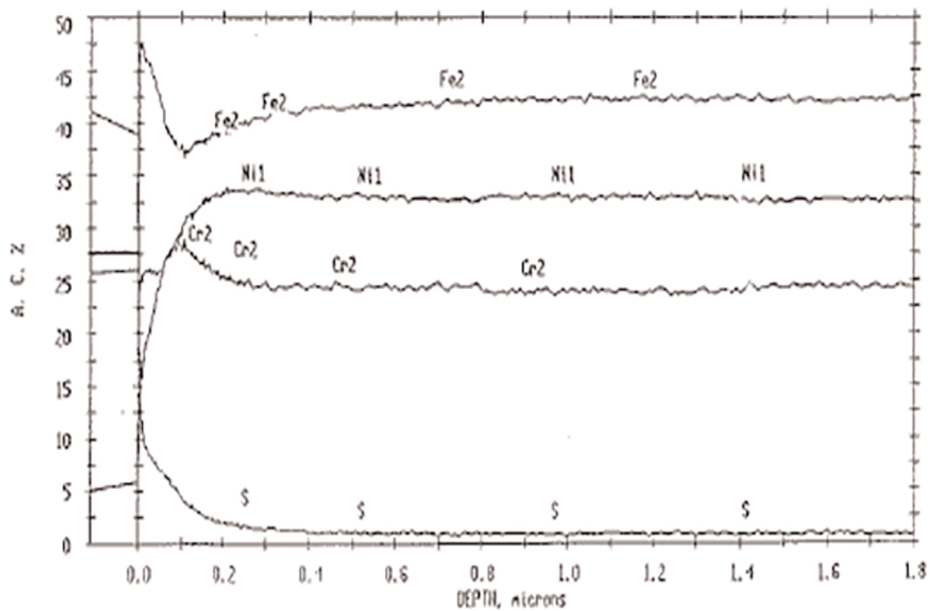
Figure 22 shows the concentration profiles obtained on the crack fracture surface formed in an Incoloy 800 tube tested in a "model boiler" in the laboratory, in acid sulfate media, with pH=4, at room temperature.

If we compare these results with the concentration profiles obtained at the bottom of cracks A and B (**Figure 21**), we observe that the main difference between these curves and those of the laboratory sample is the existence of nickel enrichment in the latter, which, as shown in **Figure 23**, is the typical trace left by alkaline environments.

Therefore, we can conclude that the cracks have been formed in a neutral or slightly alkaline environment. Alkaline environments with pH > 10 can be discarded due to the presence of silicates. Sulfur presence would suggest acidic environments, although this evidence is not fully conclusive in all performed analyses. However,

Figure 22. Auger analyses. Concentration profiles of the oxides at the bottom of a crack in an Incoloy 800 tube were tested in a model boiler in acid sulfate media.

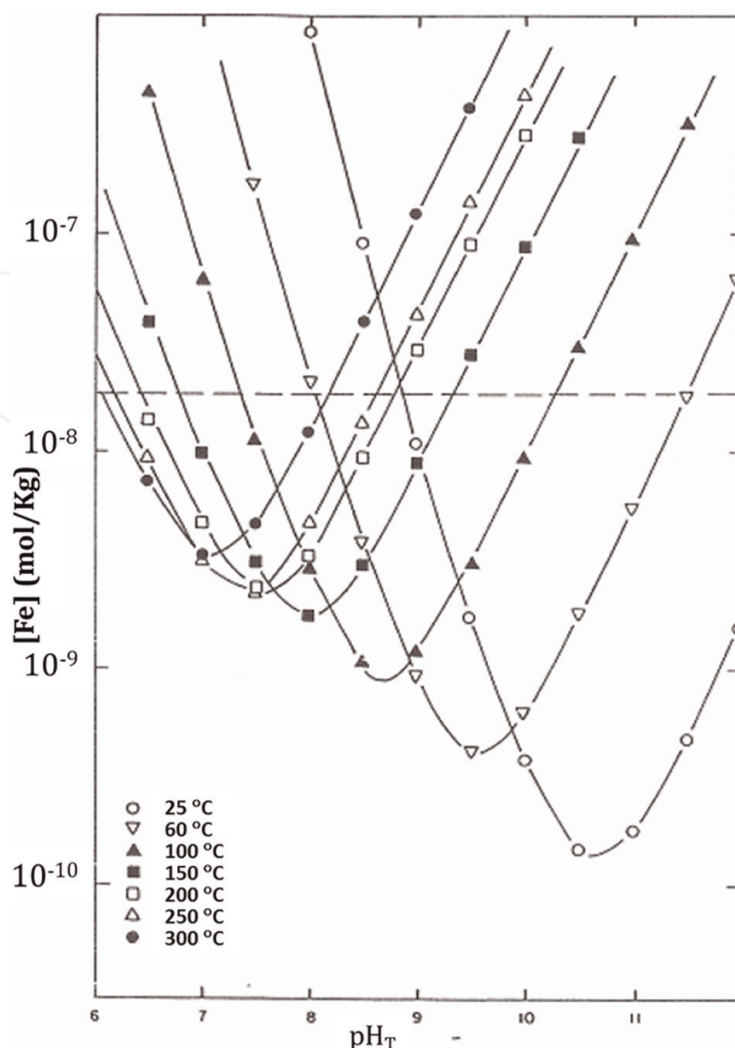
Figure 24.

Magnetite solubility is very strongly dependent on both pH and temperature (**Figure 24**). For 300°C there is a minimum in solubility (about 5·10⁻⁹ M) found at about pH₃₀₀=7. However, the solubility increases one order of magnitude with the change of one unit of pH at 300°C in both directions [21]. As a rule, the magnetite solubility presents a minimum value for each temperature and pH, diminishing for lower temperatures and higher pH. This is why efforts to avoid the deposition of magnetite by ETA injection before shutdown and, thus, reduce the magnetite solubility and FAC. Obviously, if the amount of iron in solution is high the magnetite deposition will occur during the shutdown, especially in the cold legs. Magnetite layer is formed by a competitive process between deposition and solubility due to the small variations around this minimum of the solubility.

A protective layer of magnetite can increase during normal operation of the plants, by these previous arguments, up to a certain thickness from which magnetite layer spallation is produced. This would explain the structure found in samples named magnetite layered where alternate layers are formed during the oxidation process of low carbon steels (tube sheet). A first oxide layer is initially composed mainly of iron and oxygen and other alloying elements that depending on their different diffusion coefficients will form enriched layers in the oxide microstructure. The thickness of this first oxide layer can increase during operation up to a limit depending on several factors: temperature, environment, and time. This process will lead to a rise in the stress between a metal surface and oxide layer. When the stress in the scale increases to the limit accommodated by elastic strain, it will deform or fracture. The spallation of the scale removes its protective function allowing direct access of the environment to the metal beneath and leads to a rapid increase in oxidation forming a second oxide layer. During the oxidation, the stresses can grow due to the different specific volumes of the oxide and the volume of the metal being consumed in the reaction, which can also be influenced by specimen geometry. Moreover, thermal stresses caused by differential thermal expansion or contraction in the oxide and the substrate during temperature change can also lift the oxide layer. FFA additions can increase the

Calculated solubilities of magnetite as a function of pH over the temperature range 25°C–300°C. $p\{H_2\} = 1 \text{ atm}$ [20].
