# Appraising the Seismic Response of a Retrofitted Adobe Historic Structure, the Role of Modal Updating and Advanced Computations

**Figure 1.** The Church of Kuñotambo: plans at choir loft level and at base floor level, east façade and longitudinal section at nave, presbytery and altar, from 2015, before retrofit [13].

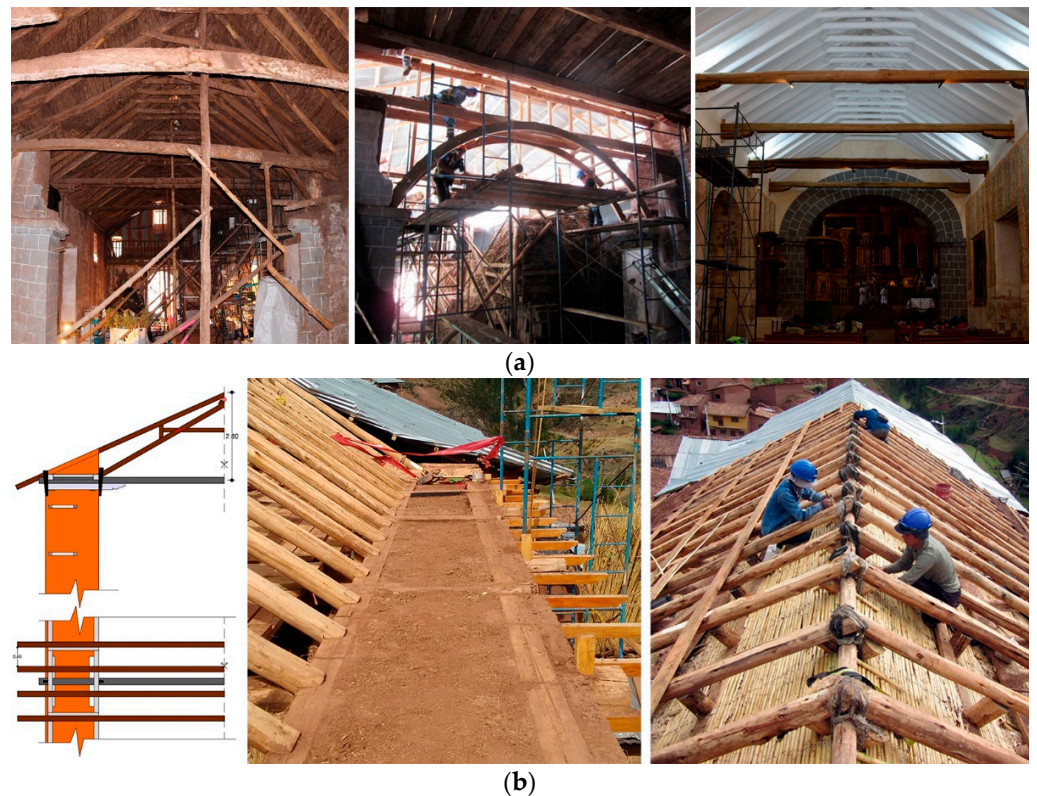
**Figure 3.** (a) Reconstruction of *quincha* arch; (b) Double rafter roof configuration. Note the anchor keys of the tie beam system, in the exterior and interior wall surfaces, highlighted in black.

The roof structure was deemed inadequate in terms of local connections and stiffness. It was also found to be severely deteriorated, while some parts had collapsed. As a result, the existing roof was replaced by a new one. The latter was composed of double rafter timber trusses resting on top of wall plates and joined with a collar tie beam, and with a ridge beam on the top, as shown in Figure 3b. Trusses have a spacing of 0.60 m. The external rafter was extended by approximately 1.0 m over the junction with the outer wall plate, thus producing an overhang to protect the structure from rainwater.

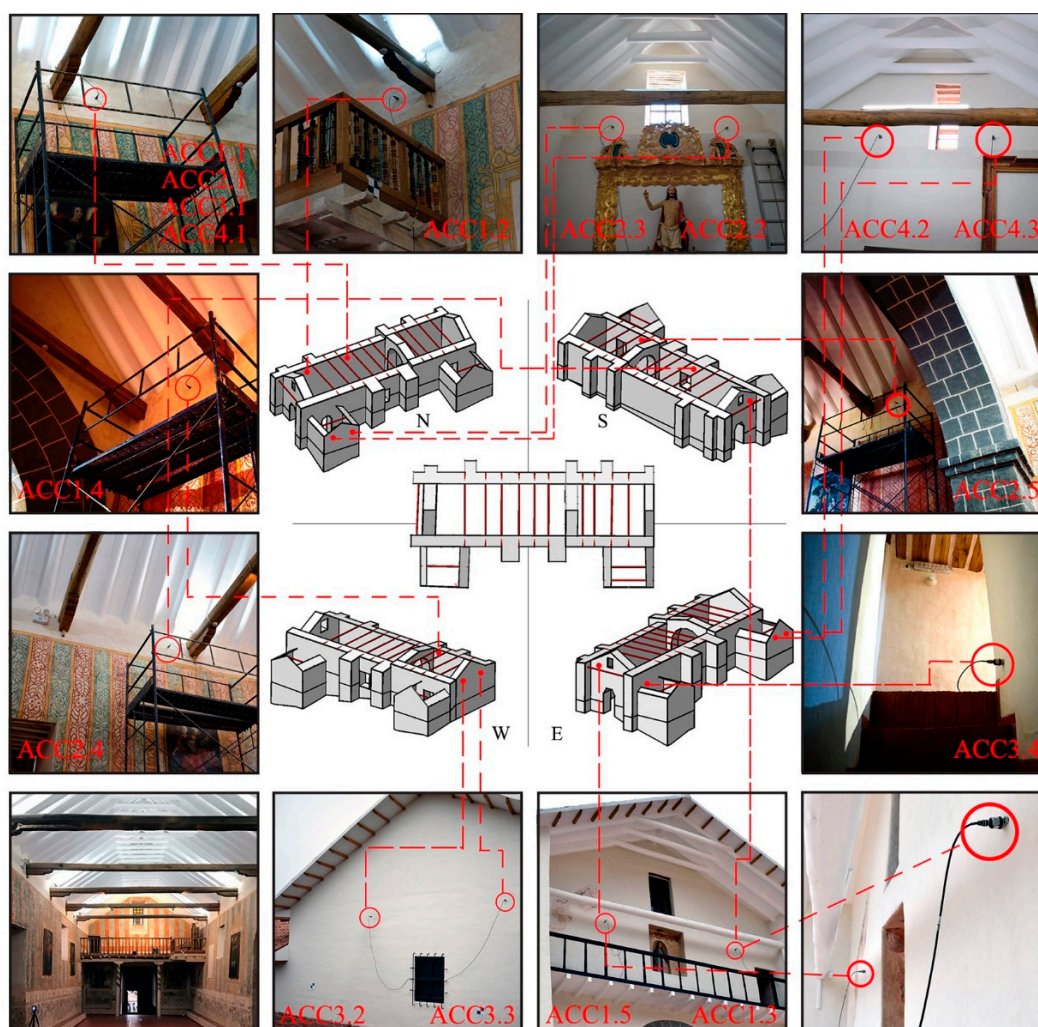
**Figure 10.** Dynamic identification tests in the retrofitted Church of Kuñotambo: placement of accelerometers at the nave, presbytery, altar, baptistery and sacristy gable walls.

The retrofitted structure exhibits a more global behavior compared to the un-retrofitted state. The improved connectivity in the corners, the anchoring of the tie beams and the addition of a bond beam and timber keys resulted in higher stiffness and an integral response. The retrofitted structure presents in-phase bending modes of single curvature, in this case, Mode 2 (3.68 Hz) and Mode 3 (4.55 Hz). Mode 1, estimated at 2.04 Hz, is a complex out-of-plane bending mode of third-order curvature, which involves mostly the nave and presbytery. Yet, from the power spectral density graphs, the peak is quite steep and with low energy. There is a chance that it is a mode generated by the flexible roof, or that the mode is an artefact and does not represent the reality. Mode 3 (4.55 Hz) involves the walls of the presbytery, which appear to be stiffer than those of the nave after the reconstruction of the *quincha* arch and the asymmetrical addition of new buttresses on the south façade.

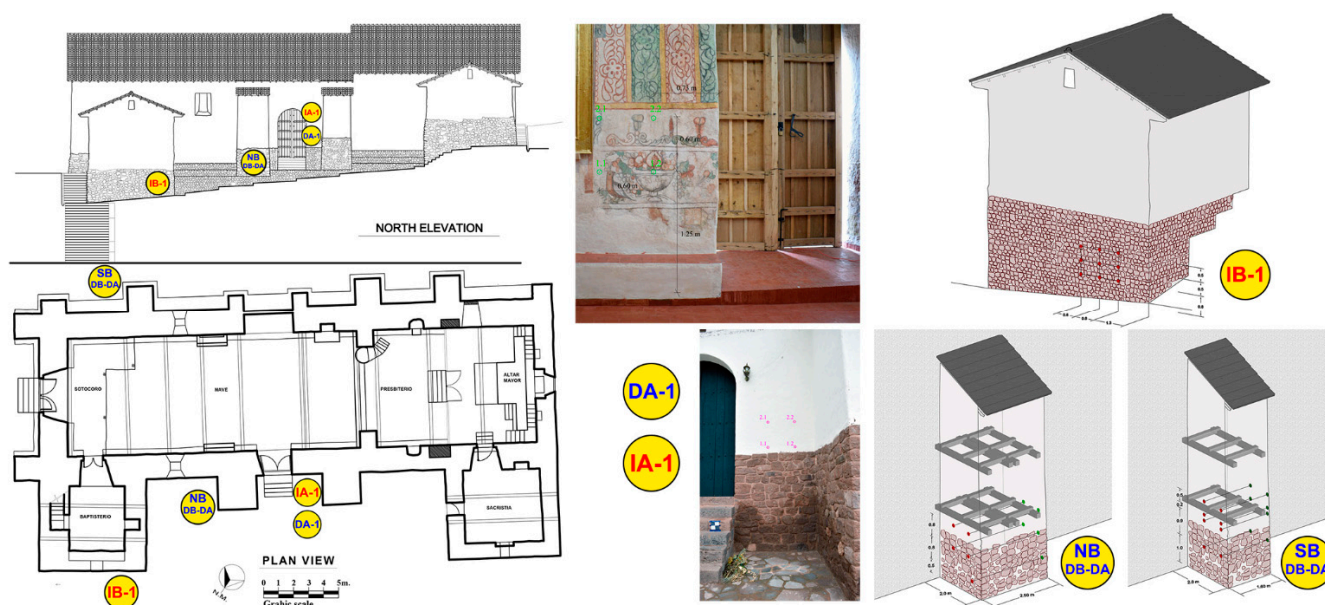
Table 1 compares the results of sonic tests before and after the retrofitting scheme. The  $E_{\text{dyn}}$  obtained from indirect sonic measurements on the rubble stone masonry base of the baptistery (test code IB-) remained unaltered after reconstruction of this section's exterior leaf, i.e.,  $1.6 \text{ GPa}$ . Direct sonic tests performed at the base course of the north and south walls' buttresses gave much lower results, as the inner rubble core was considered in these measurements. The  $E_{\text{dyn}}$  determined at the base of the north buttress (Figure 12) is  $450 \text{ MPa}$  (NB/DB-1), while that of the buttress added on the south wall was  $720 \text{ MPa}$ . The higher modulus of the newly constructed buttress is possibly due to the more regular construction pattern adopted.

Regarding adobe masonry, direct sonic tests on the north wall of the nave (DA-1) gave an  $E_{\text{dyn}}$  of  $210 \text{ MPa}$ , which is close to the  $250\text{--}290 \text{ MPa}$  values obtained during the May 2015 campaign. Indirect sonic tests on the exterior surface at the same location gave a much higher value ( $420 \text{ MPa}$ ). The difference is probably because the exterior adobe masonry layers were consolidated, and new adobe blocks replaced deteriorated ones, improving the condition of the exterior adobe masonry layers. Direct sonic tests of the adobe sections of the newly constructed south buttress (SB/DA-3) revealed the same  $E_{\text{dyn}}$  ( $420 \text{ MPa}$ ). Instead, a value of  $200 \text{ MPa}$  was registered from direct sonic tests on the adobe sections of the north buttress (NB/DA-1), which was only partially rebuilt.

**Figure 12.** Retrofit state of the Church of Kuñotambo: location of direct and indirect sonic tests in adobe and rubble stone masonry during the December 2019 field campaign (after strengthening).

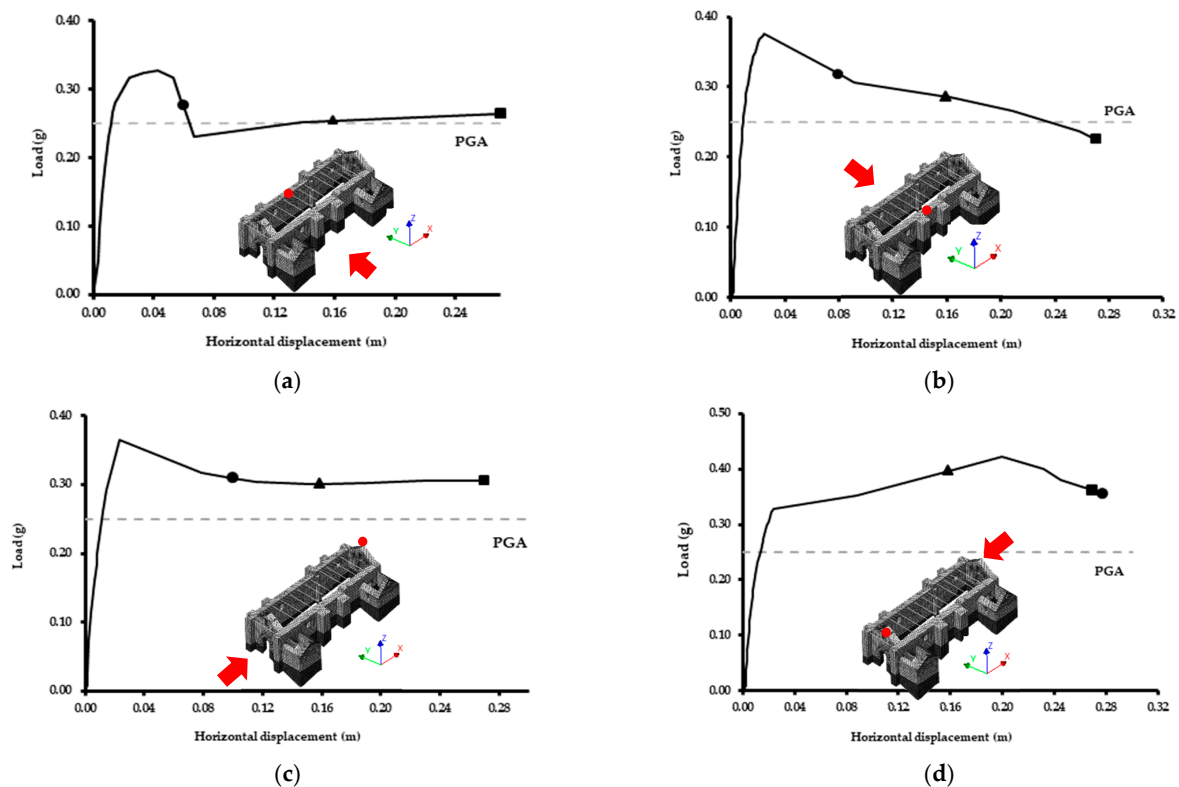
As shown in Figure 18a, the capacity of the un-retrofitted church in the +YY direction, is less than the region's 0.25 g design peak ground acceleration [14]. The maximum estimated capacity of MODEL\_2 is equal to 0.33g, which surpasses the capacity demand for the region. From the plots of the maximum principal tensile strains, presented in Figure 19a, it is evident that the strengthened structure presents a more global failure mode, which consists of out-of-plane bending of both lateral walls, together with diagonal and vertical shear cracks in the side walls of the baptistery, the sacristy and the east façade. The more homogenous structural response is mainly the result of the bracing timber elements. These prevented the early separation and out-of-plane overturning of the south lateral wall that occurred in MODEL\_0.

**Figure 20.** Pushover curves in different directions: (a) +YY, (b) -YY, (c) +XX and (d) -XX. Here, the representative points for the ASCE41-13 (■), NTC 2018 (●) and KADET 2021 (▲) are presented.
