FAILURE THRESHOLDS FOR RCC CREST CAPS

TONY L. WAHL¹, BRYAN J. HEINER¹ AND JACOB F. KEPLER²

Keywords: RCC overlays, overtopping protection; failure modes

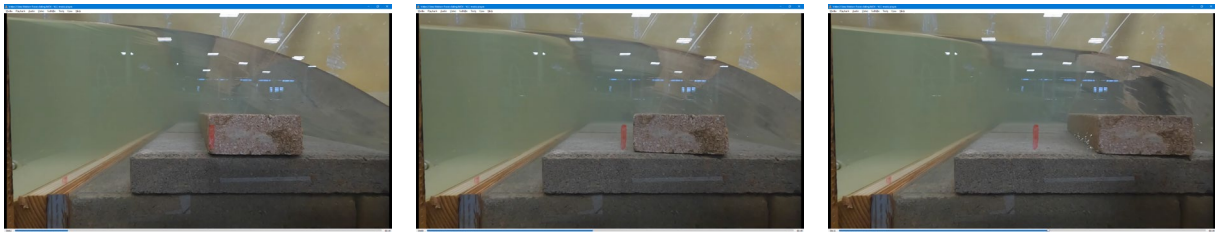
Several tests in the wider flume were recorded using GoPro cameras at rates up to 240 frames per second to allow better observation of the failure mechanics. For most of the tests (except those described in sections 3.3 and 3.4), the video recordings clearly showed that failure occurred by sliding (Figure 7).

Figure 7: Sliding failure of a 40-mm (1.57-inch) concrete paver block. Flow is left to right, and time increases from left to right. Elapsed time from the first image to the last is about 1 second.

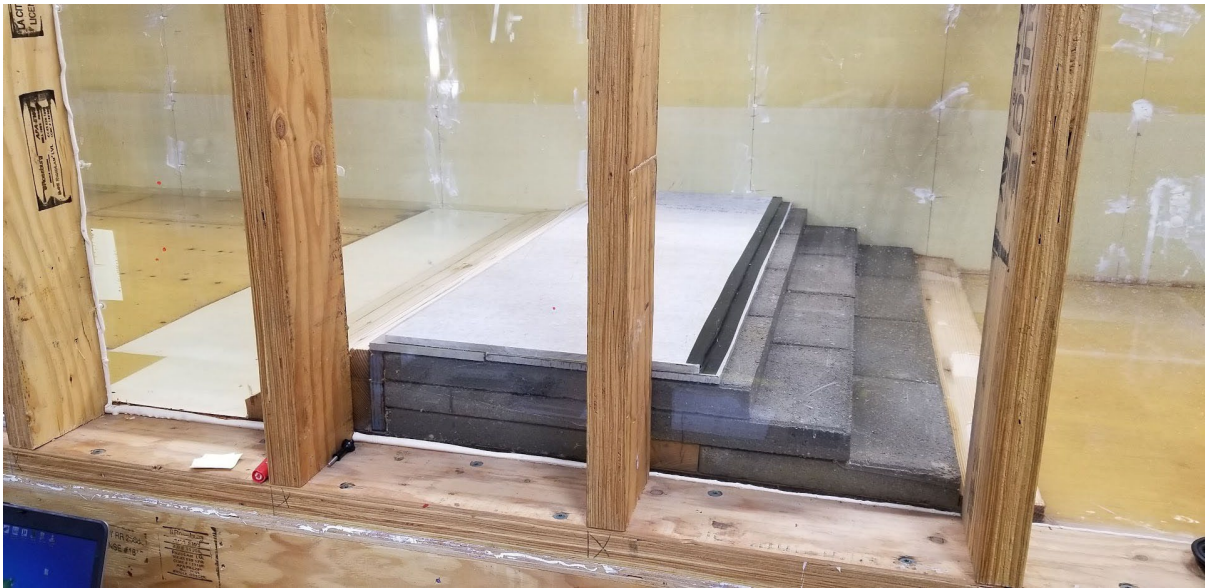
The simple stacking of unbonded blocks to create the dam structure allowed flow through the seams between the lifts that cap the dam crest. This was expected to allow some relief of the uplift pressure that was transmitted into the upstream edge of the seam between blocks. No attempt has ever been made to seal the upstream or downstream edge of the seams between these blocks at Umbarger Dam. However, to evaluate the potential effects of a sealed downstream edge, about 3 to 4 tests were conducted with a piece of duct tape applied to the downstream seam as shown in Figure 8. These tests produced uplift/rotation of the top lift around the downstream bottom corner at a very low head and the threshold was observed to be almost constant for increasing values of crest width, w .

Figure 8: Dam and crest cap configuration for a sealed-downstream-edge test.

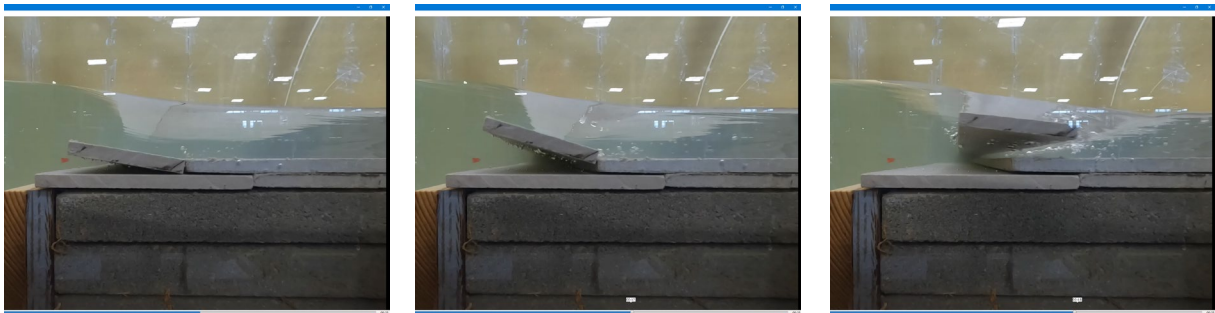
To simulate a longitudinal crack like those observed at Umbarger Dam, several tests were conducted with the top lift split lengthwise into two pieces so that it would be possible for the upstream or downstream portion to slide or uplift sooner than a fully intact piece. Failure in these tests occurred by uplift of the upstream piece (Figure 9). Following removal of the upstream piece, the downstream piece failed by sliding.

Figure 9: Failure sequence for uplift of crest cap upstream from a longitudinal crack. Elapsed time is less than 1 second.

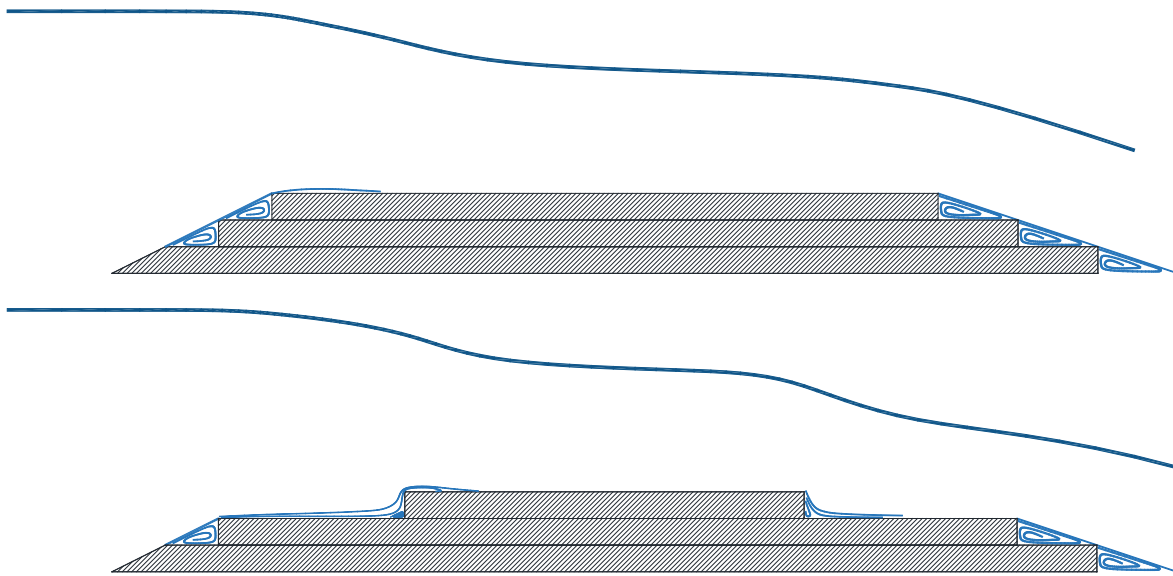
In the wider flume, limited tests were conducted of square-edged lifts that were intentionally made too narrow for the crest of the dam, so that either the upstream or downstream edge was not aligned with the prevailing slope of the lower body of the dam. Both situations led to failure by sliding at much lower overtopping heads. This is believed to be due to a change in the structure of the vortex that forms in the corner of the step, as illustrated in Figure 13. The vortex typical of the aligned-step condition apparently reduces the fraction of reservoir head that penetrates the upstream seam and may also increase the tendency for uplift pressure to be relieved at the downstream edge of the seam.

Figure 13: Illustration of changes in flow structure when crest cap lifts are aligned (top) or not aligned (bottom) with the upstream and downstream dam face slopes.
