Seismic damage assessment of school buildings after 2012 Emilia Romagna earthquake

Antonio Formisano*

SUMMARY – In the paper the usability checks performed on precast RC gyms and masonry school buildings, located in the Municipalities of San Pietro in Casale (BO), Bomporto (MO) and Bondeno (FE) after the seismic events occurred on 2012 May 20th and 29th, are reported and discussed. First, the main features of surveyed buildings have been identified. Later on, on the basis of the detected damages, their seismic deficiencies have been recognized. Finally, the indication of some appropriate simple interventions for retrofitting studied buildings has been given.

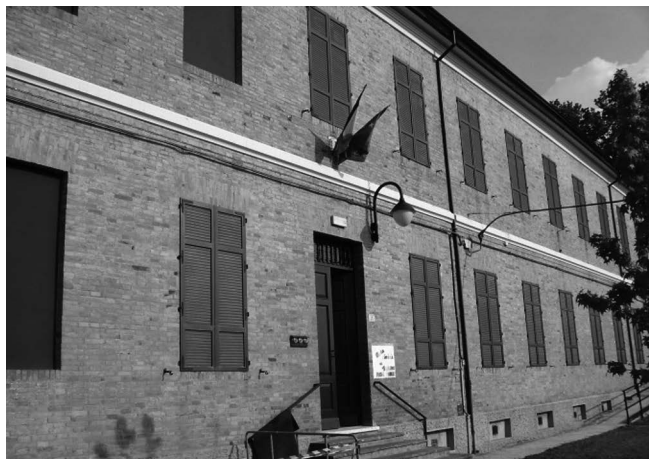
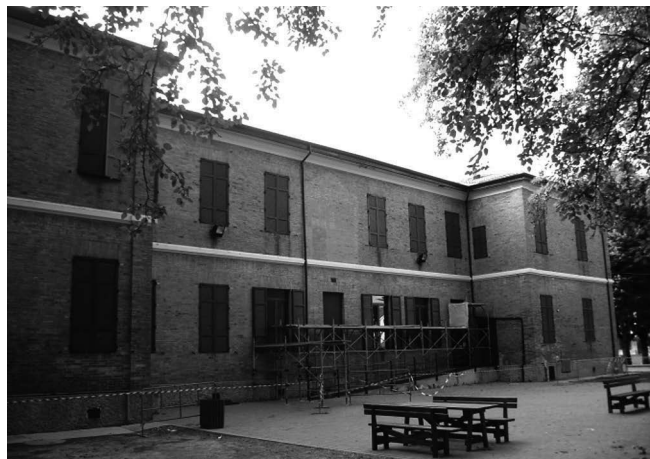
The “Maccaretolo” primary school was built between 1919 and 1945 with a rectangular plan layout of about 500 m² developed on three levels (Fig. 1). The main vertical bearing structure is composed of 28 cm thick brick masonry walls surmounted by a pushing timber roof structure. Floors are made of timber beams covered by r.c. slab without tie-beams.

Fig. 1. Front and back views of the “Maccaretolo” school building.
Vista frontale e posteriore della scuola «Maccaretolo».

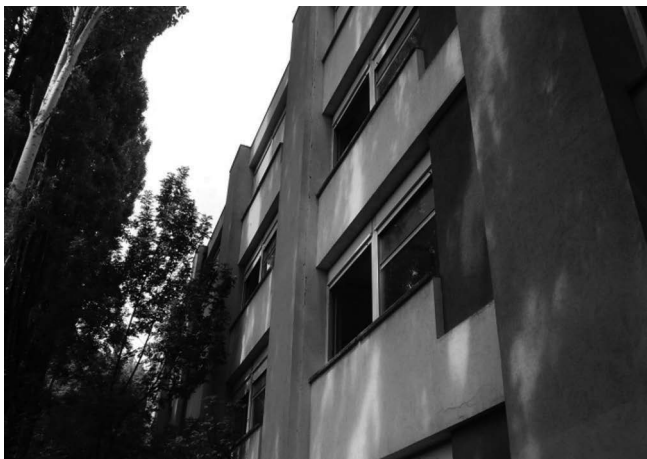
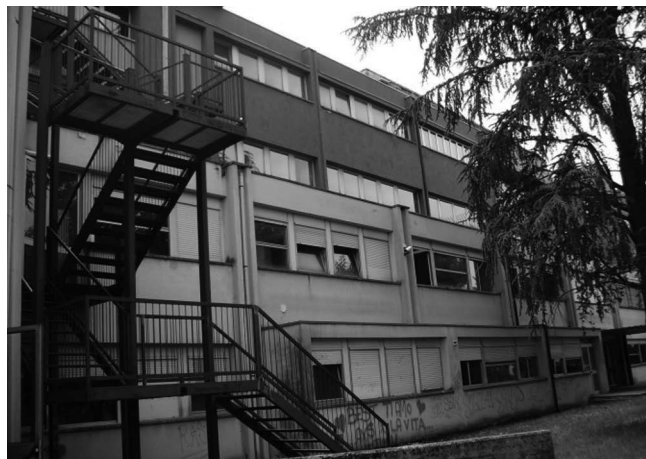
The “Bagnoli” secondary school is composed of two buildings having rectangular shape and developed on five

levels (Fig. 4). Such buildings, erected into different historic periods, are joined each other. In particular, the oldest building was built between 1972 and 1981, whereas the youngest one was fabricated in the last ten years.

Fig. 4. Some views of the school building “Bagnoli”.
Viste esterne della scuola «Bagnoli».

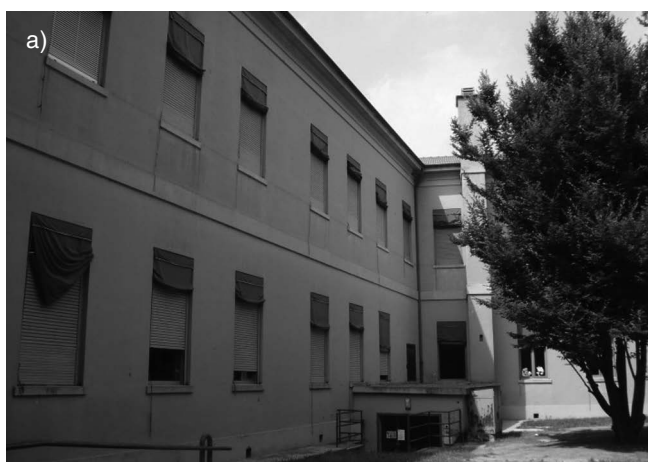
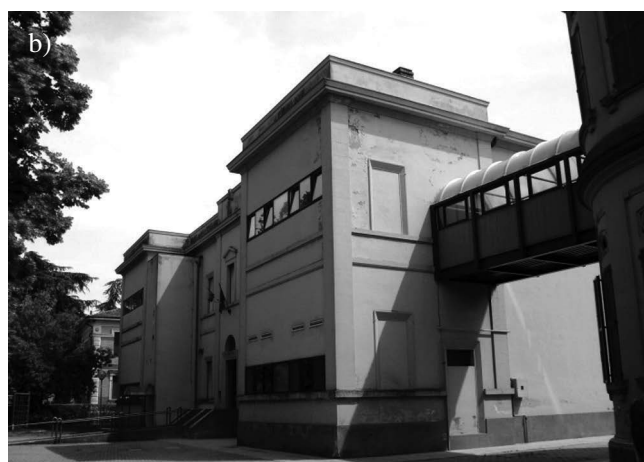
The “De Amicis” primary school is composed of two buildings built in two different periods, namely before 1919 (Fig. 8a) and between 1945 and 1961 (Fig. 8b). Even if two structural bodies are connected each other through a steel footbridge at the first level, they can be considered as separate buildings.

Fig. 8. Back views of the ancient (a) and the new (b) parts of the "De Amicis" school buildings.
Viste posteriori della parte antica (a) e della parte nuova (b) della scuola «De Amicis».

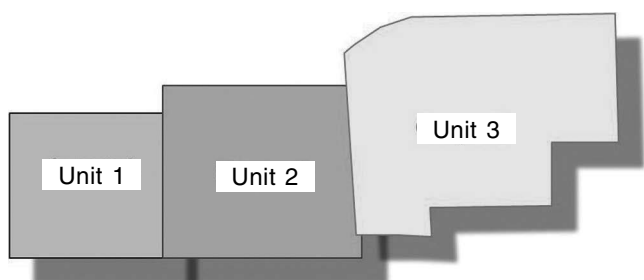
The school building "Menotti" is a building aggregate composed of three structural units schematically illustrated in Figure 11.

Fig. 11. General scheme of the "Menotti" primary school structural units.
Piano generale delle unità della scuola elementare «Menotti».

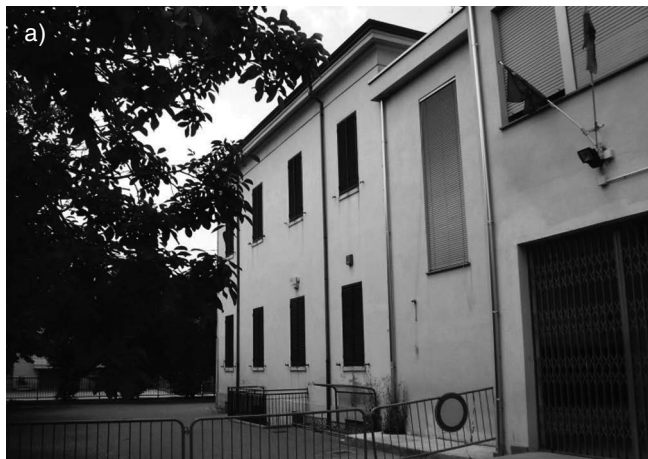
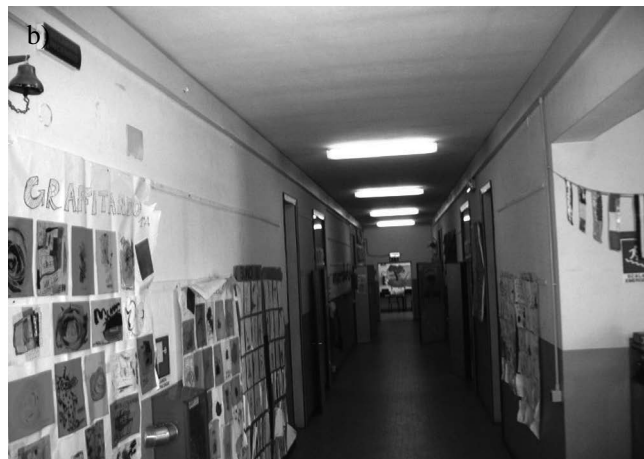
The oldest construction (Fig. 12a), built before 1919, has a load bearing vertical structure analogous to the one of other investigated schools and mixed steel beams – hollow tiles floors (Fig. 12b). Medium-heavy damages have been detected, they being represented by the floor-wall detachment due to the scarce link level among these parts (Fig. 13a), cracks into the vault key, horizontal cracks into floors and diagonal cracks into walls (Fig. 13b).

Fig. 12. Masonry structural unit of the school building "Menotti": external view (a) and internal corridor covered by a mixed steel beams-hollow tiles floor (b).

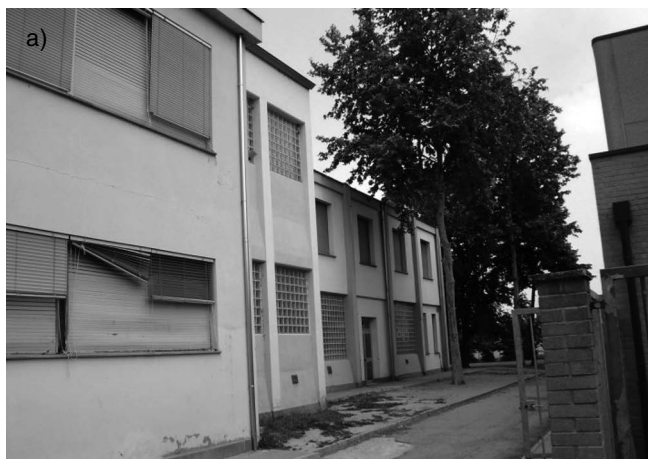
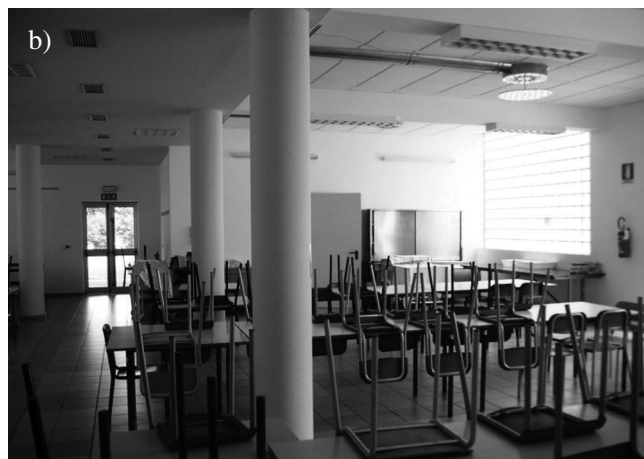
The last structural unit, erected in 90's to host the school refectory, has a r.c. structure with frames in one direction only (Fig. 15a). Damages to structural and non-structural components have not been recorded

(Fig. 15b). Nevertheless, also in this case, absence of transverse connections among r.c. frames requires the seismic retrofitting of the school building according to the currently used code.

Fig. 15. The new r.c. structural unit of the “Menotti” school: external view (a) and refectory (b).
La nuova unità in c.a. della scuola «Menotti»: vista esterna (a) e refettorio (b).

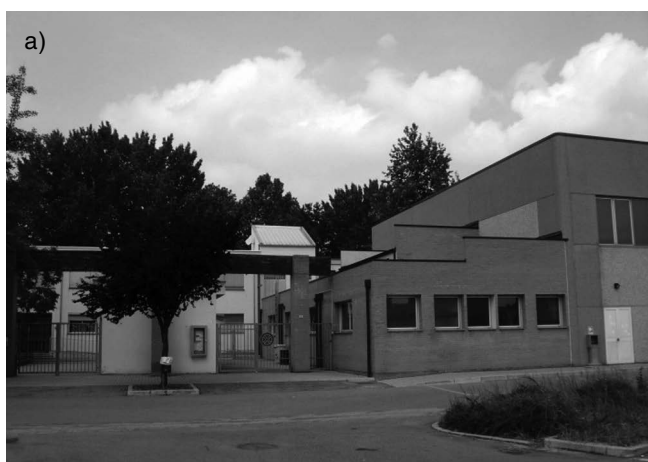
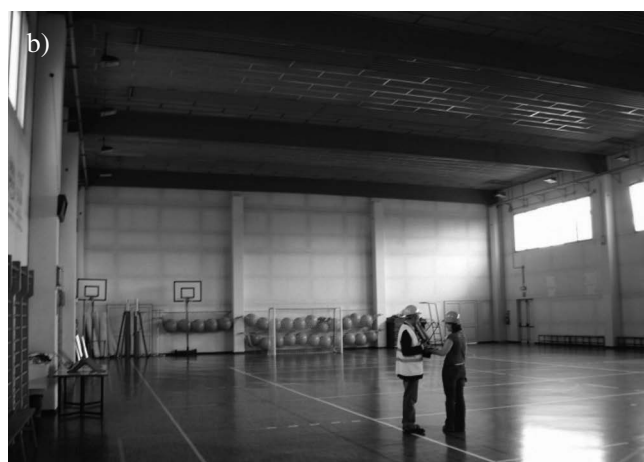
Fig. 16. External (a) and internal (b) view of the “Menotti” gym building.
Viste della palestra della scuola «Menotti»: (a) esterna, (b) interna.

The building has not shown damages to load-bearing vertical structures, whereas precast cladding panels have overturned externally to the building, their connection with columns being completely compromised. In addition, some damages to ceiling, consisting of failure of some panels, have been detected.

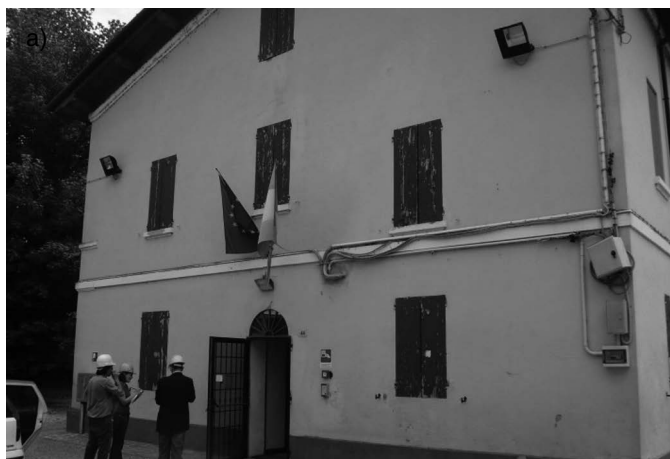
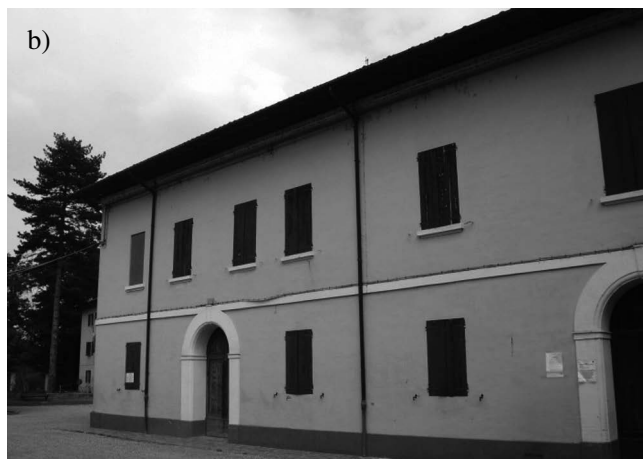
The primary school “Sorelle Luppi” has been built before 1919 and, due to valuable architectural features, is now under the control of the Superintendence of Architectural Heritage (Fig. 17). The main vertical structure is made of masonry brick walls with deformable timber floors without steel chains and r.c. tie-beams.

In the building few damages among walls and not significant floor-wall cracks have been recorded. Diagonal cracks into masonry piers and horizontal cracks in vaults are very diffused (Fig. 18).

Fig. 17. Front (a) and back (b) views of the “Sorelle Luppi” school building.
 Fronte (a) e retro (b) dell’edificio scolastico «Sorelle Luppi».

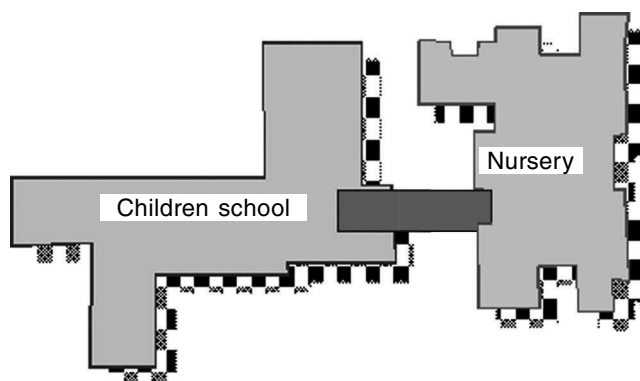
Fig. 22. Schematic view of the “Margherita” building block.
Vista schematica dell’edificio «Margherita».

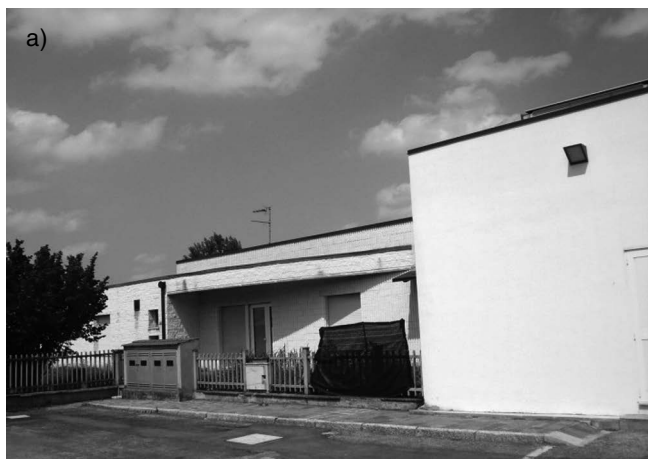
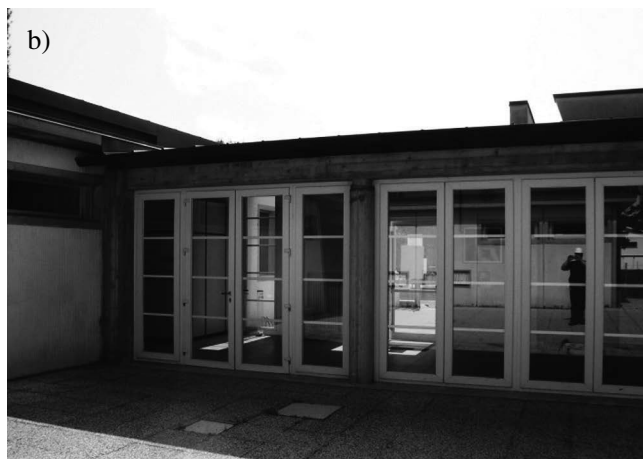
Fig. 23. The two structural units of the “Margherita” building block (a) and the passage corridor between buildings (b).
Le due unità strutturali dell’edificio «Margherita» (a) ed il corridoio di collegamento tra i due blocchi (b).

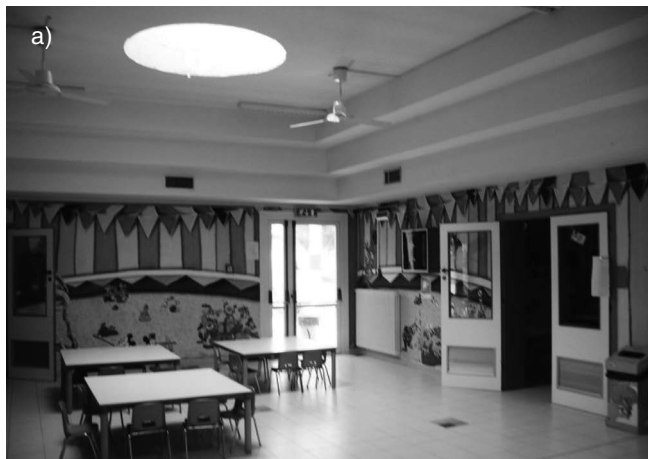
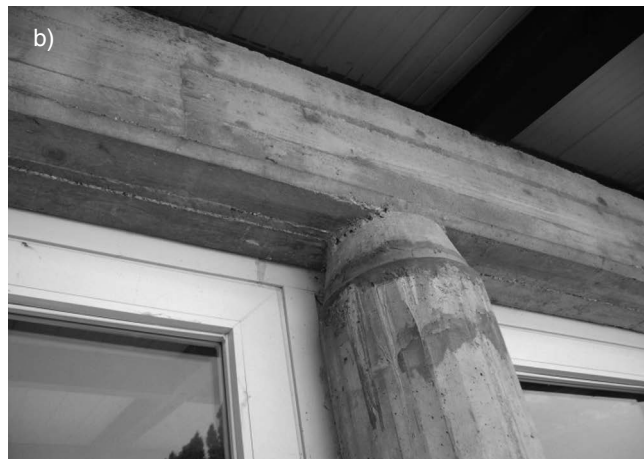
The second building of the block, erected in the last decade, has a vertical structure made of r.c. frames. It has exhibited a satisfactory seismic response, since no significant damage has been observed after earthquake (Fig. 26).

Fig. 26. The nursery of the “Margherita” school building block (a) and a view of the beam-to-column joint (b).
L’asilo dell’edificio scolastico «Margherita» (a) e una vista di un giunto trave-colonna (b).

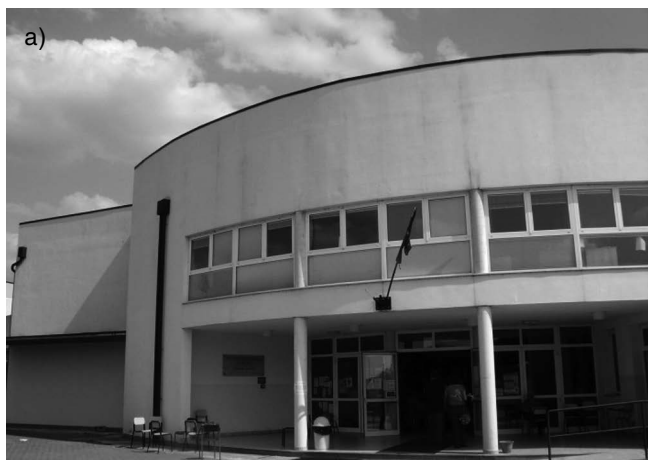
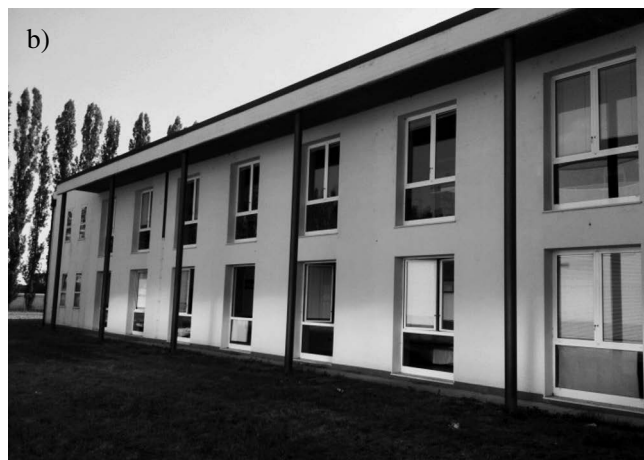
The secondary school “Bonati” (Fig. 27) is a r.c. building built after 2005. Connected to an adjacent gym building (Fig. 28a), the school building is strongly irregular in plan, so to be subdivided into six structural units opportunely joined each other (Fig. 28b). Never-

Fig. 27. External views of the “Bonati” secondary school.
Vista dell’esterno della scuola media «Bonati».

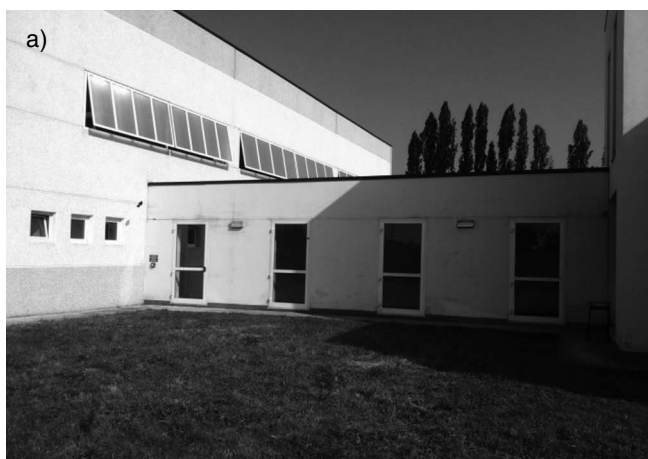
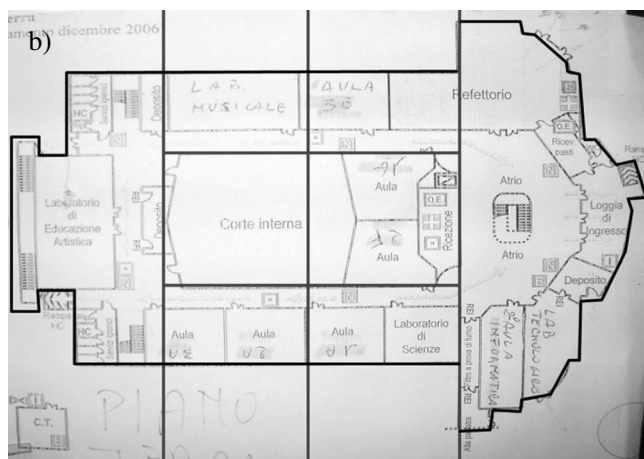
theless, since structural joints have not been made following the “rule of art”, that is leaving an appropriate

distance among two adjacent buildings, the main damages have been detected there. In fact, important plaster cracks have been observed both among adjacent col-

Fig. 28. The “Bonati” secondary school: connection construction between school and gym (a) and plan view with indication of structural joints (b).
La scuola media «Bonati»: collegamento tra scuola e palestra (a) e pianta dell’edificio con indicazione dei giunti strutturali (b).

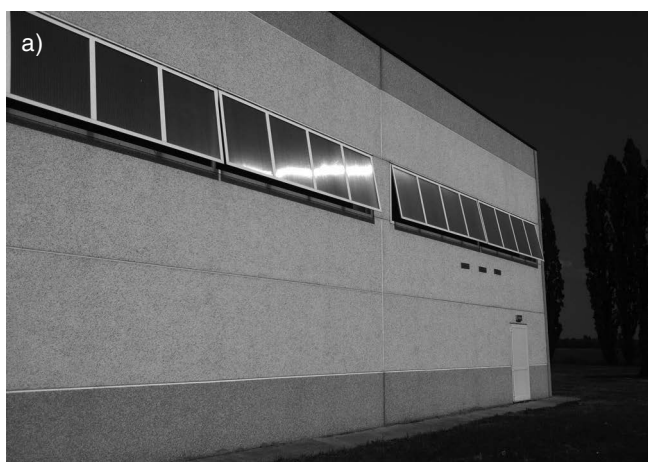
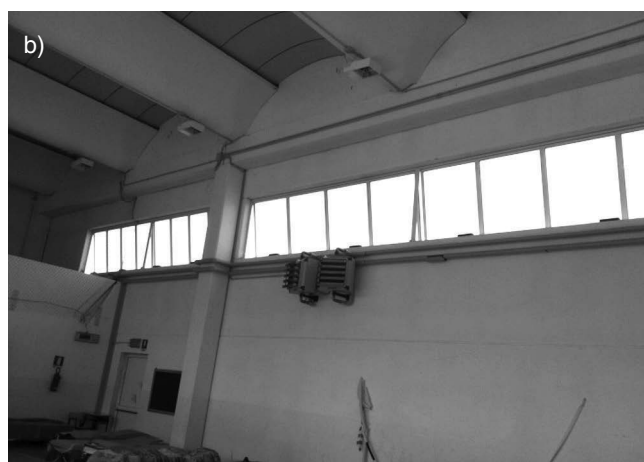
Fig. 31. External (a) and internal (b) views of the gym building of the "Bonati" secondary school.
Vista esterna (a) ed interna (b) della palestra della scuola «Bonati».

Considered as a strategic building, the gym has cladding panels significantly damaged. In fact, some

of them, badly connected to columns, have suffered an overturning out-of-plane mechanism which has produced detachment of panels from columns (Fig. 32a). In particular, a vertical crack developed along the entire building height at the panel-column interaction zone has been noticed. Also the hammering effect between gym and the connection structural body with the school building has been recorded (Fig. 32b).

As a whole, the observed damages, due to the absence of beam-to-column connections and the inefficiency of panel-to-column ones, make building susceptible to undergo severe damage under future earthquake, so to require appropriate seismic retrofitting interventions able to improve their global behaviour.

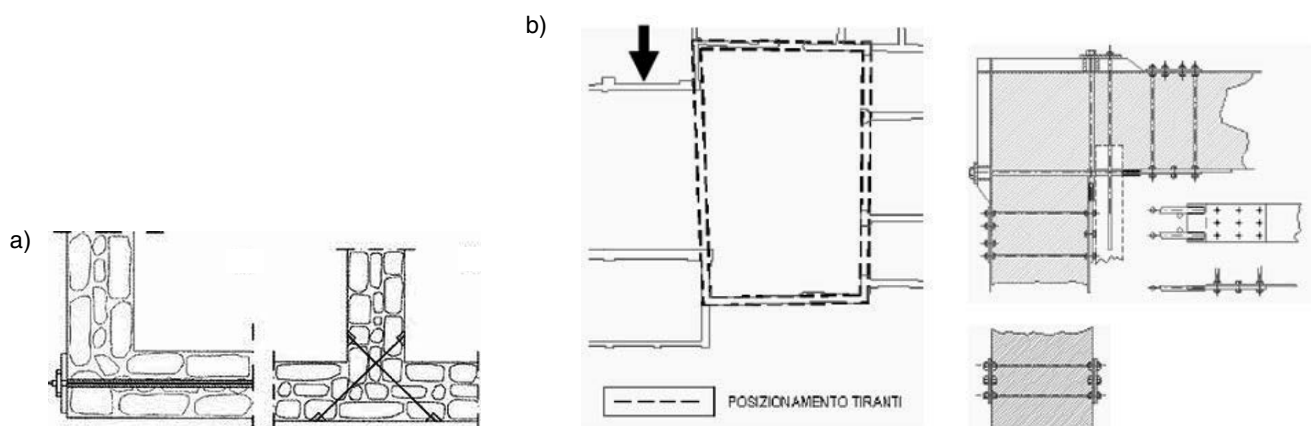
The damages observed within investigated school buildings have shown the typical deficiencies of such constructions: lack of wall-floor connections and high masonry wall slenderness for masonry buildings and

- Steel or r.c. tie-beams, in order to make effective wall-to-wall and wall-to-floor connections [Modena, 2007] (Fig. 33);
- Steel or r.c. jacketing of masonry walls, to be used when they are not able to sustain applied loads [Mazolani, 2008] (Fig. 34).

Fig. 33. Steel tie-beams for wall-to-wall (a) and wall-to-floor (b) (Modena, 2007).
Collegamenti metallici tra muri (a) e muri-orizzontamenti (b) (Modena, 2007).
