***Effect of geological structures, rock weathering,
and clay mineralogy in the formation of various
landslides along Mugling–Narayanghat road
section, Central Nepal Himalaya***

Amar Deep REGMI*¹ and Kohki YOSHIDA*²

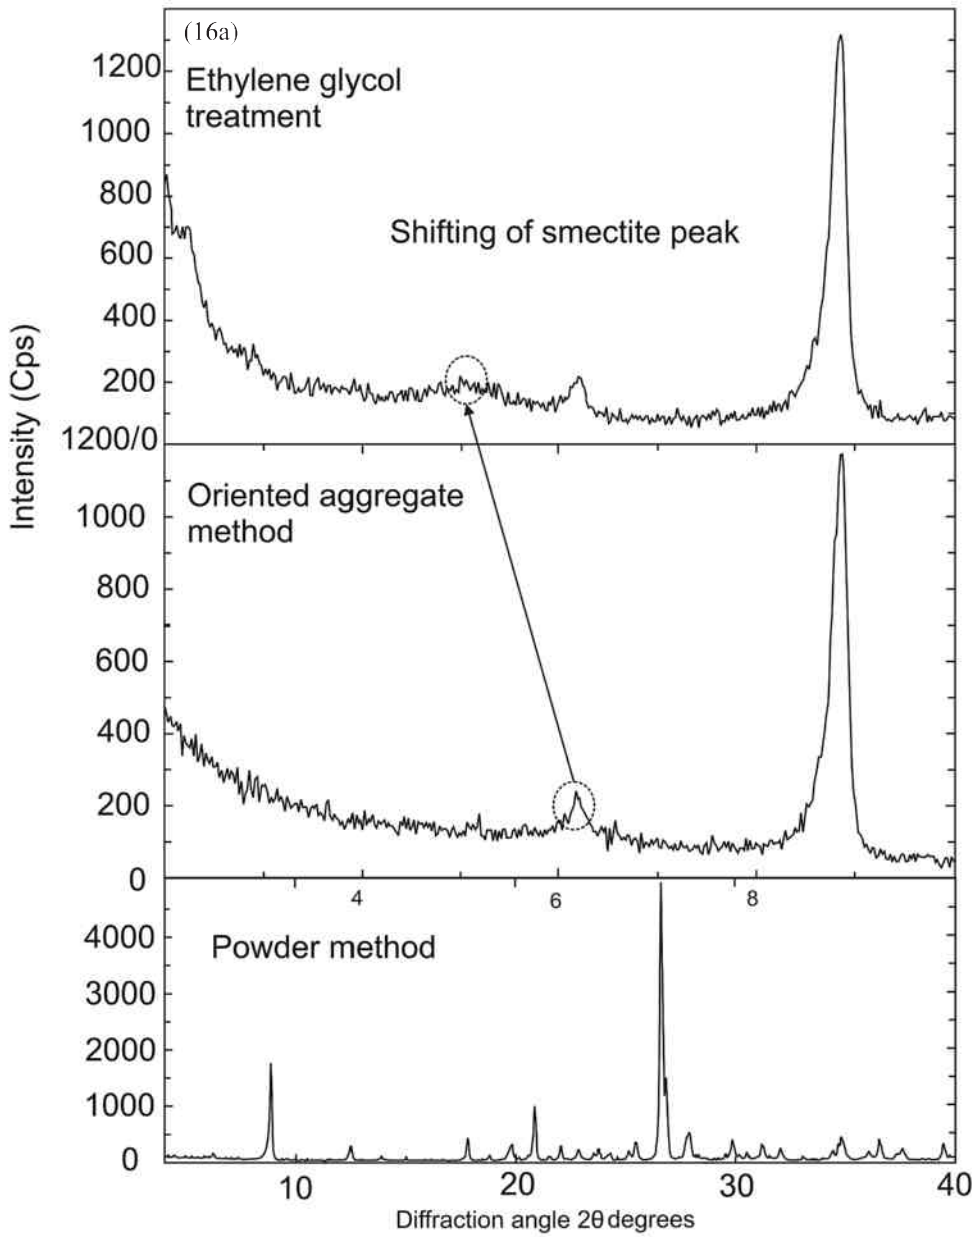
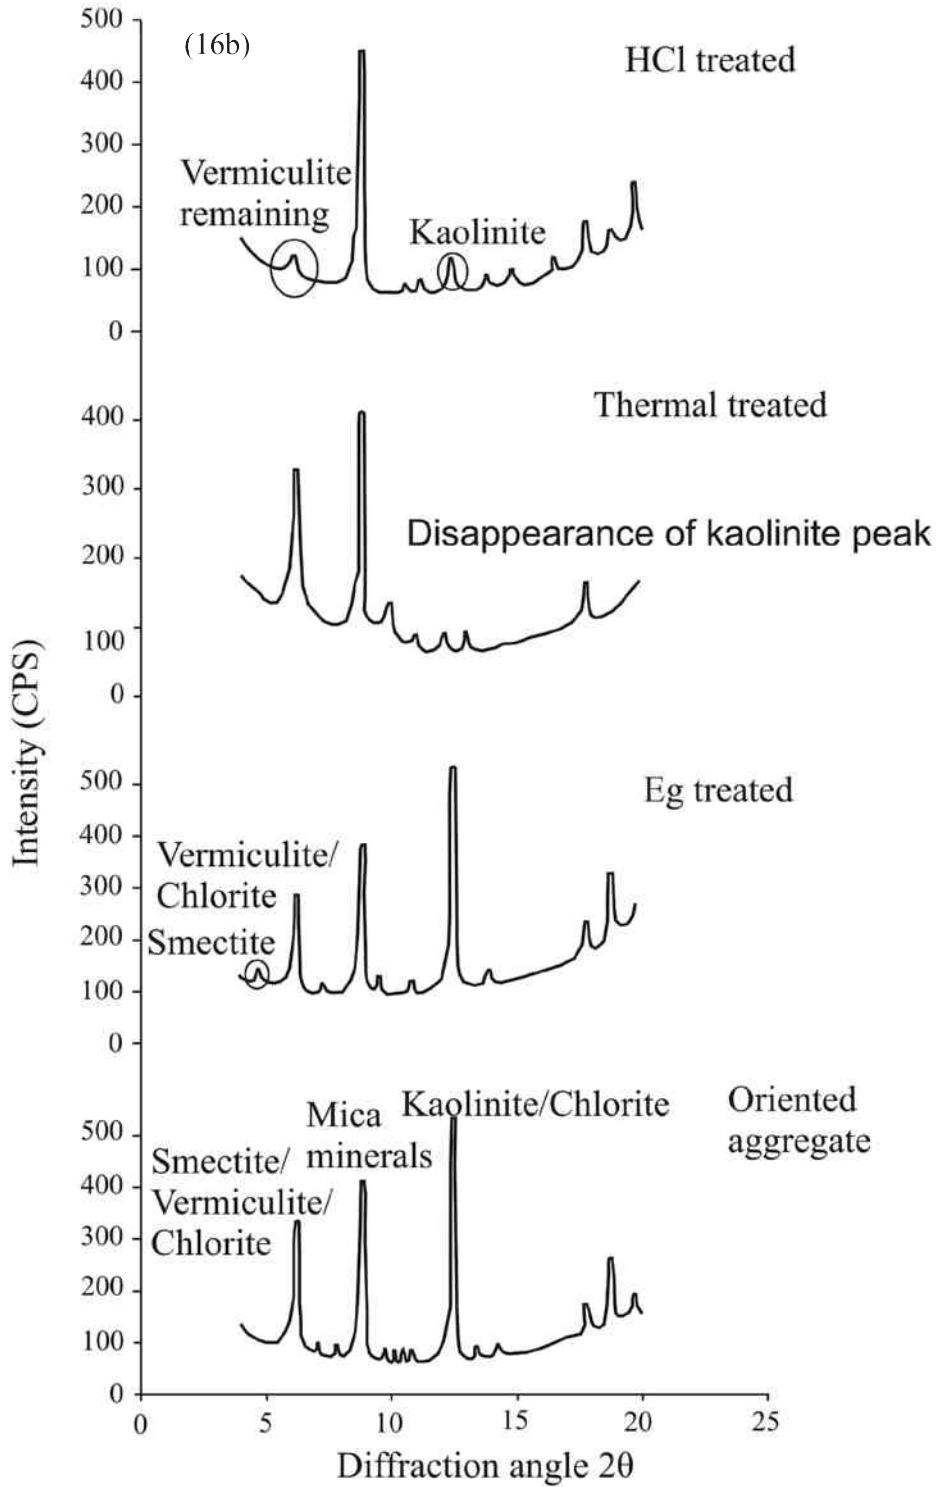
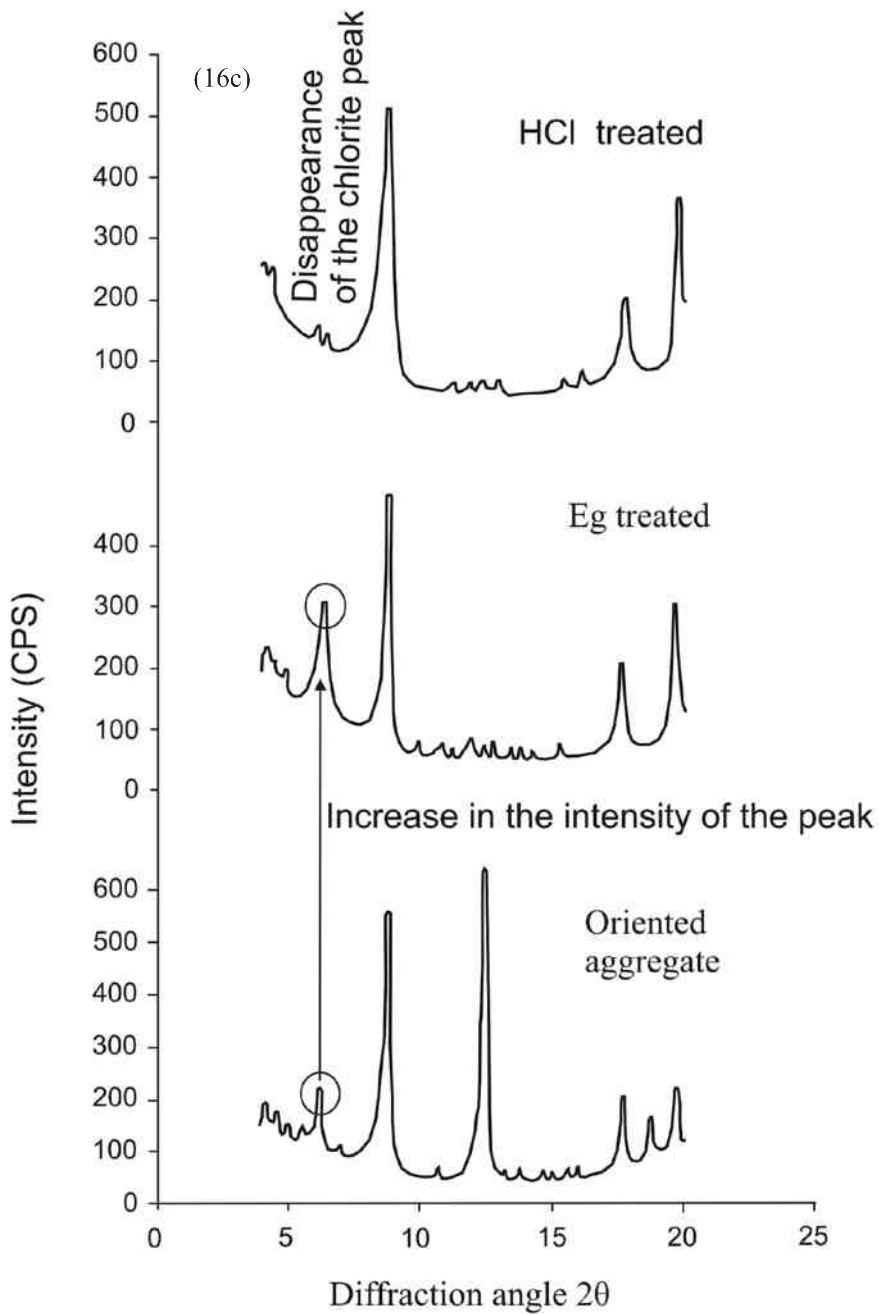
Fig. 16: (a) Shifting of smectite peak shown by the XRD pattern of the rock sample from Dumre Besi landslide (b) Smectite, vermiculite and kaolinite shown in the XRD pattern of rock sample from 23.600 km landslide (c) XRD pattern of rocks from Jugedi Khola landslide, showing the weathering of chlorite mineral, here it is seen that the chlorite peak intensity increases due to the EG treatment.

Rock weathering plays a key role in the formation of Dumre Besi landslide. The lower portion of the landslide consists of fresh to slightly weathered rocks. A thrust passes through the centre of the landslide making the area susceptible to weathering. The rocks are highly and complexly weathered around this thrust. Thick debris is distributed around the thrust. The upper part consists of less weathered rocks, and the top is covered by residual soil (Regmi et al. 2012). Thin section and XRD analysis of the collected rock samples showed that smectite and vermiculite were formed during weathering.

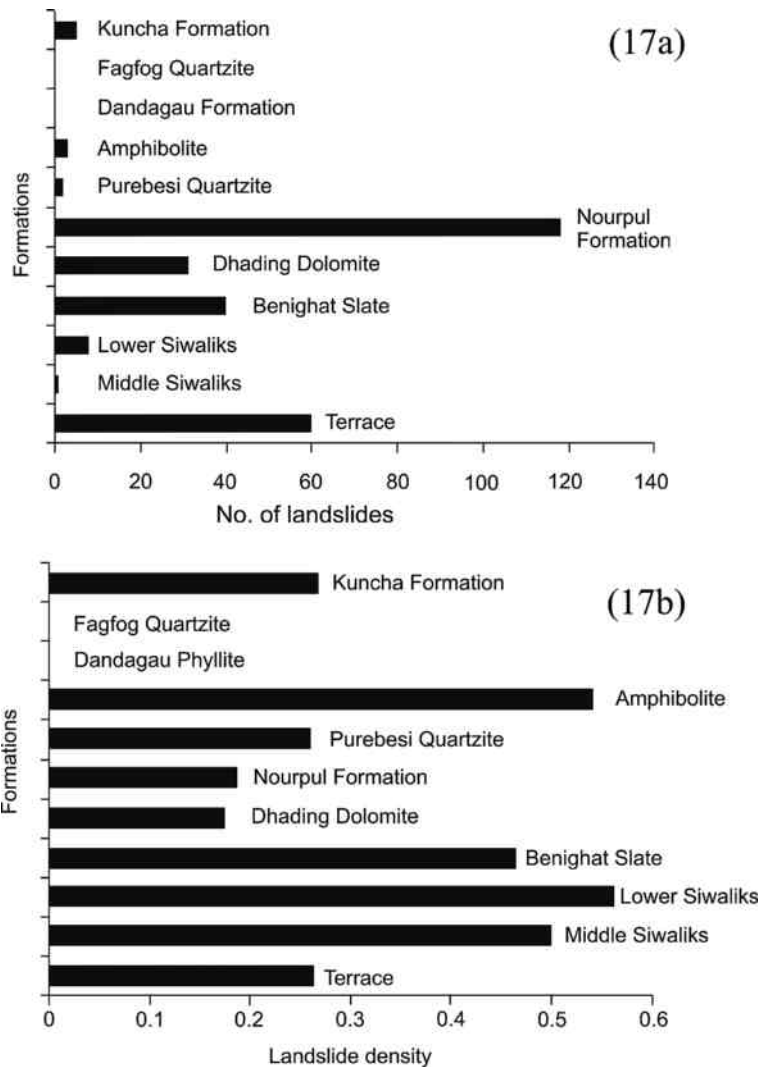
The geologic unit in the study area with the most landslides per unit area of exposure is the Amphibolite (Table 2) followed by the Lower Siwaliks, the Middle Siwaliks, and the Benighat Slate Formation (Fig 17b). The Amphibolite is intruded within the Nourpul Formation (Fig. 2). The slates, phyllite are highly weathered while amphibolites is highly fractured and jointed. The rocks in the Purebesi Quartzite member and Dhading Dolomite Formation are highly jointed and fractured making them vulnerable to rock fall and rockslide. This finding agrees with the general agreement of Gerrad et al. (1994) according to whom phyllite rocks are the most susceptible to landsliding followed by shales, schists, poorly cemented sandstones, gneiss, granites and quartzites.

Fig. 17: (a) Distribution of landslides in each lithological unit, (b) Landslide density in lithological unit

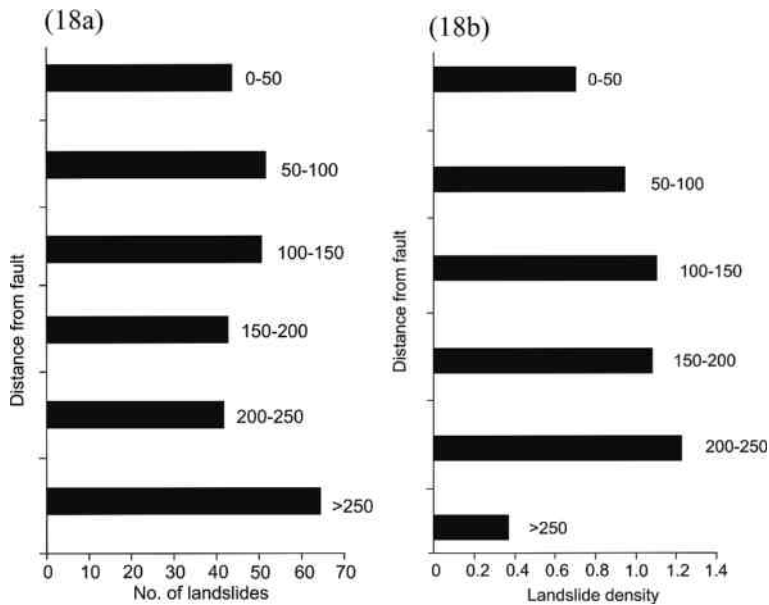
Fig. 18a shows the distribution of landslides with the increasing distance from the fault. From this figure, it is seen that the landslide distribution is higher within the distance of 50–100 m from the fault. Also, it is seen that higher amount of landslides are located at a distance greater than 250 m from the fault. In Fig. 18b, it is seen that the landslide density is higher within the distance of 0 to 200 m from the fault. As, the distance increases, the density decreases. From this, it is clear that the faults play greater role in the landslide formation along Mugling–Narayanghat road section and its surrounding regions. Also, as stated in the case of individual landslides, geological structures as fault, joints and fractures play great role in their formation and further enlargement of these landslides. Thus, it is seen that the geological structures have a prominent role in the slope instability in the regional scale as well as in individual landslides along the road section and its surrounding area.

Fig. 18 : (a) Distribution of landslides with the increasing fault distance along the Highway and its surrounding region, (b) Landslide density in each fault distance zone

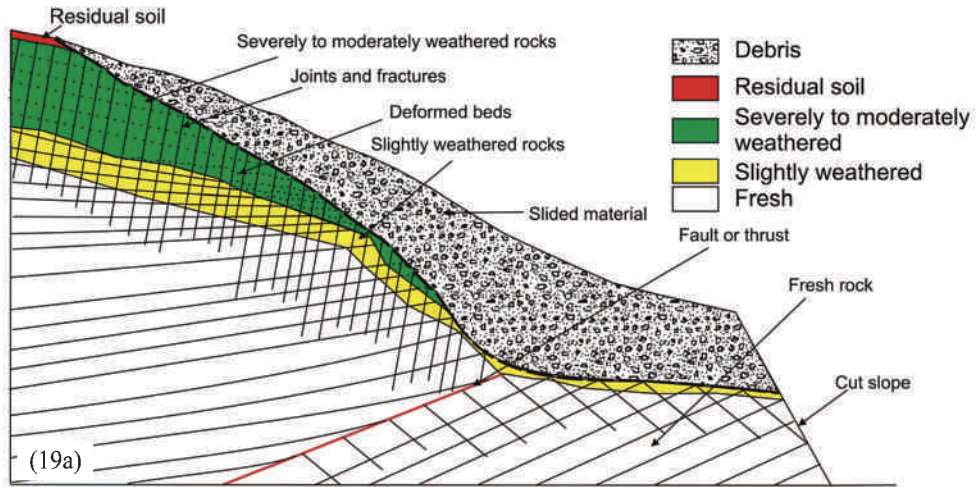
Model showing the development of large complex landslide

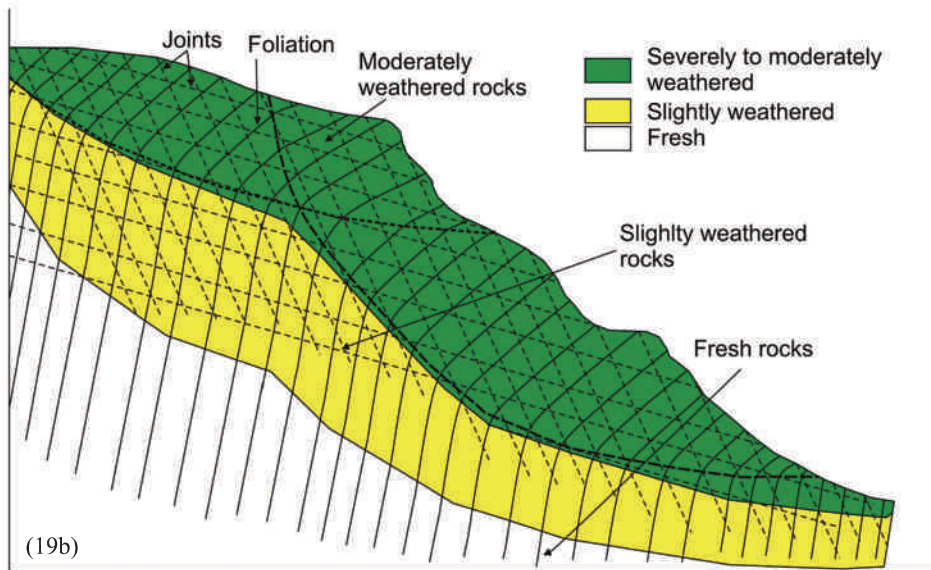
Model showing gravitationally induced complex landslide

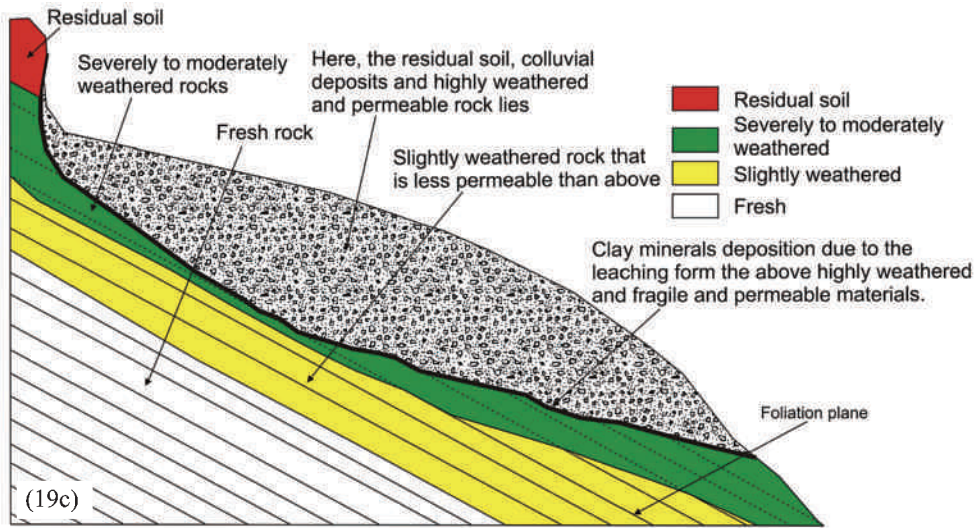
Model showing the development of rotational type of landslide

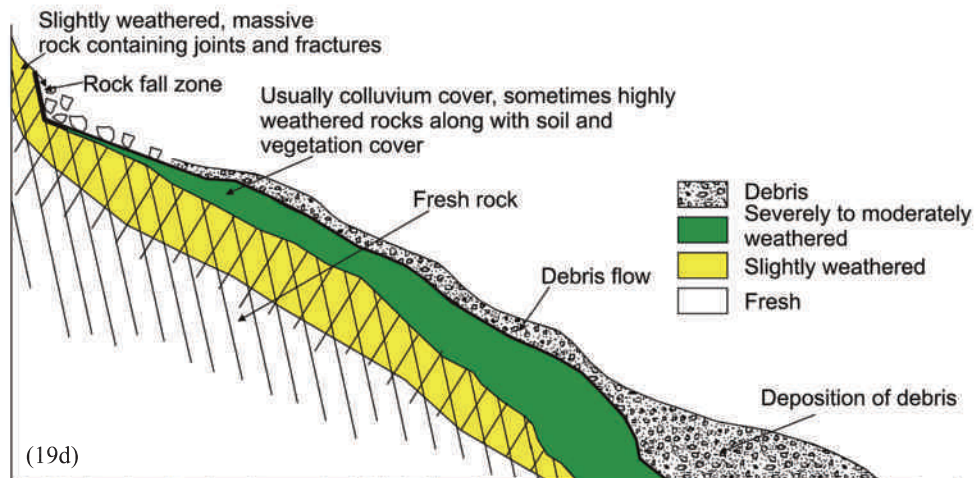
Model showing the development of debris flow, in some cases, except the rock fall at the top part, all other features are similar

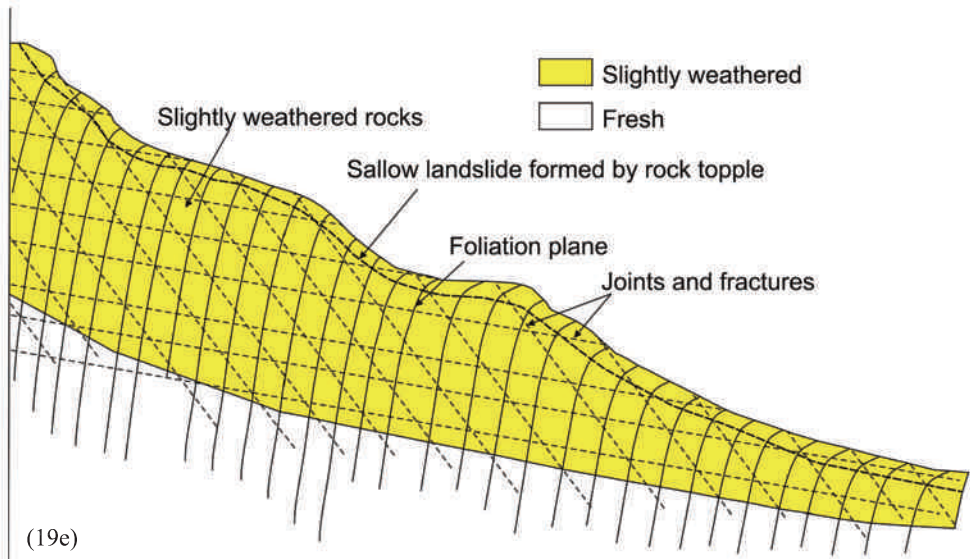
Model showing development of shallow landslide formed by rock topple

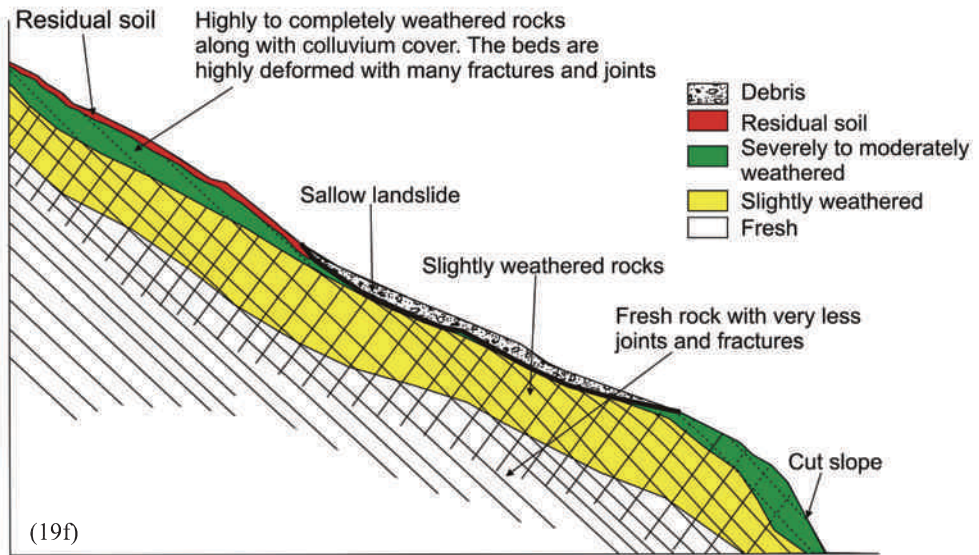
Model showing the development of shallow landslide

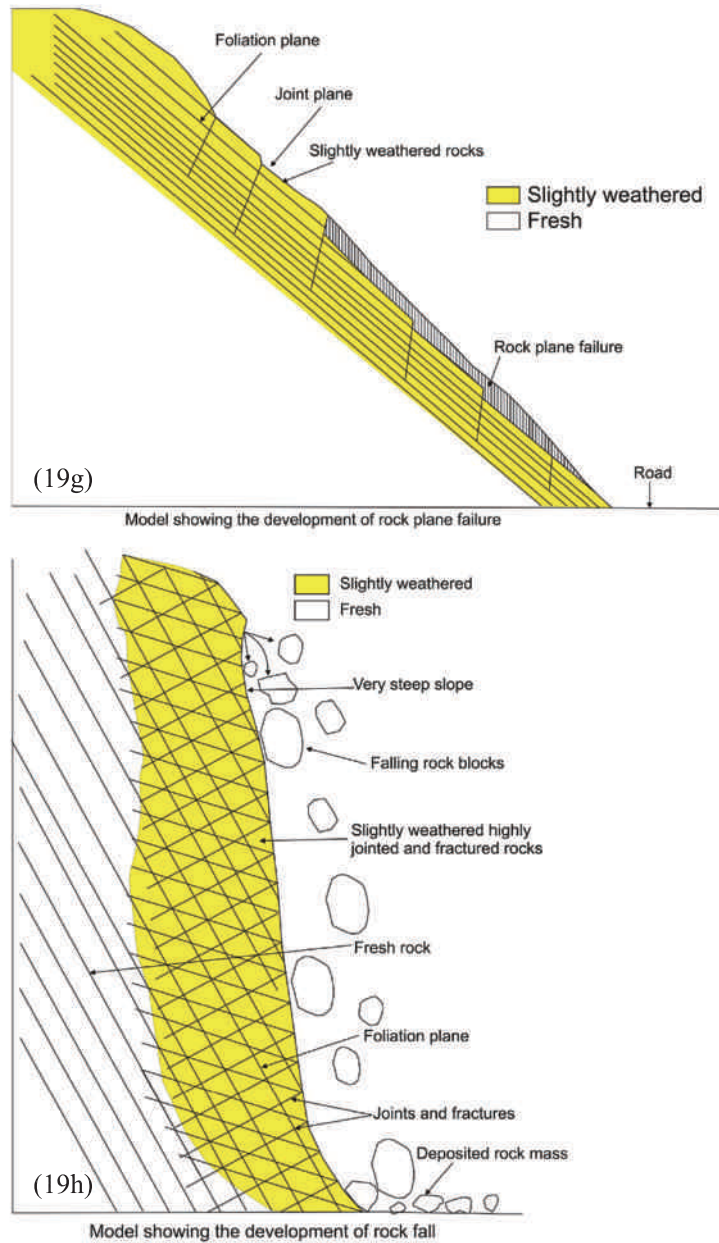
Fig. 19 : Models showing different types of landslides occurring at Mugling–Narayanghat road section and its surrounding area and their relationship with general geology and rock weathering. (a) Large scale complex landslide, (b) Large and complex landslide formed due to gravitational deformation, (c) Rotational type of landslide, (d) Shallow landslide formed by rock topple, (e) Shallow landslide in colluviums covered slope, (f) Rock fall at the upper slope and debris flow down-slope, (g) Rock plane failure occurring in slightly weathered rocks, and (h) Rock fall in very steep slope.

Mugling-Narayanghat road section consists of different types of landslides. However, some factors were common to all the landslides analysed. For example, large scale complex landslides are common in deeply weathered rocks, where different lithological units are found. Also, geological structures as fault, joints and fractures play a prominent role in creating deep weathering in such landslides (Fig. 19a). The weathering degree ranges from fresh to completely weathering degree in these landslides. In the other type of large landslides, geological structures as attitude of foliation plane, faults and slope angle have a prominent role, while rock weathering have less effect (Fig. 19b). Much of the medium scale rotational types of landslides are located the deep slope, where the rock is also considerably weathered. These types of landslides are mostly found in the slope with uniform lithology. Rock is completely to highly weathered in these landslides (Fig. 19c). Debris slides and debris flow are the dominant types of landslides occurring along the Mugling-Narayanghat road section and its surrounding region. Most part of the area is covered by thick colluviums or residual soils. Rock is also highly weathered below these cover. Thus, in every monsoon they flow down as debris flow or debris slide. In some case, there may be rock fall at the upper slope. The materials from the rock fall get mixed with the colluviums and other materials lying on the slope downhill and flow as debris flow (Fig. 19d). Shallow landslides are of three types. Several small-scales, very shallow landslides are located in slopes covered by thick colluviums or residual soil. The rock is rather fresh below the colluviums (Fig. 19e). Some part of the road section is suffered from some shallow rock plane failure. The rocks dipping towards the natural slope with similar angle to that of the slope and where the road cut has daylighted the foliation plane suffers from such failure (Fig. 19f). The rock is rather fresh in such slides. The other one, i.e. rock topple is observed in slightly weathered to fresh rocks, where the attitudes of foliation plane and slope angle are very high (Fig. 19g). Rock fall is encountered on steep slopes. The rocks are highly jointed and fractured and are not much weathered in these steep slopes (Fig. 19h).
