## Utvrđivanje uzroka nastanka havarije motora SUS na osnovu retrospektivne funkcije dijagnostike

# Determining the Cause of Engine Failure Based on the Retrospective Diagnostic Function

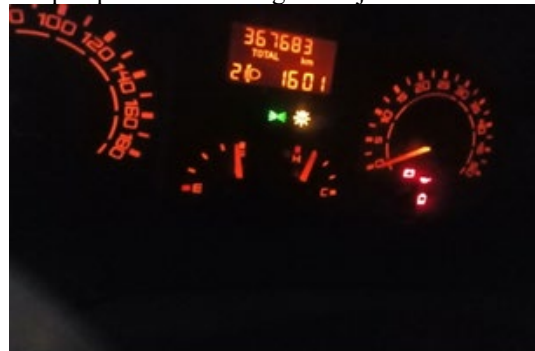
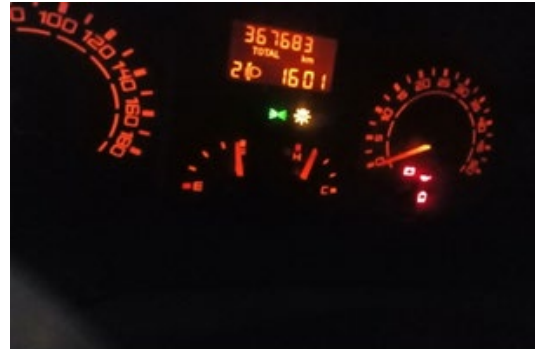
Slika 3: Pokazivači u komandnoj kabini vozila IVECO, modela 65C18DAILY

Figure 3: Indicators in the vehicle control cabin IVECO, 65C18DAILY

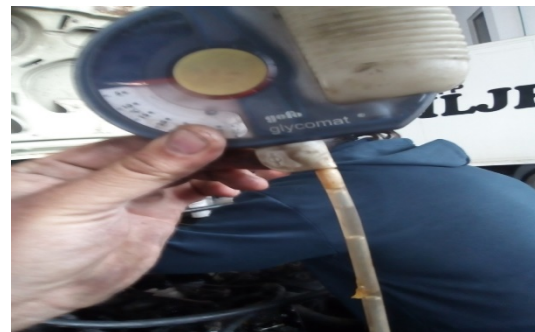
Slika 4: Kontrolom vrste i kvaliteta rashladne tečnosti u motoru, došlo se do zaključka da se u njemu nalazi obična voda

3. In the cooling system, instead of the prescribed coolant, ordinary water is poured, which is technically unacceptable (Figure 4). The use of ordinary water instead of coolant, which is recommended by the vehicle manufacturer, and which must be used during the operation of the vehicle, has a catastrophic negative effect on engine performance:

It is a well-known fact that the use of ordinary water in the engine cooling system leads to numerous problems during the operation of the vehicle or engine. One of the causes, due to the occurrence of the first and second breakdowns of the engine in question in the vehicle, is the use of ordinary water instead of the prescribed coolant.

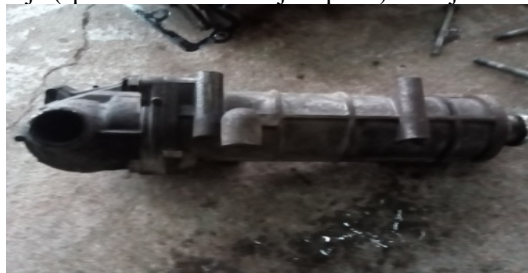
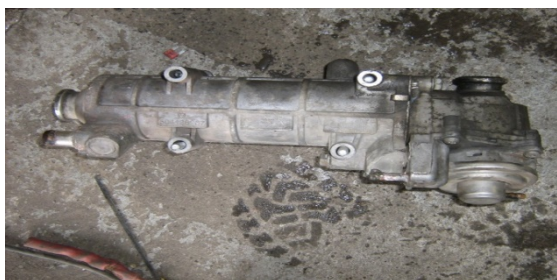
4. Ne funkcioniše EGR-ventil (slike 5 i 6).

negativnog delovanja na rad motora. Uzrok je pojava začepljenja, pre svega usled taloženja čestica čađi

Slika 5: EGR ventil pogonskog motora proizvodnje "IVECO " tipa F1CE0481H\*C003 je nefunkcionalan - izrazito zaprljan-pogled 1

Slika 6: EGR ventil pogonskog motora proizvodnje "IVECO" tipa FICE0481H\*C003 je nefunkcionalan - izrazito zaprljan-pogled 2

4. The EGR valve does not work (Figures 5 and 6). In the case of the EGR valve on the motor in question, there was a disturbance in its operation, primarily due to inadequate maintenance, which leads to its negative effect on the operation of the motor. The cause is the appearance of clogging, primarily due to the deposition of soot particles. EGR valves are used to regulate the combustion of the mixture, in order to increase economy and reduce the amount of nitrogen oxides and hydrocarbons.

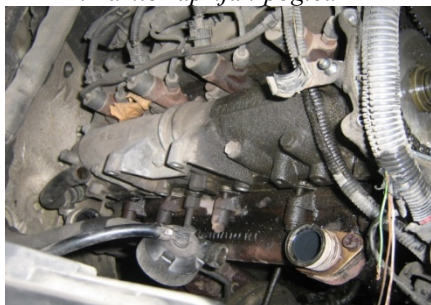
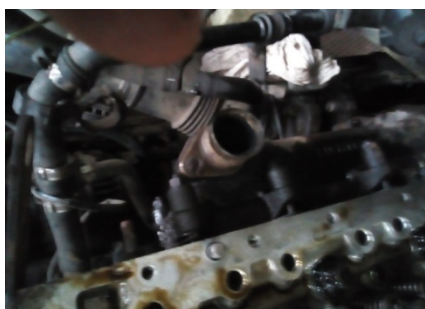
Reprogramiranjem upravljačke jedinice motora, i fizičkim uklanjanjem DPF-ventila sa izduvnog sistema, dovodi do oštećenja na turbo punjaču, jer nema DPF-ventila koji mu daje podpritisak. U ovim uslovima rada motora, vozilo znatno uvećava potrošnju goriva na većem broju obrtaja i povećava se količina dima pri povećanju dovoda goriva u motor.

Slika 7: Pogonski motor proizvodnje "IVECO" tipa FICE0481H\*C003 - nema PDF ventila-pogled 1

Slika 8: Pogonski IVECO motora tipa FICE0481H\*C003 nema PDFventila-pogled 2

5. Does not work-there is no physical DPF-FAP filter (Figures 7 and 8). The engine in question was manufactured with a DPF-FAP filter and then met Euro 4 standards. This engine, at the time of determining its technical condition, does not meet the Euro 4 norm, but works at the level of the Euro 3 norm, and even lower, primarily because the DPF-FAP filter has been removed (Figures 7 and 8), and the EGR valve is dirty and non-functional (Figures 5 and 6). Since there is no DPF-FAP filter on the subject motor (means that the motor does not work with the PDF filter), the following negative effects occur:

- Turbo engine group, pistons, nozzles, EGR valve, piston rings and other engine parts are damaged because high temperature and pressure are created.
- Larger drop in performance, limits engine operation to 3000 rpm.

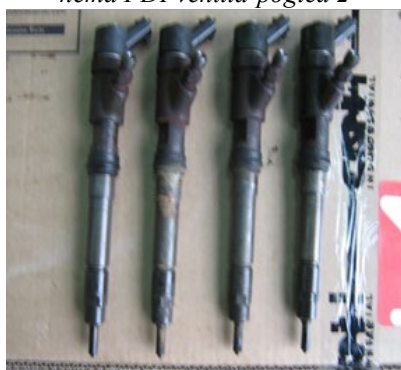
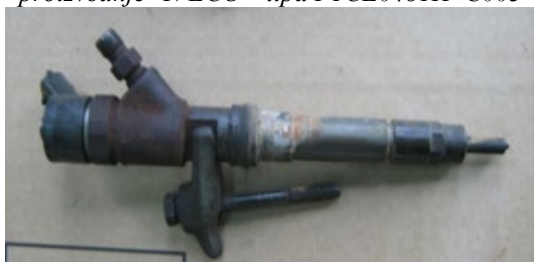
6. Brizgač na četvrtom cilindru predmetnog motora je sa izuzetno mnogo naslaga kamenca i korozije (slike 9 i 10).

Pod dejstvom rashladne tečnosti (vode), na pogonskom motoru proizvodnje "IVECO " tipa F1CE0481H\*C003, došlo je do pojave velikih naslaga kamenca i korozije na injektoru četvrtog cilindra.

Pošto je tečnost, koja se koristi za hlađenje motora, dolazila do injektora na četvrtom cilindru (kod tehnički ispravnih motora to se ne može dogoditi), ta ista tečnost je oštećivala i druge delove motora i izazivala njegov nepravilan rad.

Slika 9: Izgled brizgača - injektora pogonskog motora proizvodnje "IVECO" tipa FICE0481H\*C003

Slika 10: Injektor četvrtog cilindra pogonskog motora "IVECO" tipa FICE0481H\*C003 -

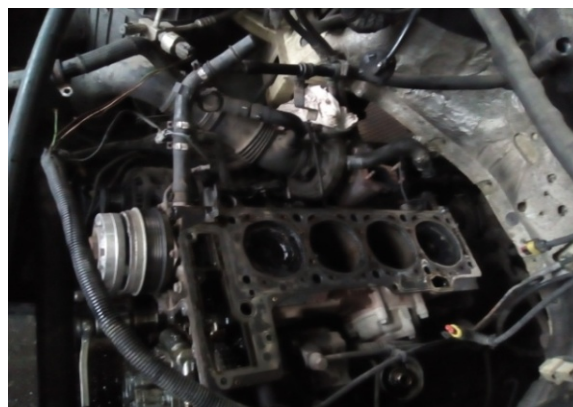
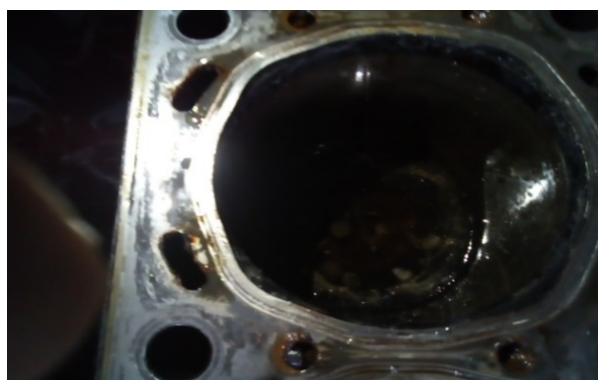
7. Stanje klipne grupe (klip-klipni prstenovi-cilindar) je izrazito loše. Prisutne su velike naslage smole, korozije i zapeknuća (slike 11, 12).

To govori da eksploatacija predmetnog vozila, ali i njegovo održavanje, nije sprovedeno na način koji je propisao proizvođač. Klipna grupa motora (klip-klipni prstenovi-cilindar) je u izrazito lošem tehničkom stanju (slike 11, 12), između ostalog, i zbog čestih pregrevanja tokom eksploatacije vozila.

Slika 11: Pogonski motor proizvodnje "IVECO" tipa FICE0481H\*C003 - Pogled na kompletan blok motora sa gornje strane, posle demontaže glave motora

Slika 12: Pogonski motor proizvodnje "IVECO" tipa FICE0481H\*C003 - Pogled na deo bloka motora - četvrti cilindar i klip u njemu, posle demontaže glave motora

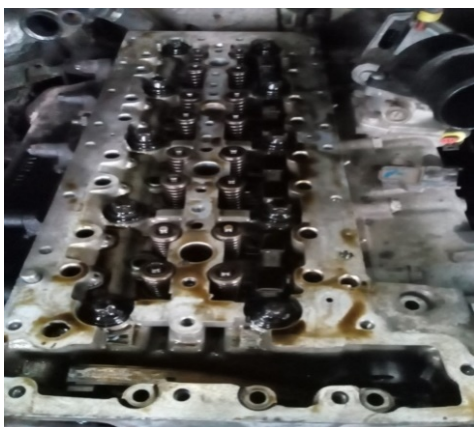
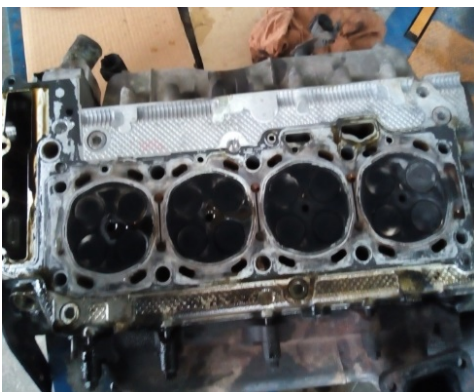
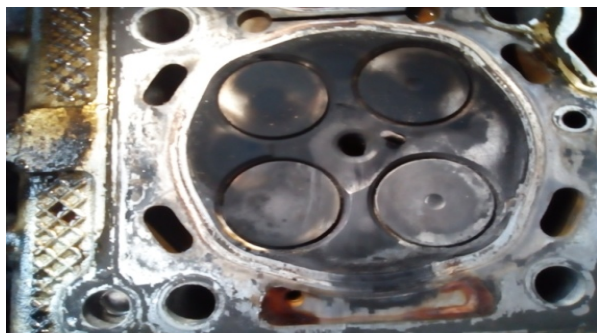
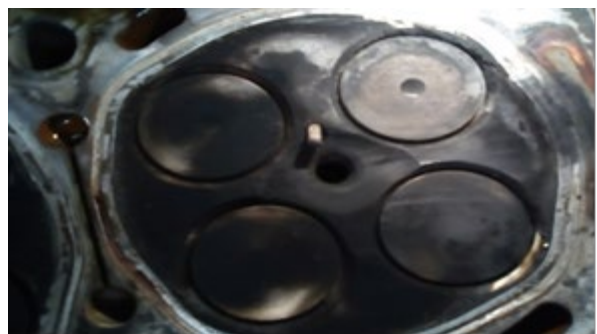
8. Usled korišćenja obične vode, kao sredstva za hlađenje motora došlo je do stvaranja naslaga kamenca u unutrašnjosti glave motora (slike: 13, 14, 15, 16), ali i u celokupnom sistemu za hlađenje predmetnog motora. To je dovelo da su protočni kanali, gde treba da se kreće rashladna tečnost, smanjeni, a samim tim i kapacitet hlađenja (sposobnost odvođenja toplote) smanjen.

Naslage kamenca su izolator, tako da i ta činjenica upućuje na zaključak da oslobođena toplota u radnom prostoru predmetnog motora nije mogla da se odvodi pravilno, onako kako je to predvideo i realizovao proizvođač predmetnog motora.

Slika 13: Pogonski motor proizvodnje "IVECO" tipa FICE0481H\*C003 - Pogled na gornji deo glave motora

Slika 14: Pogonski motor proizvodnje "IVECO" tipa FICE0481H\*C003 - Pogled na donji deo glave motora.

Slika 15: Pogonski motor proizvodnje "IVECO" tipa FICE0481H\*C003 - Pogled 1 na donji deo glave motora iznad četvrtog cilindra.

Slika 16: Pogonski motor proizvodnje "IVECO" tipa FICE0481H\*C003 - Pogled na donji deo glave motora iznad četvrtog cilindra.

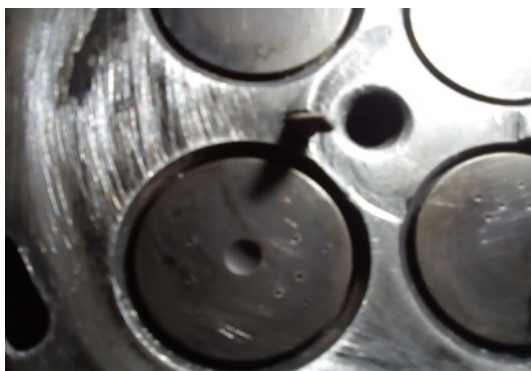
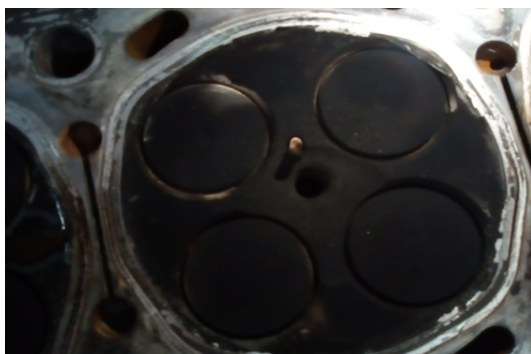
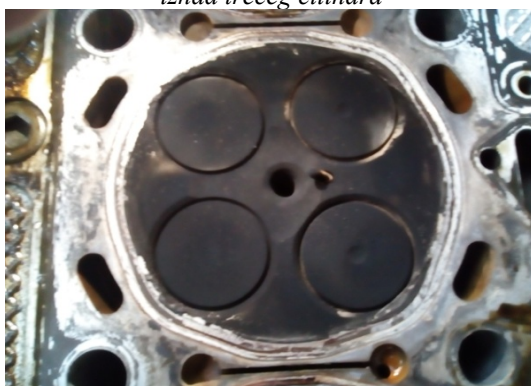
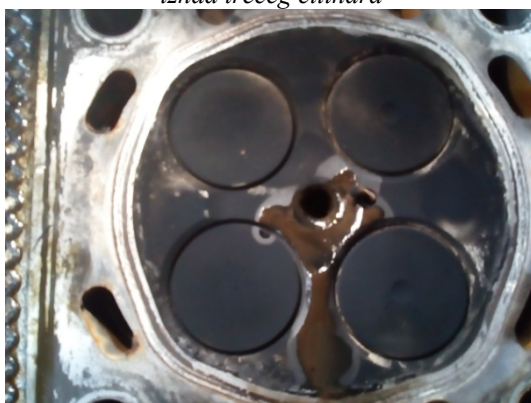
Slika 17: Pogonski motor proizvodnje "IVECO" tipa FICE0481H\*C003 - Pogled 3 na donji deo glave motora iznad četvrtog cilindra

Slika 18: Pogonski motor proizvodnje "IVECO" tipa FICE0481H\*C003 - Pogled na donji deo glave motora iznad trećeg cilindra

Slika 19: Pogonski motor proizvodnje "IVECO" tipa FICE0481H\*C003 - Pogled 2 na donji deo glave motora iznad trećeg cilindra

Slika 20. Pogonski motor proizvodnje "IVECO" tipa FICE0481H\*C003 - Pogled 2 na donji deo glave motora iznad drugog cilindra

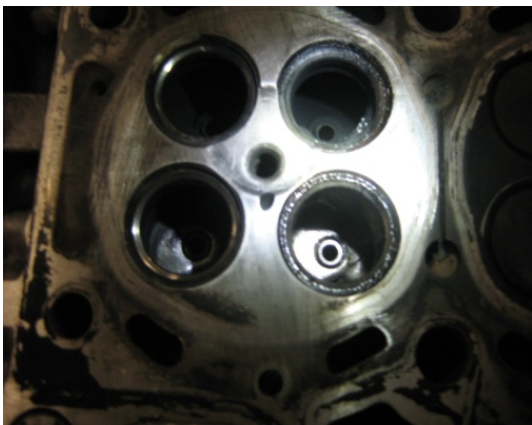
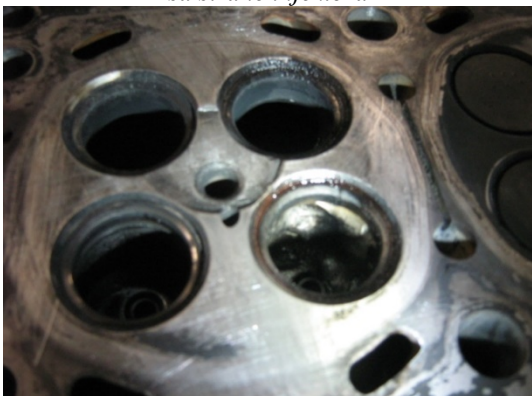
Slika 21: Pogonski motor proizvodnje "IVECO" tipa F1CE0481H\*C003 - Pogled 3 na donji deo glave motora (iznad četvrtog cilindra) gde je došlo do pojave pukotine sa strane injektora

Slika 22: Pogonski motor proizvodnje "IVECO" tipa F1CE0481H\*C003 - Pogled 2 na donji deo glave motora (iznad četvrtog cilindra) gde je došlo do pojave pukotine sa strane injektora. Na slici je pogled na zavareni deo sa strane ventila.

9. Zavarena glava motora na četvrtom cilindru sa strane ventila (slike 21,22), gde je glava predmetnog motora imala pukotinu sa strane injektora.
