Failure Analysis on Tube Arm Cylinder Hydraulic Excavator

Abstract— The Failure on tube rod arm cylinder hydraulic excavator caused to lose production and processing time on mining site. Investigation included visual inspection, chemical analysis, metallography analyze, and microhardness test. Tube material used high silicon material type while the standard used ST52 carbon steel type. The tube was broken and crack to several pieces. The chemical composition of the tube has different in sulfur and silicon content. From hardness test with micro hardness method, sample tube broken has lower hardness compared to standard hardness. Metallography analysis obtained the phase of tube has same phase with standard which is ferrite and pearlite phase but has different grain size. Based on this study, it can be resumed failure on tube is because impurities and different specification on raw material.

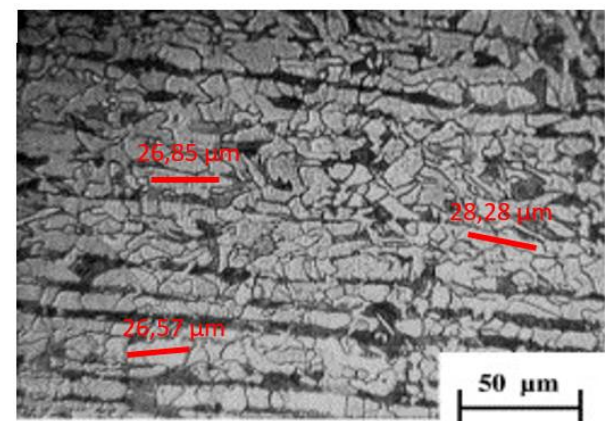
St 52 Carbon Steel
Figure. 5 Reference Sample Microstructure

ferrite and pearlite phases which have ductile and tough properties. Whereas the reference ST52 also consists of ferrite and pearlite phases which have ductile and tough properties. Based on the analysis of ferrite grain size, it can be seen that the grain size of ferrite up to the arm cylinder sample looks larger (34-60 μm) than the grain size of Reference ST 52 ferrite, which is (26-28 μm) (Zhou et al., 2020). The larger the grain, the lower the hardness and tensile strength, but the better the ductility (Khodabakhshi & Gerlich, 2020). As explained in the graph below

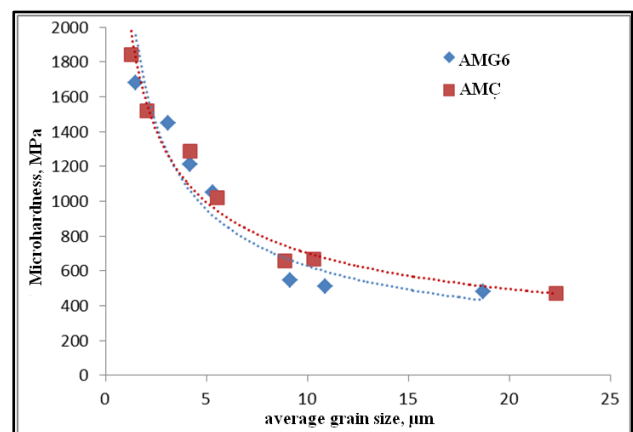
Figure. 6 Correlation Hardness and Grain Size

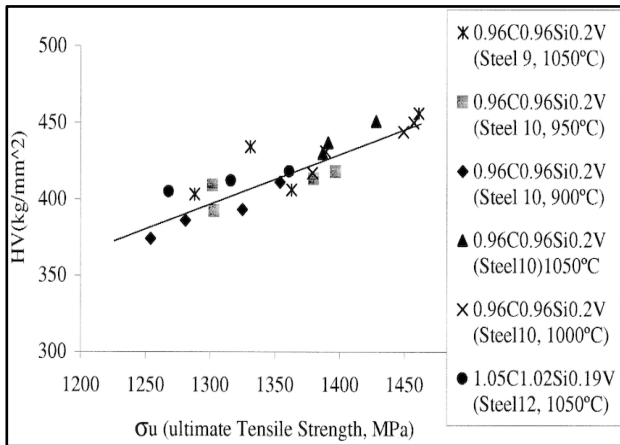
Based on the hardness test with a microhardness tool, it can be concluded that the hardness of the tube arm cylinder part material is 178.06 HV (below 10 HRC) and on the ST 52 reference tube is 222.74 (19.54 HRC). So based on the microhardness test, it can be seen that there is a hardness difference of around 10 HRC between the arm cylinder and the reference ST52. This can reduce the strength of the tube cylinder and be a starting point for fracture and failure. And according to the initial hypothesis in the microstructural analysis, the larger the grain size, the lower the hardness (Wang et al., 2021). Pressure was happened in tube cylinder is internal pressure from oil and external pressure from the mounting on hydraulic excavator.

Figure. 7 Correlation Hardness and Tensile Strength
