ASSESSMENT OF THE ST. GIUSTA CHURCH IN BAZZANO AFTER THE L'AQUILA EARTHQUAKE ON APRIL 6, 2009

One of the first surveyed historical buildings was the church St. Giusta in Bazzano, about 7 km from L'Aquila city, one of the most beautiful churches of the area.

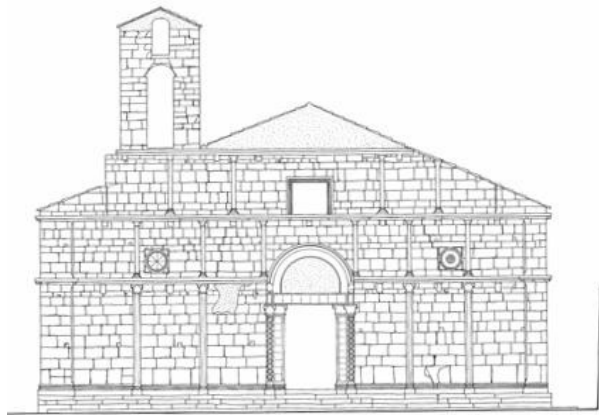
Figure 1: The façade of St. Giusta church.

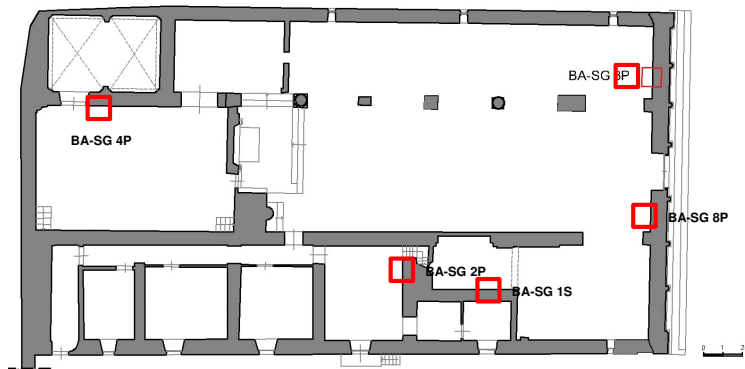
Figura 5: Localization of the surveyed points for the definition of the masonry qualità.

For the definition of the masonry walls quality of St. Giusta church, five survey points were selected (Fig.5).

The choice of points had to cover all the different textures found in the church walls in order to compare them with data from historical sources and understand the evolution of the building construction. In reality the choice of the points could only fall on the walls without plaster or partially collapsed, in accessible areas and where it is possible to work in security. Walls without plaster show clearly the many changes that took place over time.

As shown in figure 6, the external leaf of the facade wall is made of calcareous regular stone blocks and, as in many other cases in the region, the internal leaf is less regular, while in the middle a third leaf is made in small irregular stones. Connections among the leaves are not visible; this explains both the high vulnerability of the top of the facade. In the other selected point the masonry has irregular texture and irregular calcareous stones.
