# Development of Guidelines for Inspection, Repair, and Use of Portable Concrete Barriers—Volume 1: Technical Report

Technical Report 0-7059-R1-Vol1

TEXAS A&M TRANSPORTATION INSTITUTE  
COLLEGE STATION, TEXAS

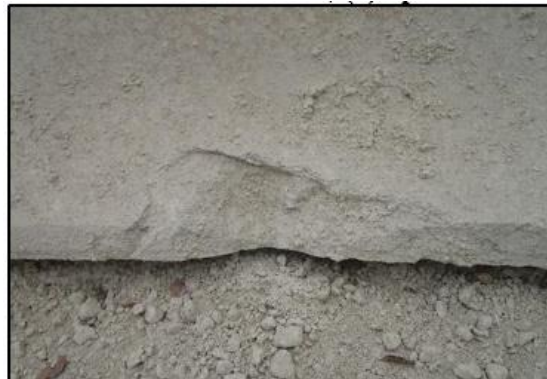
Spalling is the breaking of flakes of concrete from the barrier body. Spalled concrete zones look like depressions along the barrier surface and corners. Figure 2.1 shows spalled zones at different locations in PCBs.

a. Spall on the Middle Base of the Barrier

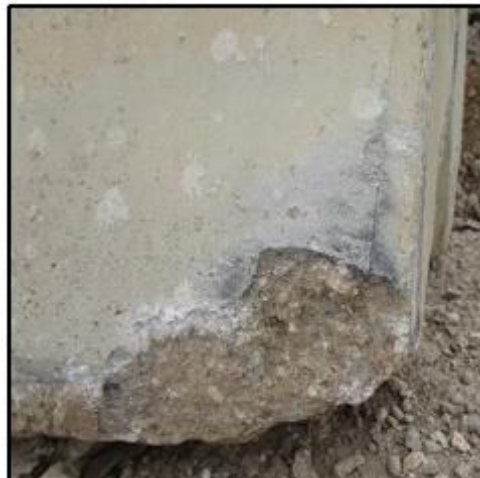
b. Spall on the Toe of the Barrier

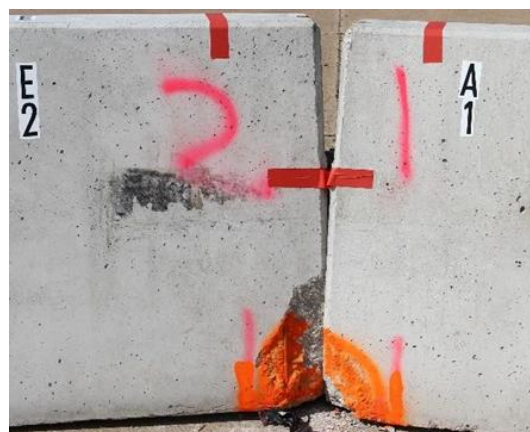
Vehicles crashing against the barrier during road accidents results in portions of the concrete breaking away (Figure 2.3). Depending on the vehicle type, impact speed, and angle, the extent of spalling may vary.

**Figure 2.3. Spalling at the Toe of Barrier E Due to a Vehicle Crashing into the Joint between Barriers A and E.**

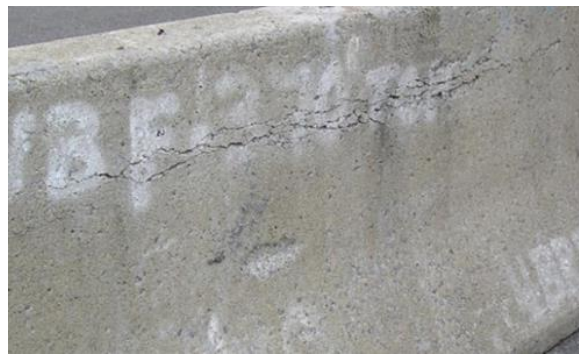
The excessively tightened grip of lifting devices may lead to clustered horizontal cracks in the upper portion of the barrier stem. Figure 2.5 shows an example of clustered horizontal cracks.

**Figure 2.5. Clustered Horizontal Cracks Due to the Tight Clamping of Lifting Devices (10).**

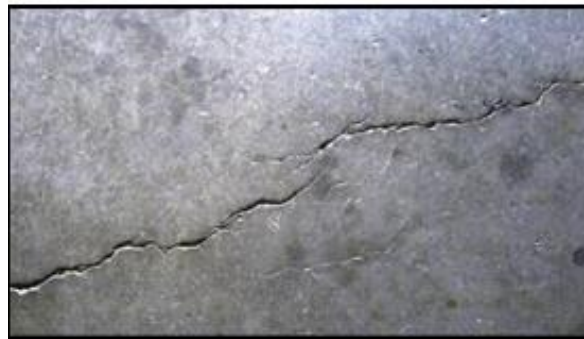
Concrete near the corners and edges is vulnerable to cracking because loss of moisture takes place from the adjacent surfaces. There is no typical pattern that drying shrinkage cracking follows because the cracks form at any location where there is a restraint to shrinkage movement. Shrinkage cracks usually develop approximately at right angles to the direction of restraint (16, 17). Figure 2.7 shows examples of shrinkage cracks.

**Figure 2.7. Shrinkage Cracks (18).**

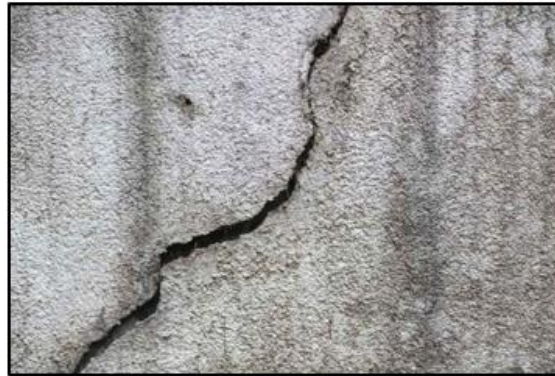
Chemical reactions can be due to the materials used in the concrete mix employed to cast the barrier or the materials the concrete mix may have encountered. Cracking is caused by the expansive reactions that take place between the aggregate and alkalis in the cement paste. The chemical reaction taking place between active silica and alkalis produces an alkali-silica gel as a byproduct. This gel forms around the aggregate surface, increasing its volume and putting pressure on the surrounding concrete. The increase in pressure can cause the tensile stresses to increase beyond the concrete's tensile strength, leading to cracks in concrete, as shown in Figure 2.8 (19).

**Figure 2.8. Crack Due to the Formation of More Voluminous Products (20).**

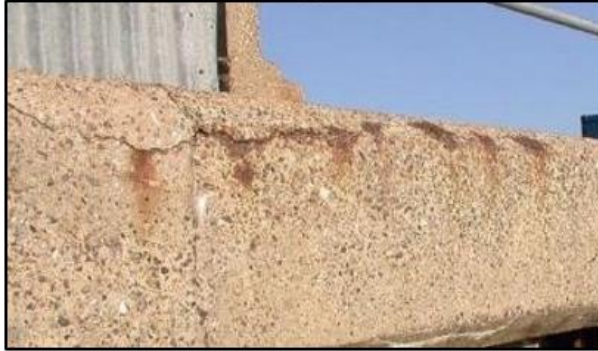
Three conditions that must be present to initiate corrosion are oxygen, moisture, and electron flow within steel. Elimination or limitation of any of these conditions reduces the corrosion of the steel reinforcement embedded in the concrete member, reducing the risk of cracking. Concrete provides a passive protection to the steel by forming a protective oxide coating around it in an alkaline environment. However, as carbonation alters the concrete's levels of alkalinity, corrosion may take place. Iron oxides and hydroxides are formed as byproducts during the corrosive reaction. As these byproducts form on the surface of the steel reinforcement, the volume of the rebar increases. This increase in volume increases the pressure on the concrete and causes radial cracking in the member because the tensile stresses developed in the concrete exceed the tensile strength (Figure 2.9). Repairing these cracks at the initial stage is important because as they become larger, oxygen and water have a greater chance to penetrate the concrete and accelerate the corrosion of the reinforcement (21).

**Figure 2.9. Crack Due to the Corrosion of Reinforcement (22).**

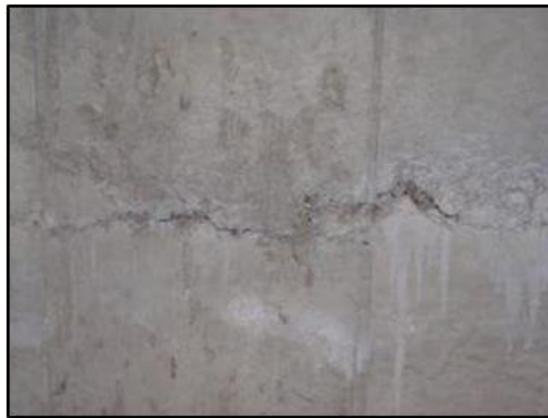
Numerous poor construction practices, such as increasing the cement content to offset a decrease in strength from the addition of water, inadequate curing, etc., can lead to cracking in concrete, as shown in Figure 2.10 (11).

**Figure 2.10. Crack-Like Formation Due to the Lack of Mixing of Two Batches of Concrete during the Pour (19).**

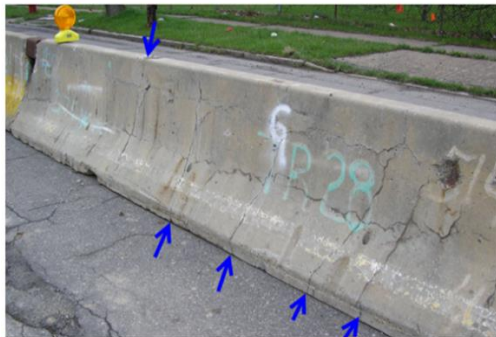
| Defects | Unacceptable |
|---|--|
| <b>Cracks</b> | <p>A PCB piece has more than one transverse crack through the section, it is not acceptable (Figure 2.12).</p> <p>A PCB piece has an open crack running more than 4 ft longitudinally, it is not acceptable (Figure 2.13).</p> <p>A single crack exhibits evidence that the reinforcing bar is rusting, the piece is not acceptable.</p> |

b. Unacceptable barrier

**Figure 2.12. Transverse Cracks—NYSDOT (27).**

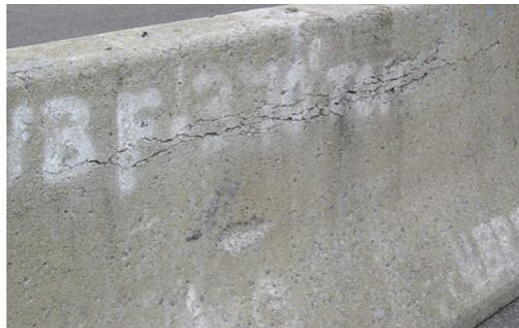
**Figure 2.13. Longitudinal Cracks—NYSDOT (27).**

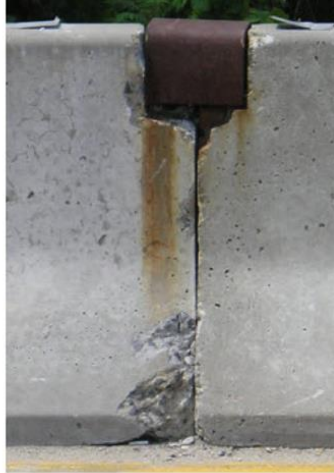
| Defects | Unacceptable |
|---|--|
| <b>Concrete Spalling</b> | <p>If spalled areas exceeding 12 inches in any direction, it is not acceptable.</p> <p>A corner of PCB has the depth of the spalling is 3 or more inches, it is not acceptable (Figure 2.14).</p> |

**Figure 2.14. Corner Damage—NYSDOT (27).**

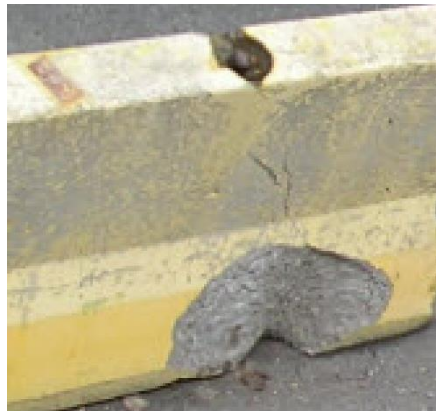
| Defects | Unacceptable |
|---|--|
| <b>Snag Risk</b> | <p>A PCB has a surface that projects towards traffic by more than 30 degrees and that is exposed to a depth of greater than 1.75 inches for traffic approaching the barrier at a 25-degree angle, it is not acceptable (Figure 2.15 and Figure 2.16).</p> |

**Figure 2.16. Unacceptable Barrier Due to Snag Risk—NYSDOT (27).**

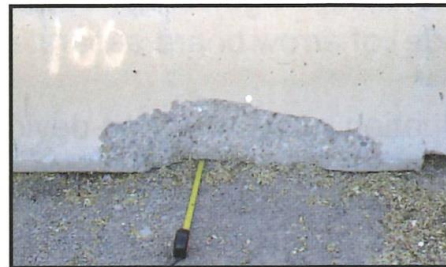
| <b>Defects</b> | <b>Acceptable</b> | <b>Marginal</b> | <b>Unacceptable</b> |
|---|--|---|---|
| <b>Cracks and Spalling</b> | The walls appear new with few minor blemishes. Spalls and chipped concrete pose no threat of damaging or snagging tires. | The walls have minor spalls with hairline cracks and minor imperfections along the base but are still structurally sound. | Large spalls and cracks, with exposed rebar or unsound concrete that could be easily removed when hit. Any spalled concrete could cause the vehicle to “snag” and twist from the direction it is going. |

c. Unacceptable

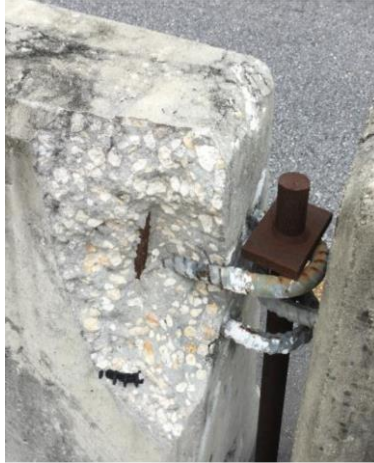
| <b>Defects</b> | <b>Acceptable</b> | <b>Unacceptable</b> |
|---|---|---|
| <b>Connection System</b> | Connection assemblies are functional with no damage, are all intact, and fixed in their positions | Connection assemblies are deformed, bent, broken, or no longer in a fixed position |

**Figure 2.19. Example of Unacceptable Barrier with Connection Assembly Damage—*FDOT (31)*.**

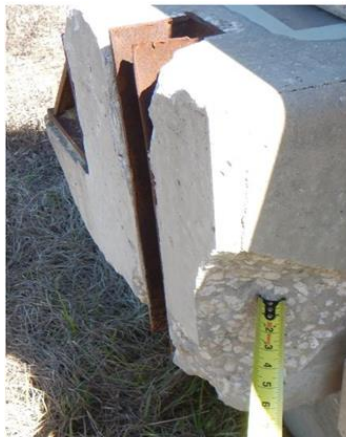
**Figure 2.20. Example of Unacceptable Barrier—*FDOT (31)*.**

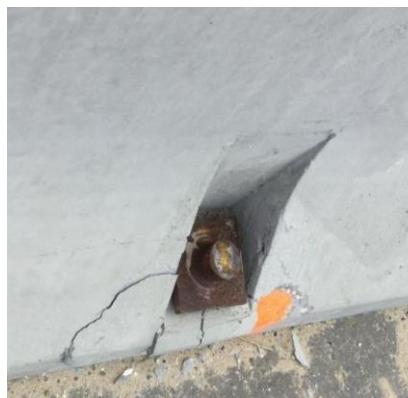
**Figure 2.21. Example of Unacceptable Barrier with Broken Concrete at Anchor Slot Due to Shear Cracking—*FDOT (31)*.**

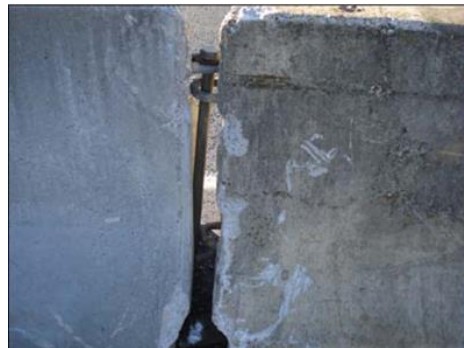
b. Unacceptable barrier

**Figure 3.1. Examples of Connection Systems—ALDOT (33).**

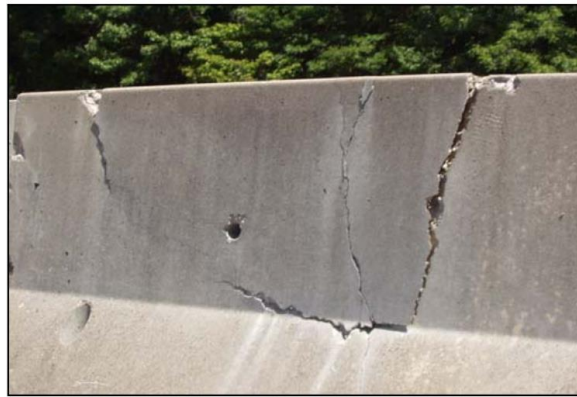
| <b>Defects</b> | <b>Acceptable</b> | <b>Marginal</b> | <b>Unacceptable</b> |
|---|--|--|---|
| <b>Spalling of Concrete</b> | Spalls and chipped concrete are no greater than 1.5 inches in depth. | Spall on a barrier, less than 4 inches measured horizontally, vertically, or diagonally. No exposed rebar. | Any spall greater than 1.5 inches in depth. A rebar is exposed. |

**Figure 3.2. Unacceptable Barrier—IDOT (34).**

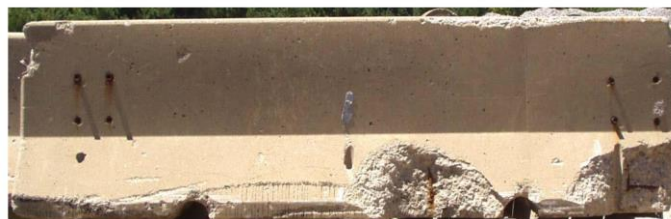
| <b>Defects</b> | <b>Acceptable</b> | <b>Marginal</b> | <b>Unacceptable</b> |
|---|---|---|--|
| <b>Spalling of Concrete</b> | No more than 3 spalls and no spall greater than 12 inches in any surface direction; and no spall or chipped concrete greater than one and one-half (1.5) inches in depth. | Wall with repaired concrete areas less than 12 inches in any surface direction. No repairs are permitted to any aspect of the connection. | The wall has one or more spalls 12 inches or larger in any surface direction. Unsound concrete that could be easily removed when hit. Spall(s) greater than one and one-half (1.5) inches in depth. Exposed reinforcing steel. |

c. Unacceptable

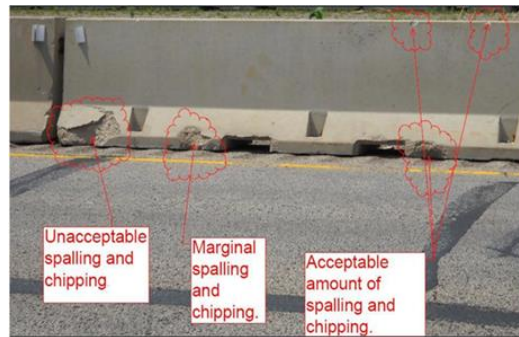
**Figure 3.4. Spalling and Chipping—WisDOT (43).**

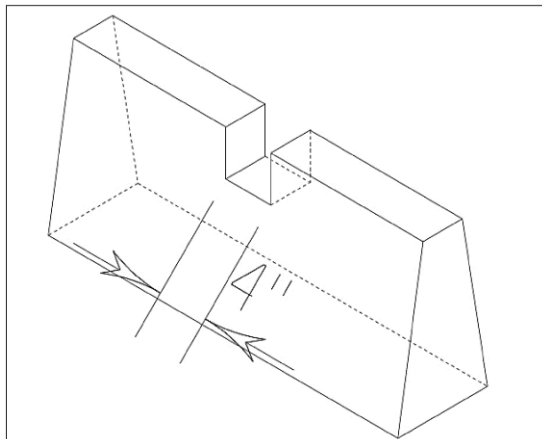
| <b>Defects</b> | <b>Acceptable</b> | <b>Marginal</b> | <b>Unacceptable</b> |
|---|--|---|--|
| <b>Snag Points</b> | N/A | N/A | If a longitudinal opening is 4 inches or greater in width. Perpendicular differences in barriers of 2 inches or greater. |

**Figure 3.5. Opening in Barrier Causing Snag Point—WisDOT (43).**

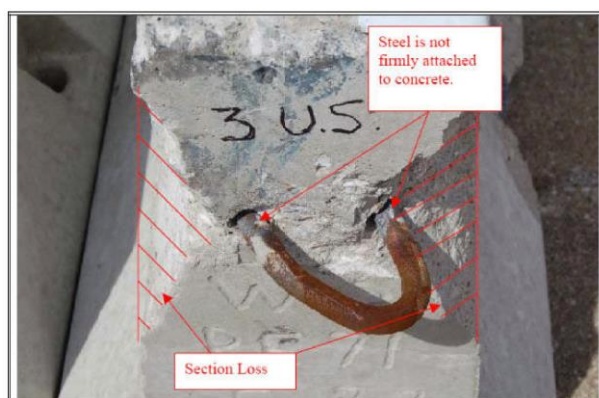
| <b>Defects</b> | <b>Acceptable</b> | <b>Marginal</b> | <b>Unacceptable</b> |
|---|--|---|--|
| <b>Connections</b> | N/A | N/A | A loop that is out of alignment. The steel loop is not firmly connected to the concrete barrier. |

**Figure 3.6. Loop Unacceptable Condition—WisDOT (43).**

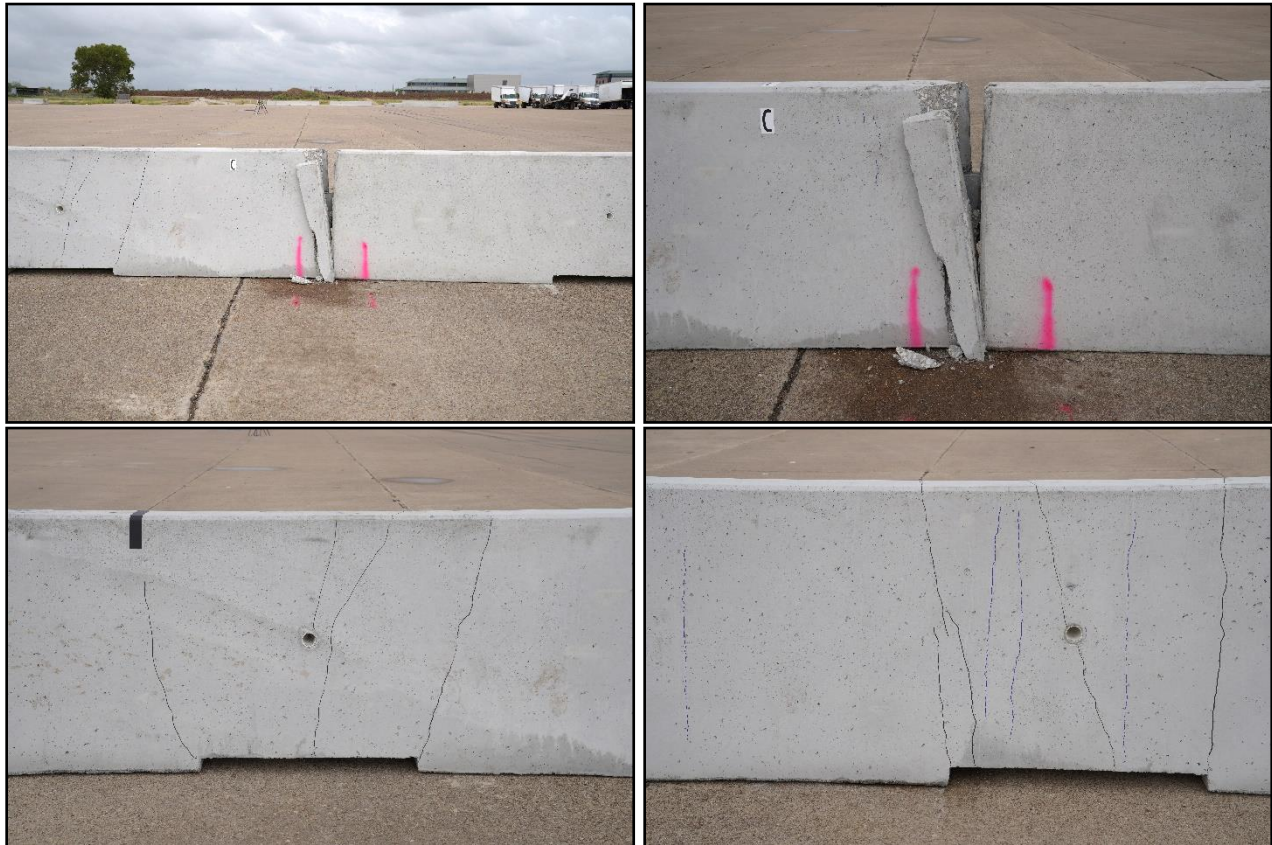
**Figure 5.4. Single-Slope Barrier after Test No. 440590-01-B1.**

Figure 5.4 shows damage to the barrier. The blue lines indicate existing cracks, and the black lines indicate the cracks post impact. The larger, more visible cracks were not marked. The left end of barrier A moved 2 inches back, and the joint at barriers A and B moved forward by 3 inches. The joint at barriers B and C moved 1 ft back, and the joint at barriers C and D moved 13 inches back. The joint at barriers D and E moved 3 inches forward, and the right end of barrier E moved 1 inch back. Measured from the top of the joints, the gaps between the barriers were as follows: the joint of barriers A and B was 2¼ inches at the front and 2 inches at the back; the joint of barriers B and C was 2 inches at the front and 2¼ inches at the back; the joint of barriers C and D was not measurable at the front and 2½ inches at the back; and the joint of

barriers D and E was 2¼ inches at the front and 1¾ inches at the back. There was some cracking at the top of the right end of barrier B. Barrier C had cracks all along the front and back side of the barrier and had some spalling on the backside of the barrier near the bottom. Barrier D had some spalling of the concrete at the right scupper. There was a crack on the bottom of barrier D near the joint of barriers C and D. Maximum dynamic deflection during the test was 16.4 inches, and maximum permanent deformation was 13.0 inches.

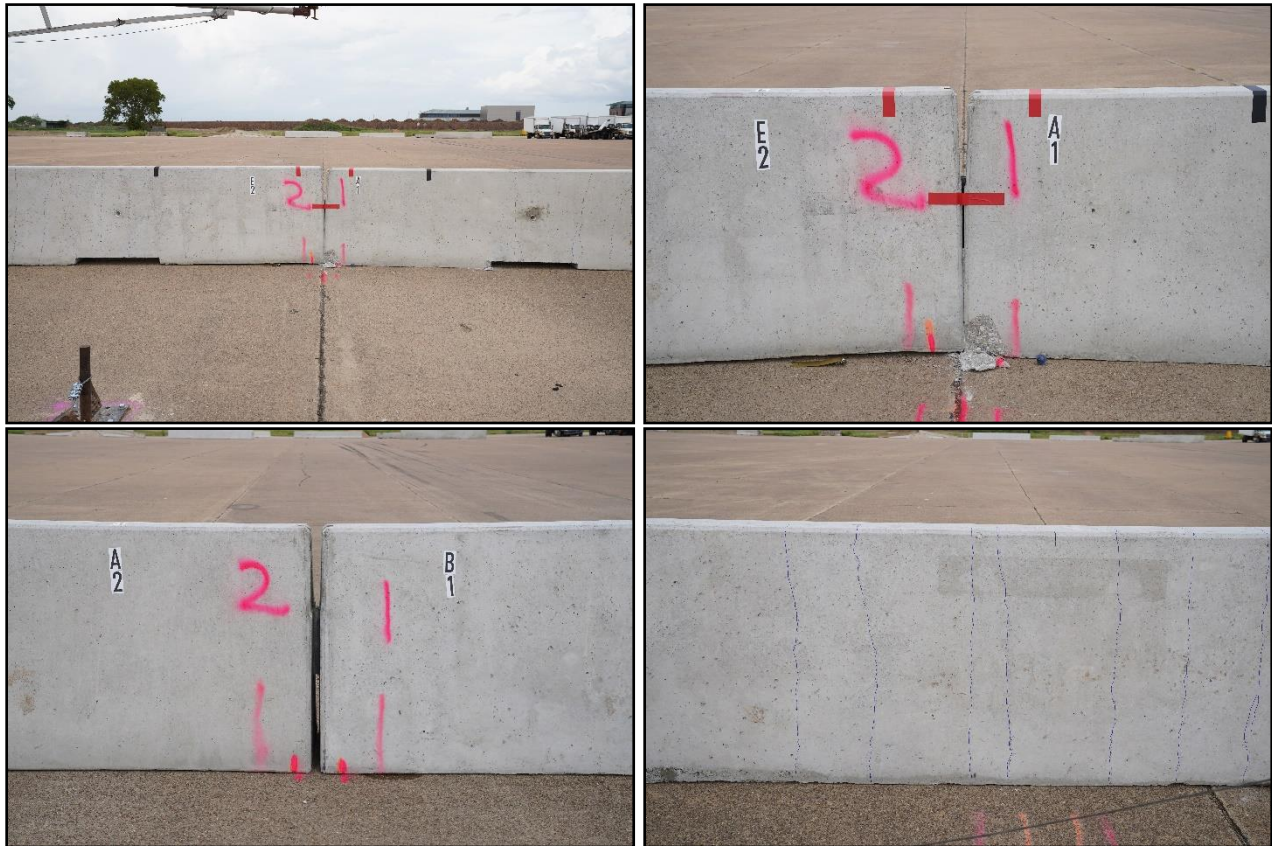
**Figure 5.12. Single-Slope Barrier after Test No. 440591-01-B2.**

Figure 5.12 shows damage to the barrier. The black lines indicate existing cracks, and the blue lines indicate the cracks post impact. The orange paint indicates existing spalling. No movement

was noted on either the far left or far right ends of the installation. The joint at barriers D and E moved 1½ inches forward and 1½ inches to the right. The joint at barriers E and A moved 15¼ inches back, and the joint at barriers A and B moved 1 inch to the left. At the top of the joint between barriers D and E, there was a 2½-inch gap at the front and a 2-inch gap in the back. The bottom of the barrier had a 1¾-inch gap in the front and a ½-inch gap in the back. At the top of the joint between barriers E and A, there was a 1⅞-inch gap in the front and a 2⅜-inch gap in the back. The bottom of the barrier had a 2⅜-inch gap in the front and no gap in the back. At the joint between barriers A and B, there was a 2⅞-inch gap in the front and a 1⅞-inch gap in the back. The bottom of the joint had a 1¾-inch gap in the front and a ⅜-inch gap in the back. There was some spalling on the base of barrier A at the joint between barriers E and A, and also on the bottom of the backside of barrier A at the joint between barriers A and B. There was also cracking noted on all barriers and marked as indicated above. Maximum dynamic deflection during the test was 15.25 inches, and maximum permanent deformation was 15.25 inches.

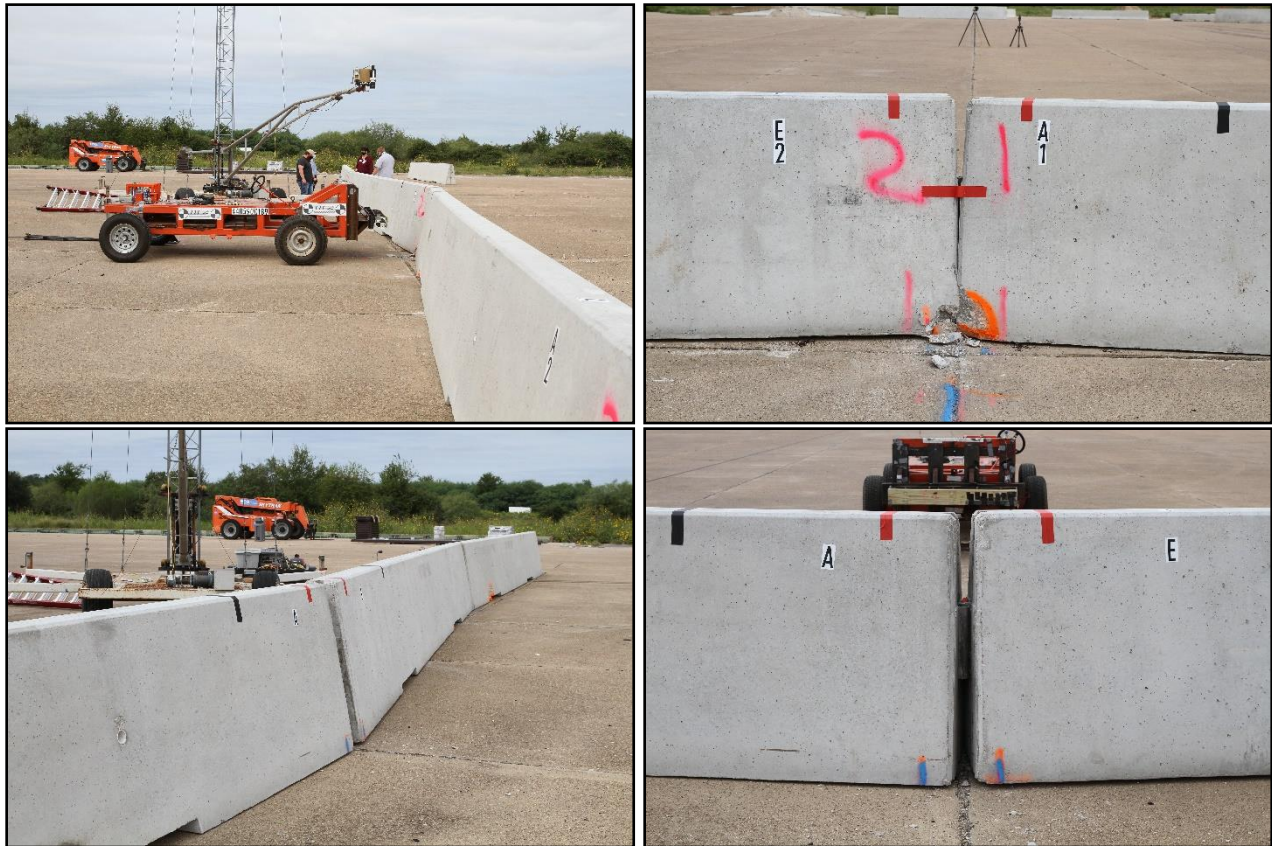
**Figure 5.16. Single-Slope Barrier after Test No. 440591-01-B9.**

Figure 5.16 shows damage to the barrier. The black and blue lines indicate existing cracks, the orange paint indicates existing spalling, and the red lines indicate cracks post impact. The left end of barrier D moved 1 inch to the right. The joint of barriers D and E moved 4½ inches forward, and the joint of barriers E and A moved 31½ inches back. The joint of barriers A and B moved 3 inches forward, and the right end of barrier B moved ¾ inches to the left. At the top of the joint between barriers D and E, there was a 2½-inch gap in the front and a 2-inch gap in the back. The bottom of the barriers had a 2-inch gap in the front and no gap in the back. At the top of the joint between barriers E and A, there was a 2-inch gap in the front and a 3¾-inch gap in

the back. The bottom of the barriers had no gap in the front and a 4-inch gap in the back. At the top of the joint between barriers A and B, there was a 2¼-inch gap in the front and a 1⅞-inch gap in the back. The bottom of the barriers had a 2½-inch gap in the front and no gap in the back. There was some spalling at the joint between barriers E and A on the front base of both barriers. Barrier A also had some spalling at its base on the backside of the barrier at the joint between barriers A and B. There were cracks on the front and back of barriers E and A, and also one small crack on the front of barrier D. Maximum dynamic deflection during the test was 31.6 inches, and maximum permanent deformation was 31.5 inches.

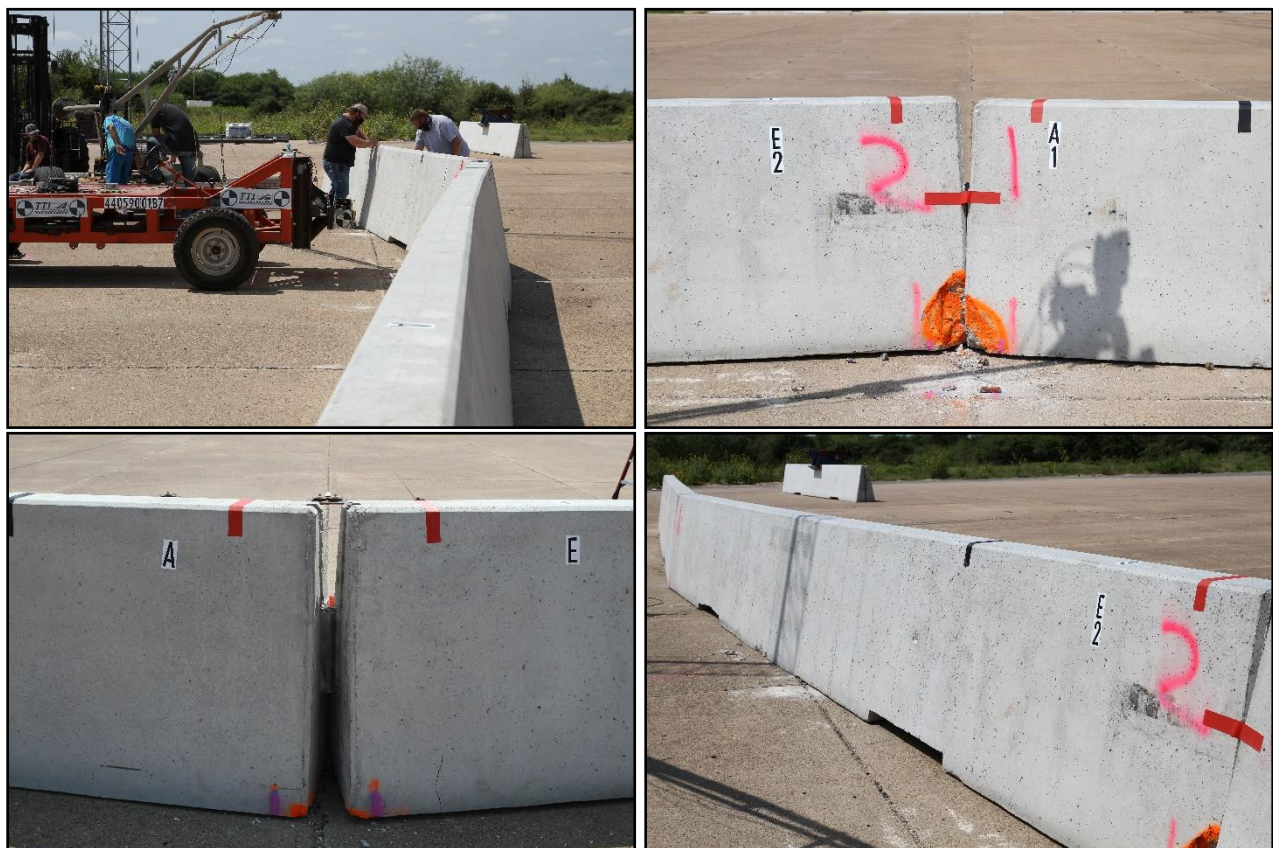
**Figure 5.20. Single-Slope Barrier after Test No. 440591-01-B7.**

Figure 5.20 shows damage to the barrier. Black, blue, and red lines indicate existing cracks; orange paint indicates existing spalling; and green lines indicate cracks post impact. The left end of barrier D moved ½ inch forward and 3 inches to the right. The joint of barriers D and E moved 4½ inches forward, and the joint of barriers E and A moved 45½ inches back. The joint of barriers A and B moved 3 inches forward, and the right end of barrier B moved ½ inch back and 2 inches to the left. At the top of the joint between barriers D and E, there was a 2½-inch gap in the front and a 2-inch gap in the back. The bottom of the barriers had a 2¾-inch gap in the front and no gap in the back. There was some slight cracking and spalling on the base of barrier D on

the backside of the barrier at the joint between barriers D and E. At the top of the joint between barriers E and A, there was a 2½-inch gap in the front and a 4¼-inch gap in the back. The bottom of the barriers had no gap in the front and a 5¾-inch gap in the back. The JJ hooks were deformed at the joint, and there was spalling on the front of each barrier near the base. At the joint between barriers A and B, there was a 2¾-inch gap in the front and a 2-inch gap in the back. The bottom of the barriers had a 2¾-inch gap in the front and no gap in the back. There was some spalling on the back of barrier A near the base at the joint. There were cracks on the front and back of barriers E and A, and also on the backside of barrier B. The front of barrier E had some spalling in the middle of the barrier at its base. Maximum dynamic deflection during the test was 45.5 inches, and maximum permanent deformation was 45.5 inches.

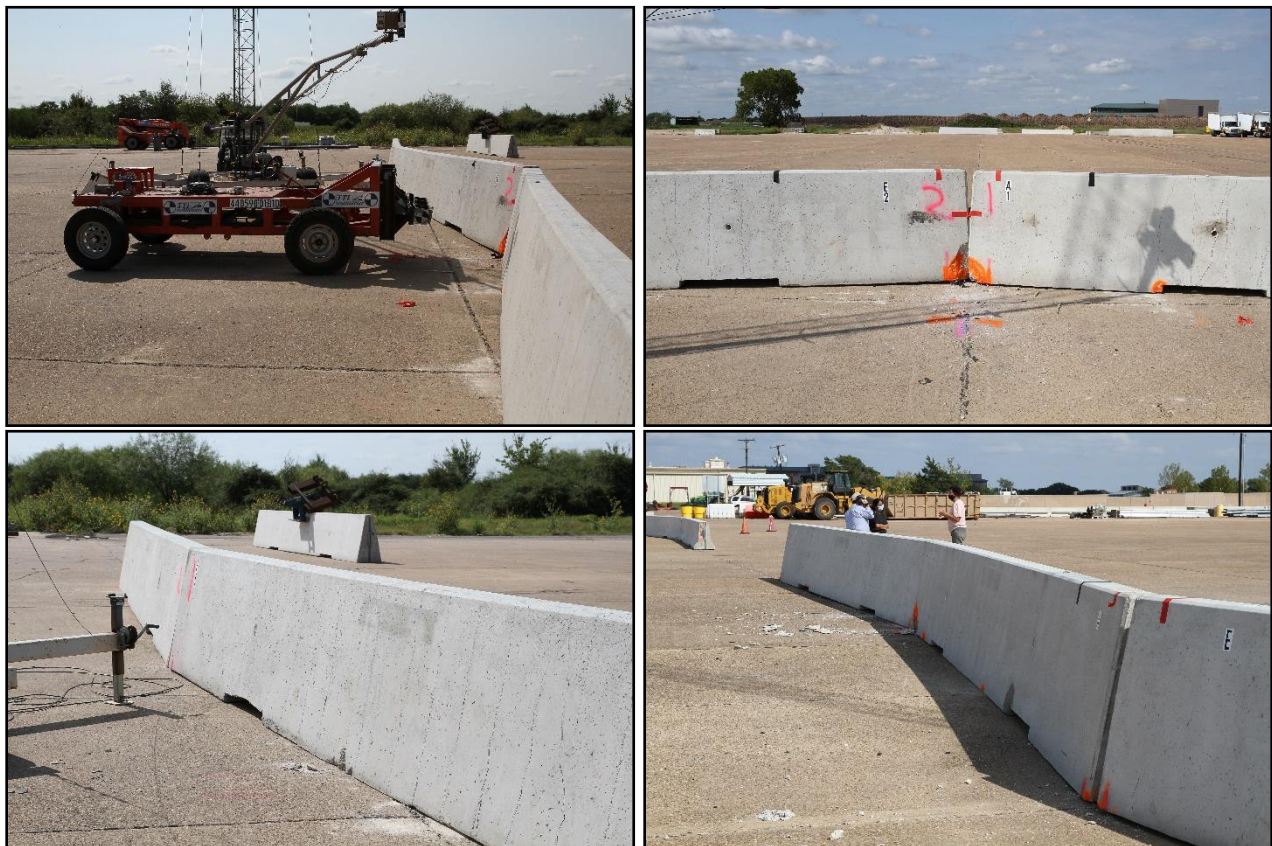
**Figure 5.24. Single-Slope Barrier after Test No. 440591-01-B10.**

Figure 5.24 shows damage to the barrier. The black, blue, red, and green lines indicate existing cracks; orange paint indicates existing spalling; and red lines labeled “-B10” indicate cracks post impact. The left end of barrier D moved ½ inch back and 3½ inches to the right. The joint of barriers D and E moved 4½ inches forward, and the joint of barriers E and A moved 49 inches back. The joint of barriers A and B moved 3½ inches forward, and the right end of barrier B moved 3½ inches left and 1 inch back. At the top of the joint between barriers D and E, there was a 2¾-inch gap in the front and a 2-inch gap in the back. The bottom of the barriers had a 3-inch gap in the front and no gap in the back. At the top of the joint between barriers E and A,

there was a 2¾-inch gap in the front and a 4¾-inch gap in the back. The bottom of the barriers had no gap in the front and a 6¼-inch gap in the back. At the joint between barriers A and B, there was a 2¾-inch gap in the front and a 2-inch gap in the back. The bottom of the barriers had a 2¾-inch gap in the front and no gap in the back. The right end of barrier B moved 3½ inches left and 1 inch back. The front of barrier D had some spalling near the top of the barrier at the joint between barriers D and E. The front of barriers A and B had spalling at the base of the barriers at the joint, and barrier A also had some spalling on the backside of the barrier at its base at the joint between barriers A and B. There was some cracking on barriers A, B, and E. Maximum dynamic deflection during the test was 49.3 inches, and maximum permanent deformation was 49.0 inches.

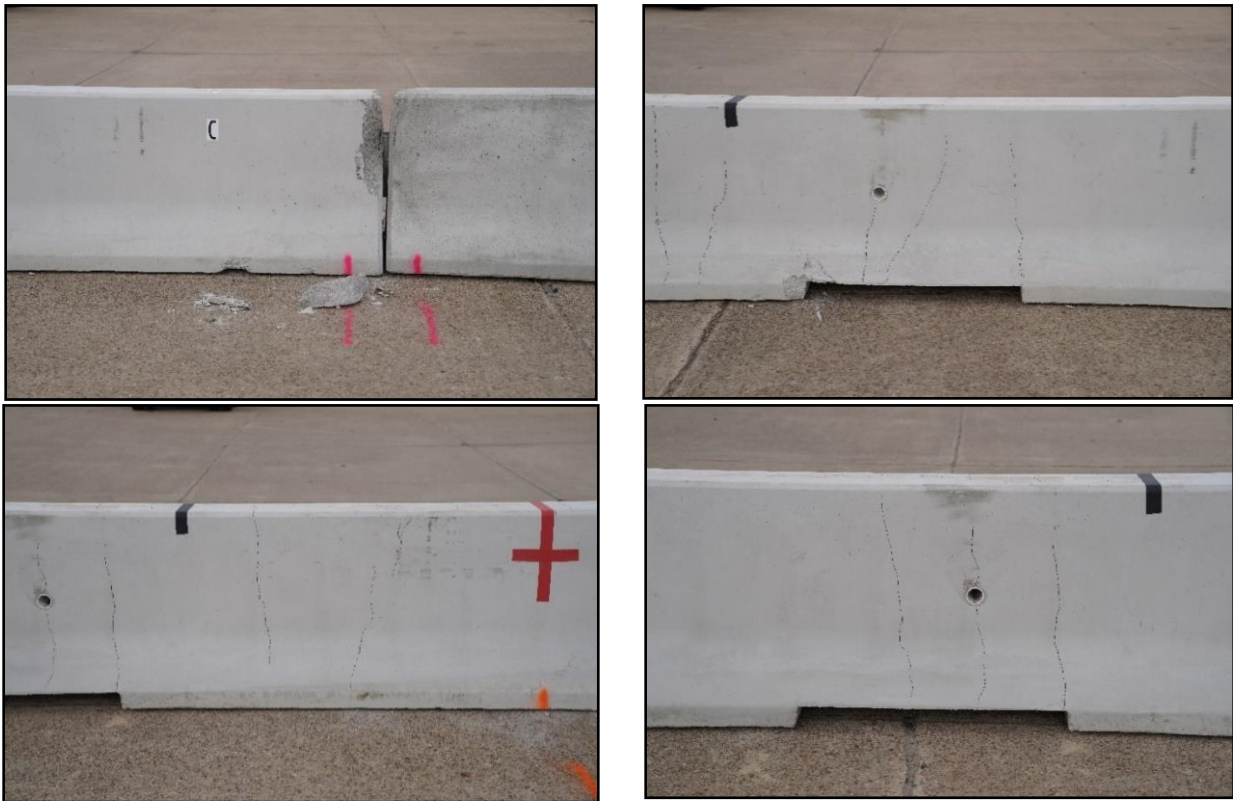
Figure 5.28. F-Shape Barrier after Test No. 440590-01-B3.

Figure 5.28 shows damage to the barrier. The red lines indicate existing cracks, and the black lines indicate the cracks post impact. The larger, more visible cracks were not marked. No movement was noted on either the far left or far right ends of the installation. The joint at barriers A and B moved 2½ inches forward, and the joint at barriers B and C moved 12½ inches back. The joint at barriers C and D moved 14 inches back, and the joint at barriers D and E moved 1 inch forward. Measured from the top of the joints, the gaps between the barriers were as follows: the joint of barriers A and B was 2¼ inches at the front and 2 inches at the back; the joint of barriers B and C was 2 inches at the front and 2½ inches at the back; the joint of barriers C and D was 2 inches at the front, and the back was not measurable due to spalling; and the joint of barriers D and E was 2½ inches at the front and 2 inches at the back. There were cracks at the scuppers of all the barriers. There was exposed rebar on the backside of barrier D at the joint of barriers C and D, and barrier C had some spalled concrete at this joint as well. Barrier D also had major cracking on its base at the middle of the barrier. There was some spalling at the base of barrier E at the joint of barriers D and E. Barrier C had some spalling at various locations along the backside of the barrier, and there was also a ¼-inch crack starting from the inner corner of the right scupper on the backside of the barrier. There was some spalling at the base of barrier B, as well as at the end and left corner of barrier A. Maximum dynamic deflection during the test was 20.2 inches, and maximum permanent deformation was 14.0 inches.

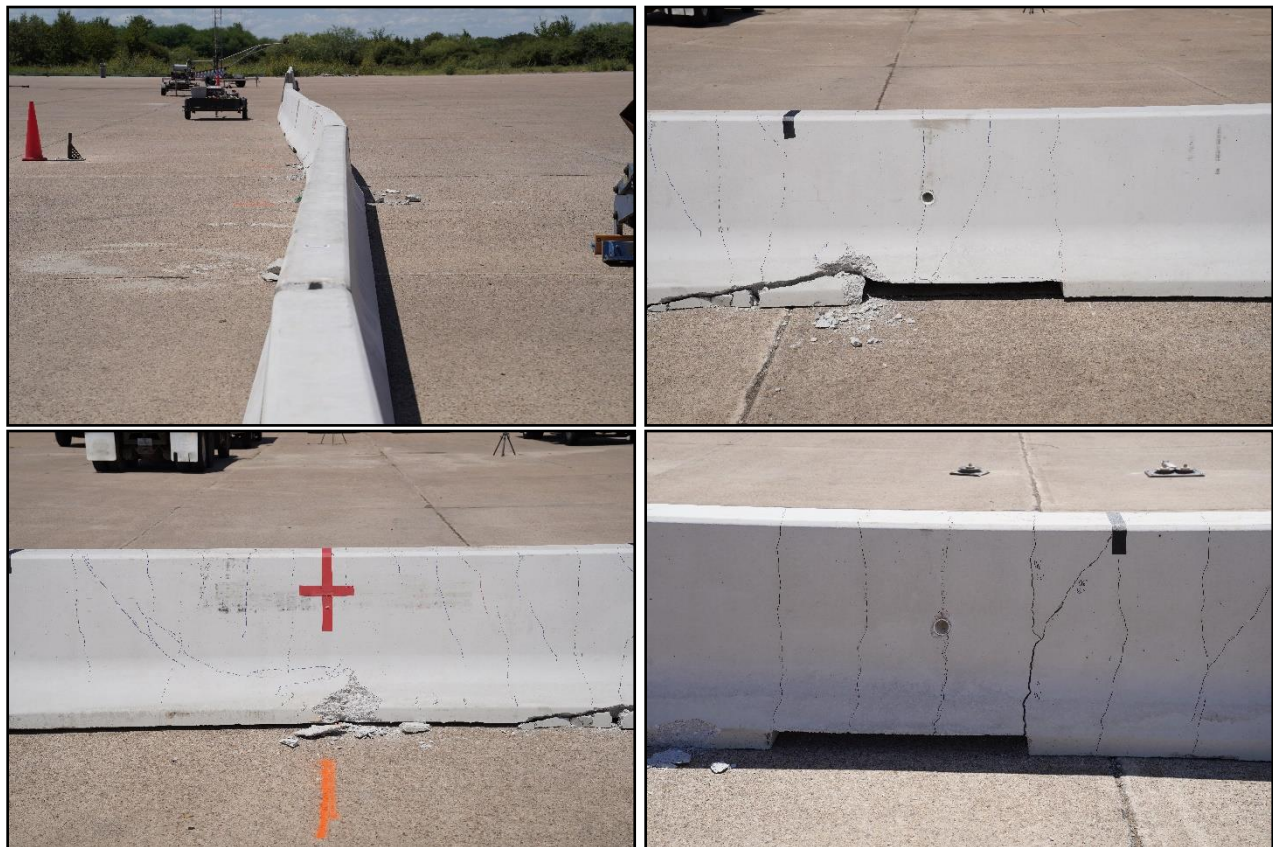
**Figure 5.32. F-Shape Barrier after Test No. 440590-01-B11.**

Figure 5.32 shows the damage to the barrier. The black and red lines indicate existing cracks, and blue lines indicate cracks post impact. Green indicates existing concrete spalling. There was no movement noted on the left end of barrier A. The right end of barrier A moved ½ inch forward, and the left end of barrier B moved ¼ inch forward. The right end of barrier B moved 13 inches back, and the left end of barrier C moved 12½ inches back. The right end of barrier C moved 16½ inches back, and the left end of barrier D moved 14½ inches back. The right end of barrier D and the left end of barrier E moved ½ inch forward. There was no movement noted at the right end of barrier E. Measured from the top of the joints, the gaps between the barriers were as follows: the joint of barriers A and B was 2¼ inches at the front and 2 inches at the back; the

joint of barriers B and C was 2¼ inches at the front and 2 inches at the back; the joint of barriers C and D was 2⅝ inches at the front, and the back was not measurable due to spalling; and the joint at barriers D and E was 2½ inches at the front and 2⅝ inches at the back. There was spalling of the concrete at barrier C on the backside of the barrier at both joints and on the front of the barrier at the joint of barriers C and D. There was also some spalling of the concrete at the base of the barrier at impact. There was some major spalling on the front of barrier C just to the left of the right scupper. There was cracking on the front and backside of barriers C and D, with a ⅛-inch crack on the backside of barrier C widening to ¼ inch. Barrier D had some concrete spalling on the front of the base in the middle. There was also cracking on the backside of barrier E and the front of barriers A and B. Maximum dynamic deflection during the test was 16.6 inches, and maximum permanent deformation was 16.5 inches.

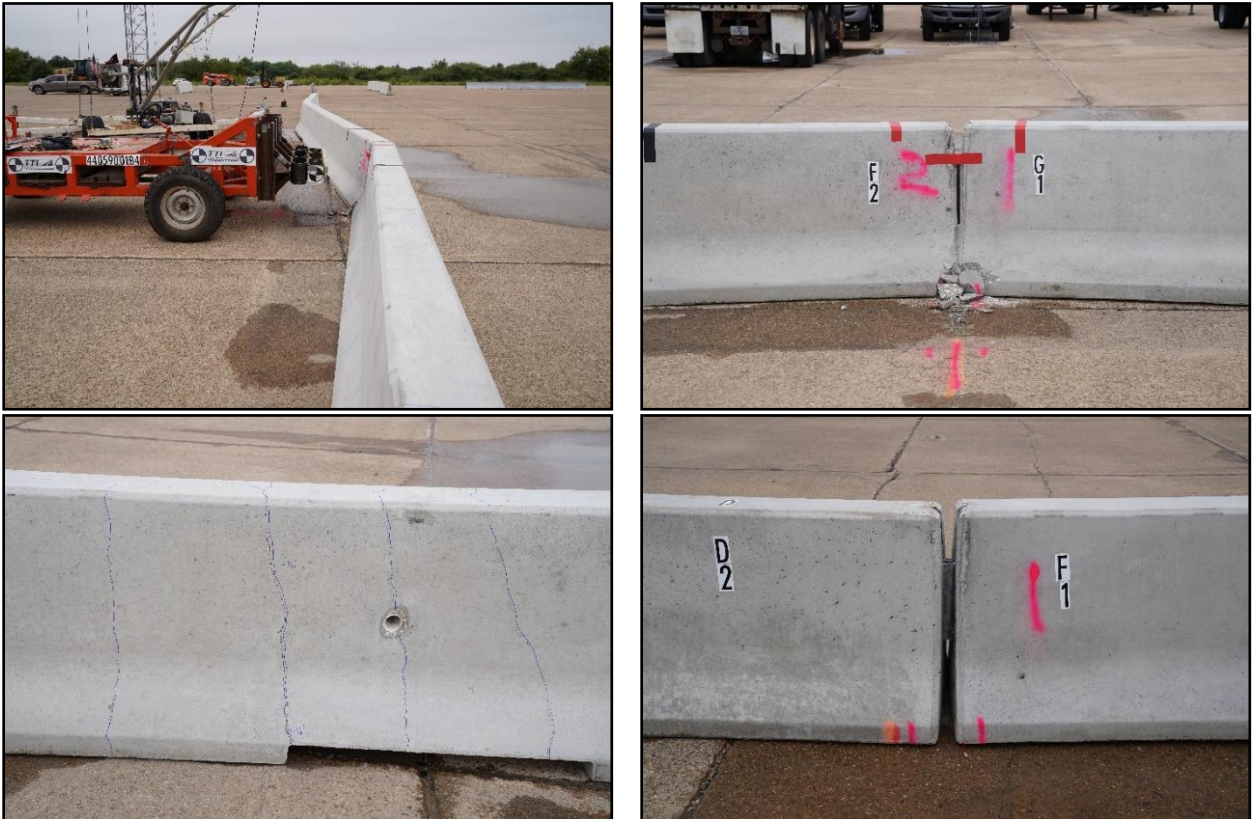
**Figure 5.36. F-Shape Barrier after Test No. 440591-01-B4.**

Figure 5.36 shows damage to the barrier. The black lines indicate existing cracks, and the orange paint indicates existing concrete spalling. The blue lines indicate cracks that occurred post impact. The left end of barrier D moved 4½ inches back. The joint at barriers D and F moved 5 inches forward, and the joint at barriers F and G moved 31 inches back. The joint at barriers G and B moved 3 inches forward, and the right end of barrier B moved 2½ inches back. At the top of the joint between barriers D and F, there was a 3-inch gap in the front and a 2-inch gap in the back. The bottom of the barriers had a 3-inch gap in the front and no gap in the back. At the top of the joint between barriers F and G, there was a 2-inch gap in the front and a 3½-inch gap in the back. The bottom of the barriers had no gap in the front and a 4-inch gap in the back. There was also some spalling at the base of both barriers at the joint. At the top of the joint between barriers G and B, there was a 2½-inch gap in the front and a 1¾-inch gap in the back. The bottom of the barriers had a 2¼-inch gap in the front and no gap in the back. There was some spalling

present on the back base of both barriers at the joint. Barrier F had a  $\frac{1}{16}$ -inch crack on the left end of the right scupper on the front face of the barrier. This crack narrowed as it traveled up the barrier to  $\frac{1}{32}$  of an inch. Maximum dynamic deflection during the test was 31.3 inches, and maximum permanent deformation was 31.0 inches.

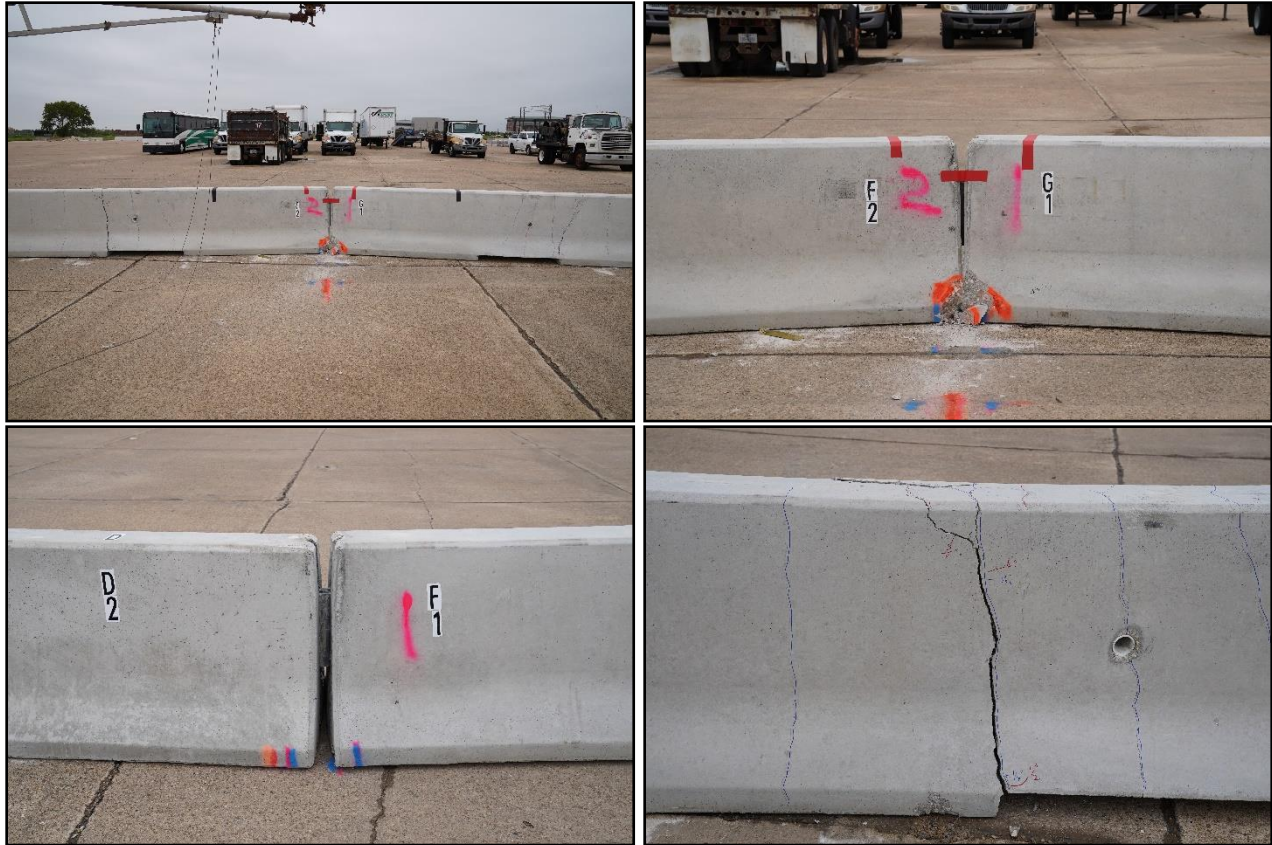
Figure 5.40. F-Shape Barrier after Test No. 440591-01-B12.

Figure 5.40 shows damage to the barrier. The black and blue lines indicate existing cracks, orange paint indicates existing spalling, and red lines indicate cracks post impact. The left end of barrier D moved 2½ inches back. The joint of barriers D and F moved 3¼ inches forward, and the joint of barriers F and G moved 42 inches back. The joint of barriers G and B moved 4 inches forward, and the right end of barrier B moved 3½ inches back. At the top of the joint between barriers D and F, there was a 3-inch gap in the front and a 1⅞-inch gap in the back. The bottom of the barriers had a 3-inch gap in the front and no gap in the back, and there was some spalling on the base of both barriers on the backside at the joint. At the top of the joint between barriers F and G, there was a 2¼-inch gap in the front and a 4-inch gap in the back. The bottom of the barriers had no gap in the front and a 5½-inch gap in the back. The JJ hooks at this joint were deformed, and there was also some spalling on the base of both barriers on the front of the joint. There were cracks on both the front and backside of barriers F and G. Barrier G had a ¼-inch crack on the front face of the barrier on the right end of the left scupper that narrowed to ⅛ inch at the top. Barrier F had an existing 1/16-inch crack on the front face of the barrier on the left end of the right scupper, which widened to ½ inch at the base and then narrowed to ¼ inch at the top. Barrier G had some more spalling at the left rear scupper, and barrier F had more spalling at the right rear scupper. At the top of the joint of barriers G and B, there was a 3-inch gap in the front and a 2-inch gap in the back. The bottom of the barrier had a 3-inch gap in the front and no gap in the back. There was some spalling at the base of both barriers on the backside at the joint. Maximum dynamic deflection during the test was 42.2 inches, and maximum permanent deformation was 42.0 inches.

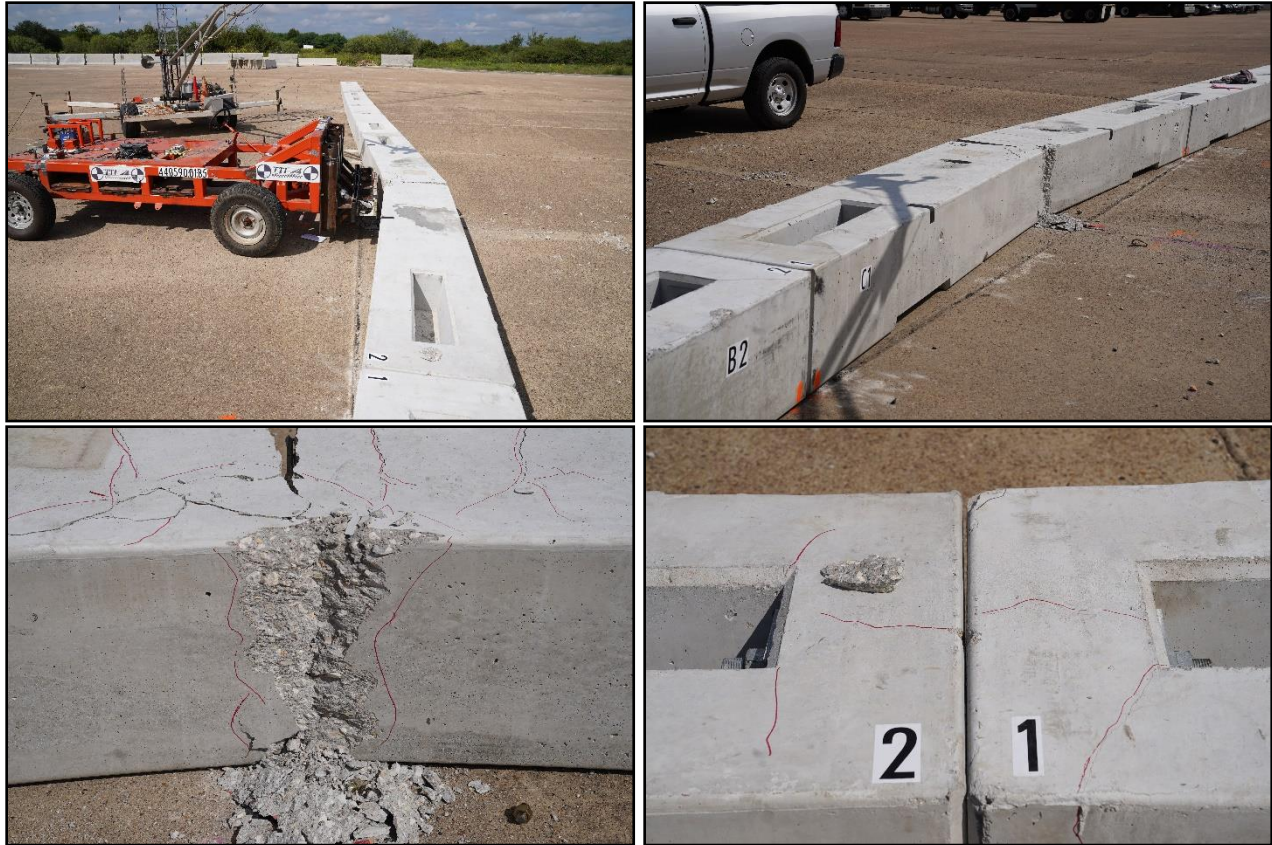
**Figure 6.3. Low-Profile Barrier after Test No. 440591-01-B5.**

Figure 6.3 shows damage to the installation. The black lines indicate existing cracks, and the red lines indicate cracks post impact. The left end of barrier A moved 13 inches forward, and the joint of barriers A and B moved 2 inches to the right and 2½ inches back. The joint of barriers B and C moved 25 inches back and 1 inch to the right. The joint of barriers C and D moved 27½ inches back, and the joint of barriers D and E moved 7 inches back. The right end of barrier E moved 12 inches forward. Maximum dynamic deflection during the test was 36.7 inches, and maximum permanent deformation was 35.0 inches.
