# Development of Guidelines for Inspection, Repair, and Use of Portable Concrete Barriers—Volume 1: Technical Report

Technical Report 0-7059-R1-Vol1

TEXAS A&M TRANSPORTATION INSTITUTE  
COLLEGE STATION, TEXAS

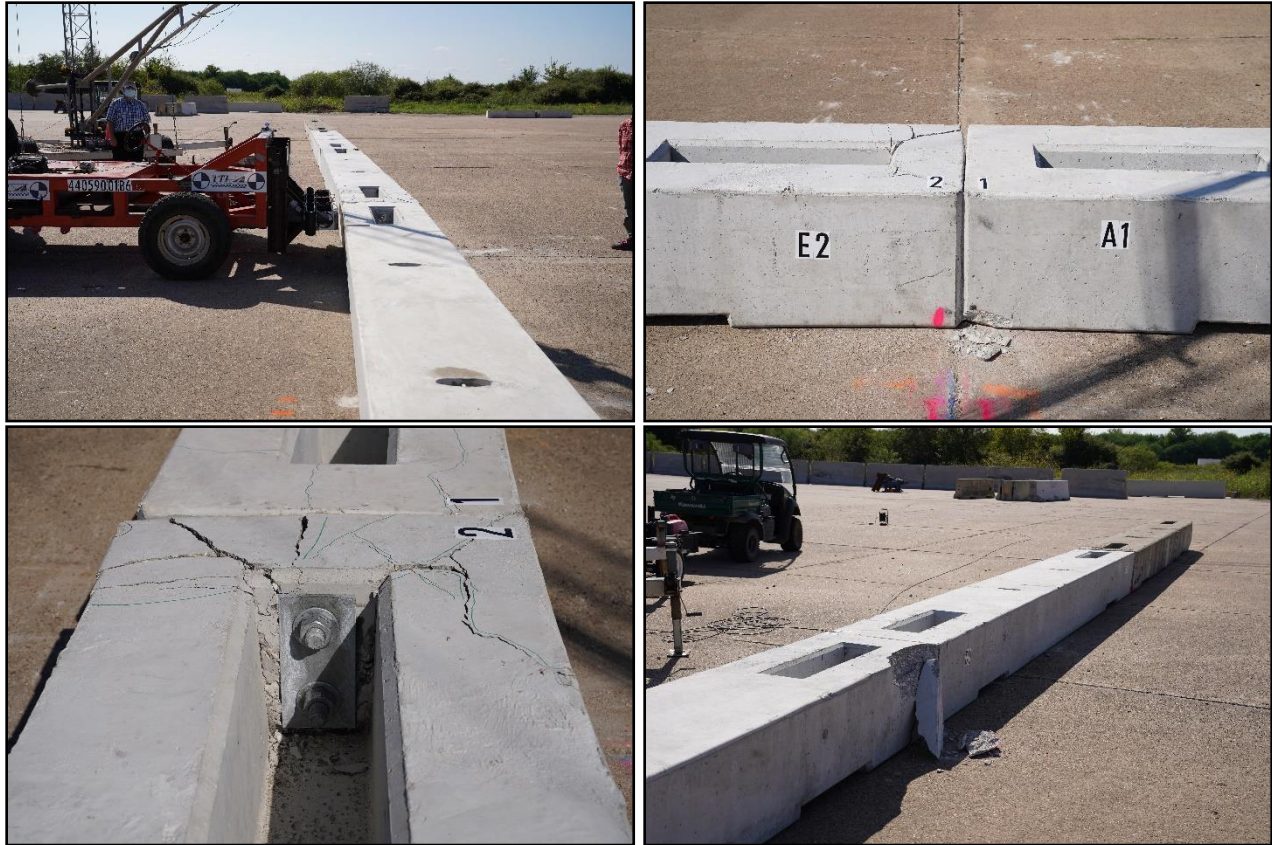
**Figure 6.7. Low-Profile Barrier after Test No. 440591-01-B6.**

Figure 6.7 shows damage to the installation. The black and red lines indicate existing cracks, and the green lines indicate cracks post impact. The left end of barrier F moved 7 inches forward, and the joint of barriers F and D moved 1½ inches back. The joint of barriers D and E moved 8½ inches back, and the joint of barriers E and A moved 14 inches back. The joint of barriers A and B moved 9 inches back, and the joint of barriers B and G moved 2½ inches back. The right end of barrier G moved 4 inches forward. The protected left top corner of barrier E spalled off and exposed rebar. Maximum dynamic deflection during the test was 15.4 inches, and maximum permanent deformation was 14.0 inches.

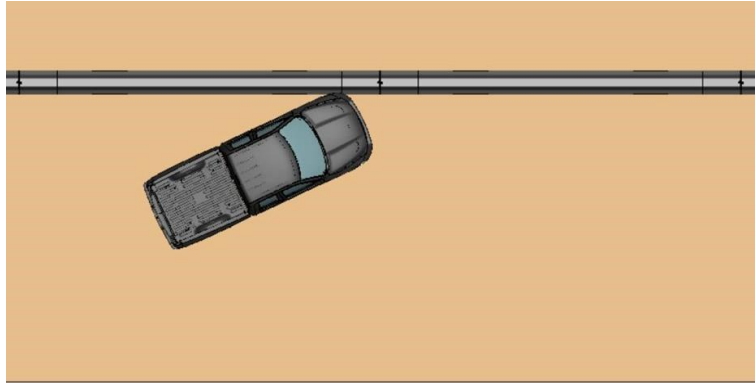
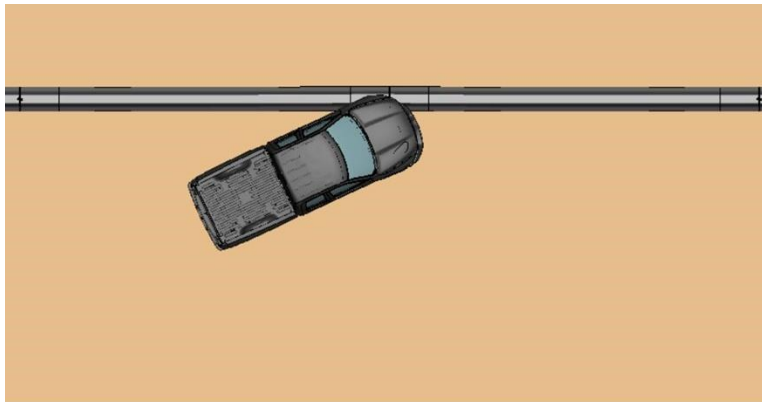
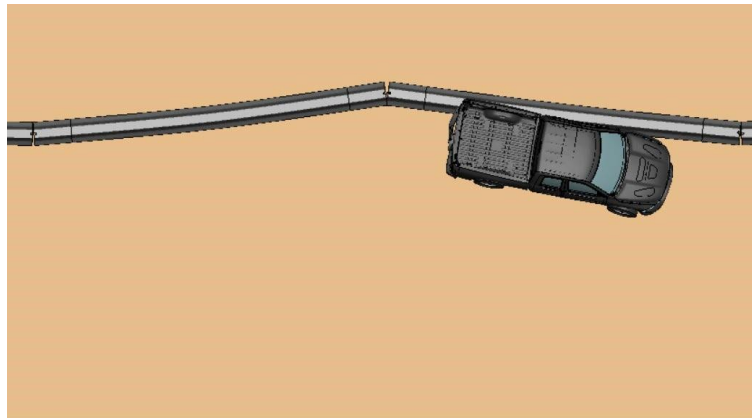
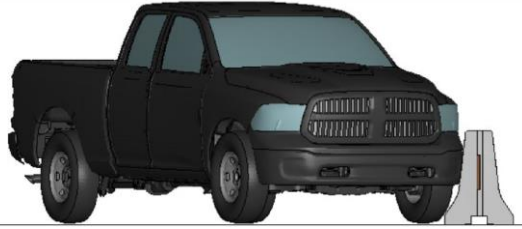
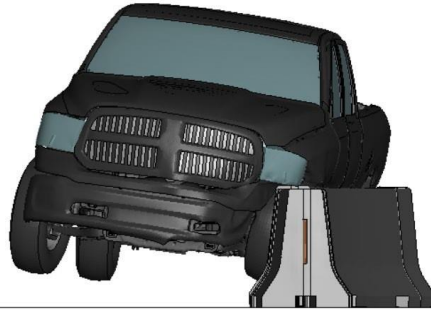
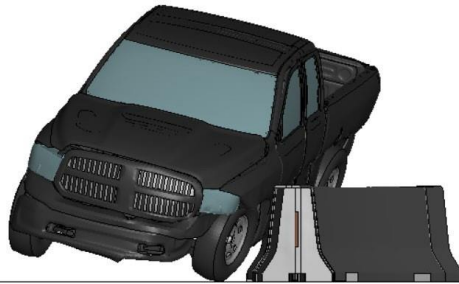
**Figure 7.10. Truck–F-Shape Barrier Interaction through Various Stages.**

Figure 7.11 illustrates the post-impact trajectory of the truck. Lateral displacement of the impacted barrier was 55 inches. TRAP analysis was performed to calculate OIV, RA, and yaw, pitch, and roll. Table 7.7 summarizes the results from TRAP.

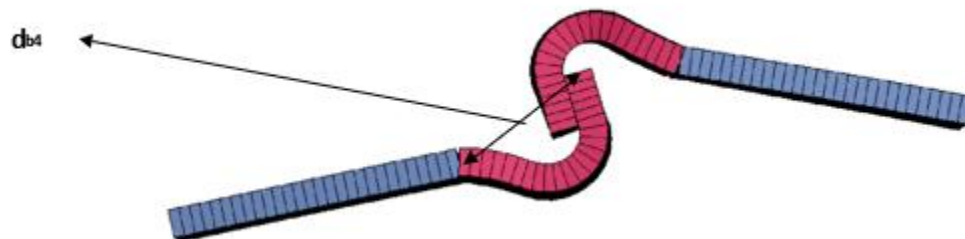
When the barrier system with pre-deformed JJ hook connectors shown in Figure 7.18 was impacted by the RAM pickup truck, the JJ hook connectors opened to a maximum distance of 52.4 mm. Figure 7.19 shows the resulting deformation in the JJ hook connectors.

**Figure 7.19. Pre-deformed JJ Hook Connectors with  $d_{b1} = 35.8$  mm Open to  $d_{b4} = 52.4$  mm and Rotation Angle Increased from 16.4 deg.**

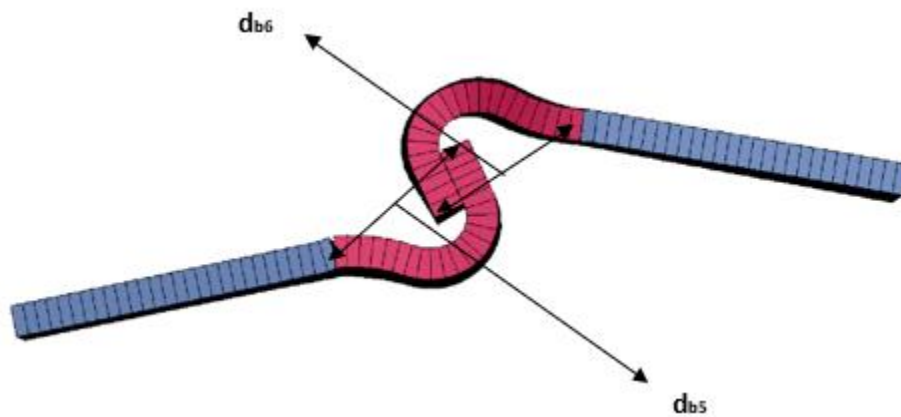
**Figure 7.21. Pre-deformed JJ Hook Open to  $d_{b5} = 50.5$  mm; Originally Undeformed Hook Open to  $d_{b6} = 50.0$  mm.**

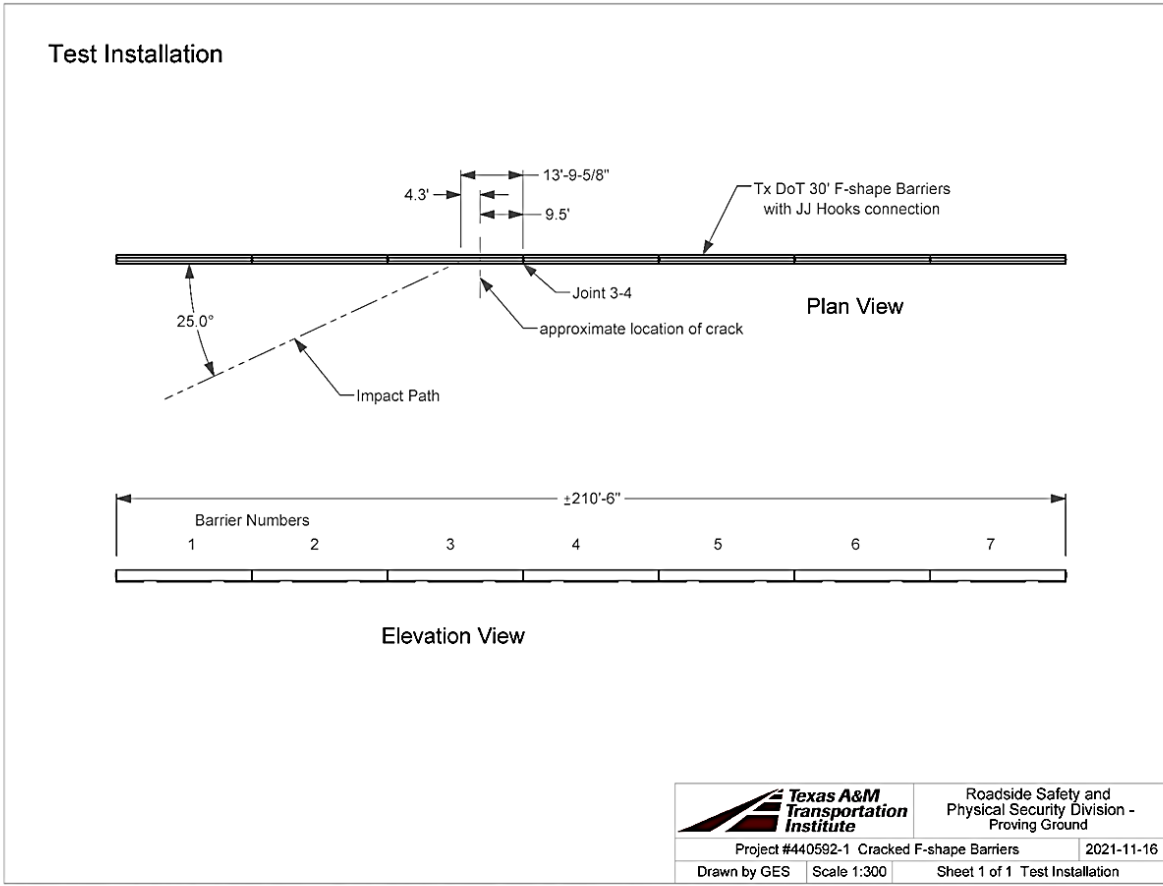
**Figure 8.3. Test Installation Layout for Test No. 440592-1.**

Specifically, the test installation for Test No. 440592-1 included a barrier segment (segment 3) that was selected due to a large 6-mm wide crack located on the field side of the installation that ran vertically 246 inches downstream from the joint of barriers 2 and 3. The downstream JJ hook on barrier 2 was bent 8 degrees. The upstream JJ hook on barrier 3 was not damaged, and the downstream JJ hook was bent 12 degrees. The upstream JJ hook on barrier 4 was not damaged.

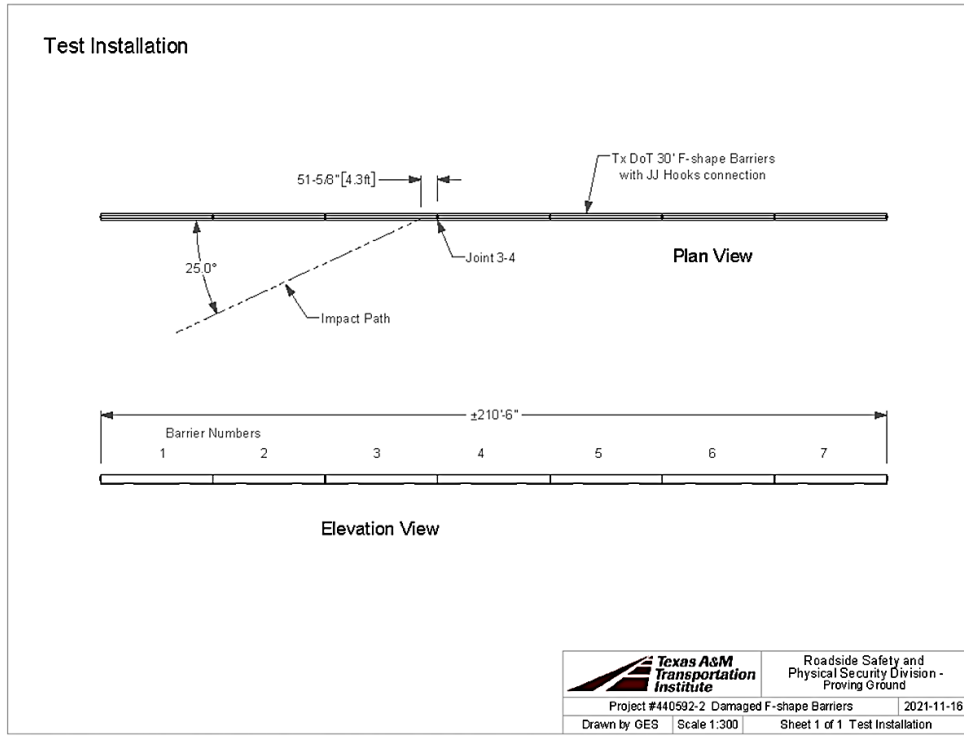
Figure 8.4. Test Installation Layout for Test No. 440592-2.

For the Test No. 440592-2 test installation, spalling was manufactured by TTI personnel on the traffic side toe of barriers 3 and 4 at their joint. Each had a spall measuring approximately 3¾ inches wide by 13 inches high by 2 inches deep. At the same joint on the field side, the toe of barrier 4 was intentionally spalled and measured approximately 24 inches wide by 5 inches high by 2 inches deep. The JJ hooks at the joint of barriers 2 and 3 were not damaged. The downstream JJ hook on barrier 3 was bent 19 degrees, and the upstream JJ hook of barrier 4 was bent 15 degrees.

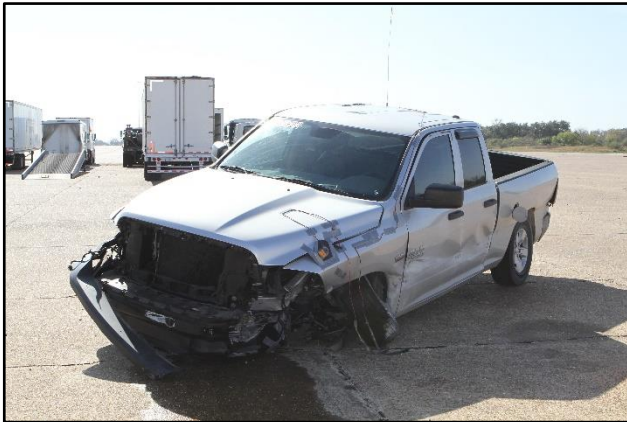
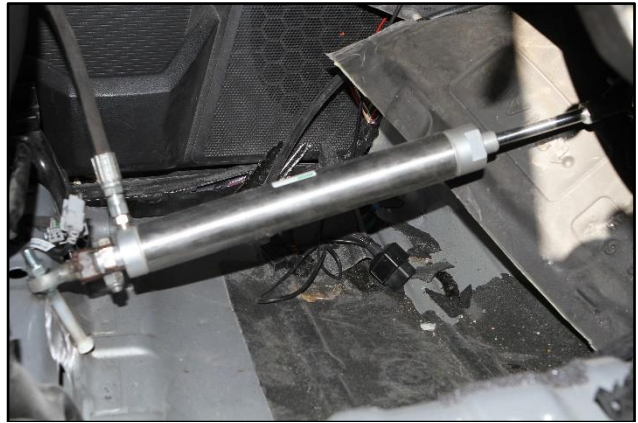
| <b>Description of Damage to Vehicle:</b> | The front bumper, hood, grill, left headlight, left front tire and rim, left front upper and lower control arms, left tire rod, left front quarter fender, left front door, left front toe panel, left rear door, left rear cab corner, left rear quarter fender, left rear taillight, and rear bumper were damaged. |

**Figure 8.12. Vehicle after Test No. 440592-2.**

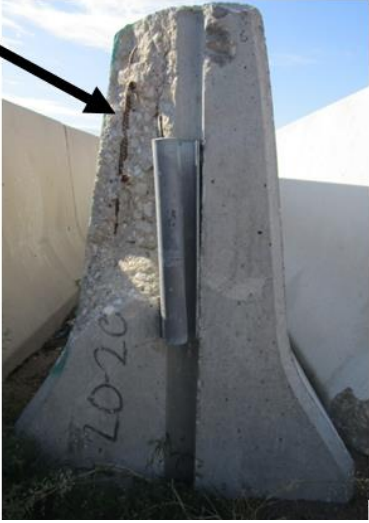
| Example | Image and Description |
|---|--|
| <p>B-1</p> | <p>Spall at barrier end exposing reinforcement. Corrosion is superficial. Barrier is acceptable with repair.</p> |

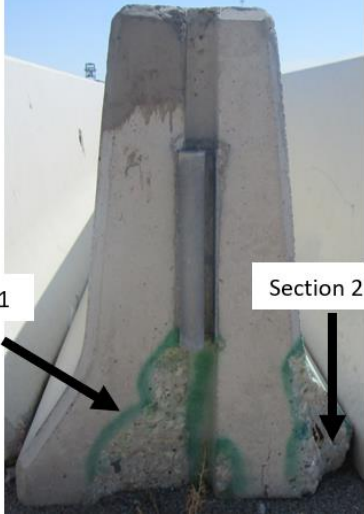
| Example | Image and Description |
|---|--|
| <p>B-2</p> | <p>Multiple spalls present at barrier end. Spall 1 does not expose reinforcement and is acceptable. Spall 2 exposes rebar with superficial corrosion. Barrier acceptable if Spall 2 is repaired.</p> |

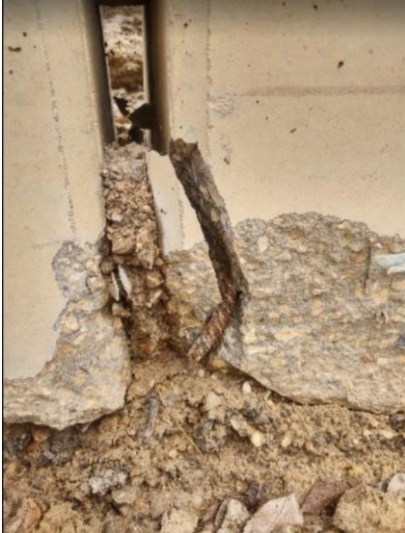
| Example | Image and Description |
|---|--|
| B-4 | <p data-bbox="548 1455 1414 1524">Spall at barrier end exposing slightly bent reinforcement. Corrosion is superficial. Barrier acceptable with repair.</p> |
