20th European Conference on Fracture (ECF20)

## Material characterization of the main steam gate valve made of X20CrMoV 12.1 steel after long term service

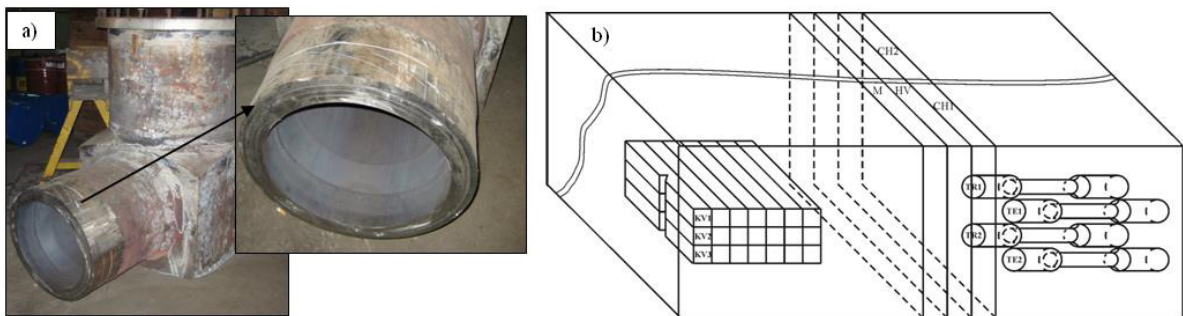
Fig. 1. (a) Main steam gate valve and sampling zone on connected pipe in vicinity of welded joint; (b) Scheme of sampling.
