ECF22 - Loading and Environmental effects on Structural Integrity

Structural integrity of butt welded connection after fire exposure

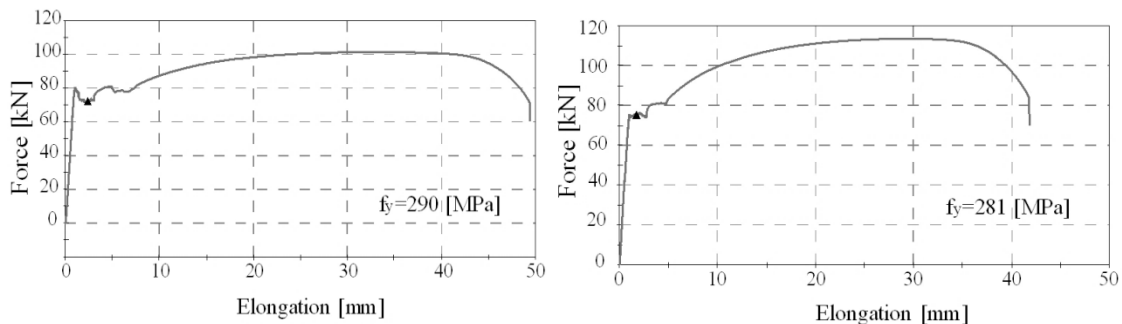
The test results on the base material (BM) was concluded that steel has a yield strength of above 300 MPa. The base material is the one sampled from the steel structure exposed to flames during the fire and damaged by the abrupt changes of temperature. The ductility of the base steel from the sampled specimens is beyond the normal limit (figure 3). The ductility at the material level it is expressed through the following requirements: the relation between the ultimate strength " f_u " and the minimum yield strength " f_y " to be at least equal with 1,20 and the elongation at the failure to be at least equal with 20%.

Fig. 3. Diagram force-elongation for base material steel

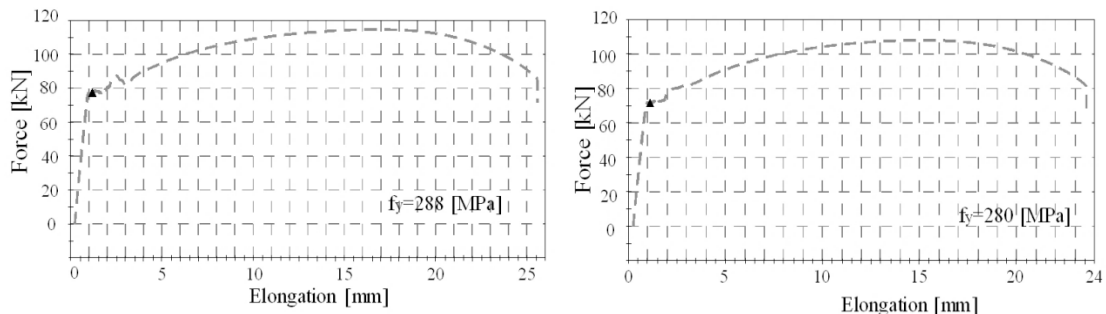
The results obtained on the butt weld joints have shown that the yield limit doesn't change significantly, but the elongation specific between the flowing limit and the breaking limit decreases in the case of welded elements (figure 4). During the cycle of heating-cooling at welding, the thermic source travels at a constant speed to the welding direction, which leads to the displacement of the welding bath, and respectively of the solidification front along with the thermic source. In the area of the welded seam, there are taking place a series of transformations and physico-chemical reactions depending on the temperature of the carbon steels [11].

Fig. 4. Diagram force-elongation for butt welded connections

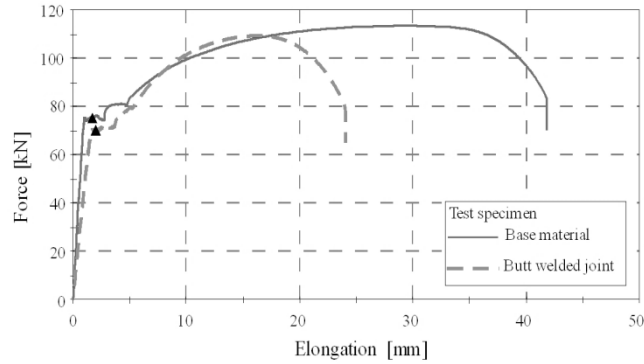
Following the base material tests results, can be concluded that the yield strength of steel does not change significantly as a result of the fire. However, in case of welded joints the material ductility decreases significantly. The ductility at the material by the welded decreases with approximate 28% (figure 5).

Fig. 5. Force-elongation curves for structural steel and butt welded joint
