CHRONOLOGY OF LOST STRUCTURAL INTEGRITY INITIATED FROM MANUFACTURING DEFECTS IN WELDED STRUCTURES

Originalni naučni rad / Original scientific paper

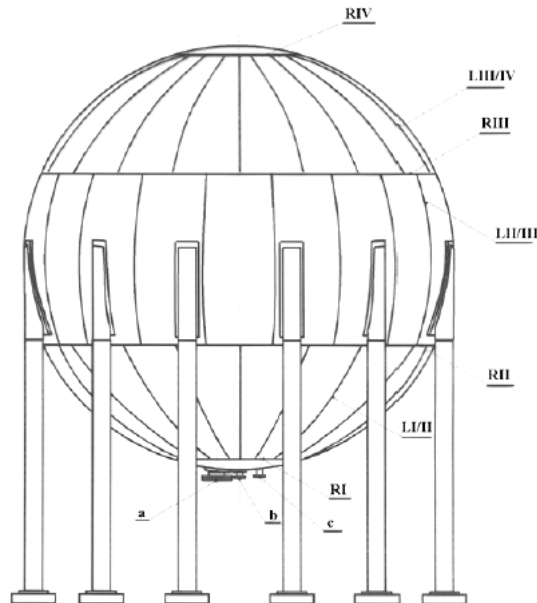
Figure 10. Spherical storage tank.
Slika 10. Sferni rezervoar

During regular inspection of spherical tanks for storage of vinyl chloride monomer (VCM), volume 2000 m³, introduced in 1977, a great number of cracks of different directions and sizes (Fig. 14, Tables 4 and 5) were detected by NDT in 1986-90 and in 1996 on inner wall side, in welded joint regions, /11/. In three cases, the cracks were detected in the parent metal, and their origin is probably the tack welding of temporary holders during sphere assembly. In some cases during grinding it was confirmed that the crack ends in the pore or the inclusion, involved in the manufacture. In all tested spheres, cracks most frequently occurred in radial welded joints (R, Fig. 10), typically in its middle (upper) part, at the liquid and gas phase border.

This is confirmed by magnetic particle test before and after cold water proof test on joints R-I and R-III (Fig. 10) and on adjacent vertical joints, where new cracks were found on the old parts of joints, e.g. on welded joint part that was not repaired by welding. Cracks were detected in longitudinal joint L-17 close to R-III joint, inside the notch induced during repair of cracks by grinding in the year 1991, as well as cracks in HAZ on joint L-12 close to R-I, not existing before proof test. On 6 of 10 detected locations, the crack is located inside the notch produced by repair in the year 1991.
