DETERMINATION OF DAMAGE AND REPAIR METHODOLOGY FOR THE RUNNER MANHOLE OF KAPLAN TURBINE AT THE HYDRO POWER PLANT 'DJERDAP 1'

Originalni naučni rad / Original scientific paper

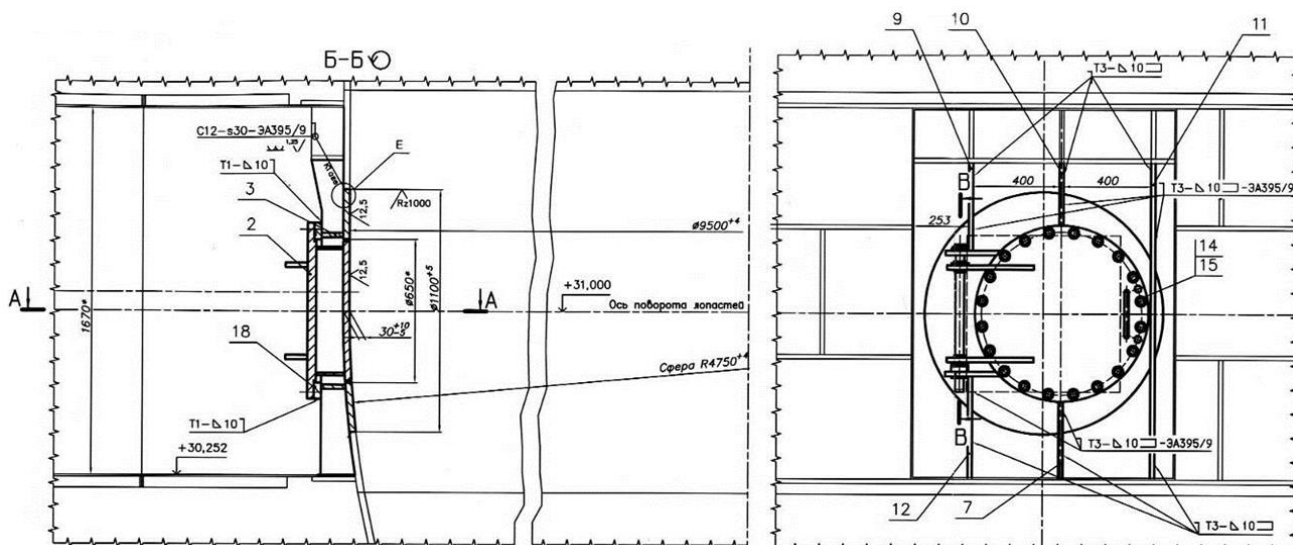
Figure 2. Drawing of the Kaplan turbine runner manhole, as part of the hydroelectric generating set A4 at hydro power plant 'Djerdap 1'.

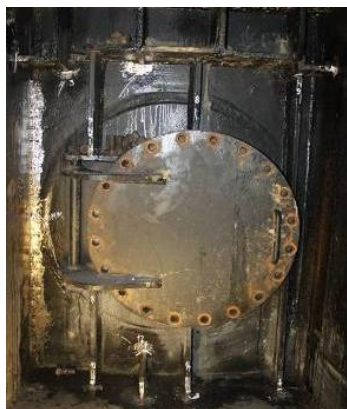
Figure 3. Kaplan turbine runner manhole as part of the hydroelectric generating set A4.

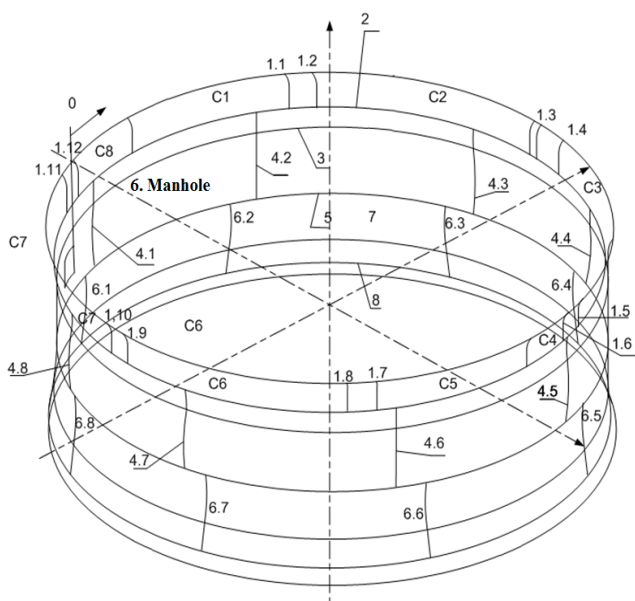
A segment of the flow tract in the manhole area is presented in Fig. 4 (numbers and letters mark the elements and welded joints at the manhole), while areas in which the water leaking occurs are shown in Fig. 5. Some of the characteristic spots in the parent material and welded joints of the manhole where damages occur, detected by visual inspection /3/, are shown in Figs. 6 and 7.

Figure 4. Appearance of a segment of the flow tract in the manhole area.
