## REPAIR WELDING OF PRESSURE EQUIPMENT WITH UNACCEPTABLE DEFECTS REPARATURA ZAVARIVANJEM NA OPREMI POD PRITISKOM SA NEPRIHVATLJIVIM GREŠKAMA

*The paper describes non-destructive testing and the repair welding technology for eliminating defects in the pressure equipment of RHE BB (Bajina Bašta) (located in Serbia). The obtained results had justified the proposed technology.*

### INSPECTION OF PRESSURE VESSEL 977

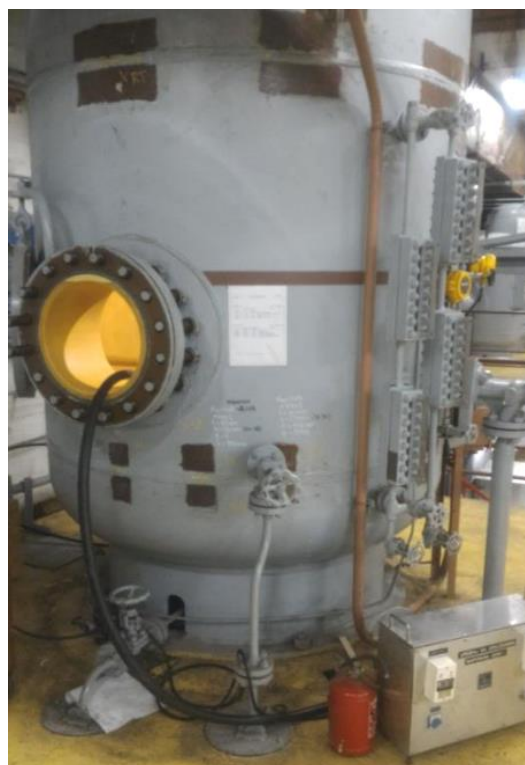
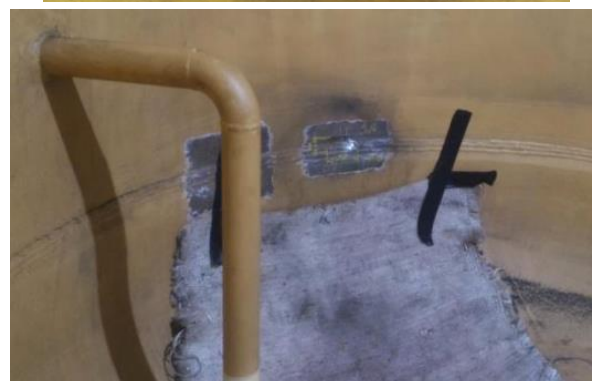
in order to be performed properly and not to impair the structural integrity. Prior to repair welding, the workspace must be prepared first, both for safety and technology, as shown in Fig. 4.

Figure 4. Working environment before repair welding.

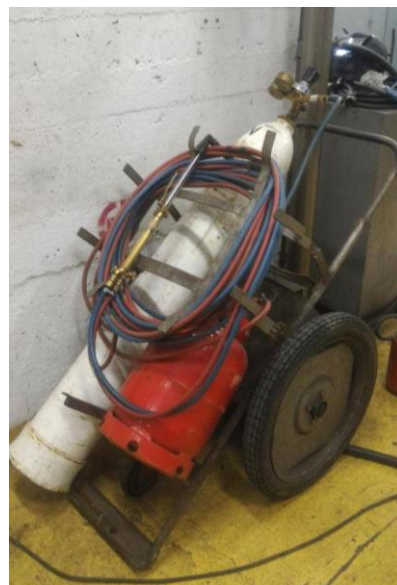
Figure 8. Preheating equipment.

Electrodes are dried at 300-350 °C for approx. 2 hours. Before the start of welding, the base material is preheated to a temperature of 200 °C. Preheating is performed with a gas flame on the outside surface of the vessel, Fig. 7, using equipment shown in Fig. 8. During preheating, the temperature is measured from the inside with a contact thermometer shown in Fig. 9. Prior to the welding itself, performed by the device in Fig. 10, the welder created a pair of test passes as shown in Fig. 11.

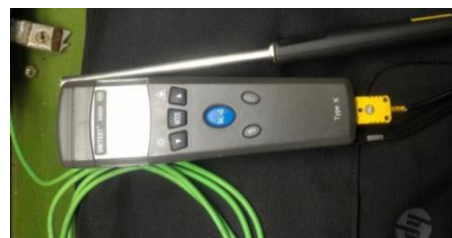
Figure 9. The contact thermometer.

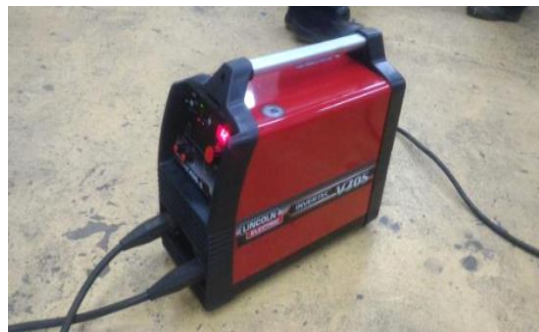
Figure 10. Welding device.

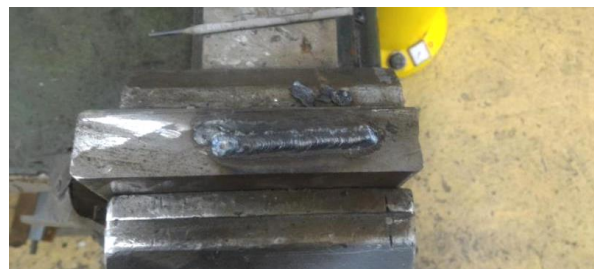
Figure 11. Welded test passes.

After creating the groove, the preheating procedure and the welded test passes, the welding process is carried out according to defined procedure (WPS), using the shielded manual arc welding (SMAW) technique. Figures 12 and 13 show the weld repaired inner and outer zone of the vessel.
