Snail Trails and Cell Microcrack Impact on PV Module Maximum Power and Energy Production

Index Terms—Electroluminescence (EL), microcracks, photovoltaic (PV) modules, PV system reliability, snail trail phenomena.

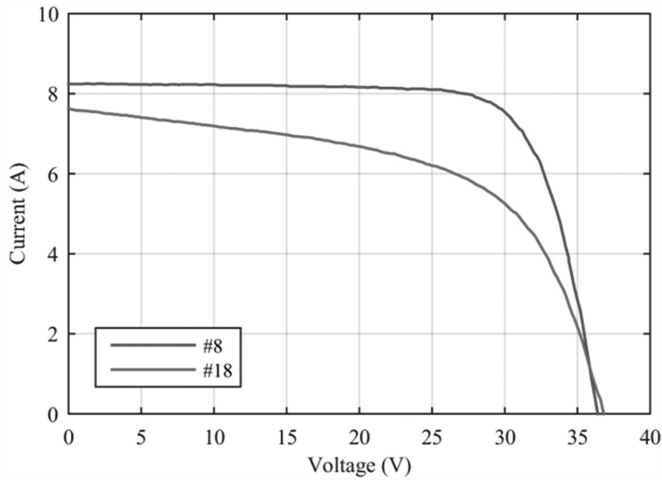
Fig. 2. Measured I - V curves of PV modules without major visual defects (#8) and with several snail trails (#18).

In Fig. 2, the measured I - V curves of two PV modules #8 and #18 are reported. The two curves show significant differences in the MPP, as well as resistance values: the shunt and series resistances in the equivalent electric circuit derived for the PV module #8 are 332.8Ω , respectively, 0.4Ω . For the PV module #18, the shunt resistance reduces to 23.6Ω and the series resistance increases to 0.8Ω . This is in agreement with the results reported in [17]. The same trend was outlined also for all the other modules affected by microcracks, but the graphs are not reported here for the sake of brevity.

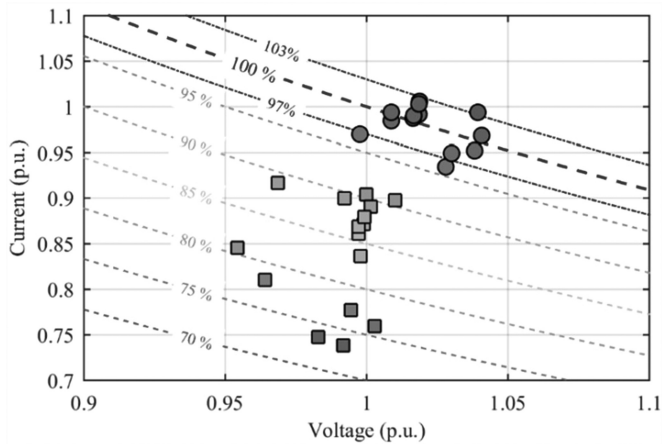
Fig. 3. MPP of the PV modules under analysis (except the one affected by diode failure) measured at STC in comparison with datasheet value (100%).

value below the nominal power; the reduction ranges from -9% to -27% with respect to the nominal power available from the datasheet.¹ In particular, a decay of the current at MPP can be outlined, while the I_{SC} and voltages are only marginally affected.

Fig. 3 summarizes the voltage and current at MPP referred to the values indicated on the datasheet of the PV module.

The dashed lines are percentages of the maximum power. The modules not affected by snail trails are between or close to the blue-dashed lines, which represent the nominal power output $\pm 3\%$ of tolerance. Modules with snail trails have power output ranging from 75% to 90% of the nominal ones, which is mainly due to current density reduction.

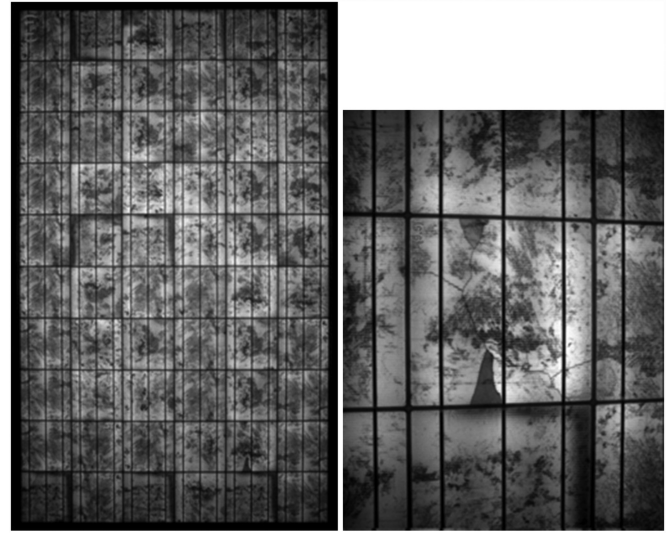
The last indoor test was the EL which was performed on all the modules. As a term of comparison, the EL image of a PV module without visual defects (#14) is reported in Fig. 4.

Fig. 4. EL image of PV modules #14.

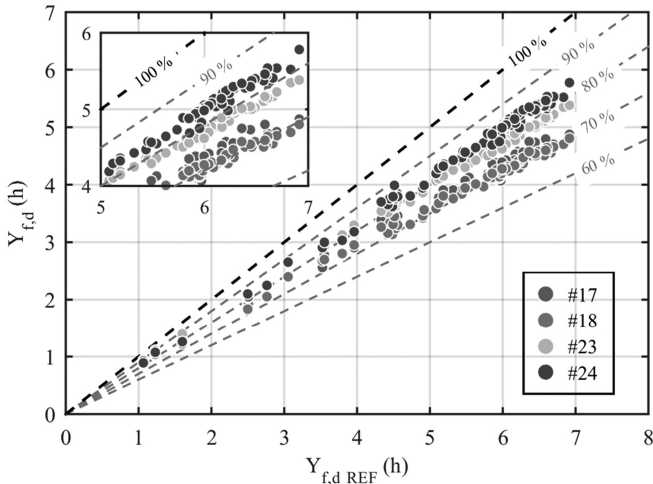
290 The energy produced by the PV modules in the period from April 2015 to August 2015 was recorded to quantify the influence
 291 of snail trails/cracks in terms of daily and total energy within the conducted test period. The daily energy generation—
 292 in terms of final yield ($Y_{f,d}$)—by PV modules referred to the final yield of REFPV module ($Y_{f,d,REF}$) is summarized in Fig. 7.
 293 The energy generation of the REFPV module, in terms of equivalent hours at peak power, is the black-dashed line.

Fig. 7. Daily final yield of the PV modules #17, 18, 23, and 24 in the period April 2015–August 2015 referred to the daily final yield of the reference PV modules.

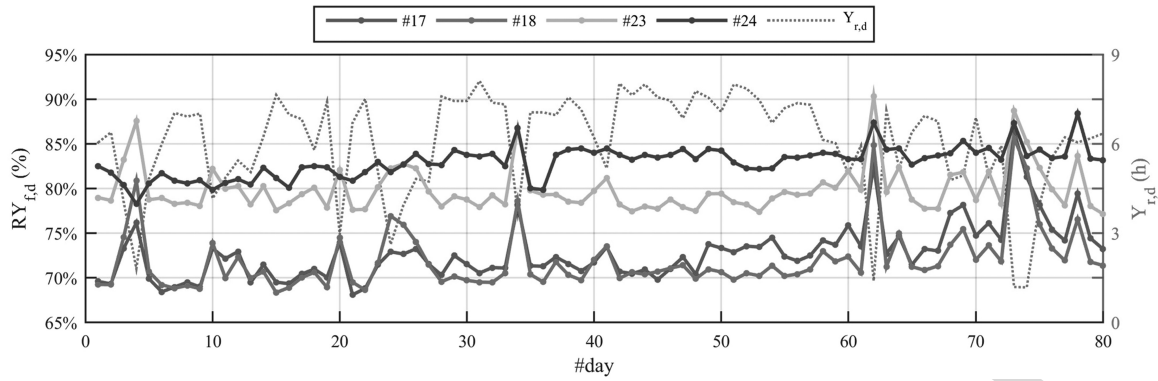
315 Fig. 8 illustrates the variation of relative daily final yield index ($RY_{f,d}$) for the four affected PV modules (#17, #18, #23,
 316 and #24) for each measured day. As illustrated in Fig. 8, the performance decay is higher during high solar radiation days
 317 characterized by high $Y_{r,d}$. Table II summarizes the final yield and relative final yield for the different months and the entire
 318 period of analysis. It is important to underline that the numbers of days in which the data are available are different for each
 319 month. PV modules #17 and #18 presents the highest reduction in energy production by about 30% than the REFPV module.
 320 Modules #23 and #24 show a lower energy reduction: they produce about 20% less in term of energy than the REFPV. These
 321 results are similar to the ones obtained by the maximum power tests. Besides diverse measurement accuracies and references

Fig. 8. Relative daily final yield index of the four PV affected modules #17, #18, #23, and #24 for 80 days in the period of analysis. The daily reference yield index for the same days has been reported on the secondary y-axes.

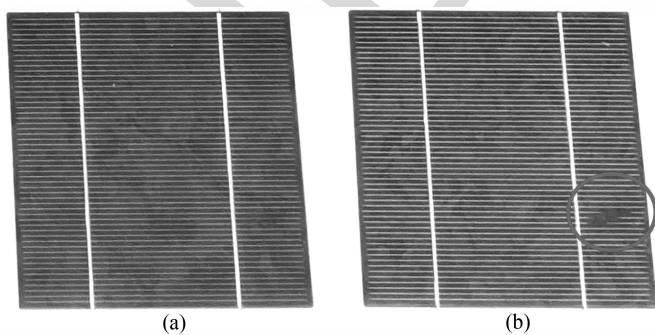
332 Furthermore, a comparison in terms of visual images was performed. The PV cell visual inspection outlined only minor variations from 2013 to 2015. In general, only one or two cells in each PV module showed new snail trails, affecting a very limited area of the PV cell. This can be seen in Fig. 9, where in 2015, a small defect, which was not present in 2013, has appeared in the bottom right area of the PV cell.

Fig. 9. Comparison among the state of the same PV cell. (a) year 2013 and (b) year 2015.
