FLANGE BOLT FAILURE ANALYSIS

Tarun Goswami

ABSTRACT

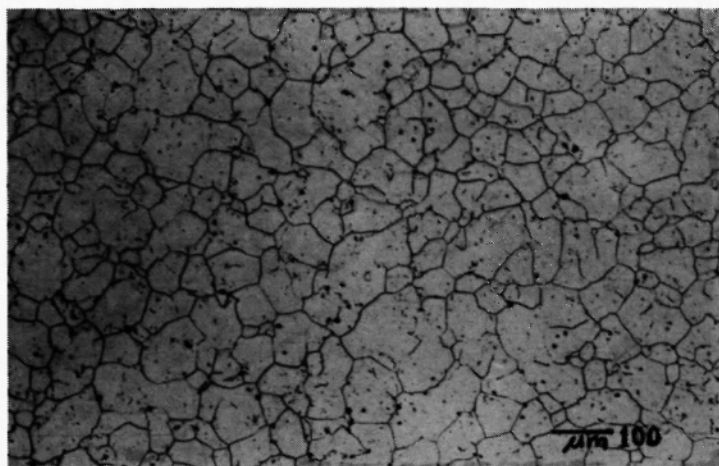
Details of solution heat treatment parameters, chemical composition and mechanical properties of Nimonic 75A have been tabulated in Tables 1-3. Bolts were made from a bar stock 16 mm in diameter. Microstructure of this bar stock is shown in Figure 2.

Fig. 2: Microstructure of Nimonic 75A (magnification 90X).
