### Humboldt Bay Independent Spent Fuel Storage Installation: Site-Specific License Renewal Application

Humboldt Bay  
Independent Spent Fuel Storage Installation  
**Site-Specific License Renewal Application**

Pacific Gas and Electric Company

Revision 0 July 2018  
NRC Docket No. 72-27

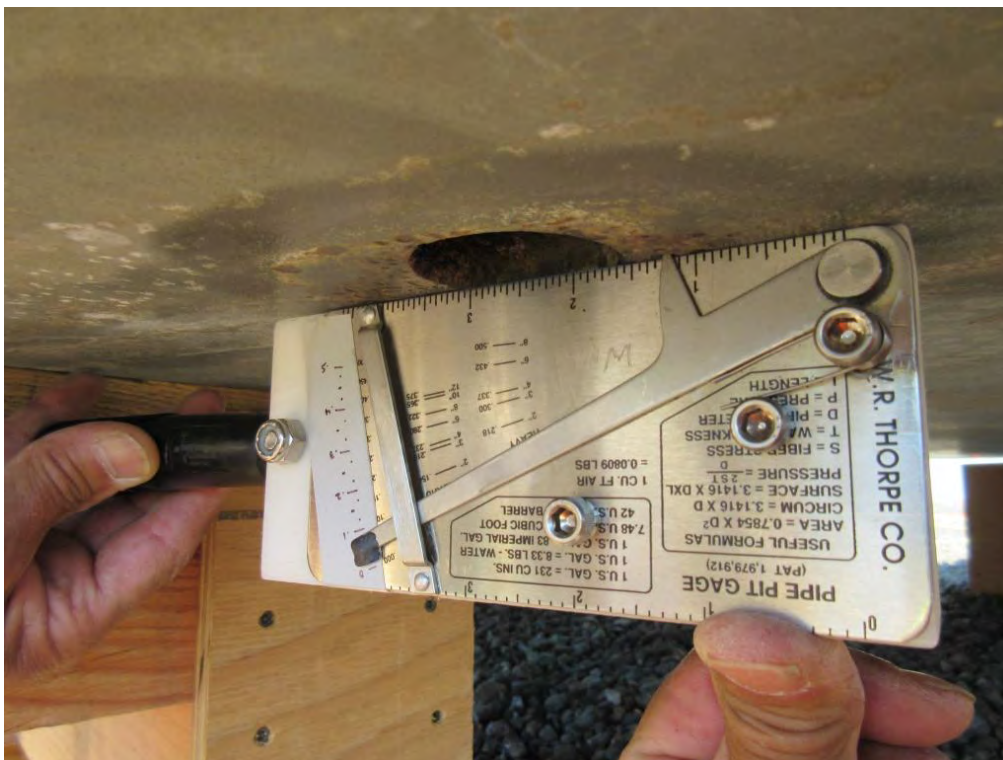
12. Measuring pit depth <math><1/16''</math>

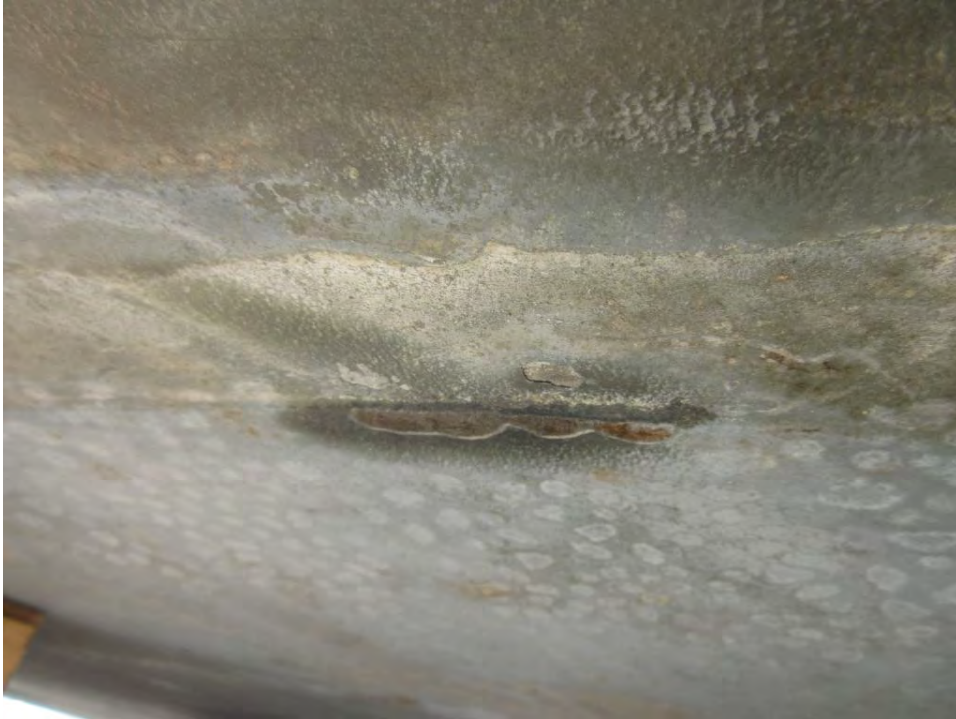
13. Coating chip on underside of lid

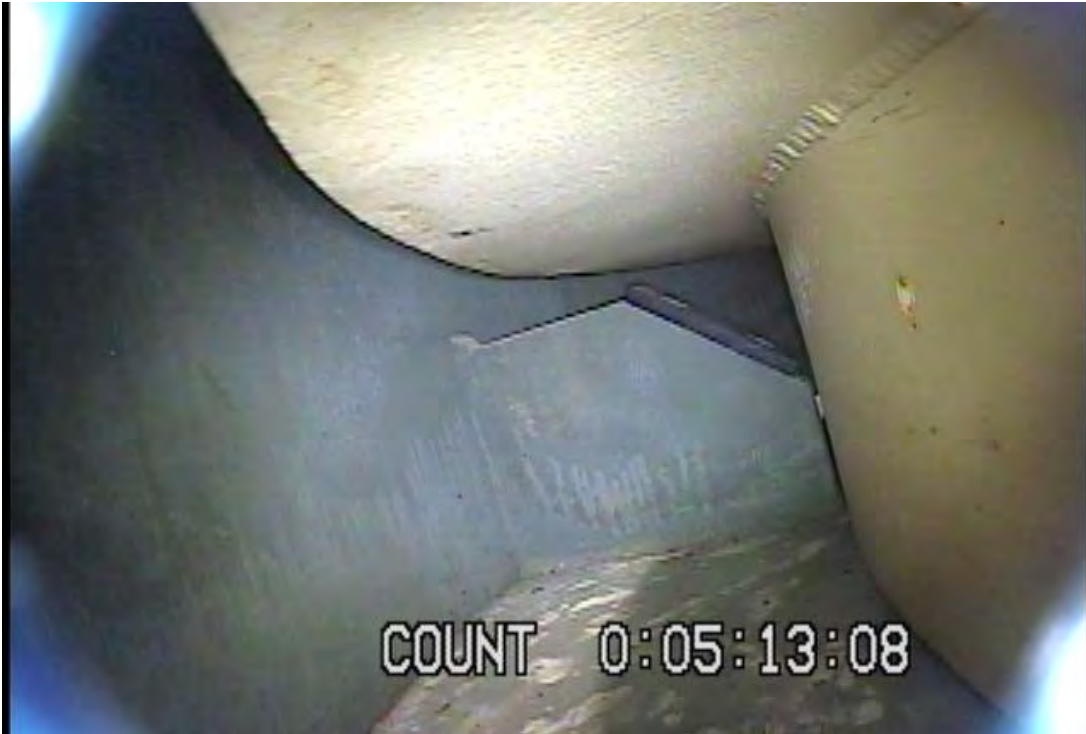
40. Overpack underside northeast section coating chip

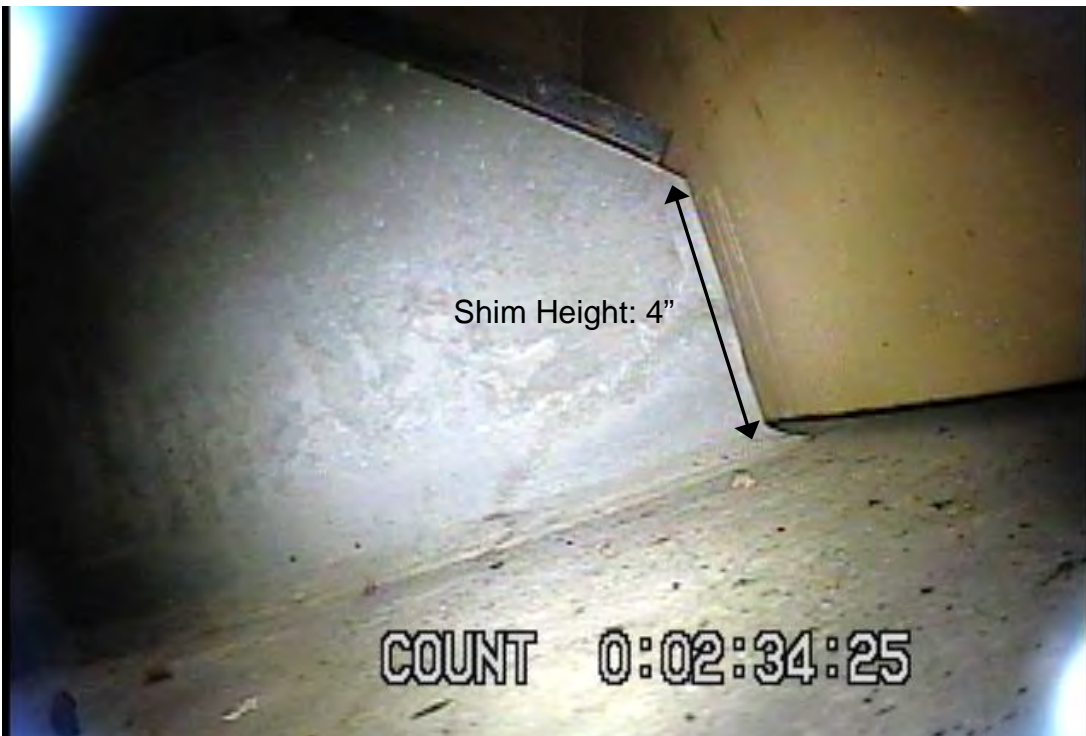
41. Overpack north section coating scrape adjacent to seismic shim

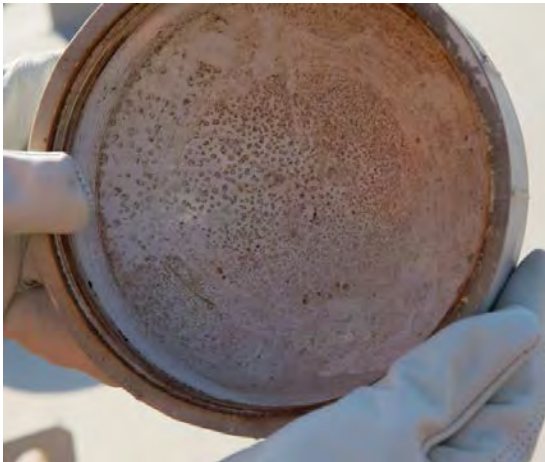
63. Underside of bolting pipe cap showing evidence of condensation

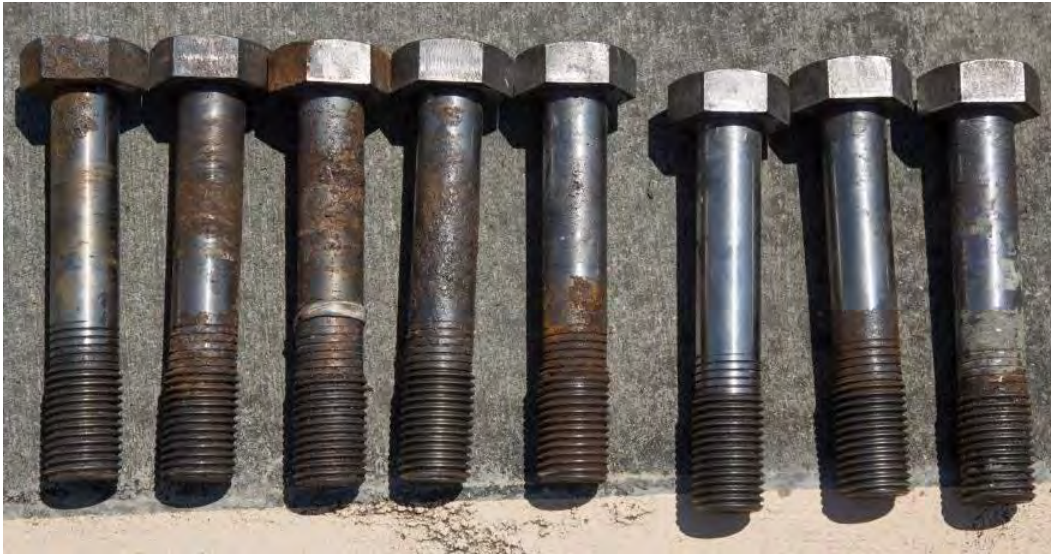
65. Cell 2 all eight removed bolts

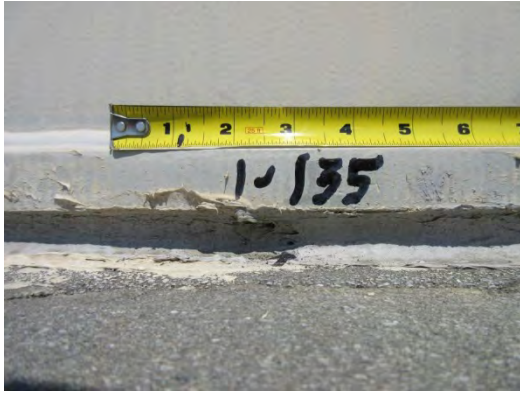
1. Cell 1 Caulking As-Found

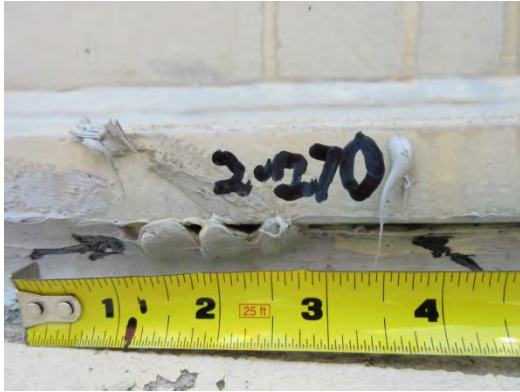
3. Cell 2 Caulking As-Found

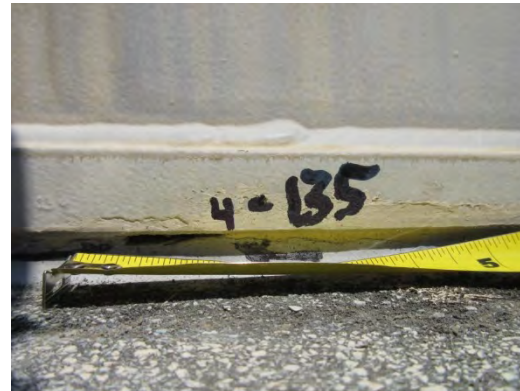
6. Cell 4 Caulking As-Found

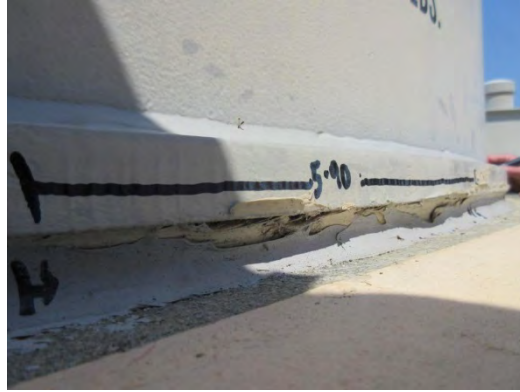
8. Cell 5 Caulking As-Found

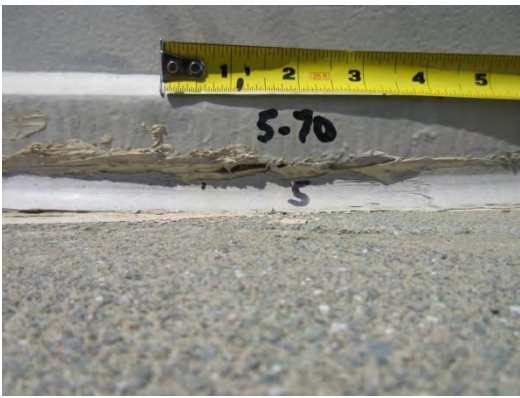
9. Cell 5 Caulking As-Found

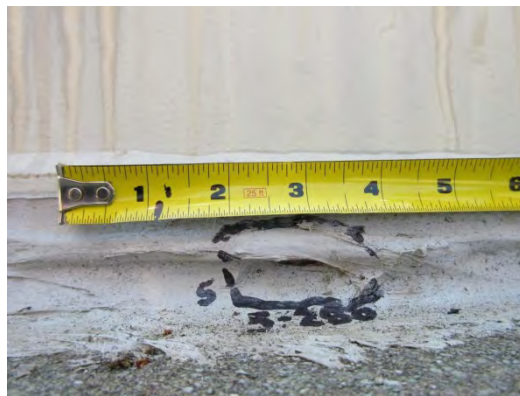
12. Cell 5 Caulking As-Found

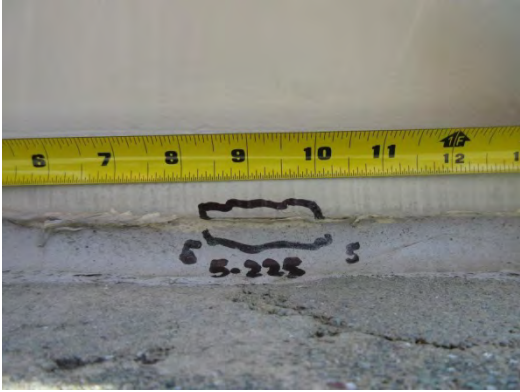
13. Cell 5 Caulking As-Found

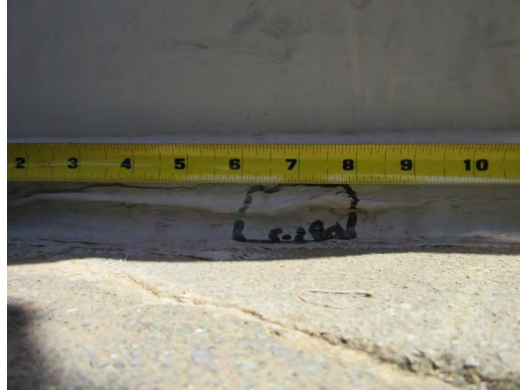
14. Cell 5 Caulking As-Found

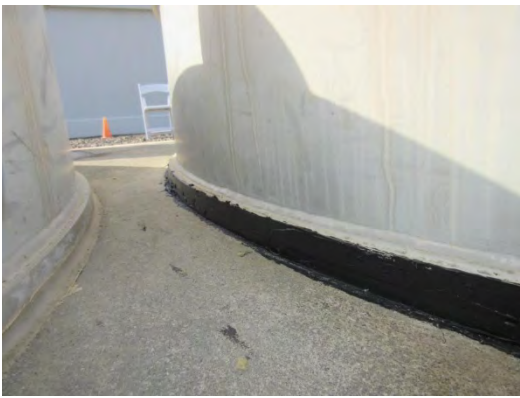
15. Cell 2 Caulking As-Left

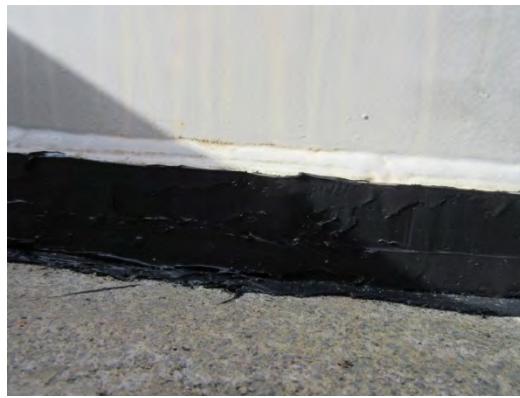
16. Cell 2 Caulking As-Left

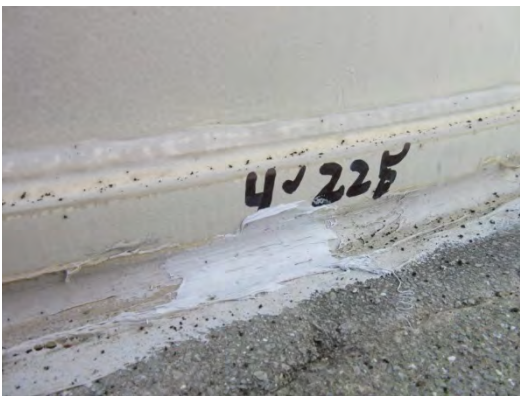
17. Cell 4 Caulking As-Left

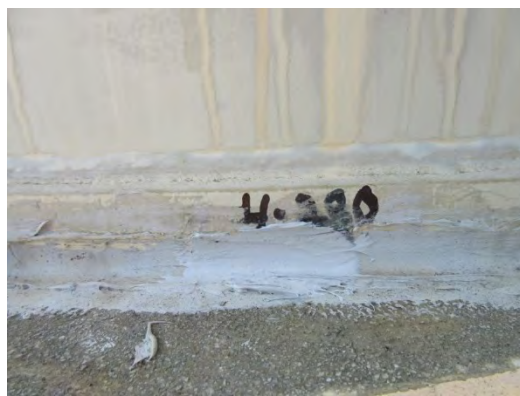
18. Cell 4 Caulking As-Left

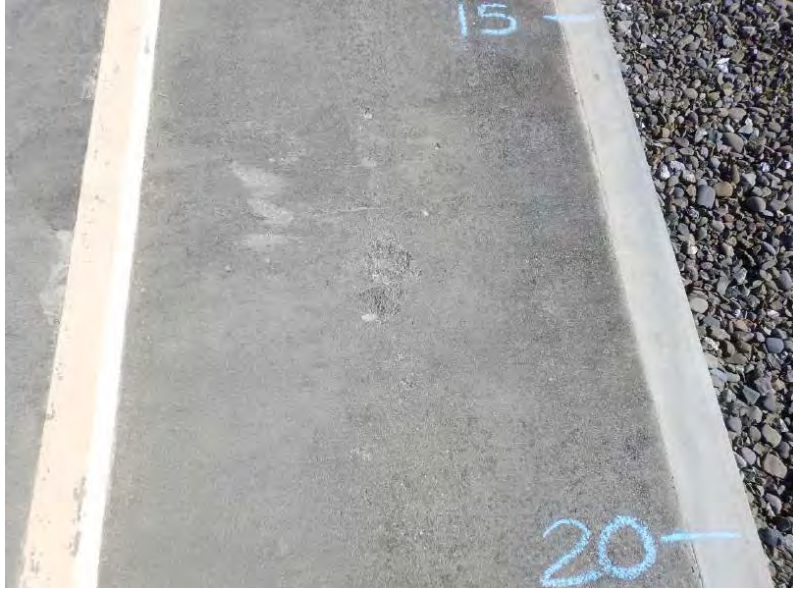
- Surface void greater than 2" in diameter – A surface void that measured 5" by 10" with a maximum depth of 3/8" was found on the south side approximately 18' from the east side and 2' from the south edge (see Attachment 7, [photo 1](#)). A closeup examination of the void surface showed that the surfaces appeared to be mechanically abraded. No signs of popouts were observed. Additional testing performed on the concrete void area and surrounding concrete surfaces was to sound for "drummy" concrete. Results showed the void surfaces and surrounding concrete were sound and intact. Because this condition did not meet the acceptance criteria, the condition was entered into CAP for evaluation (CAP 114406209).

1. South side surface scaling/peeling at (18, 17) that is approximately 5" wide by 10" long by 3/8" deep

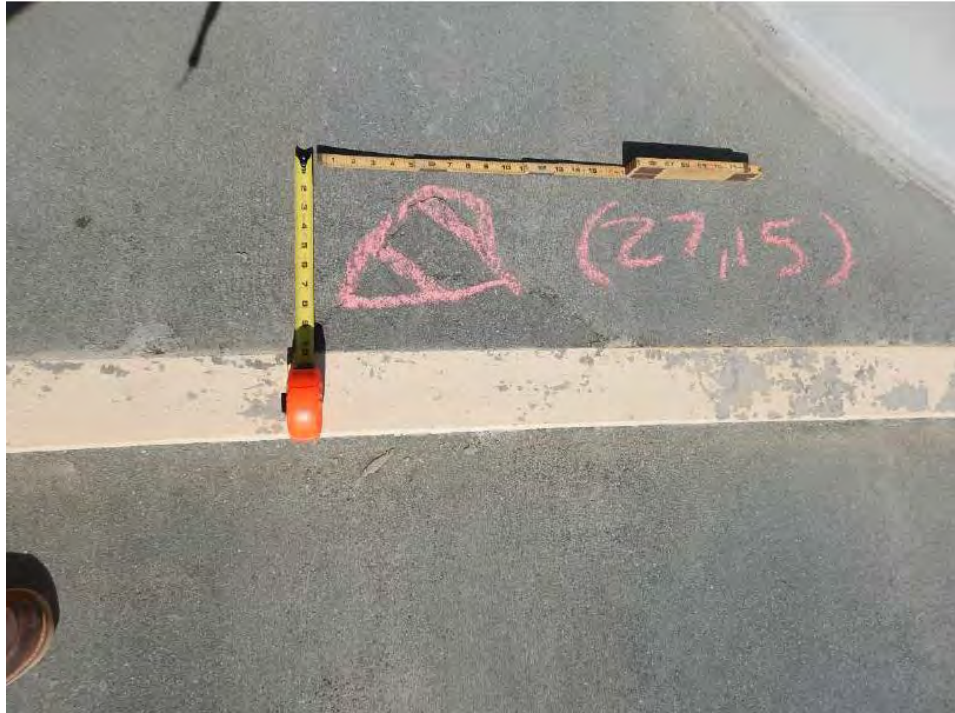
- Nine areas of efflorescence deposits were observed in areas typically adjacent to a surrounding steel angle member.
- Seventeen locations of surface voids were observed. Most of the surface voids were located along the middle portions of the north and south sides. The surface voids located in the middle section of the north and south sides along the travel path of the crawler appear to be scraped, resulting in a shallow scaled/peeled surface. The largest area of scaled/peeled concrete is approximately 5" by 10" by 3/8" (see Attachment 7, [photo 1](#)).
- All accessible concrete was sounded for delaminated and/or drummy areas. Two areas with disbonded patches were found. The patches are located on the center section on the north and south edges in the space between casks #4 and #5 (see Attachment 7, [photos 2-3](#)). No evidence of corrosion was observed.

3. Center disbanded patch at (27, 15) that is approximately 8" by 6"

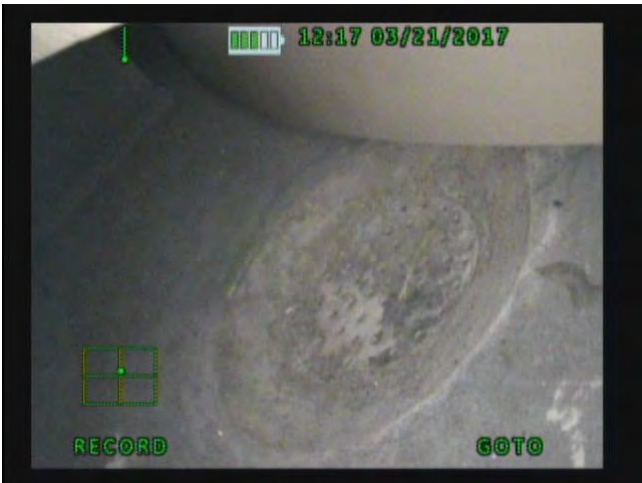
5. Vault Liner Bottom and Vault Drain

2. As discussed in Sections 3.1, 3.2, 3.3, 3.5, and 3.6, white deposits were noted around the floor drains in cells 1, 2, 3, 5 and 6. The deposit appearance is crystalline with no apparent discoloration, similar to concrete efflorescence or leaching. The boroscope video does not provide enough detail to establish the condition of the drain. It should be noted that the floor drain is not important to safety because of a defense-in-depth design and is not in the scope of license renewal. Although identification of the white deposits are not addressed in the exam acceptance criteria, this finding was entered into CAP as an observation (SAPN 1429074, Task 33) for further evaluation.

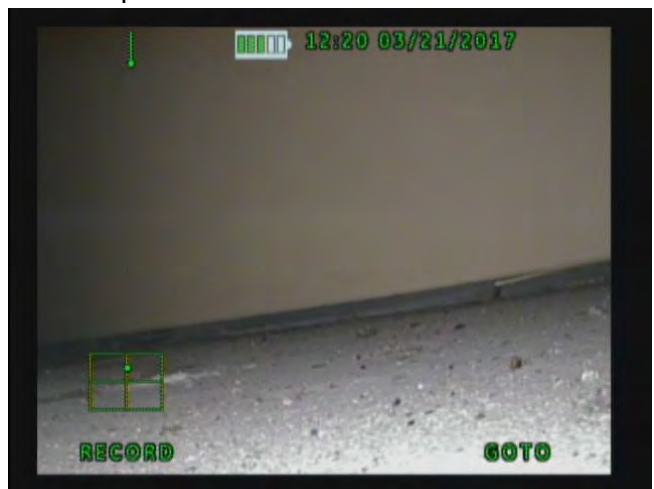
12. Overpack and Vault Liner Bottom with Debris
