Concluding destructive investigation of a nine-year-old marine-exposed cracked concrete panel

This study undertaken on a nine-year-old cracked concrete panel further investigates the impact of cracks on the corrosion performance of conventional steel reinforcement in marine-exposed concrete to explain observed monitoring data. The present data covers seven 1.80 m long (12.6 m) reinforcing bars embedded in good quality concrete ($w/b = 0.40$ and cover >75 mm). Each bar was crossed by two horizontal cracks (surface crack widths 0.20–0.30 mm). The investigation showed no corrosion on the surface of the reinforcing bars, in either cracked or uncracked areas. Two of the seven reinforcing bars were instrumented in the vicinity of the cracks. Extensive corrosion was found in the interior of all instrumented parts of these bars. This may explain the monitoring data despite the lack of corrosion on the exterior surface of the two instrumented rebars. However, with no other weaknesses, the remaining conventional rebars showed no impact from the cracks.

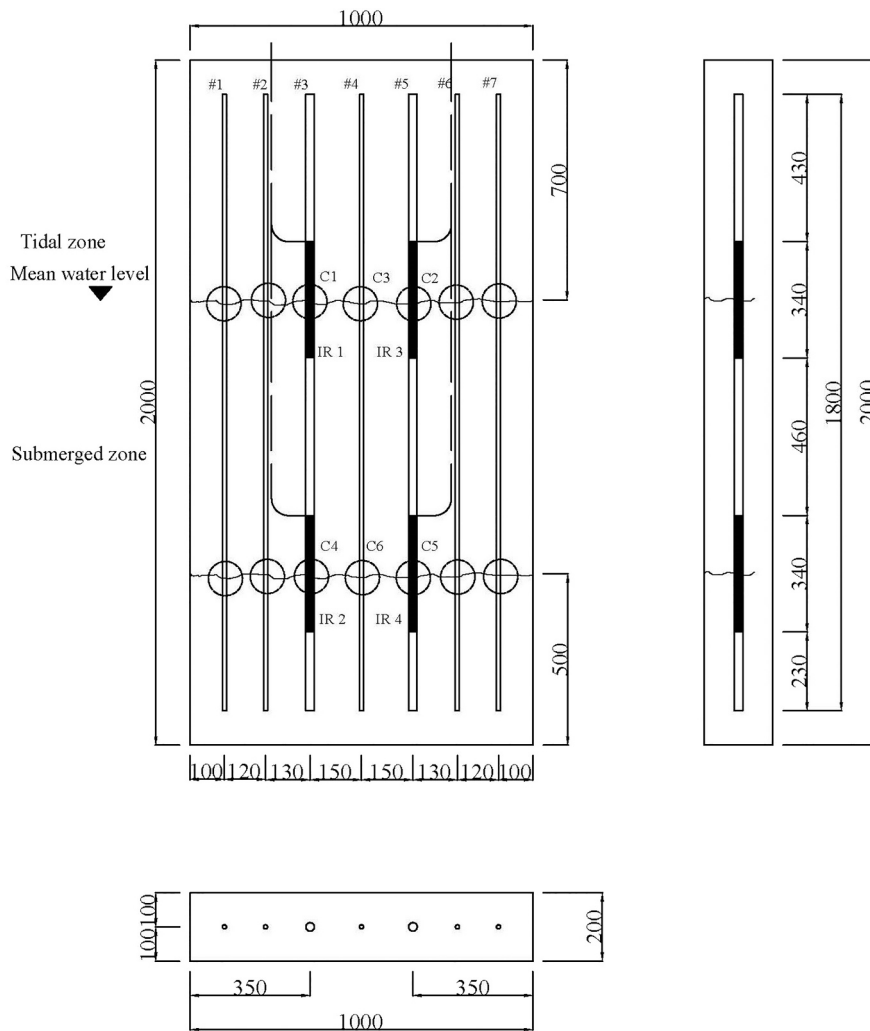
Subsequently and before exposure, two cracks were mechanically introduced in the panel by means of three-point bending. The cracks were located approximately 0.70 m (Crack 1, tidal exposure) and 1.50 m (Crack 2, submerged exposure) from the top of the panel, see Fig. 1. A DEMEC Mechanical Strain Gauge was used to measure crack width in both locations (for three pairs of measuring points along the crack path) both during the cracking and after 1.5 years. Upon cracking, two recesses of approximately 10 cm \times 5 cm \times 5 cm (length \times width \times depth) were cut at the edges and along the crack path of the panel. Subsequently, the recesses were filled with fast-hardening repair mortar to retain induced crack widths (see Table 3). The repair mortar was allowed to cure sealed for 24 h before maintaining the applied load and, thus, the crack widths. Then the specimen was stored for seven months onsite still sealed in plastic until exposure.

Fig. 1. Dimensions of the panel, location of mean water level, the two horizontal cracks, and cores extracted for this study: Series 1: cores C3 and C6 include parts of conventional reinforcing bars, cores C1, C2, C4 and C5 include parts of instrumented reinforcing bars; Series 2: numbering of cores. #1–7, numbering of rebar sections: IR 1–4, instrumented rebars: #3 and #5. All measures in mm.

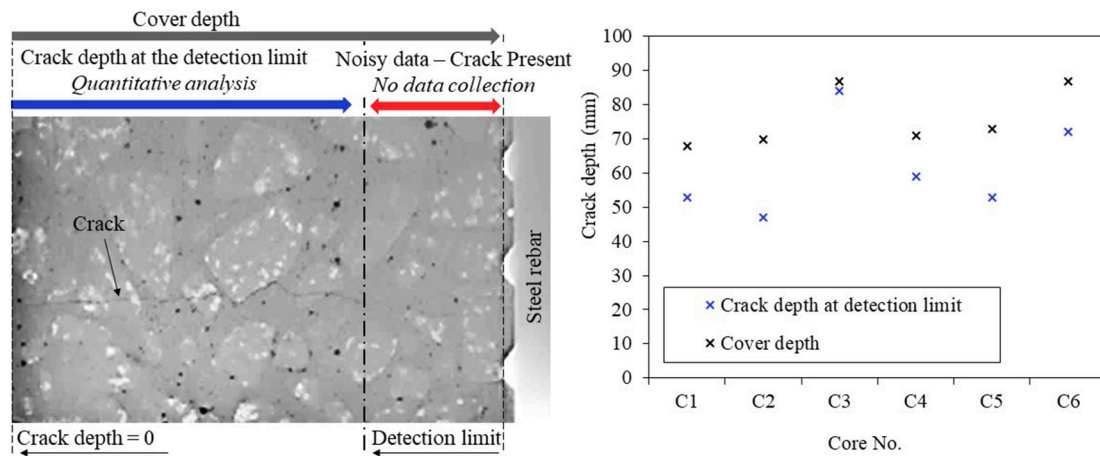
Fig. 4. Schematic illustration of detection limit for quantitative analysis of μ -CT scans due to low resolution and image noise, artefacts associated with scanning near rebars. Left: a representative crack with identification of limit for image segmentation. Right: the crack depths at the detection limit and the cover depth for all six cores (Series 1) investigated.

All the cracks were positioned almost perpendicular to the exposed surface, and visual observation of μ -CT images near the steel rebar confirmed that the cracks had fully penetrated the concrete cover. However, due to the detection limit, the cracks could not be quantified in the vicinity of the rebars (see Fig. 4). The quantification given below therefore only covers part of the cracks. As supplementary material, crack volume 3D profiles are also given.--

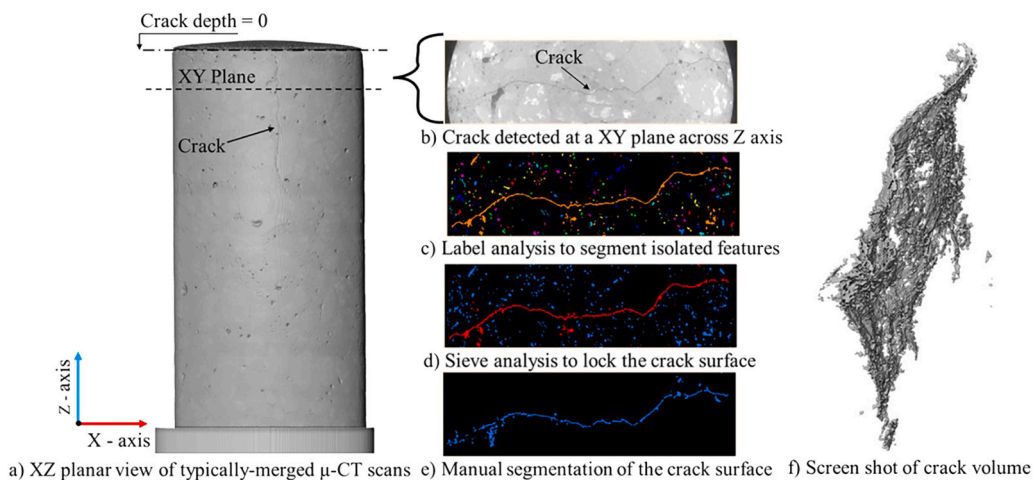
Fig. 5. Schematic illustration of a) an XZ planar view of typically-merged μ -CT scans, b)–e) the process followed to segment the crack in 3D space using the relevant modules available in Avizo, and f) a representative screenshot of the 3D crack volume illustrating the crack from a specific angle. Images of core C1.

The methodology applied is illustrated in Fig. 5 across a 3D profile of a representative crack and was implemented for all samples investigated. The selection of appropriate intensity thresholding range was consistent on all occasions to facilitate comparison. Image segmentation employed to separate cracks failed to provide quantitative data at crack depths near the rebar due to noise artefacts present in the corresponding image datasets induced by the steel rebar. Data were therefore, collected from zero crack depth to the image segmentation detection limit (see Fig. 3). It should be noted that visual observation of μ -CT images near the steel rebar confirmed that the cracks had fully penetrated the concrete cover.

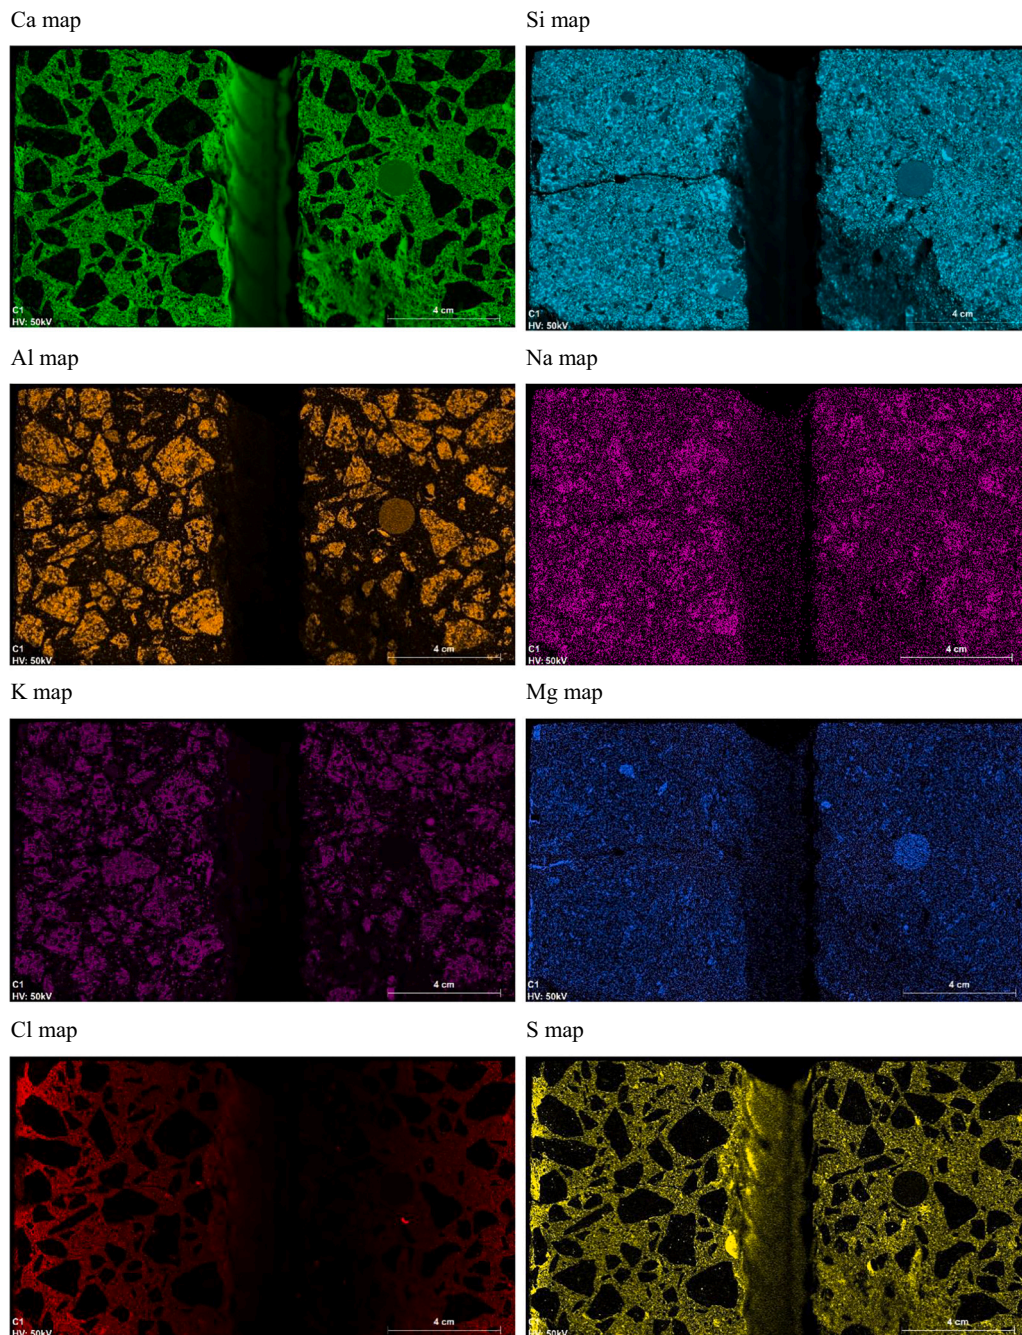
Fig. A1. Elemental overview maps of core C1, with the cracked surface of the panel to the left.

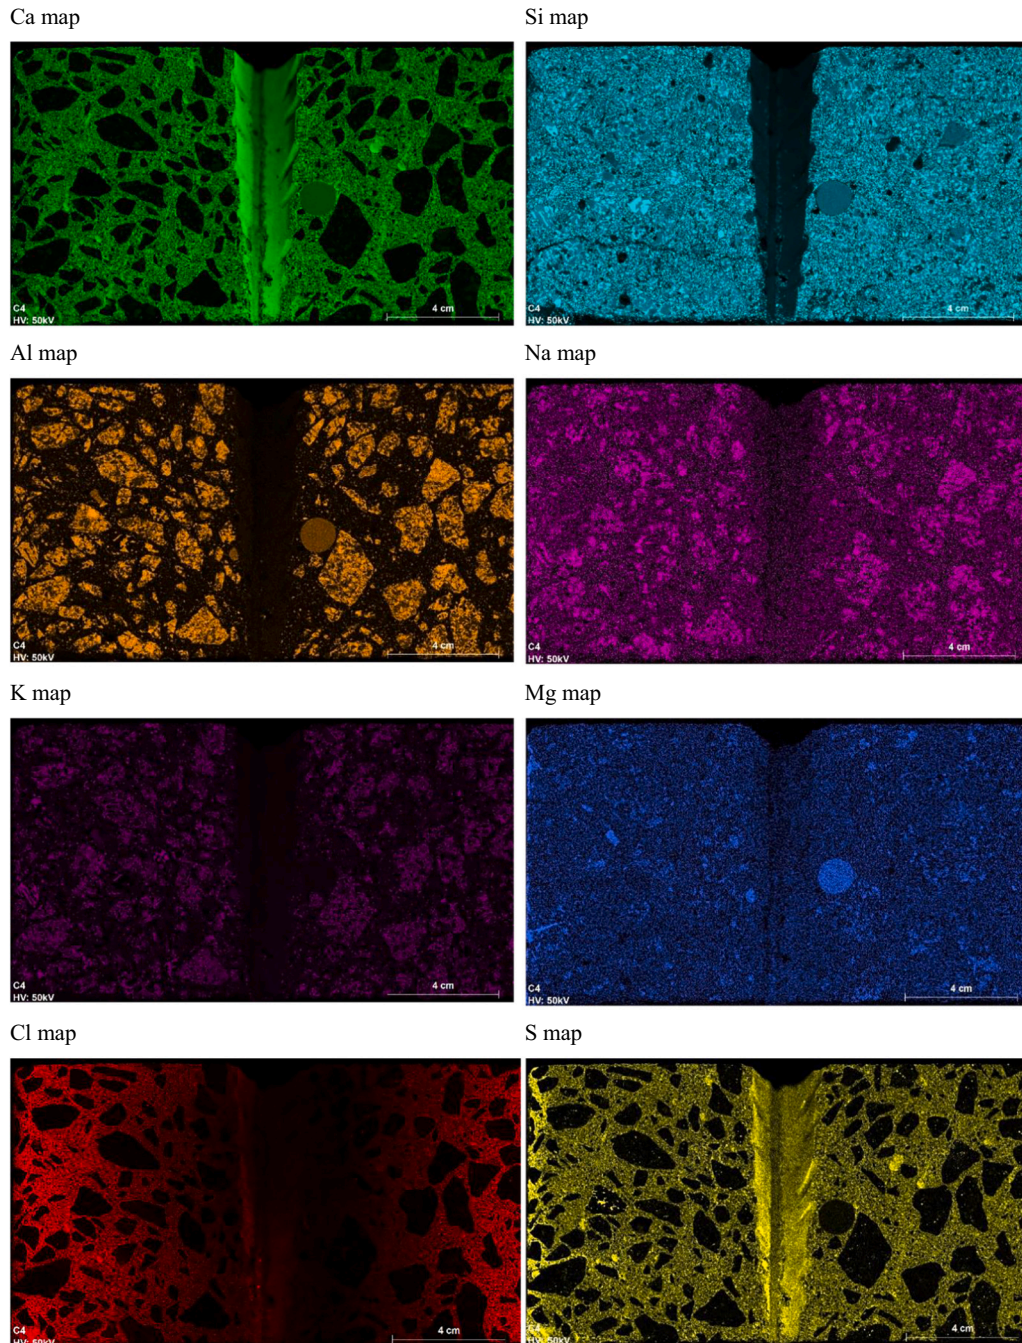
Fig. A2. Elemental overview maps of core C4, with the cracked surface of the panel to the left.
