Heidarzadeh, M & Feizi, S 2022, 'A cascading risk model for the failure of the concrete spillway of the Toddbrook dam, England during the August 2019 flooding', *International Journal of Disaster Risk Reduction*, vol. 80, 103214. <https://doi.org/10.1016/j.ijdr.2022.103214>

1 **A cascading risk model for the failure of the concrete spillway of the**
2 **Toddbrook dam, England during the August 2019 flooding**

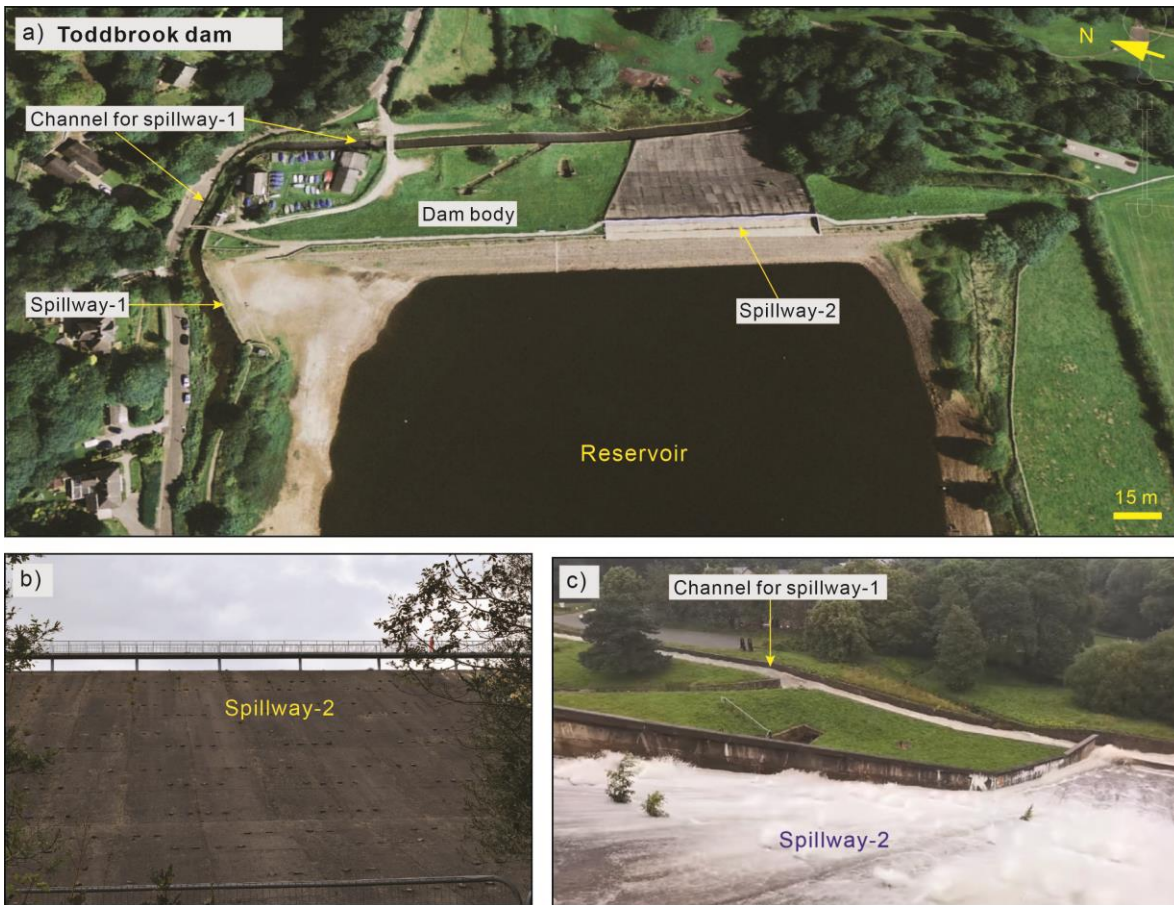
99 The Toddbrook dam is a zoned earth-fill dam with a clay core acting as its water sealing element (Figure
100 2). The height of the dam is approximately 24 m, its crest length is 310 m, the reservoir capacity is 1.29
101 million m³, and the slope of the upper part of its embankment is 2 (horizontal):1 (vertical), (Balmforth,
102 2020). The dam construction was completed in 1840 and its purpose was to supply water to a nearby
103 navigation canal (Hughes, 2020). The dam was originally equipped with a side channel as its spillway, which
104 is called spillway-1 throughout this report (Figure 3). These types of spillways usually have limited discharge
105 capacities and are susceptible to blockage by flood debris as they are located at a side of the dam and are
106 usually narrow. Therefore, it was concluded that the original spillway does not have enough capacity and a
107 new spillway, called as spillway-2 hereafter (Figure 3), was built in 1970. The new spillway is of chute type

108 with an entrance width of 76 m that extends from the dam crest to the downstream channel connected to
109 spillway-1 (Figure 3) and with 15-cm thick concrete slabs (Hughes, 2020). The crest elevation of spillway-2
110 is 1.4 m below the dam crest elevation. With the combined discharge capacities from the two spillways, it is
111 expected that the dam has been provided with sufficient protection during severe flooding in the area.

124 **Figure 3.** The two spillways of the Toddbrook dam named as spillway-1 and spillway-2. Panel “c” is a
 125 snapshot from the video at: www.youtube.com/watch?v=-5I-t7YTkec (YouTube channel of Matthew P.
 126 E. Forrest).

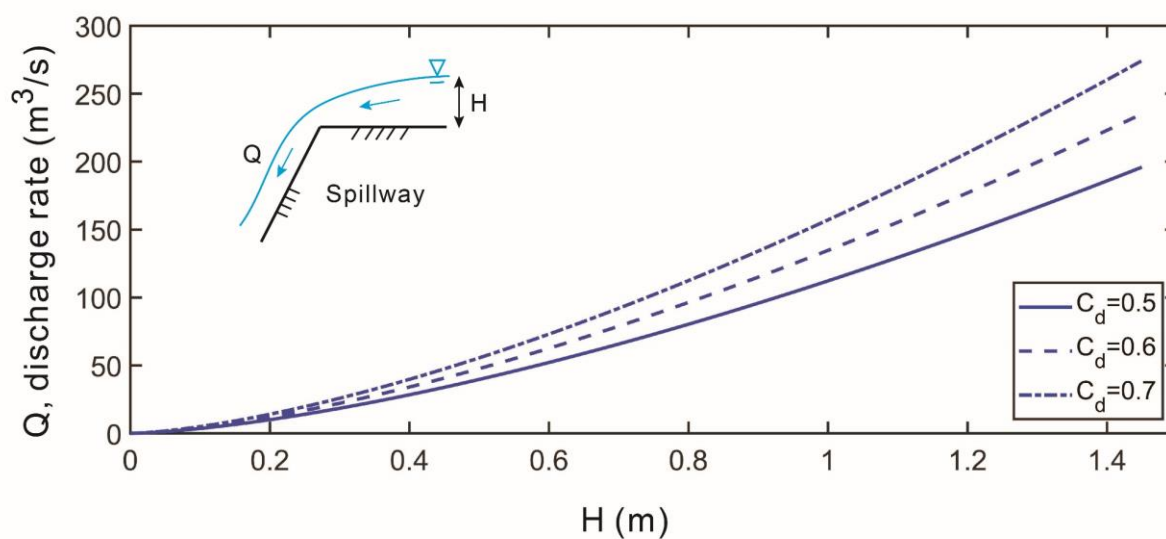
144 where, Q is discharge in m^3/s , C_d is discharge coefficient, which is assumed to be in the range of 0.5 – 0.7
145 in this study, g ($= 9.81 \text{ m/s}^2$) is gravitational acceleration, b is spillway width ($b = 76 \text{ m}$), and H is water
146 elevation difference between water surface in the reservoir and the crest elevation of the spillway (Figure 4).
147 The result of discharge calculations is shown in Figure 4 indicating that the spillway-2's discharge rates are
148 $177.0 \text{ m}^3/\text{s}$, $134.7 \text{ m}^3/\text{s}$, and $96.4 \text{ m}^3/\text{s}$ for the H values of 1.2 m, 1.0 m and 0.8 m, respectively (assuming
149 $C_d = 0.6$ in Figure 4). The Probable Maximum Flood (PMF) for the design of the Toddbrook dam is reported
150 as being $164.0 \text{ m}^3/\text{s}$ at the reservoir level of 187.1 m (equivalent to $H = 1.2 \text{ m}$) (Hughes, 2020). We note
151 that Equation (1) results in a discharge rate of $177.0 \text{ m}^3/\text{s}$ for $H = 1.2 \text{ m}$; therefore, we assume a PMF of

164 **Figure 4.** The discharge capacity of the Toddbrook dam spillway-2 at different water heights above the
 165 spillway crest level (H) as a function of C_d (discharge coefficient).
