Use of Non-Destructive Tests for the Assessment of Integrity and Service Life of Hydro-Mechanical Equipment

Keywords: hydro turbine, non-destructive testing, degradation of material, structural integrity

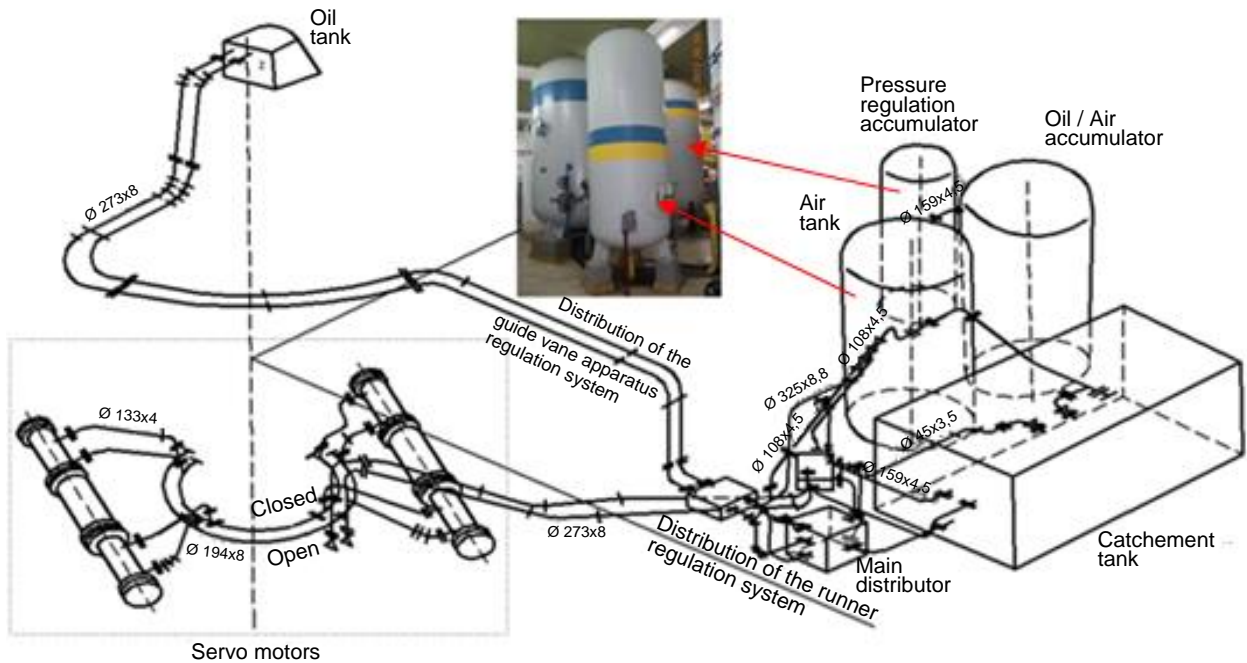
Figure 5. Appearance of the turbine regulation system

Purpose of these tests is to analyze the condition of welded pipes and elbows of the regulation system pipeline at the hydroelectric generating set A6 during production and exploitation, as well as to determine the influence of local wall thinning and material degradation on their integrity under

combined influence of the internal pressure of turbine oil ($p = 4 \text{ MPa}$) and planar loads, Fig. 5. Function of the regulation system, which comprises the pipeline for the supply of the turbine regulator with oil, is to open and close vanes of the guide vane apparatus and regulate the position of runner blades and their number of revolutions. Characteristic damages that occur during the production and exploitation of pipes and elbows are presented in Fig. 6. Pipes and elbows have been made of steel St 20, in accordance with GOST 977/88 (A 53 according to ASTM).

On the basis of experimental tests the evaluation of the global deformation behaviour of welded pipes and elbows of turbine regulation system was executed, through the use of elasticity theory and three-dimensional elastic-plastic finite element analysis and depending on parameters that refer to the quality of welded joints and wall thinning, such as: type and location of defects in welded joints, decrease of wall thickness, length of section with thinned wall, circumferential angle of the elbow for different types of bending and various geometric characteristics of elbows. It was determined that the pressure which could be considered critical for the integrity of welded pipes and elbows, with defects that occur during production and exploitation, is $p=10$ MPa, [2].

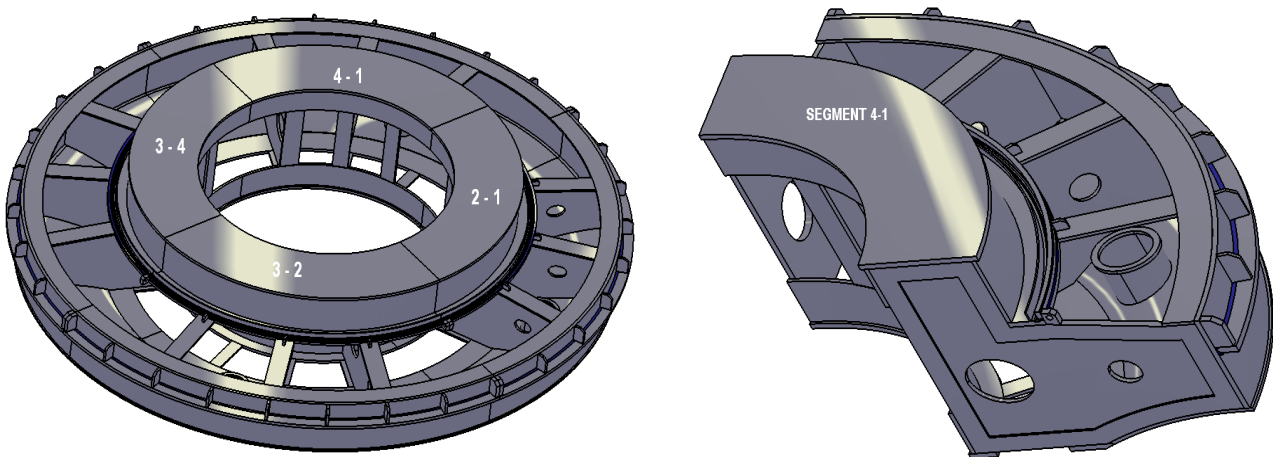
Figure 8. Model of turbine cover and segment 4-1

Turbine cover, which weighs 118636 kg, was fabricated by welding 4 segments made of steel St 3 together, in accordance with GOST 977/88. Models and results of magnetic particle testing (MT) carried out at welded joints of a turbine cover segment are presented in Fig. 8, Fig. 9 while Fig. 10 displays echographs taken during ultrasonic testing which show lamellar tearing in the area of the welded joint.
