Concluding destructive investigation of a nine-year-old marine-exposed cracked concrete panel

ABSTRACT

The experimental study investigated a cracked reinforced concrete panel made from plain Portland cement after nine years of marine exposure, from June 2011 to October 2020.

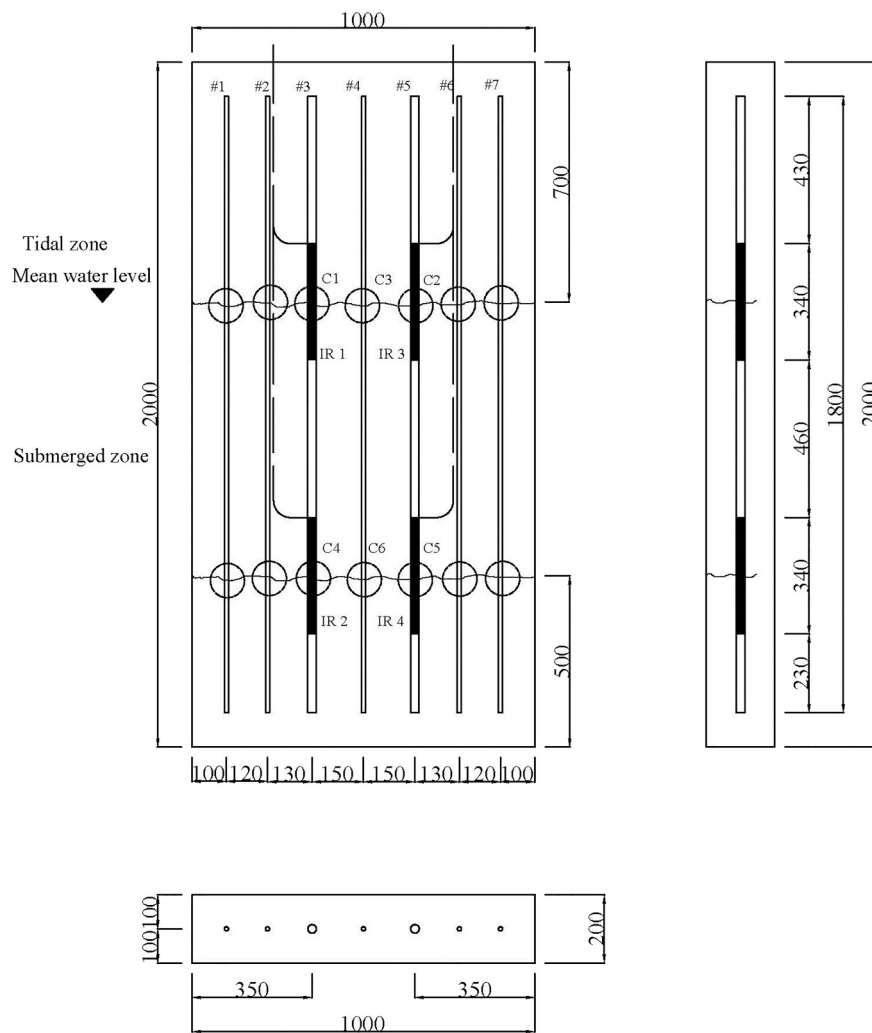
Subsequently and before exposure, two cracks were mechanically introduced in the panel by means of three-point bending. The cracks were located approximately 0.70 m (Crack 1, tidal exposure) and 1.50 m (Crack 2, submerged exposure) from the top of the panel, see Fig. 1. A DEMEC Mechanical Strain Gauge was used to measure crack width in both locations (for three pairs of measuring points along the crack path) both during the cracking and after 1.5 years. Upon cracking, two recesses of approximately 10 cm \times 5 cm \times 5 cm (length \times width \times depth) were cut at the edges and along the crack path of the panel. Subsequently, the recesses were filled with fast-hardening repair mortar to retain induced crack widths (see Table 3). The repair mortar was allowed to cure sealed for 24 h before maintaining the applied load and, thus, the crack widths. Then the specimen was stored for seven months onsite still sealed in plastic until exposure.

Fig. 1. Dimensions of the panel, location of mean water level, the two horizontal cracks, and cores extracted for this study: Series 1: cores C3 and C6 include parts of conventional reinforcing bars, cores C1, C2, C4 and C5 include parts of instrumented reinforcing bars; Series 2: numbering of cores. #1–7, numbering of rebar sections: IR 1–4, instrumented rebars: #3 and #5. All measures in mm.

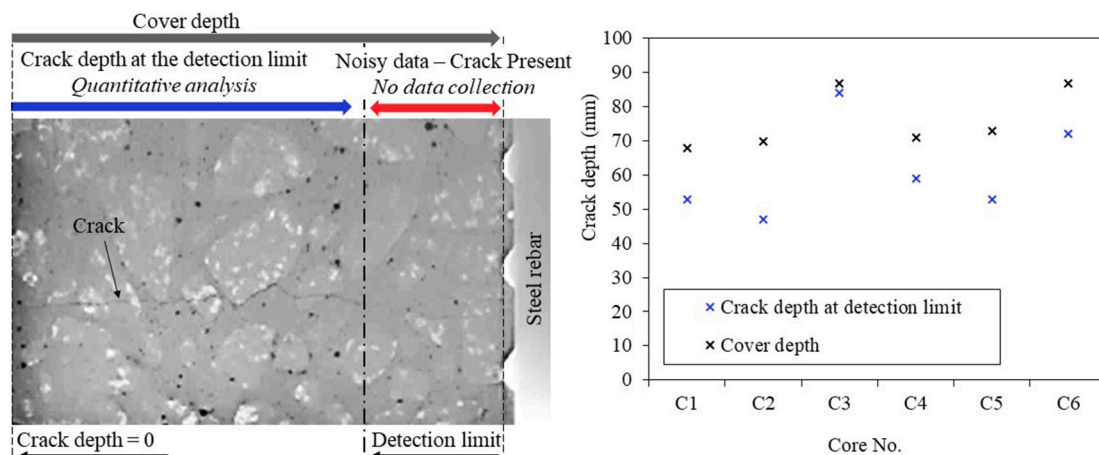
Fig. 4. Schematic illustration of detection limit for quantitative analysis of μ -CT scans due to low resolution and image noise, artefacts associated with scanning near rebars. Left: a representative crack with identification of limit for image segmentation. Right: the crack depths at the detection limit and the cover depth for all six cores (Series 1) investigated.

All the cracks were positioned almost perpendicular to the exposed surface, and visual observation of μ -CT images near the steel rebar confirmed that the cracks had fully penetrated the concrete cover. However, due to the detection limit, the cracks could not be quantified in the vicinity of the rebars (see Fig. 4). The quantification given below therefore only covers part of the cracks. As supplementary material, crack volume 3D profiles are also given.--
