## CONSERVATION OF THE LATE ROMANESQUE SANDSTONE PORTAL OF THE CHURCH OF THE PREMONSTRATENSIAN CONVENT IN KRAKÓW, POLAND

### Abstract

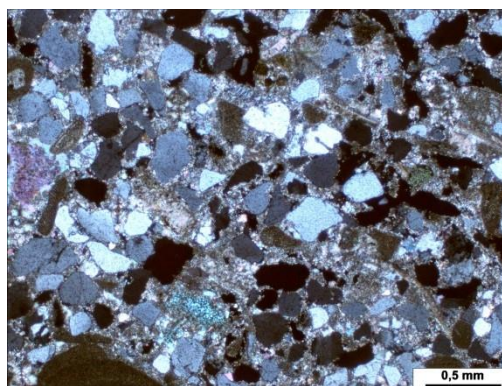
**Fig. 9.** Sandstone from the church of the Premonstratensian Convent in Kraków (sample 1). Microphotography, cross-polarised light

The mineral composition of these sandstones is dominated by quartz (a share reaching nearly 70%), while the other granular components constitute only a few percent, the clay cement is present in only slightly higher concentration, and carbonate cement in minimum amounts. The sandstone in sample 1 has a rich basic carbonate cement, whose share exceeds 40% and separates the clastic components (Fig. 9). It is a fine- and fairly even-grained sandstone with predominant grain size around 0.3mm and including grains of up to 1mm. Its main clastic component is quartz in sharp-edged and semi-sharp-edged grains.

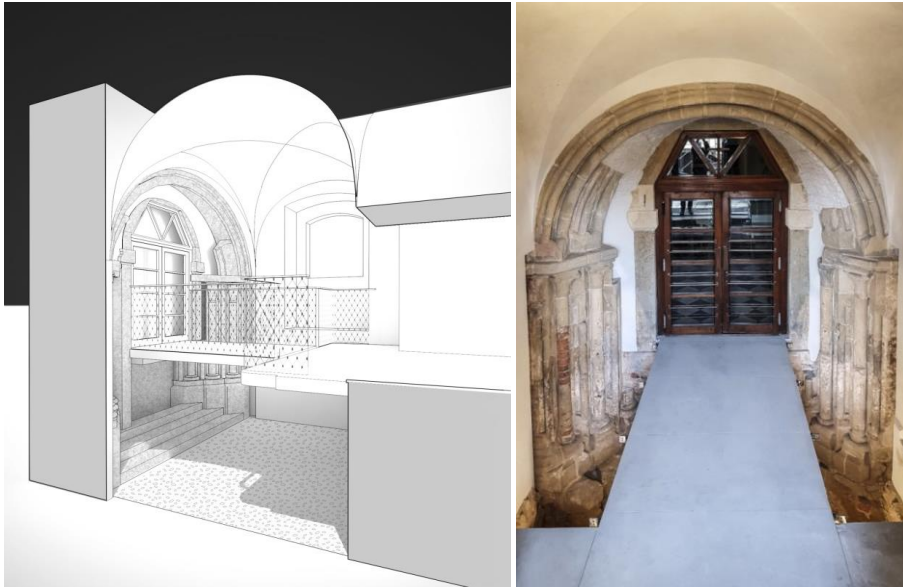
Fig. 12. Architectural design of how the portal is to be exposed with the use of a footbridge leading to the church

Figure 12 shows the architectural design system of how the portal will be exposed using a walkway leading to the church and the state of the portal after the first stage of conservation works and the construction of the walkway.

7. As the whole portal will be displayed to the view, a balustraded footbridge over the archaeological excavation will be constructed to allow access to the church and a view of the portal (Fig. 12) [37].
