Arch Bridges  
ARCH'04  
P. Roca and E. Oñate (Eds)  
© CIMNE, Barcelona, 2004

## REPAIR OF STONE MASONRY ARCH BRIDGES

**Daniel V. Oliveira<sup>\*</sup> and Paulo B. Lourenço<sup>†</sup>**

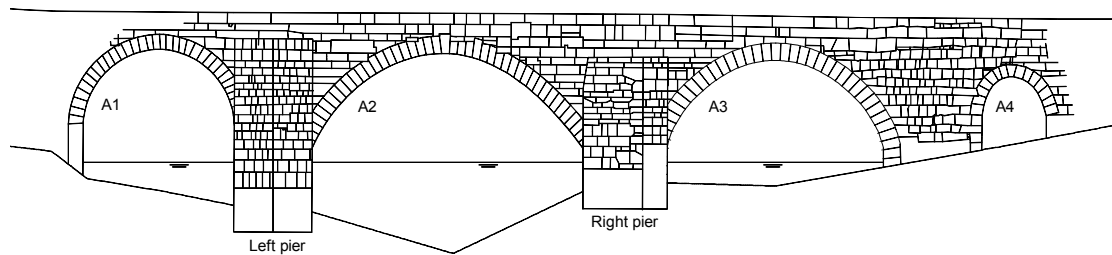
The bridge has a flat roadway, supported by three semicircular stone masonry arches, with different spans (6.6 m + 11.8 m + 9.4 m), as schematically illustrated in Figure 4. The bridge reaches a total length of 62.0 m and has a roadway width of 3.4 m. The central arch presents the larger span and it is supported by two massive piers, endowed with two triangular cutwaters at upstream and two rectangular cutwaters at downstream. On the right shore it is possible to find a flood arch, with a span of 2.7 m, constituting a 4<sup>th</sup> arch.

Figure 4: Donim bridge (upstream view)

The spandrel walls as well as the parapets were built with stone masonry, but successive maintenance works carried out over the years have changed some original characteristics as it can be noticed by the parapet wall partially rebuilt with concrete blocks and the granitic paving-stone pavement built during the 20<sup>th</sup> century.
