Selected research and case studies in ancient Portuguese structures

Summary

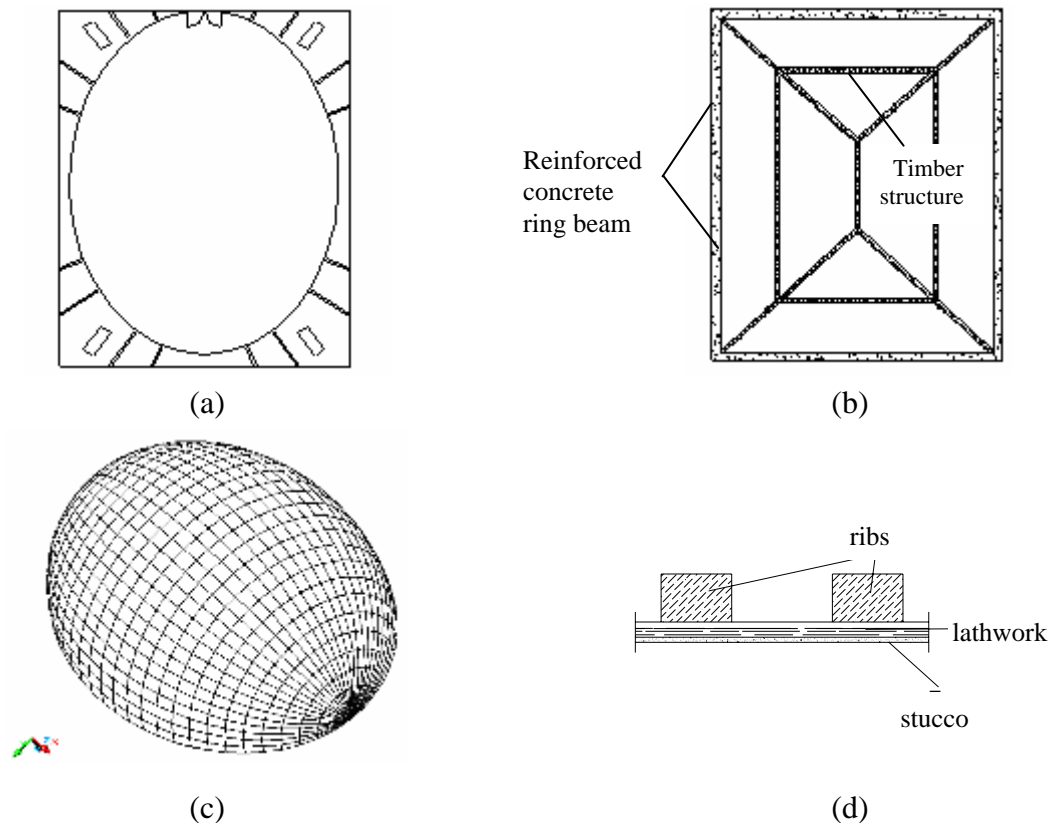
Fig. 1 Reliquary Room: (a) plan with main vault and secondary vaults; (b) main roof structure; (c) view of lathwork vault; (d) detail of vault structure

The origin of this monastery dates back to 1131. The reliquary room exhibits considerable deformation and cracking of a timber vault, due to deformation of the roof above it, see [1] for details. The dimensions of the room are $12.5 \times 15 \text{ m}^2$ in plan, with a four-sloping roof with clay tiles and a timber lathwork vault rendered with stucco, see Fig. 1.

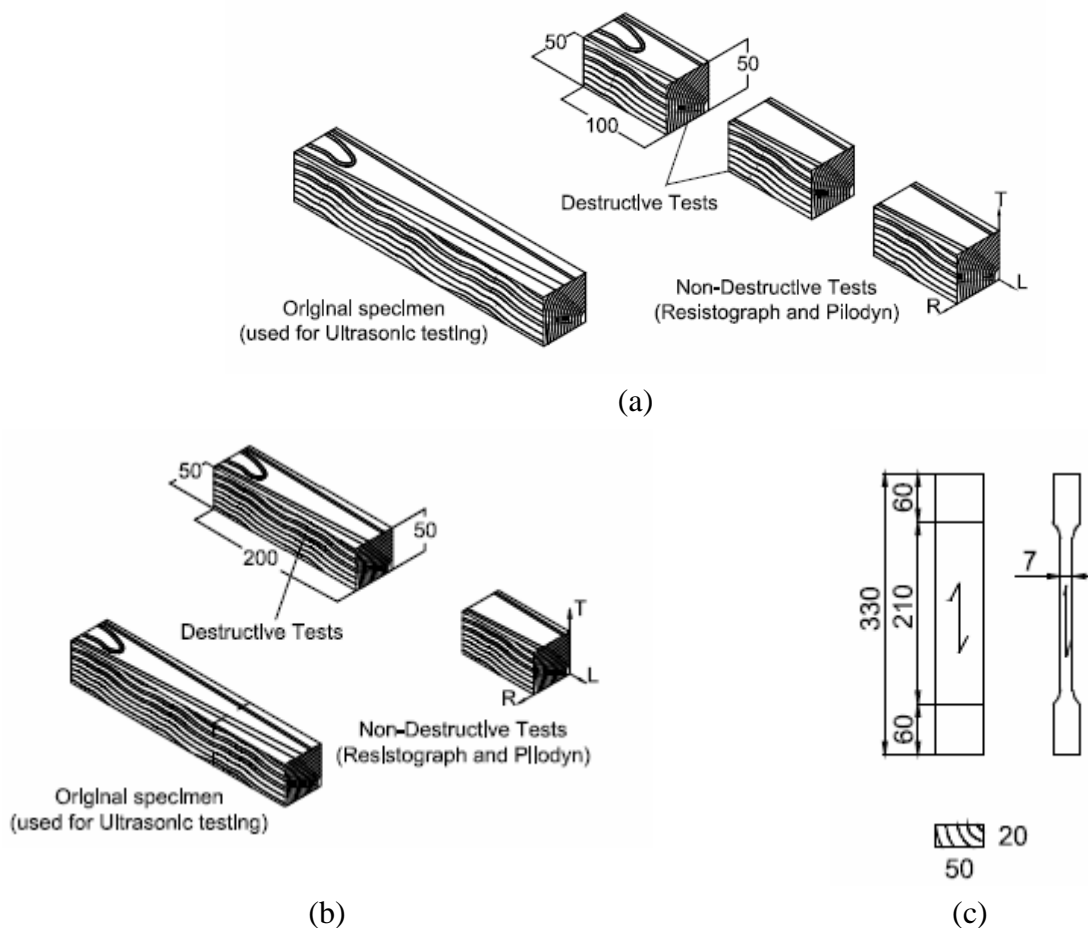
Fig. 13: Test specimens prepared by Feio[7]: (a) for compression perpendicular to the grain; (b) for compression parallel to the grain and (c) for tension parallel to the grain

This work involved about 370 destructive tests (160 for compression perpendicular to the grain, 94 for compression parallel to the grain and 114 for tension parallel to the grain), half of these new chestnut wood (NCW), and the remaining, old chestnut wood (OCW). There were also made a set of non-destructive tests for correlation with the latter ones, namely Pilodyn, Resistograph, and Ultrasonic tests, see Fig. 13.

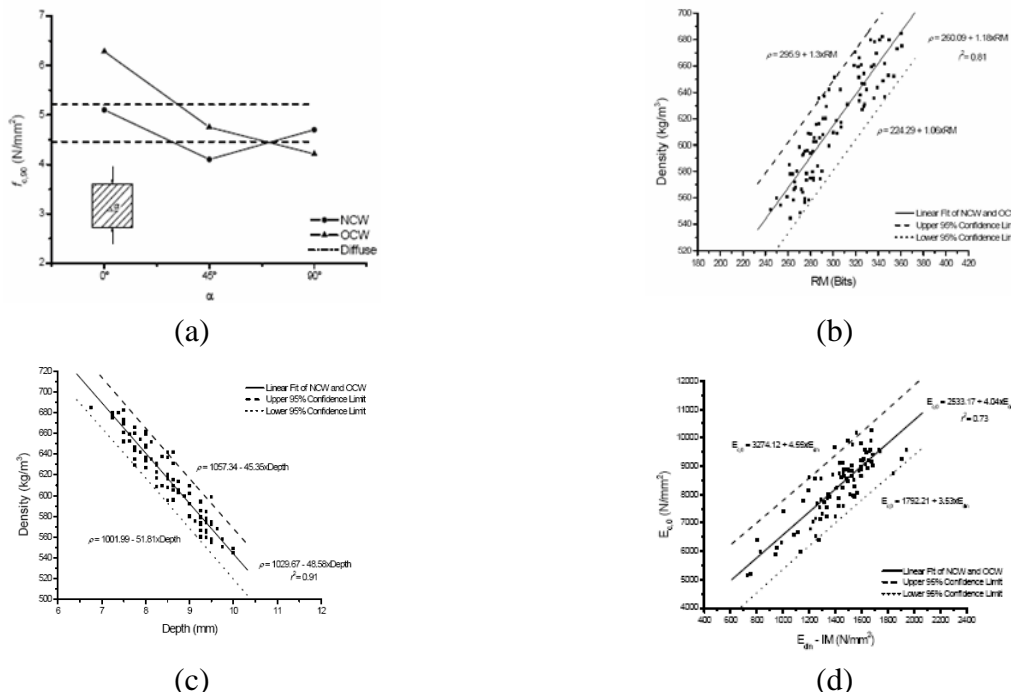
Fig. 14: Some of the key results obtained by Feio[7]: (a) compression perpendicular to the grain vs. angle; (b) Density vs. resistograph measure; (c) Density vs. Pilodyn depth; (d) $E_{c,0}$ vs. E_{dim} obtained by the indirect method;

Novel single-parameter linear regressions have been proposed for density, elasticity modulus and tensile/compressive strength parallel and perpendicular to the grain, using the Resistograph, Pilodyn and ultrasonic testing. The global conclusions are that, with respect to density, the Resistograph and the Pilodyn provide reasonable correlations. With respect to mechanical characteristics, correlations need a re-calibration with the wood population. As this is not reasonable for practical purposes, expressions with a lower 95% confidence of the mechanical parameters have been proposed for the ultrasonic testing. The usage of the Resistograph and the Pilodyn to obtain quantitative mechanical data is not recommended, due to the high dispersion found.

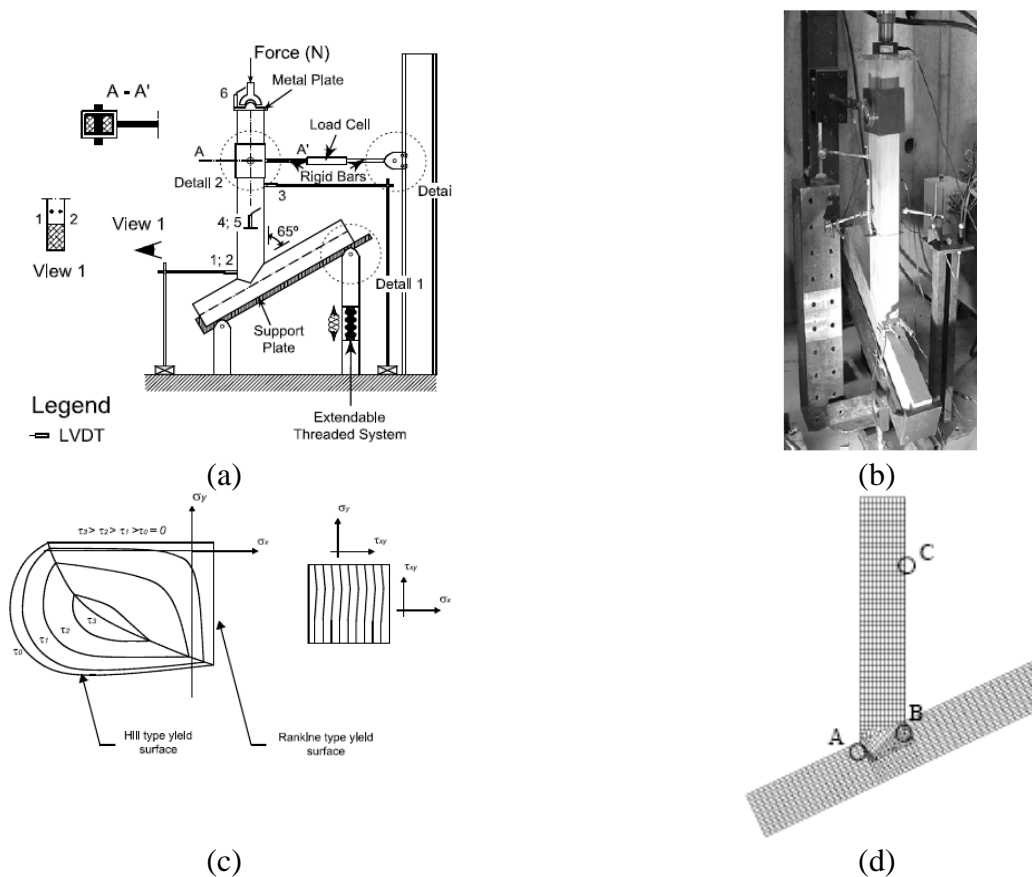
Fig. 15: Behaviour of the traditional mortise and tenon connection: (a) experimental set-up developed by Feio [7], (b) photograph of the test apparatus; (c) adopted constitutive model for FE analysis; (d) numeric model

The behaviour of a traditional mortise and tenon joint has been investigated experimentally and numerically under monotonic loading conditions, and a good agreement has been found between the numerical results and the experimental data, see Fig. 15. The experimental analyses allowed a better understand of the behaviour of the connection and discuss the influence of defects in the mechanical behaviour. The sensitivity of the results to the various material parameters, such as the normal and tangential stiffness of the interface, the elastic modulus of elasticity and the compressive strength, can be tested using a numerical approach. These models show that the influence of the interface stiffness between the two timber members is significant for the response. The proposed compressive constitutive material model (anisotropic Rankine-Hill composite yield criterion, with different strength values for tension and compression) improved the predictions of local and global behaviour, and was shown to be effective in the prediction of strength and stiffness properties of the tested specimens.

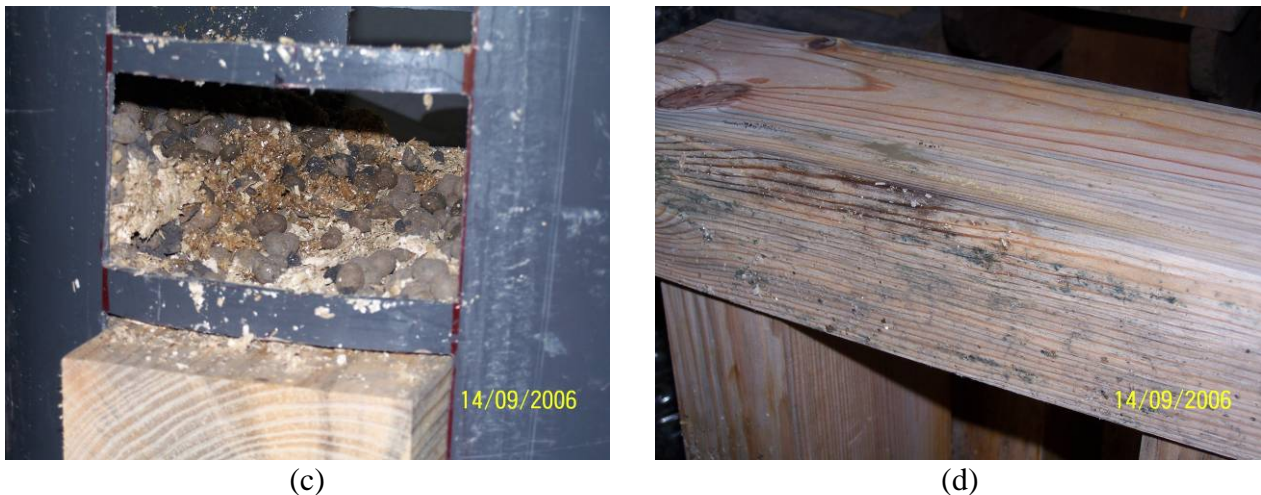
Fig. 16: Decay tests currently running on LNEC: (a, b) mounting of a decay column; (c) Detail of the mixture used to fill the tube; (d) incipient decay detected in some test specimens

The apparatus to create decayed test specimens is to place them into a tube filled with an optimum environment for the development of fungus, composed by sawdust, LECA, vermiculite and malt extract, together with the fungus itself. In Fig. 16 is shown some decay columns actually mounted in LNEC. There will be used pine wood (*Pinus Pinaster ait.*) and chestnut wood (*Castanea Sativa Mill.*) in these tests, due to it wide use in Portuguese timber structures.
