# Monastery of Salzedas (Portugal): Intervention in the cloister

P.B. Lourenço, L.F. Ramos, G. Vasconcelos

## ABSTRACT

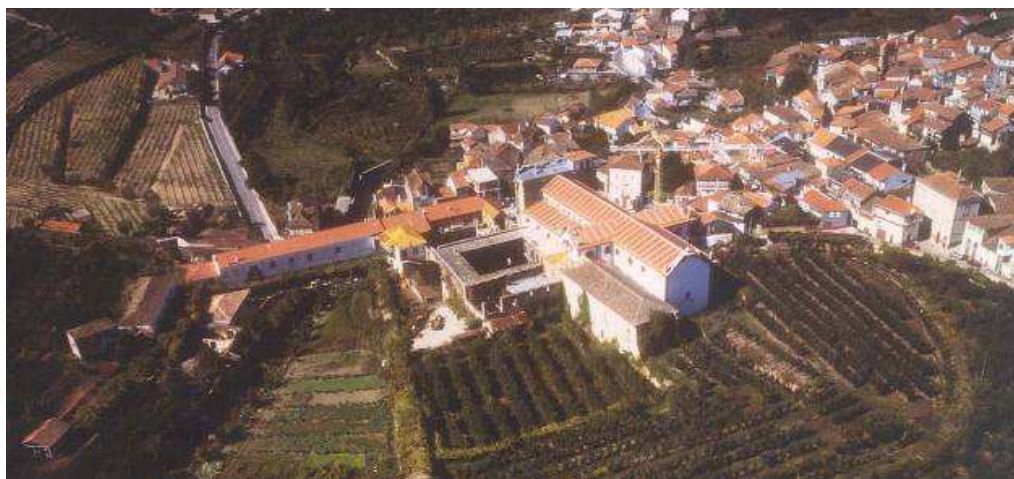
(a)

The Monastery and Church of Salzedas are located in Salzedas, Tarouca, and the church was recently classified as a National Monument. The church is essentially set in an urban environment, whereas the monastery is set in a more rural environment (Fig. 1a). The plan dimensions are very large, 75 x 101 m<sup>2</sup>. The monastery and church possess a longitudinal irregular plan with different volumes, typical of a Cistercian Abbey (Fig. 1b). The conservation works addressed here focus in the cloister dated from the 17<sup>th</sup> century (Main Cloister, in the picture).

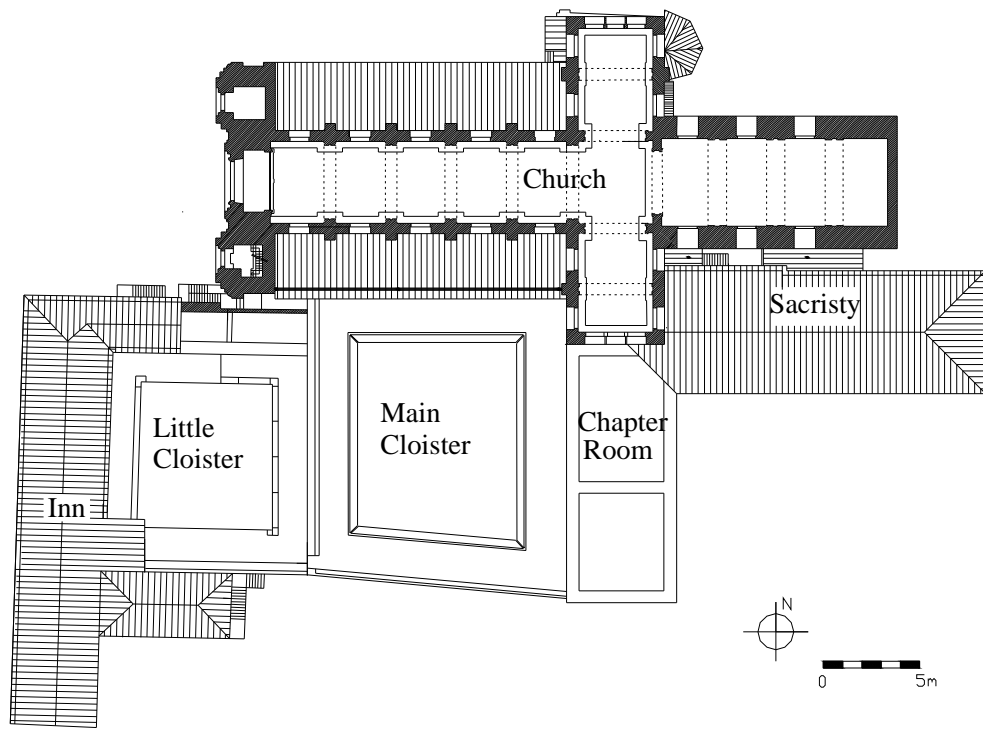
(b)  
Figure 1. Monastery and Church of Salzedas: (a) aerial view; (b) plan and spatial units.
