An Inspection of Three of Famagusta's Churches

Paulo B. Lourenço and Luís F. Ramos

In Famagusta three churches were selected for advanced, non-destructive inspection, namely dynamic and sonic testing, and preliminary diagnosis. These were: St. George of the Latins, St. George of the Greeks and The Carmelite Church.

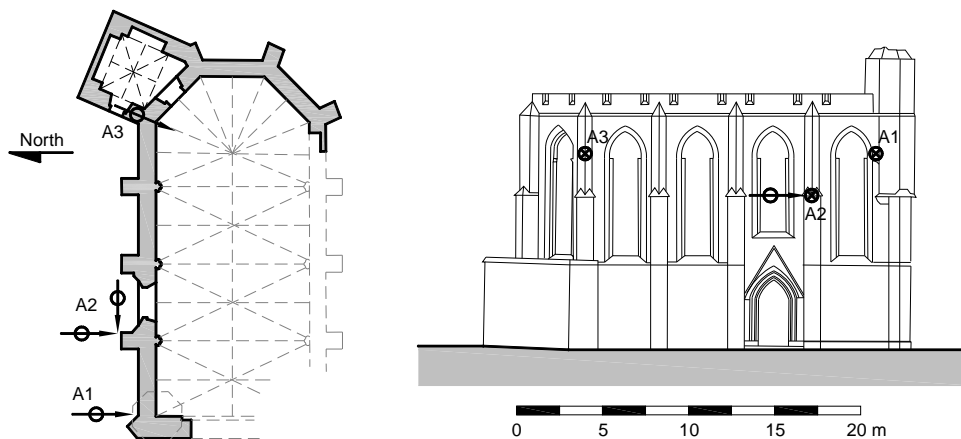
Figure 6: Test planning of St. George of the Latins church: top plan; and North façade.

The measurements were carried out in three points in the North façade, close to the top of three buttresses. The measuring points are indicated in the letter A (Fig 6). Images of the dynamic measurements can be seen (Fig 7 a-c) as can the stabilization diagram of the SSI method, where 17 stable columns can be observed, corresponding to 17 natural frequencies of the structure below 20 Hz (Fig 7 d). The standard deviation values for frequencies are very low, indicating

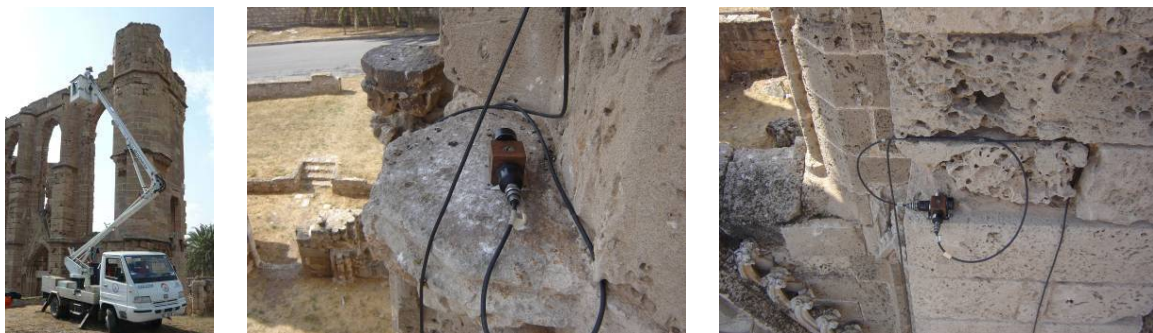
Figure 7: Dynamic Testing at St. George of the Latins

Dynamic testing at St. George of the Latins church: (a) lorry used to place the sensors in the structure; (b) accelerometers at position A1; (c) accelerometers at position A2; and (d) stabilization diagram.

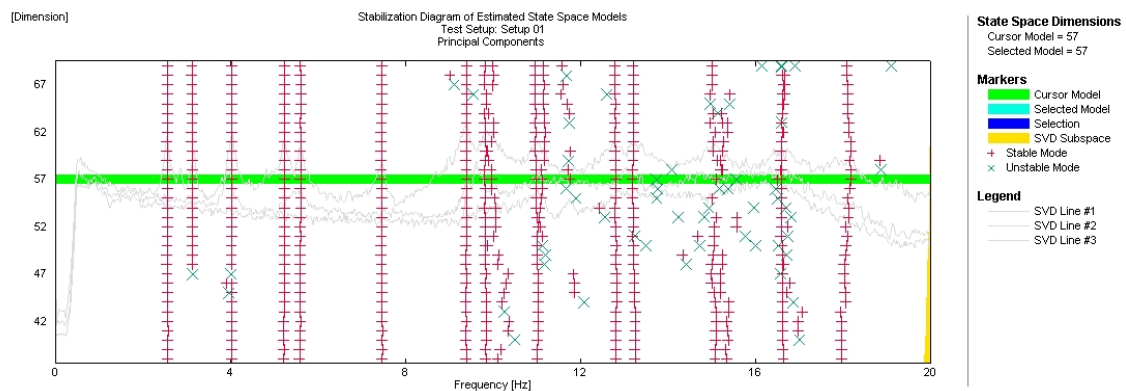
(d)

that the estimation is accurate. The mode configurations are mainly out-of-plane modes, as expected due to the unconstrained walls of the church ruins.
