THE OLD MUNICIPAL CHAMBERS BUILDING – DAMAGED BUT NOT DESTROYED – WILL IT BE THERE IN ANOTHER 125 YEARS?

ABSTRACT: *The Old Municipal Chambers is a Category I heritage building situated in Worcester Street, Christchurch. It was designed by architect Samuel Hurst Seager in the Queen Anne Arts and Crafts Style and was opened in 1887. The two storey building is constructed in solid brick and incorporates several decorative features, and it is an important part of the cultural heritage fabric of Christchurch. Some securing works were undertaken in 1989 to improve its performance under seismic loads. This paper will outline damage during the earthquake on 4 September 2010, subsequent aftershocks and the 22 February 2011 earthquake which resulted in some localised zones of collapse. The structure of the building has been stabilised externally, to secure or allow retrieval of very significant heritage features. The high cost to repair the building makes the future of the building uncertain despite its very significant heritage value. In response to the building's seismic vulnerability and possible retrofitting, finite element and simplified equivalent frame models were used for pushover

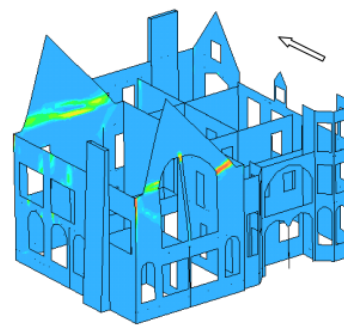
Figure 16: Deformed shape and damage state for the +X analysis with the tyings option.

The failure mode in the X direction is the collapse of the SW corner of the building, and the roof is not modeled in the simulation. As the roof might provide a certain level of restraint at the top of those walls, another model was prepared using tyings between the nodes of the top left of the South façade and the top right of the North façade. This tries to simulate the existence of a relatively stiff roof in the Council Chamber, with a good connection between roof purlins and walls, or the addition of steel ties between the walls. The new analyses in the X direction provide similar results for each loading sign. In Figure 16 it is shown that a much different behavior of the building is found due to ties in the Council Chamber (refer to Figure 13a-b). The new capacity curve for +X direction can be found in Figure 17, when compared with previous analysis, where it is shown that the capacity increase is moderate.

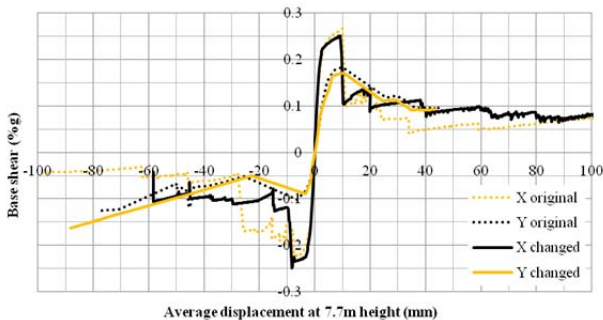
Figure 18: Capacity curves obtained for the original and changed building structures

The studied building was subjected to structural changes by a renovation in 1989, which has been identified on a collection of sketches obtained from the Christchurch City Council. These drawings show that several alterations have been made inside the building with much use of reinforced concrete. Then, a new macro-element model was created by introducing the main changes in the building structure, with the aim to evaluate the influence of the alterations in the pushover response. From the computed capacity curves in Figure 18, it seems that the influence in the global building response of the intervention made is very low, only a slightly improved ductility being observed due to the reinforced concrete elements contribution.

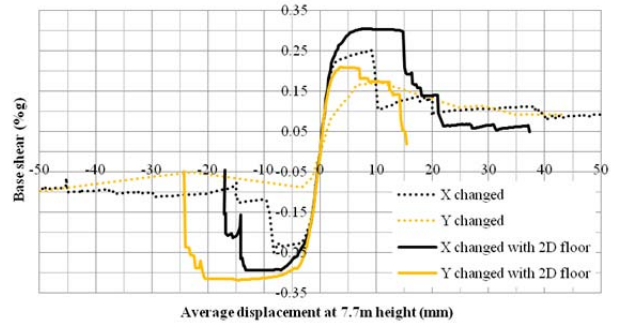
Figure 19: Capacity curves obtained for the altered building considering 1D and 2D floors

A final analysis was made considering a bidirectional diaphragm for all floors of the building, which can simulate a possible strengthening intervention with adequate tying of the building. This model can also replicate the existing behavior if the previous structural alterations managed to reach this goal, which cannot be confirmed at this stage without a careful inspection of the building from the inside. The results in Figure 19, comparing the unidirectional and bidirectional floors, clearly show a significant improvement of the building response for bidirectional floors, both in terms of base shear and ductility. The minimum capacity of the building (in the +Y direction) is now about 20% of the weight, or 0.2g. The capacity increase for the -Y direction is dramatic.

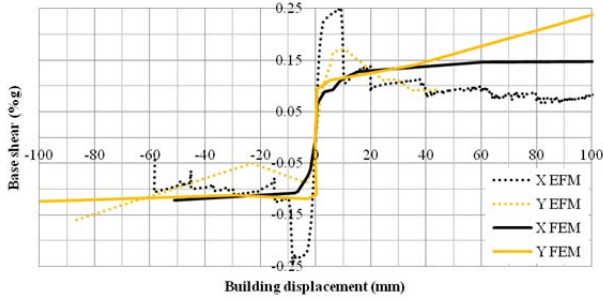
Figure 20: Comparison of capacity curves obtained for the FEM and 1D floor EFM models

Figure 20 compares the capacity curves obtained from the pushover analysis on the FEM and 1D floor EFM models. Note that the results from EFM and FEM are not directly comparable, given that the diaphragmatic action is considered for the floors in the EFM model while out-of-plane failure is considered in the FEM model, and given that the assumed response of masonry piers in the EFM is brittle. Effectively, a discrepancy is observed of the predicted peak strength in the X direction, which is possibly due mostly to absence of floors in the FEM model, and because the floors in the EFM model work mainly in the X direction. In the Y direction the approximation between the two models is better. The results of both predictions seem to be very conservative, in the sense that the building survived the February 2011 Christchurch quake with a MSA of 1.0g (note that the MSA in the New Zealand code [NZS, 2004] is 0.66g). Therefore, it is assumed that the EFM with the 2D floor model provides a better representation of the present condition of the building, as the new capacity curves in Figure 21 provide higher strength and ductility.
