## Conservation of cultural heritage buildings: Methodology and application to case studies

P.B. Lourenço

Modern societies understand built cultural heritage as a landmark of culture and diversity. Only during the last decades the idea that ancient buildings could be conserved and reused became appealing. Still, a large part of this heritage is affected by structural problems which menace the safety of buildings and people. The developments in the areas of inspection, non-destructive testing, monitoring and structural analysis of historical constructions, together with recent guidelines for reuse and conservation, allow for safer, economical and more adequate remedial measures. The paper addresses the issues of the methodology to adopt, of different cases studies and of present challenges. In particular, recent interventions in Portuguese cases studies (the Cathedral of Porto and a theological school in Braga) are analyzed in detail.

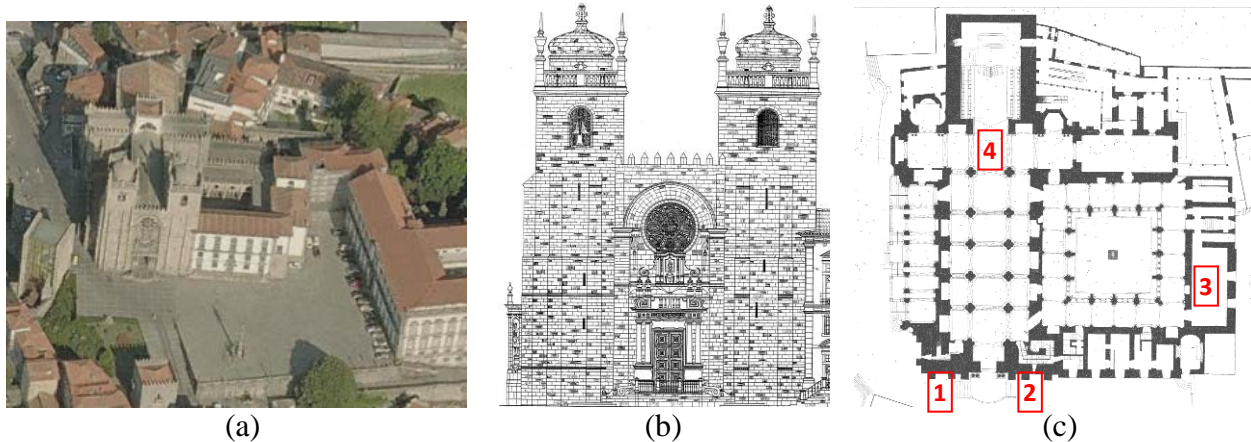
Figure 3: Aspect of the Cathedral: (a) Aerial View; (b) Façade; (c) Plan.  
 Legend: 1 – North Tower; 2 – South Tower; 3 – St. Vincent Chapel; 4 - Skylight.

Figure 3 shows selected views of the compound of the Cathedral, which has dimensions about 60 × 60 m<sup>2</sup> in plan, with a maximum height of the towers about 35 m. The compound includes the church, a gothic cloister on the south side, side chapels, a gallery on the north side, a sacristy, several chapels and other annexes. The church has a typical Latin cross, with three naves and five spans, and two rectangular towers facing west.
