# IOMAC'13

5<sup>th</sup> International Operational Modal Analysis Conference 2013 May 13-15 Guimarães - Portugal

# EXPERIMENTAL MODAL IDENTIFICATION OF AN EXISTENT EARTHEN RESIDENTIAL BUILDING

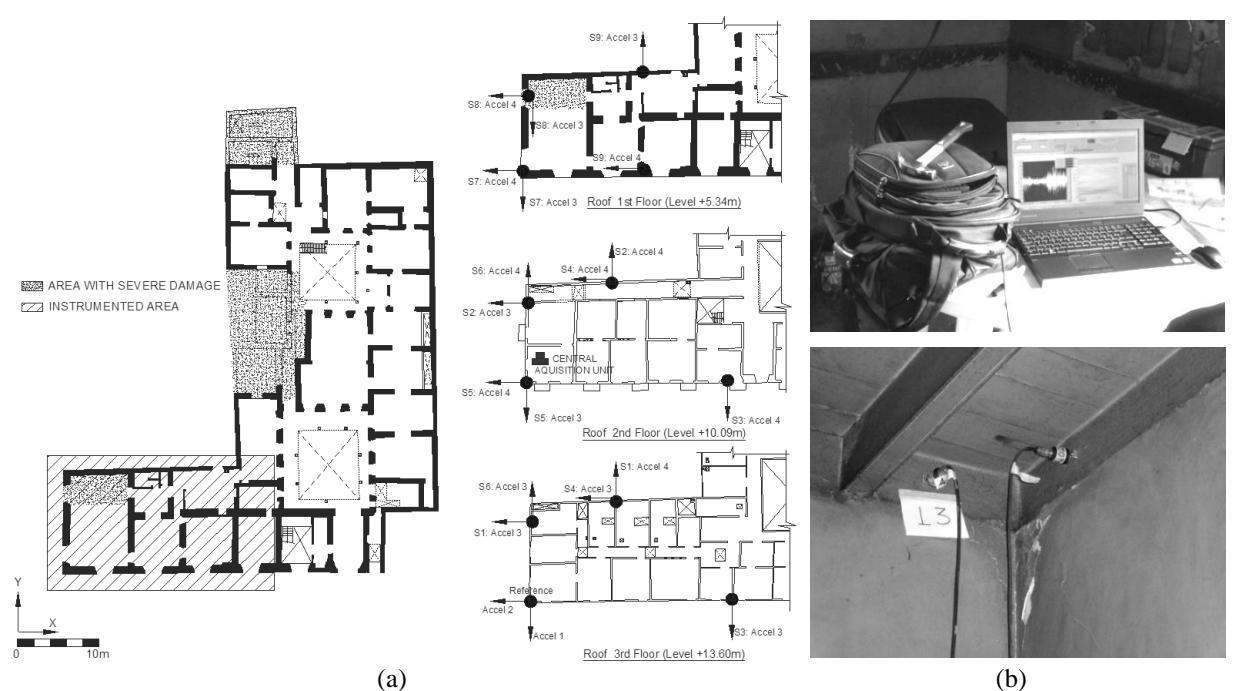
Figure 4 Operational Modal Analysis tests setups: (a) plant view of the instrumented area and details of the measurement setups; and (b) signal acquisition and measurement process

of the tests evidence a structural problem that should be studied in detail in further studies. In these studies, in addition to the solutions for repairing the areas with evident damage, it should be studied the condition of the façade wall parallel to the Y-Y axis in Figure 4.

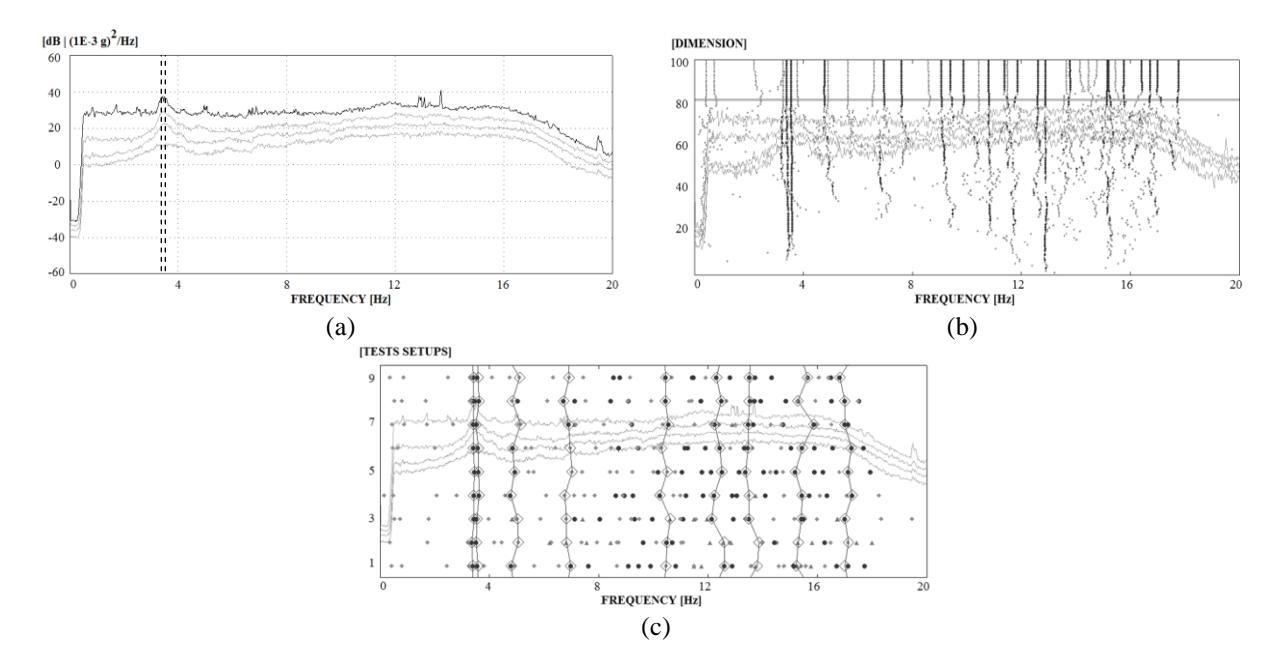
The modal identification process was carried out using the Artemis software [17]. The dynamic properties of the building were calculated using different modal identification methodologies namely the FDD, EFDD, and the SSI-data methods. The results of the singular values of the spectral density matrices and the stabilization diagrams are presented in Figure 6. The frequency domain results (Figure 6a) indicate two closely separated peaks around 4 Hz and other sharp peaks in higher frequencies which evidence the presence of undesired noise. The results of the SSI method (Figure 6b) indicate the complexity of the identification process since several columns of stable poles appear at different frequencies throughout the whole measurement setups. The final selection of the proper model order as well as the columns of stable poles (Figure 6c) was carried out considering consistency not only in frequency but also in damping and modal shapes results.

Figure 5 Data processing details: (a) average of the normalized singular values of the Spectral Density Matrices - EFDD method; (b) stabilization diagram of Setup 01 - SSI method; and (c) selection and linking process across all tests setups - SSI method

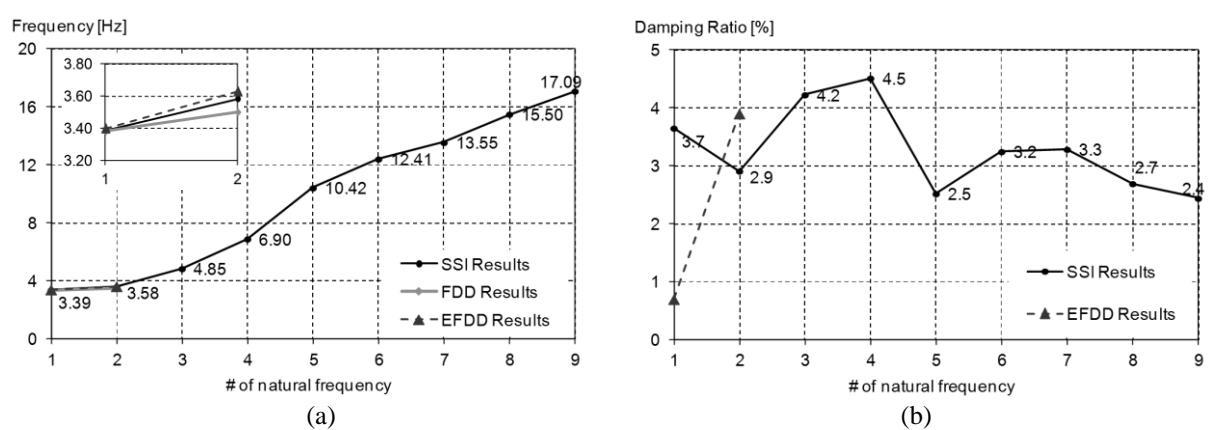
Figure 6 shows the results of the identified natural frequencies and damping ratios with the three methodologies. As shown, the FDD and EFDD methods allowed the identification of only the first two frequencies while the SSI method resulted in an improved identification of nine natural frequencies. In case of the first two frequencies, it is feasible to observe the small variability of the results on the three methods (see Figure 6a). Less reliable results were obtained for the damping ratios (see Figure 6b) which confirm the uncertainties on this value and the difficulties on properly identifying this parameter by the use of OMA. Despite of this, the results of damping ratios are coherent varying in the range of 2% to 5% in the whole cases.

Figure 6 Modal identification results: (a) identified natural frequencies; (b) identified damping ratios

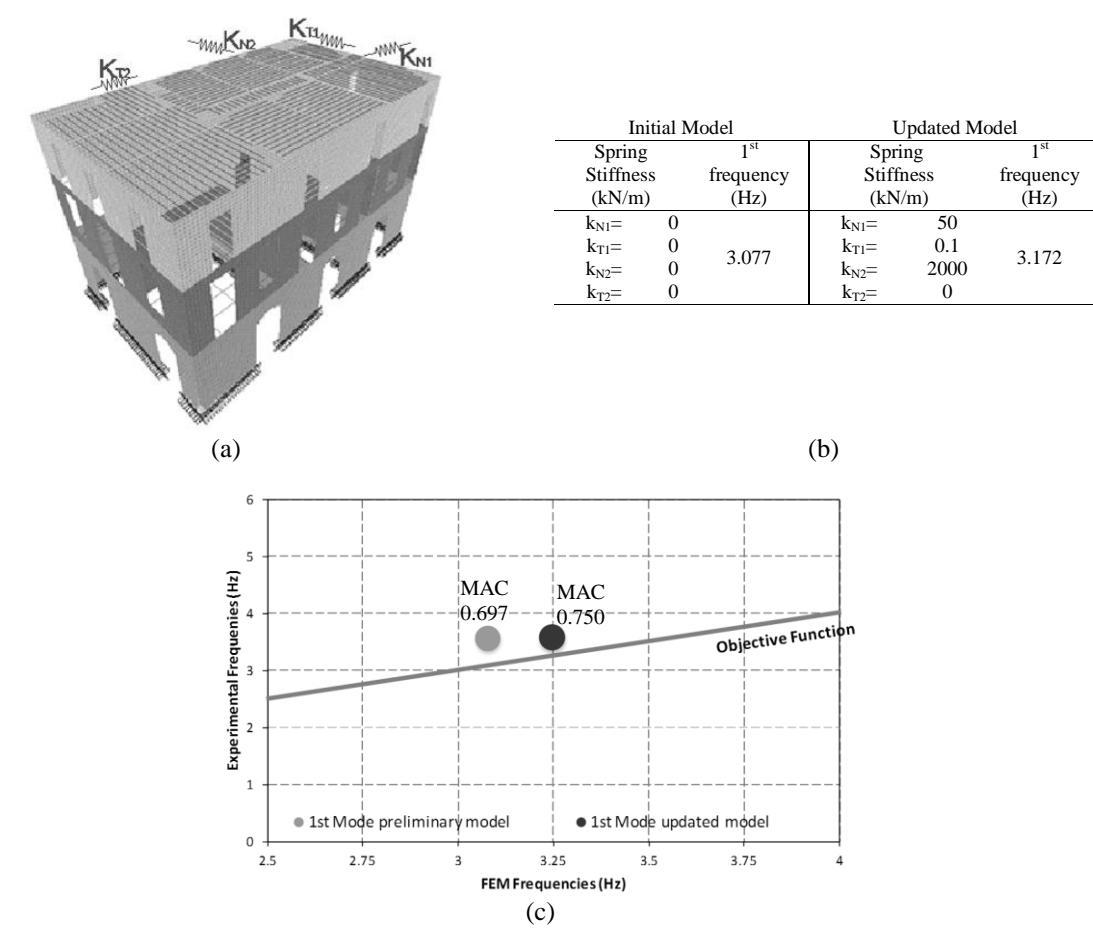
Joint springs were defined in the numerical model to simulate the missing part of the Hotel, and the neighbouring conditions (see Figure 9a). The model calibration process consisted in tuning the stiffness of the springs verifying the correspondence of frequencies and modal shapes between analytical and experimental results. The preliminary manual updating evidenced the contribution of the normal stiffness in the missing part and in the interaction limit with the other neighbouring buildings (Figure 9b). As shown in the MAC and frequency comparison plot (Figure 9c), even if the results show small differences in frequencies (11%) and acceptable MAC values of 0.75, the process is still not completed. Further works might be oriented in an extensive experimental campaign aiming at measuring more nodes in the structure and the implementation of automatic routines with an optimization algorithm for a proper calibration of the numerical model.

**Figure 9** Numerical analysis of the Hotel Comercio: (a) FE model; (b) stiffness properties; and (c) MAC – Frequency comparison plot of the first natural frequency
