## NOVEL PREFABRICATED PANELS FOR THE REPAIR OF DAMAGED INTERIOR RC BEAM-COLUMN JOINTS

**ABSTRACT:** A novel prefabricated panel is introduced for the repair and strengthening of damaged interior RC beam-column joints. This prefabricated hybrid composite plate (HCP) is made of a Strain Hardening Cementitious Composite (SHCC) reinforced with CFRP materials. Besides the higher durability of this system when compared to EB-FRP, thanks to the high ductility of the SHCC, anchors can be used in combination with adhesive to attach the HCP to the concrete substrate. The first section of this paper reports the methodologies to apply HCP for the repair of two severely damaged interior RC beam-column systems. To evaluate the performance of this rehabilitation technique, the repaired specimens were subjected to the same loading pattern as it was imposed to their virgin states. Since both repaired specimens showed a higher lateral load and energy dissipation capacities than the corresponding values in their undamaged state, the effectiveness of the HCP for the repair of damaged interior beam-column joints is proved.

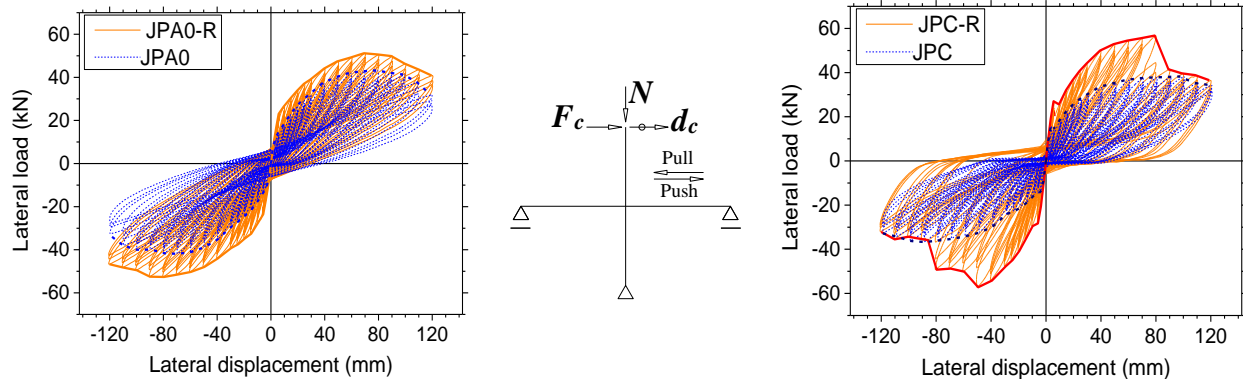
**Fig. 4 - Hysteretic and Enveloped Responses of the Repaired and Virgin Specimens**

Both repaired specimens were subjected to the same test setup and loading history that were used to characterize the response in their virgin state. For the virgin and corresponding repaired specimens, the hysteresis response in terms of lateral load versus column-tip displacement and its envelope are shown in Fig. 4. According to this figure both repaired solutions showed a higher lateral load carrying capacity than their virgin specimens. In addition, JPC-R presented lower pinching effect when compared to JPC.

The peak load of JPA0-R has increased 25.5% and 18.2% in the pull and push loading directions, respectively; while in JPC-R the values of 54.5% and 48.3% were obtained.

The addition of the lateral panels has provided an increase of 22% in initial secant stiffness of JPC-R while in JPA0-R the property registered in its virgin state was restored.
