Conservation of cultural heritage buildings: Methodology, research and applications

P.B. Lourenço

3. CATHEDRAL OF PORTO

4. THEOLOGICAL SCHOOL IN BRAGA

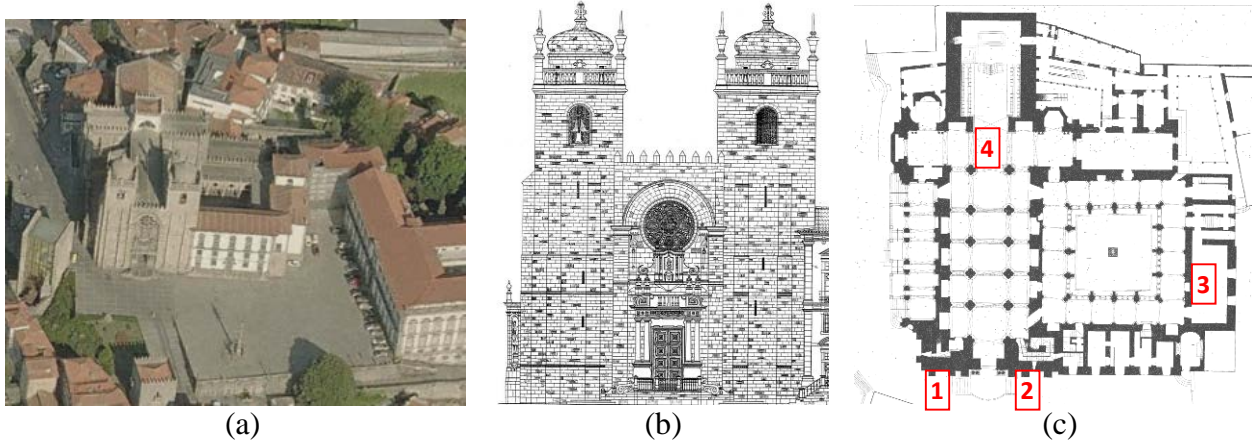
Figure 3: Aspect of the Cathedral: (a) Aerial View; (b) Façade; (c) Plan.
 Legend: 1 – North Tower; 2 – South Tower; 3 – St. Vincent Chapel; 4 - Skylight.

Figure 3 shows selected views of the compound of the Cathedral, which has dimensions about 60 × 60 m² in plan, with a maximum height of the towers about 35 m. The compound includes the church, a gothic cloister on the south side, side chapels, a gallery on the north side, a sacristy, several chapels and other annexes. The church has a typical Latin cross, with three naves and five spans, and two rectangular towers facing west.

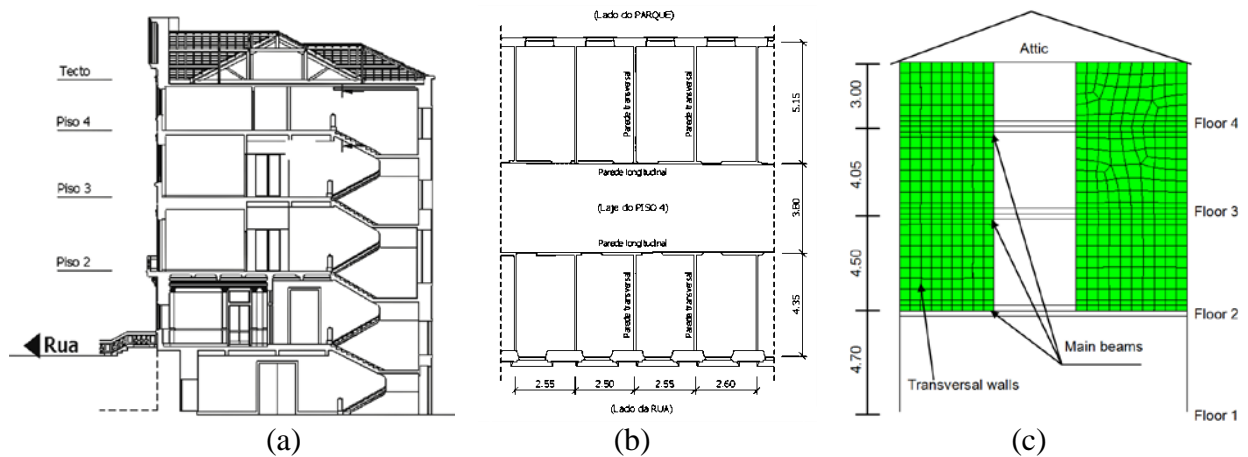
Figure 9: Theological school: (a) Vertical section; (b) Plan; (c) Main transversal structure.

This building has $110 \times 15 \text{ m}^2$ in plan and 5 floors, as shown in Figure 9a. The inner walls and slabs are made of an early 1930s reinforced concrete structure, while the external walls are made of ashlar granite masonry. Floor 5 is an attic with a timber structure, while floors 3 and 4 were used as students' dormitory in the past. The slabs at these levels are supported in beams supported in the external masonry walls. The internal walls between floors 2/3, 3/4 and 4/5 are made in reinforced

Figures 9b,c present the geometrical survey of the building and the main structure. Cores and steel samples were obtained from the building in order to characterize the materials used. The transversal walls are separated each 2.6 m, with asymmetric location of the longitudinal walls. The thickness of the external masonry walls varies between 0.30 and 0.60 m. The transversal beams have cross sections of $0.25 \times 0.50 \text{ m}^2$ (floors 3 and 4) and $0.30 \times 0.60 \text{ m}^2$ (floor 2). The thickness of the slabs is 0.12 m and the internal walls have a thickness of 0.06 m. The concrete strength found was 24.6 N/mm^2 (slabs) and 11.9 N/mm^2 (walls). All the reinforcement found is unribbed and mild steel. The slabs have a single layer of reinforcement with $\phi 3/8'' @ 0.125$ for the main reinforcement and $\phi 3/8'' @ 0.25$ for the secondary reinforcement. The walls have also a single layer of reinforcement with $\phi 3/16'' @ 0.25$ in the vertical direction and $\phi 5/32'' @ 0.25$ in the horizontal direction. The lower reinforcement in the transversal beams is $3\phi 1''$ (floors 3 and 4) and $4\phi 1\frac{1}{4}'' + 4\phi 1''$ (floor 2). Besides the dead load, for the current use of the building the live load according to the Portuguese code is 3.0 kN/m^2 in general with 5.0 kN/m^2 is the access zones. With the new use, the planned live load is 14.8 kN/m^2 for floor 2, 13.5 kN/m^2 for floor 3 and 11.0 kN/m^2 for floor 4.
