Survey and dynamic behaviour of the Our Lady of Conception Church, Portugal

ABSTRACT

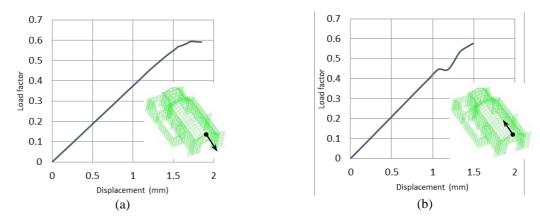
Pushover analyses with a horizontal load pattern proportional to mass were carried, aiming at evaluating the dynamic behaviour of the church. For the material constitutive model the Total Strain Fixed Crack Model, which it is a model of distributed and fixed cracks based on the total strains, was adopted. For more details on the material properties see [Besca 2012]. Several pushover analyses in the positive and negative longitudinal (Y) and transversal (X) direction were carried out. Furthermore, the response of the structure was evaluated in several points of control, which presented similar behaviour. Fig. 9 presents the capacity curves of the pushover analyses in the longitudinal direction. The maximum load factor is equal to 0.60, which corresponds to a high value, and the displacement at the top of the façade is small (about 2 mm). These aspects are related to the high stiffness in the longitudinal direction (buttresses). On the other hand, the maximum load factor in the transversal direction is about 0.35 and presents higher deformation (Fig. 10). Thus, the results of the pushover analysis show that the transversal direction is the most vulnerable direction of the church and the maximum load factor is equal to 0.35.

Figure 9. Capacity curves in the longitudinal direction: (a) - X; (b) + X.

As a future works, pushover analysis with load pattern proportional to the first mode shape and dynamic non-linear analysis with time integration should be carried out, aiming at concluding on the safety of the structure and influence of the existing damage.
