1st International Symposium on Building Pathology

Rain infiltration mechanisms in ventilated façades: literature review, case studies, understanding common practice flaws

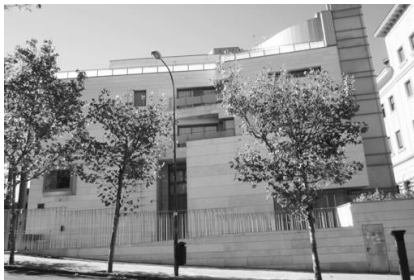
Figure 8. General view.

the gap by gravity creating some kind of tank (see C in Fig. 12). Thereby, as the infiltrated rainwater is not drained and has difficulties in being evaporated, it might cause the spalling of the plaque in that area if it freezes. This type of damage has been observed during the inspection of the building (see Fig. 10). Wind pressure might force the occluded water to drip down the threaded rod of the anchor (level VII) or the inner surface of the plaque (level IV; D in Fig. 12). On the other hand, rainwater infiltrates in vertical joints by means of capillary suction (level II) since the stone plaques are placed side by side in horizontal rows. Then, vertical joints are capillary pathways, in which water can be driven to the backside of the plaques by wind forces and by pressure differences (level IV; B in Fig. 13). Note that both horizontal and vertical joints can get easily occluded, leading to an airtight exterior leaf, corresponding poor pressure equalisation, and in turn high pressure differences over the cladding causing water to infiltrate more quickly into the cavity. The moisture stains at the bottom border of the façade demonstrate that water flows down along level VII.

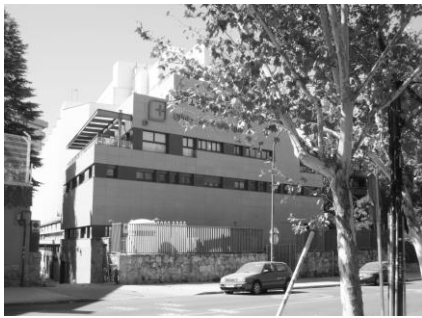
Figure 14. General view.

(level II; Fig. 18). However, whether water will reach the thermal insulation layer (level VII; B in Fig. 18) or only come into contact with the horizontal profile (level V; B in Fig. 17 and A in Fig. 18) and the vertical profile (level VI; C in Fig. 17) is uncertain. The rainwater that collides with the horizontal profile (see B in Fig. 18) will run down and accumulate at the bottom part (level V; A in Fig. 18) by gravity. Albeit, if it comes into contact with the screws it might be forced through the gap to the rod of the screw and / or the backside of the vertical profile by means of wind pressure and capillary suction (see D in Fig. 17). The rainwater impinging on the exterior surface of the vertical profile (level VI; C in Fig. 17) will trickle down by gravity until it reaches the top border of the horizontal profile. Then, it can flow down through the contact interface between the profiles (level VI; E in Fig. 17) or it can be held in the horizontal profile (level V; F in Fig. 17). If the stagnant rainwater reaches the connection between two horizontal profiles by local air currents and / or wind pressure, it might leak and run down either the inner surface of the panel (level IV) or the vertical surface of the horizontal profile (level V; G in Fig. 17). Finally, the rainwater that collides with the panel (level I; H in Fig. 17) will run down by gravity until it reaches the lower border, where it might flow sideways by surface tension and drip down in level III by gravity. Note that whereas the water flowing along the lower face of the panel (level I) might infiltrate in the anchor gap by capillary suction, the water flowing in level III might drip in the gap by gravity (see I in Fig. 17). Like in the before mentioned case, the freezing of this infiltrated rainwater might cause the spalling of the panel (see Fig. 15). In addition, red and black stains over the fibre cement panels and moisture stains over the bottom border of the façade have been identified during the inspection (see Fig. 16).

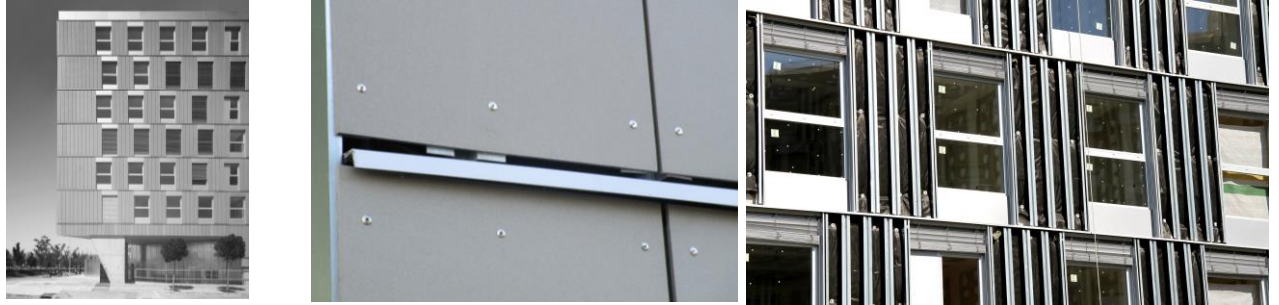
Figure 19. General view.

profile, which will drain it directly outside the façade. Note that if the splash caused by the rainwater colliding with the horizontal profile might project water droplets onto the insulation is uncertain. In contrast, the entry of rainwater through the lower area of the joint (see F in Fig. 22) is rather unlikely as the shape of the profile prevents it. Note that the rainwater channelled outwards by the horizontal profile might leak down through the connection between profiles by gravity. There might be a critical point in the connection of the horizontal profile with the bracket if the slope of the profile is not sufficient. If rainwater reaches that point it might leak down through the gap of the screw by gravity (see G in Fig. 22). No damages have been identified during the inspection of the building.
