Fatigue failure mechanism analysis of 1Cr17Ni2 stainless steel blades ground by an abrasive belt

Fatigue failure, as the main failure form of aero-engine blades, has a direct impact on the reliability and service life of aviation equipment. In order to improve the service performance of machined blades, it is necessary to understand the failure process and failure mechanism of blades and then optimize the grinding process. This paper takes abrasive belt grinding of an 1Cr17Ni2 stainless steel blade as the research object and analyzes the fatigue failure mechanism by characterizing the surface morphology, cross-sectional microstructure, and cross-sectional characteristics of the fatigue failure blade. The results show that cracks are prone to propagate in carbon-rich areas with poor mechanical properties inside the material, and the accumulation of large-size carbon-rich areas leads to continuous cracks easily and accelerates crack growth. The grinding process promotes the migration and consumption of surface carbon elements and forms a carbon consumption layer on the surface of the material, which can inhibit the initiation of fatigue cracks. The point-like pits on the ground surf

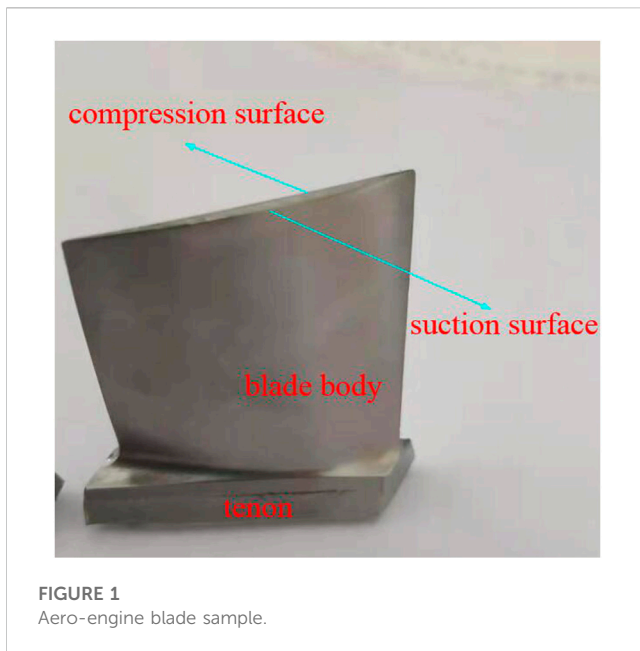
FIGURE 1
Aero-engine blade sample.

The object of this paper is 1Cr17Ni2 stainless steel grinding by using an abrasive belt, and its geometric structure is shown in Figure 1. It is mainly composed of a tenon and a blade body, and the blade body is composed of a suction surface and a compression surface; also, they are two typical complex surfaces. The chemical composition mass ratio and mechanical properties of the samples are shown in Table 1 and Table 2, respectively. The blades were processed from forged blanks by reduced materials. The blank was first milled to ensure the accuracy of the profile followed
