Guidelines for Conservation and Restoration of Historic Polychrome Plasterwork: the Church of St María la Blanca in Seville, Spain

Case study: the Church of Santa María la Blanca

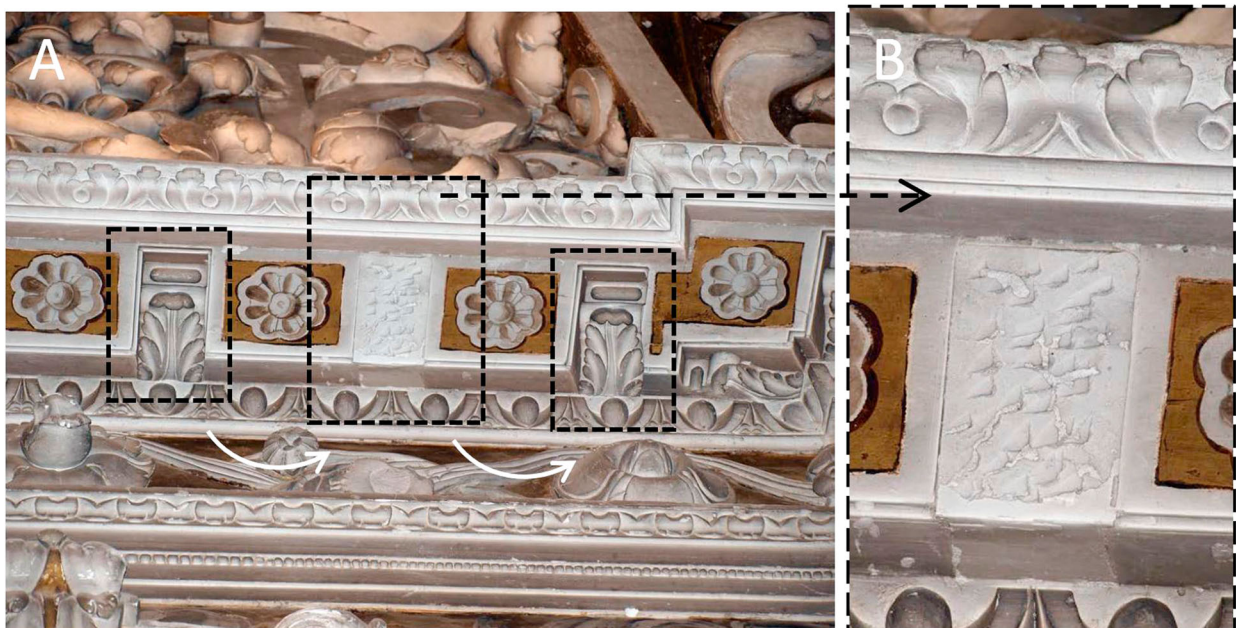
Figure 3. Cornice of the central nave (A), marks made to adhere a corbel, partially filled with the adhesion grout (B).

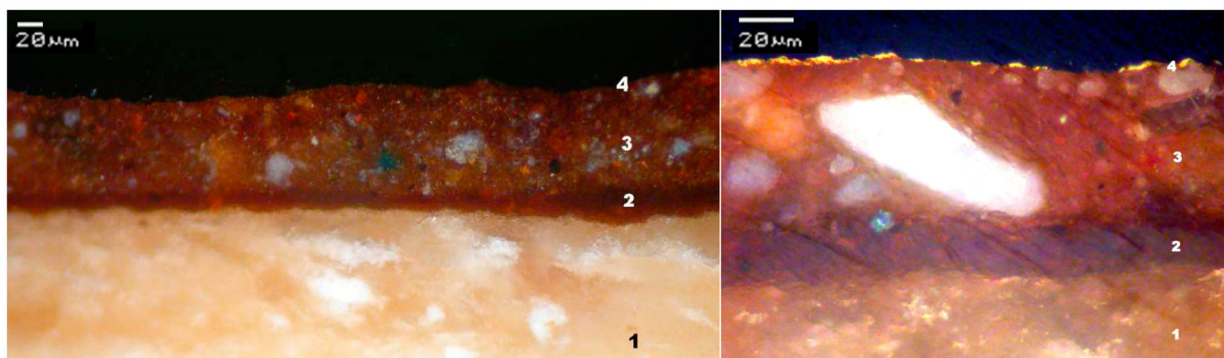
In N1 sample, the inner double-preparation layers are very rich in a lipid-based binder (Figure 8). It can be described that the base for gilding was achieved with a double layer of brown color. The first (layer 2) is very rich in linseed oil; another thicker layer (layer 3) was added, with a higher proportion of pigments than the previous one, but also rich in oil, onto which the gold leaf was applied.

Figure 8. (A) Cross-section of micro-sample N1 obtained under a light microscope (20X / 0.40 MPlan objective); (B) (50X / 0.75 MPlan objective) partially crossed polarizers. The metallic shine of the gold leaf can be seen.

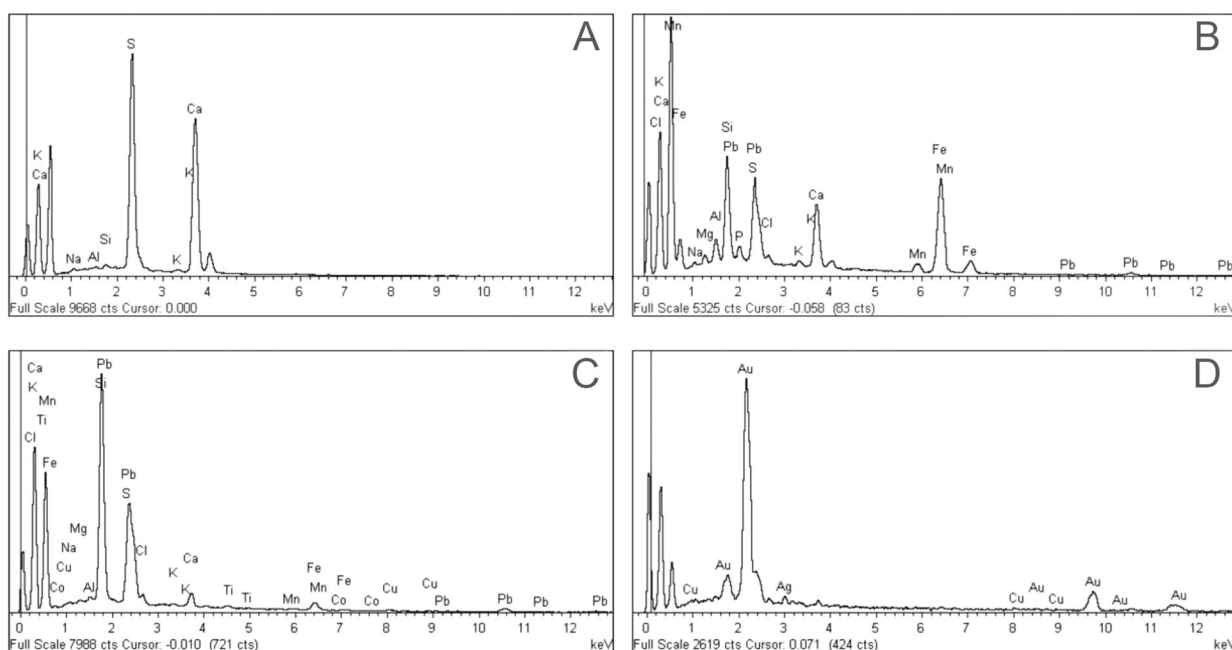
The EDX spectrum (Figure 9) in N1 sample shows that the first white layer is essentially gypsum with a very low proportion of silicates. Layer 2, approximately $20\text{ }\mu\text{m}$ thick, has a chemical composition attributable to the presence of red earth, shade earth, white lead in a low proportion, calcium carbonate and gypsum also in a low proportion, and bone black in a very low proportion. In layer 3, which is thicker than the previous one (approximately $80\text{ }\mu\text{m}$), blue enamel appears in low proportions and azurite in very low proportions, together with those components found in layer 2 such as red earth, white lead, shade earth, and gypsum. Finally, layer 4, which is almost $1\text{ }\mu\text{m}$ thick, shows gold with 93.4%, silver 5.7%, and copper with 0.9%. Cerussite is a mineral consisting of lead carbonate (PbCO_3), and its use as a siccative suggests the use of

Figure 9. EDX spectrum of sample N1: layer 1 (A), layer 2 (B), layer 3 (C), layer 4 (D).

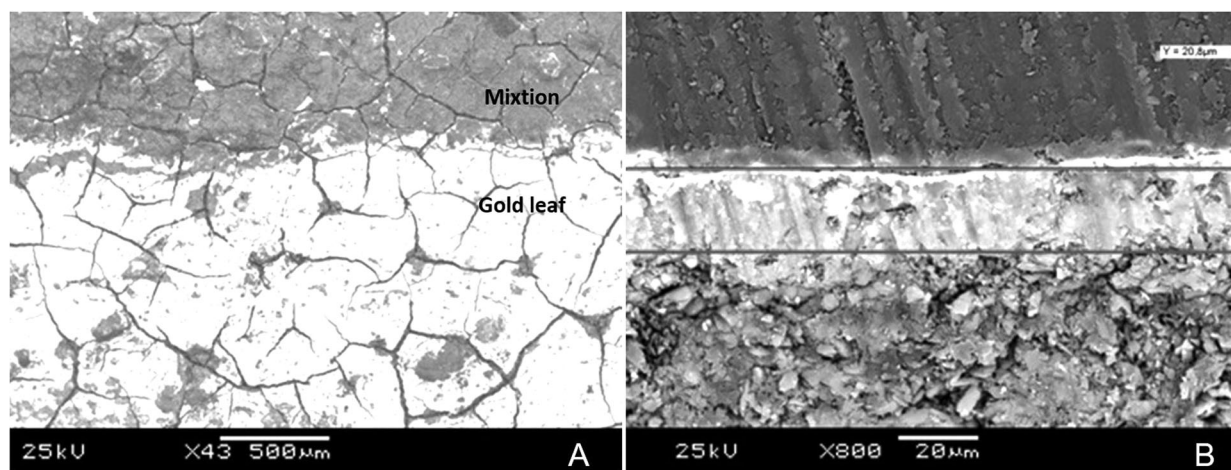
Samples N1 and N2 indicate that the gold was applied in a very thin sheet barely one micron thick, which is gilded with gold leaf, on a mixed mordant (20–80 μm) and without any other prior preparation or bole so it is possible that a light wetting of the varnish (clay or iron oxide) would adhere it (Figures 8–10). Sample N2 of altered gilding (Figure 10A), in which the stamping of the gilding is observed, is in a worse state than sample N1.

Figure 10. (A) SEM images in BSE mode of sample N2 and (B) stratigraphy of sample N2.

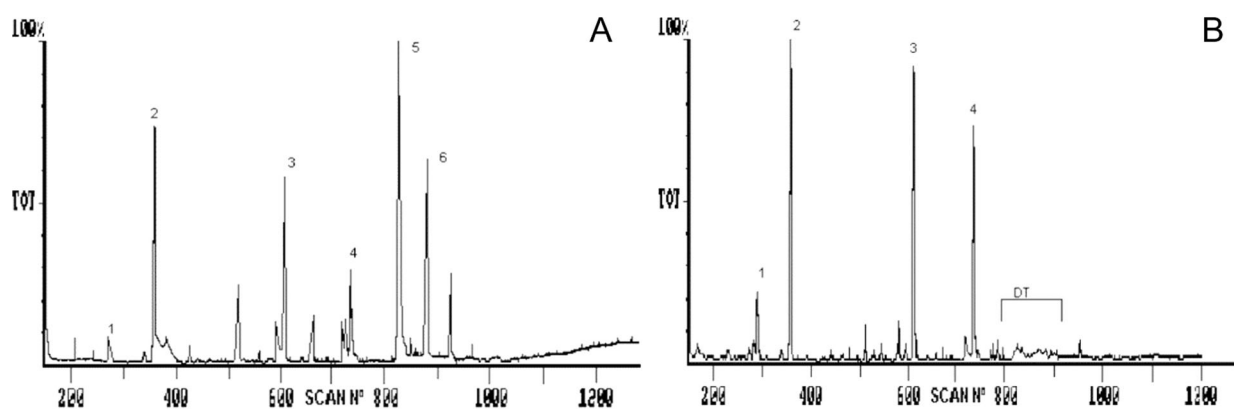
From the study by GC-MS of sample N1, it was concluded that the most transparent material, corresponding to the layer in contact with the gold, has fatty acids (palmitic acid, stearic acid, suberic acid, and azelaic acid) and terpenes (dehydroabiatic acid and 7-oxodehydroabiatic acid), compounds that reveal a linseed oil content and a conifer resin, probably rosin (Peris Vicente 2008) (Figure 11(a)).

Regarding sample N2 (Figure 11(b)), the results indicate a clear linseed oil due to the proportions of palmitic and stearic acid, with a small fraction of diterpenes. As in the case of sample N1, the relationship between the proportions of suberic and azelaic acid appears to indicate a previous cooking of the oil to increase its drying properties, or simply as a consequence of the manufacturing process of the homogeneous mixture itself.

Figure 11. (A) Chromatogram obtained by GC-MS of sample N1, in which it is observed that the composition of terpenes/fatty acids characterizes the sample as a mixture of rosin and linseed oil; (B) Chromatogram obtained by GC-MS of sample N2: a minimal presence of diterpenes is observed in a linseed oil base. [1 Methyl suberate, 2 methyl acetate, 3 methyl palmitate, 4 methyl stearate, 5 methyl dehydroabierate, 6 7-oxo-dehydroabierate].

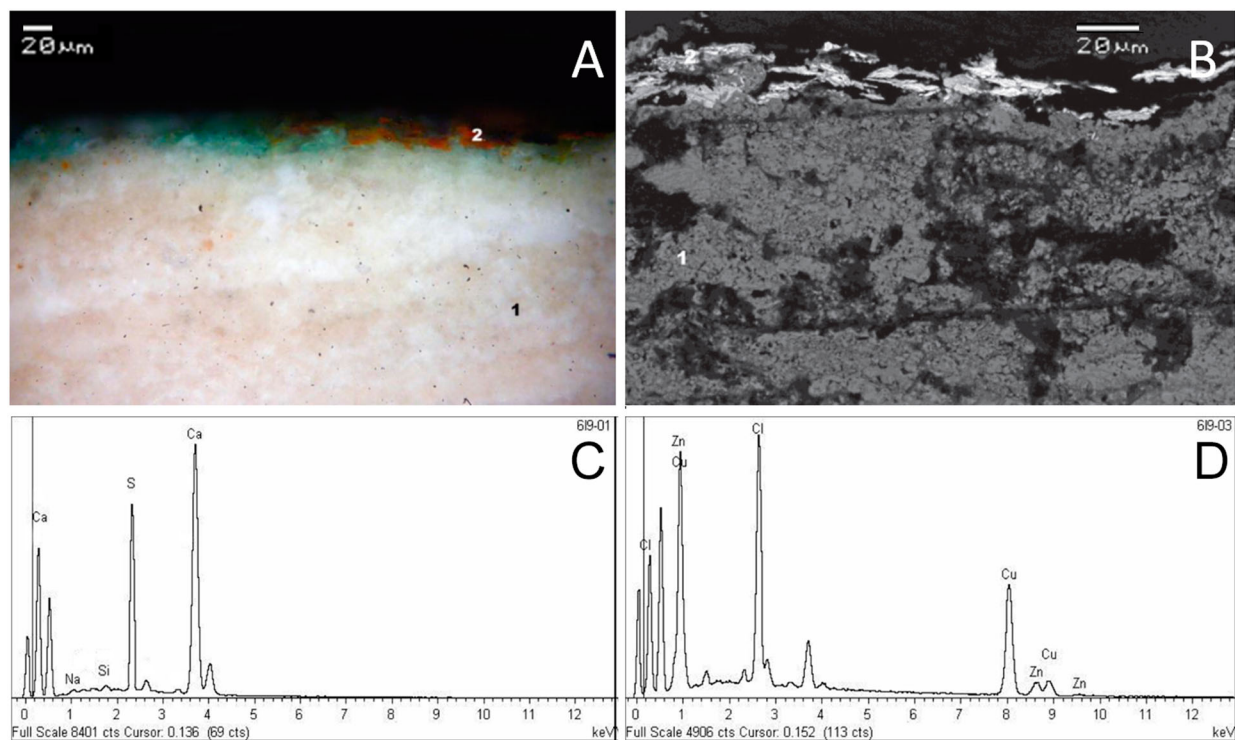
of approximately 450 μm , has a chemical composition mainly attributable to the presence of calcium carbonate and gypsum; and layer 2, with a thickness of around 30 μm , with a reddish and greenish color, is composed of 87.5% copper and 12.5% zinc. Therefore, the green color is assignable to a paratacamite, a hydroxychloride of copper and zinc.

Figure 12. Sample N3 image of the cross-section viewed under a light microscope (MPlan 20X/0.40 objective) (A); SEM images in BSE mode (900X) (B); EDX spectrum: layer 1 (C), layer 2 (D).

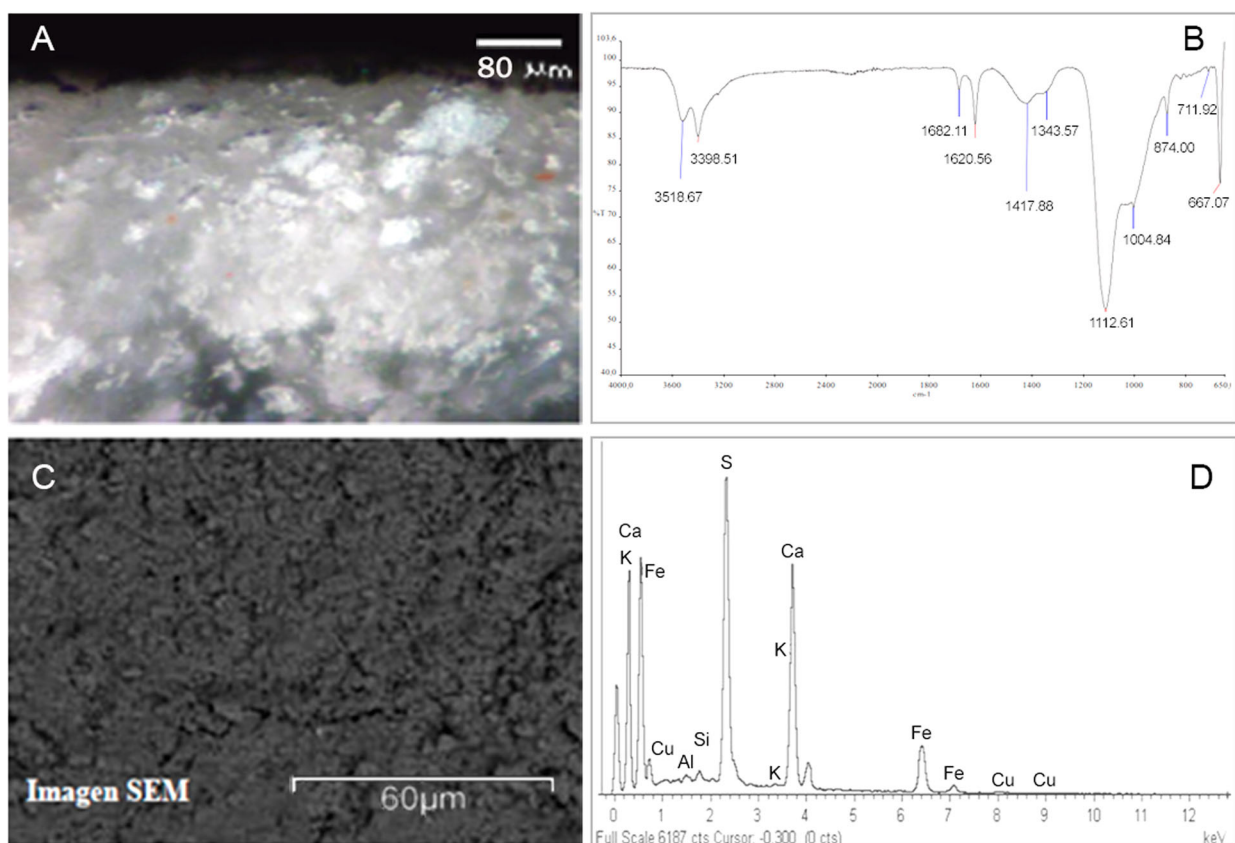
The infrared spectrum of sample N4 (Figure 13(b)) was clearly useful to identify gypsum (calcium sulfate dihydrate), as it shows absorption bands at 1110, 670, and 597 cm^{-1} , characteristic of the sulfate group (vibration modes of sulfur–oxygen bonds). In particular, bands over 3000 cm^{-1} (3524 and 3398 cm^{-1}) are related to water incorporated in the gypsum structure (O–H stretch vibrations), apart

Figure 13. Sample N4 (A) Cross-section viewed under a light microscope (MPlan 20X/0.40 objective); (B) FTIR spectrum; (C) image obtained by SEM; (D) EDX spectrum.
