**Final Report on the
I-129 Missouri River Bridge
Deck Condition Assessment Using Non-Destructive
Testing Methods**

Bridge No. 9700.0S129, Sioux City, IA

**Final Report
I-129 Missouri River Bridge
Deck Condition Assessment Using Non-Destructive Testing Methods
Bridge No. 9700.0S129, Sioux City, IA**

November 5, 2012

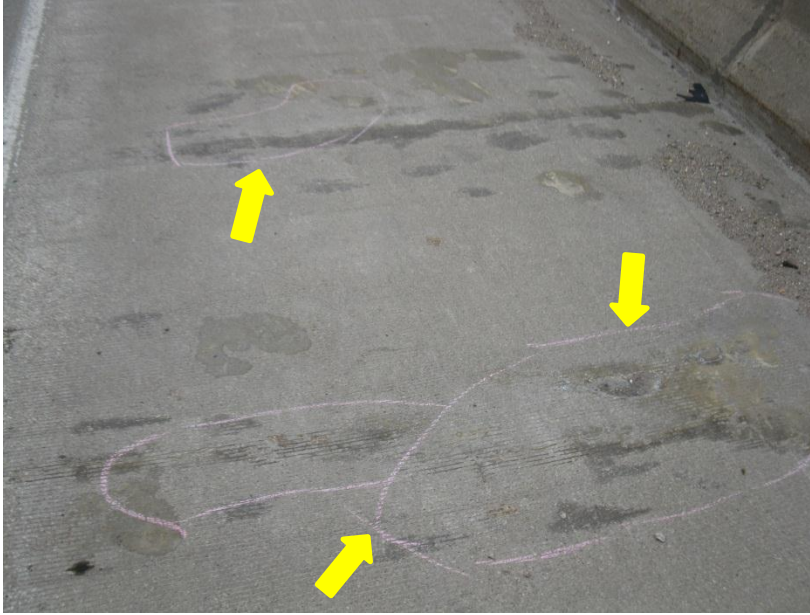
concentrated in the shoulder, as shown in Figure 2.10. Approximately three-fourths of the damage identified in the eastbound lanes occurs between Pier Nos. 6 and 7 and between Pier Nos. 1 and 3.

Figure 2.10. Delamination in shoulder (highlighted in chalk). Note epoxy injection resin on the surface.

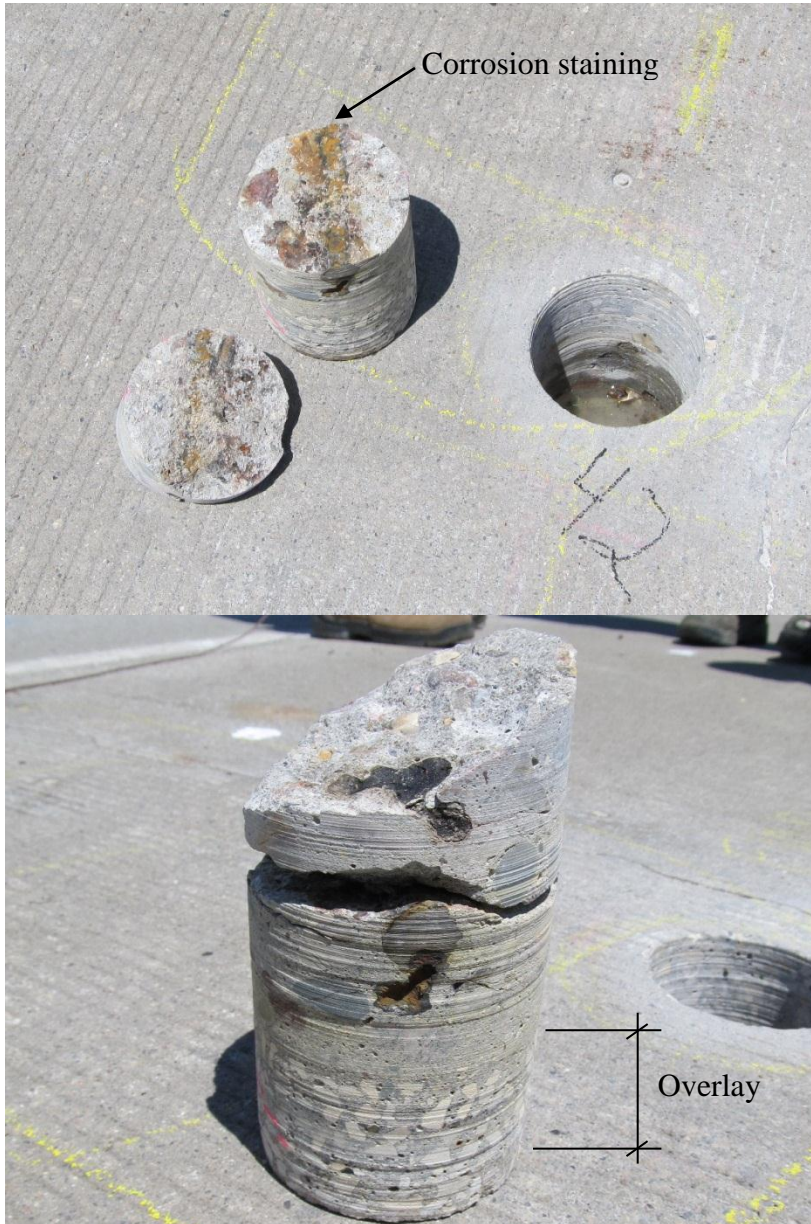
Core sections separated to show both faces of core at delamination plane.

Figure 2.11. Core sample with evidence of horizontal cracking/delamination along the plane of reinforcement due to corrosion of the reinforcing. Note smaller coarse aggregate in overlay visible in bottom photograph.

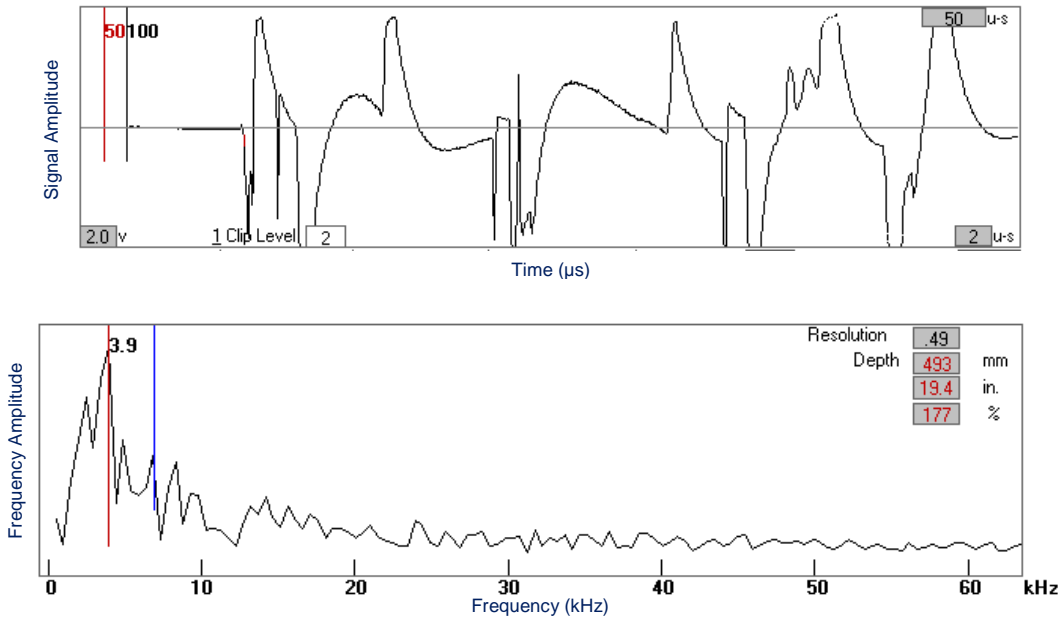
Figure 5.6. IE test result showing a shallow delamination (Study Area EB-1; Station 318).

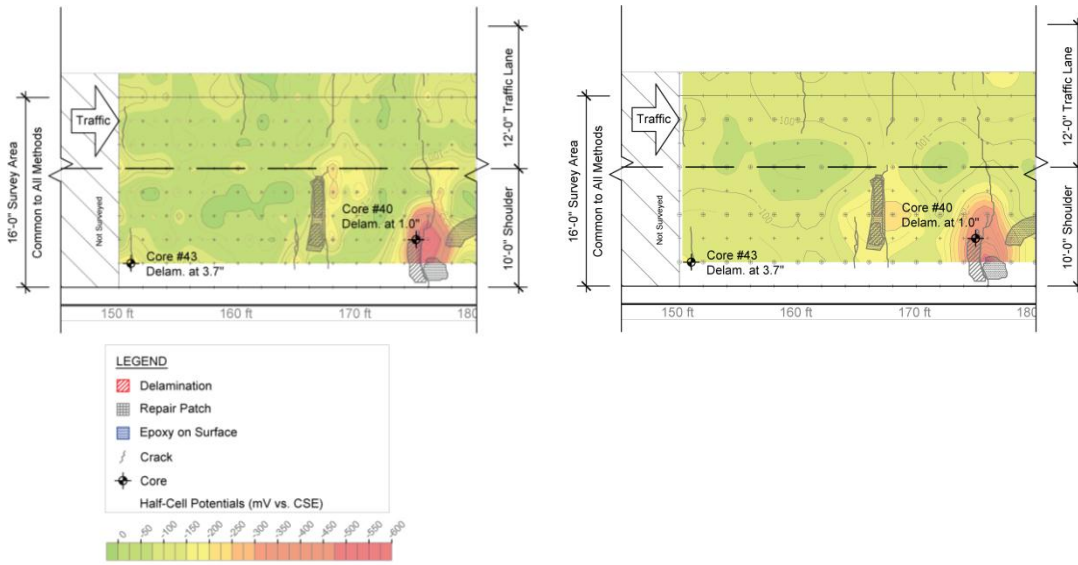
Figure 6.8. Comparison between a) single rolling wheel and b) rolling cart equipment. Note that the elevated corrosion potential at Core #40 is shown in both a) and b), but that the elevated corrosion potential at Core #43 is only resolved in data collected with the single rolling wheel shown in a).

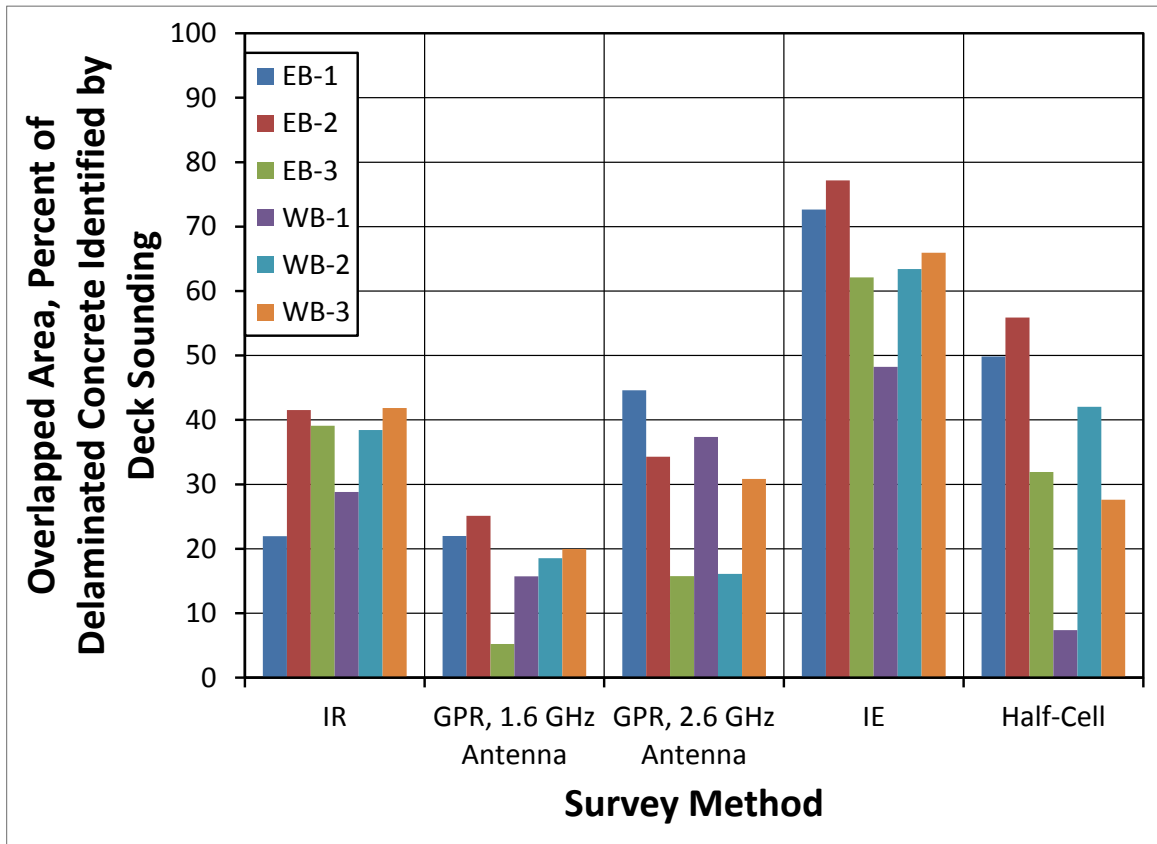
Figure 7.1. Overlap between the areas identified as delaminated by the NDT methods and by sounding for each in-depth study area, as a percentage of total delaminated area. Note that Study Area WB-2 was 12-ft wide, whereas all other study areas were 16-ft wide.

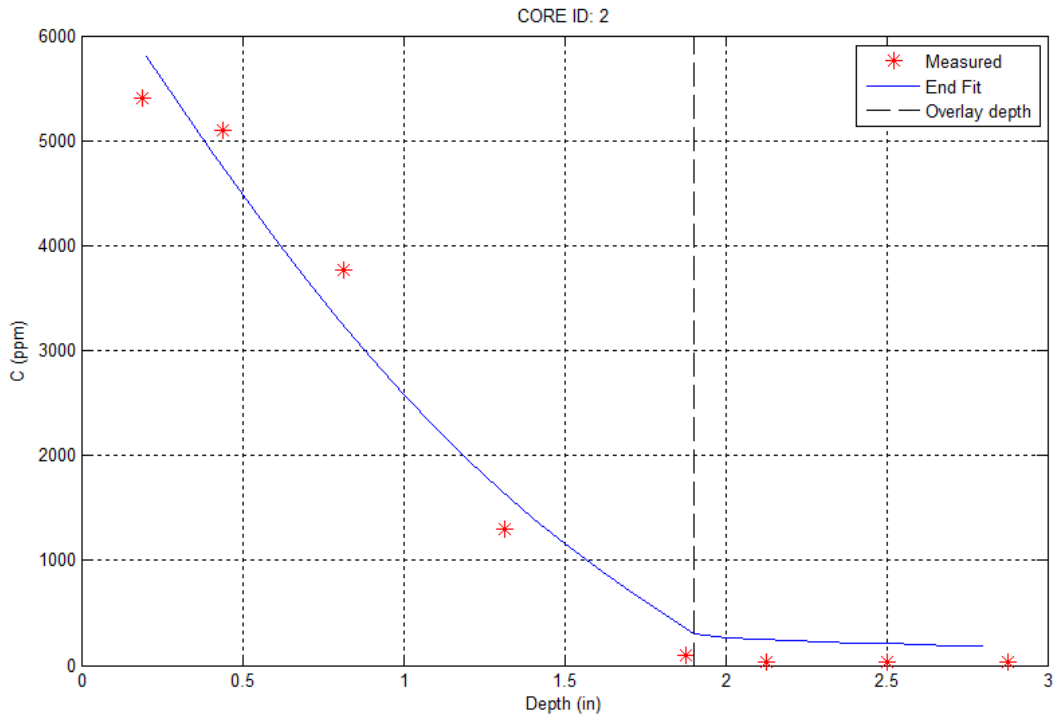
For typical bridge deck concretes, apparent diffusion coefficients in uncracked concrete may be categorized as very low to high, when they range from 0.05 in.²/yr. to 0.30 in.²/yr., respectively (Krauss, Lawler, & Steiner, 2009). In the overlay, apparent diffusion coefficients were determined based on a least-squares error fit of the finite difference discretization to measured chloride content data from cores, an example of which is shown in Figure 8.9.

Figure 8.9. Example of least-squares fit to measured chloride content using finite difference solution.

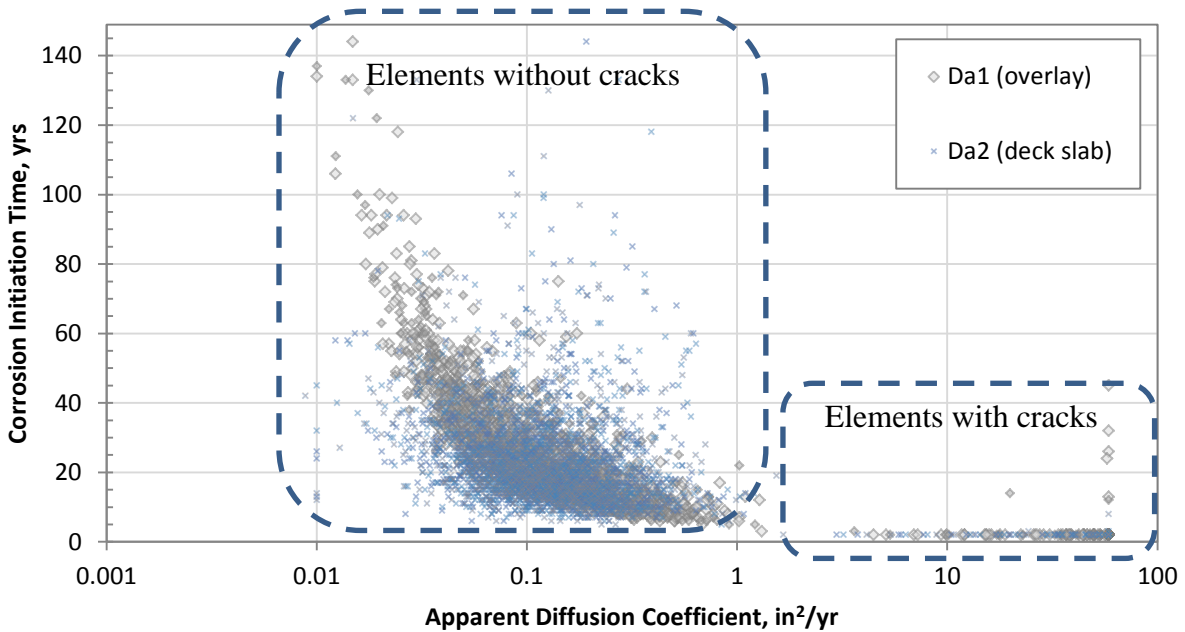
The modeled performance with and without the overlay show similar damage levels through the first 10 years due to the early incidence of damage at cracked regions. In this phase, the first phase of the damage curve, the permeability of the overlay has minimal discernible effect on reducing damage because it does little to reduce chloride penetration at cracks, where most of the chloride penetration and deck damage occurs in the early life of a bridge deck. This influence is best illustrated by the following comparison of the corrosion initiation time for each segment of the bridge deck, as defined in Section 8.3.1.1. Each such segment was assigned properties defined by the statistical distributions measured or assumed for the specific deck. Figure 8.13 and Figure 8.14 plot corrosion initiation time for each segment versus apparent diffusion coefficient for both the as-built and no-overlay conditions, respectively. The apparent diffusion coefficients in cracked regions are generally greater than 1 in.²/yr. regardless of whether or not an overlay is present, and have corresponding low corrosion initiation times generally less than 5 years for both conditions. For uncracked regions, initiation time correlates with the apparent diffusion coefficients of the upper zone of concrete in the deck (D_{at}), which is a low-permeability concrete in the case with the overlay and ordinary concrete in the case without the overlay. When the low permeability of the overlay is considered, corrosion initiation times are generally greater than 60 years, as shown in Figure 8.13. However, when the overlay permeability is no greater than the deck slab concrete, initiation times still correlate with D_{at} , but are reduced and generally range between 5 and 60 years (see Figure 8.14).

Figure 8.14. Relationship between apparent diffusion coefficient and corrosion initiation time, plotted for Study Area EB-1, calculated without the benefits of a low-permeable overlay.

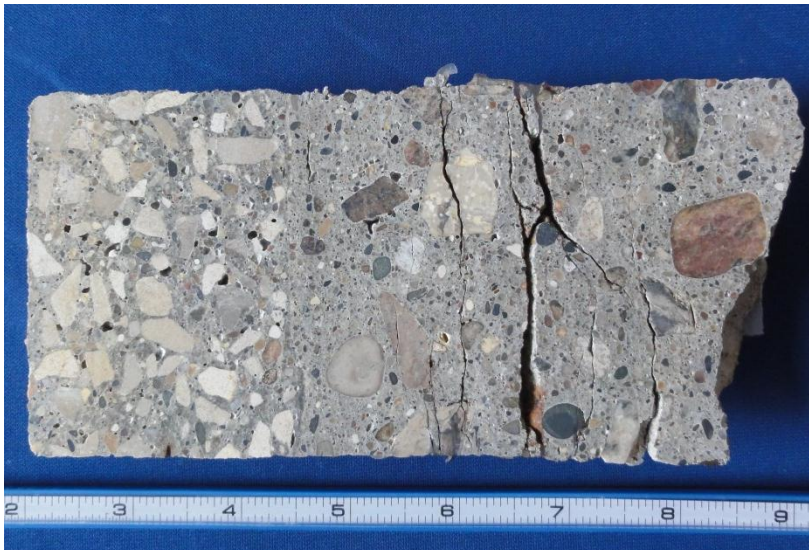
The core was 5 to 6-3/4 inches long, and 3-3/4 inches in diameter. The core consisted of two different concrete mixes: a topping constituting the top 2-1/4 inch of the core; and base concrete constituting the bottom 2-3/4 to 4-1/2 inches of the core. The top surface of the core had shallow grooves as in Core 6, and the bottom end was a fractured surface. As received, the topping was bonded to the substrate concrete (Figure 7). A 3/4-inch diameter (No. 6) rebar was embedded in base concrete, 3-1/2 inches from the top of the core. The rebar was significantly corroded (Figures 8 and 9).

Figure 7. Lapped section of Core 42; top end is on the left of the photo. Numerous cracks due to corrosion and ASR are present in the base concrete; no cracking was detected in the topping concrete.

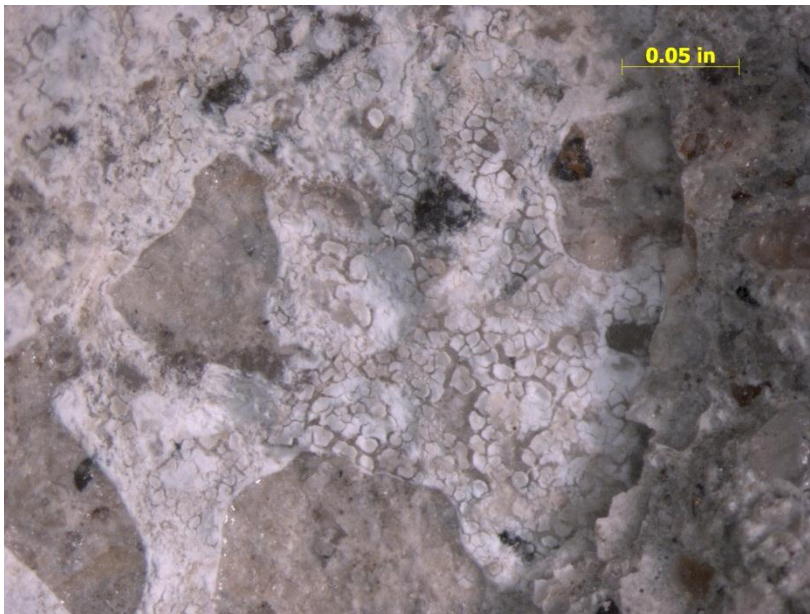
Figure 11. Core 42; close up of the light color area of the bottom surface of the core from Figure 8 showing that the surface is coated with ASR gel.

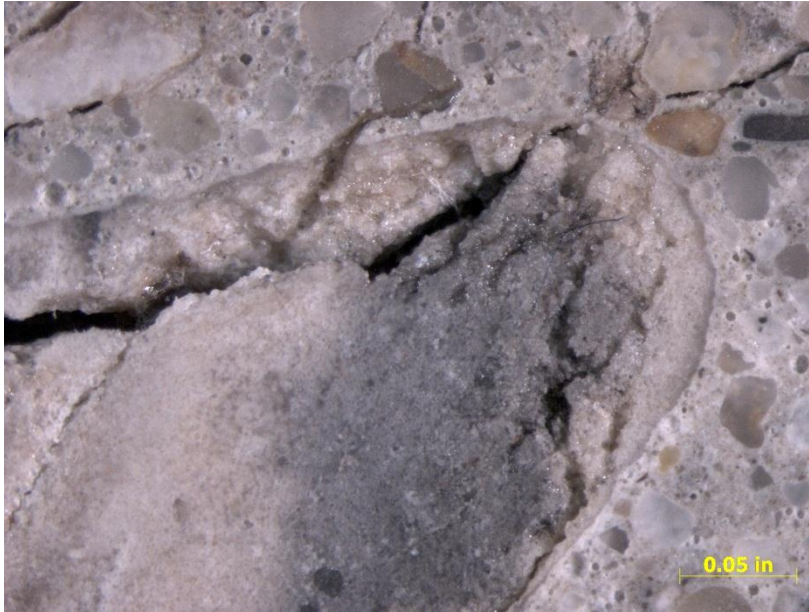
Also present in the cracked zone were two particles of sandstone; one was relatively large measuring 1/2 by 3/8 inch. Similar particles were not observed in any other location of either of the two cores (Figure 12). This particle contained reactive elements and was partially consumed in ASR.

Figure 12. Core 42 base concrete; reactive sandstone particle, partially consumed in ASR; cracks extending into the surrounding cement paste.

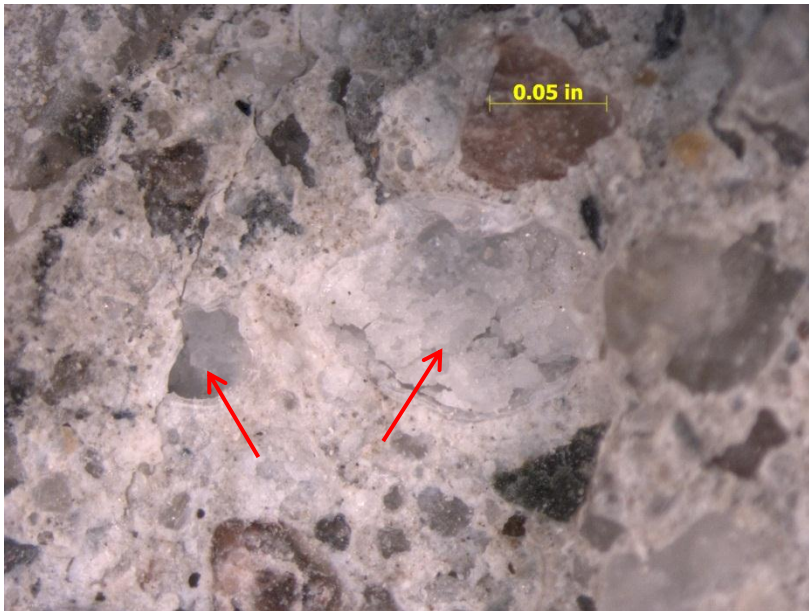
The fine aggregates were similar to those in Core 6. Soft particles of shale contained major amounts of siliceous, glassy material. Some of these particles were associated with the presence of ASR gel (Figure 13).

Figure 13. Core 42; air voids partially filled with ASR gel at one of the crack surfaces in the base concrete.

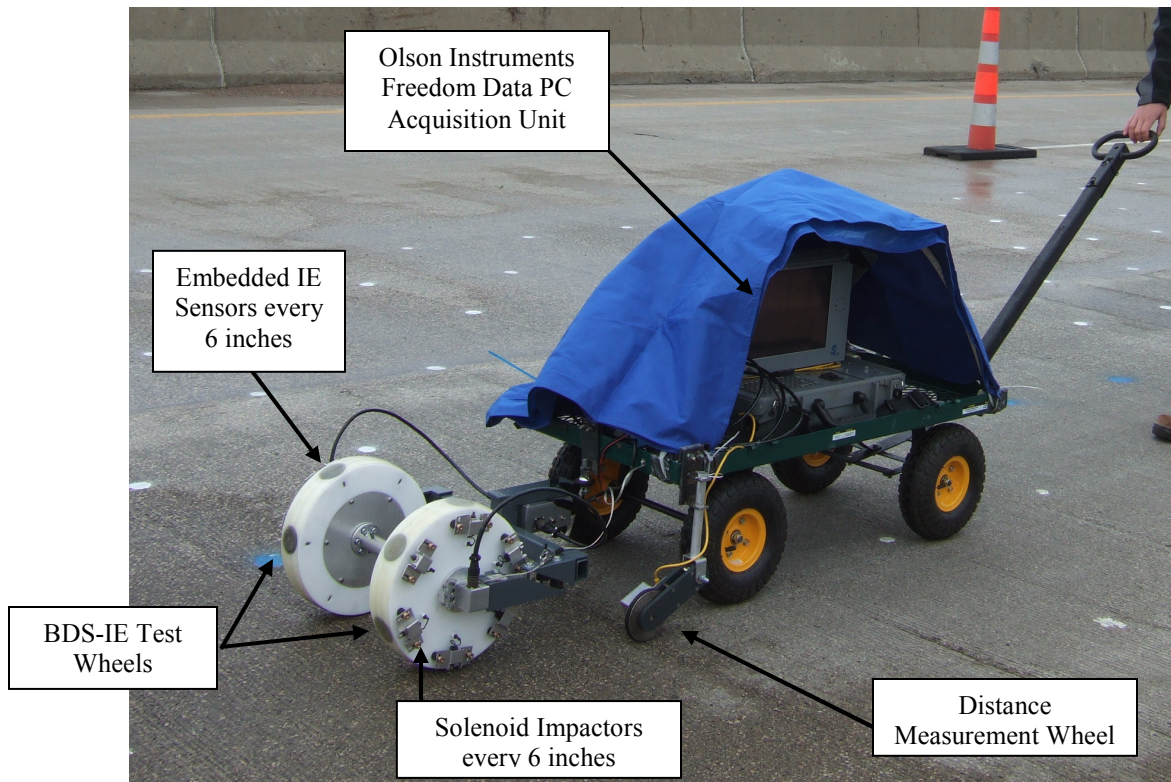
Figure 1: Photograph of Olson Instruments BDS-IE system (2 transducer wheels) on the I-129 Bridge. The computer acquisition system was covered with a tarp due to rain.

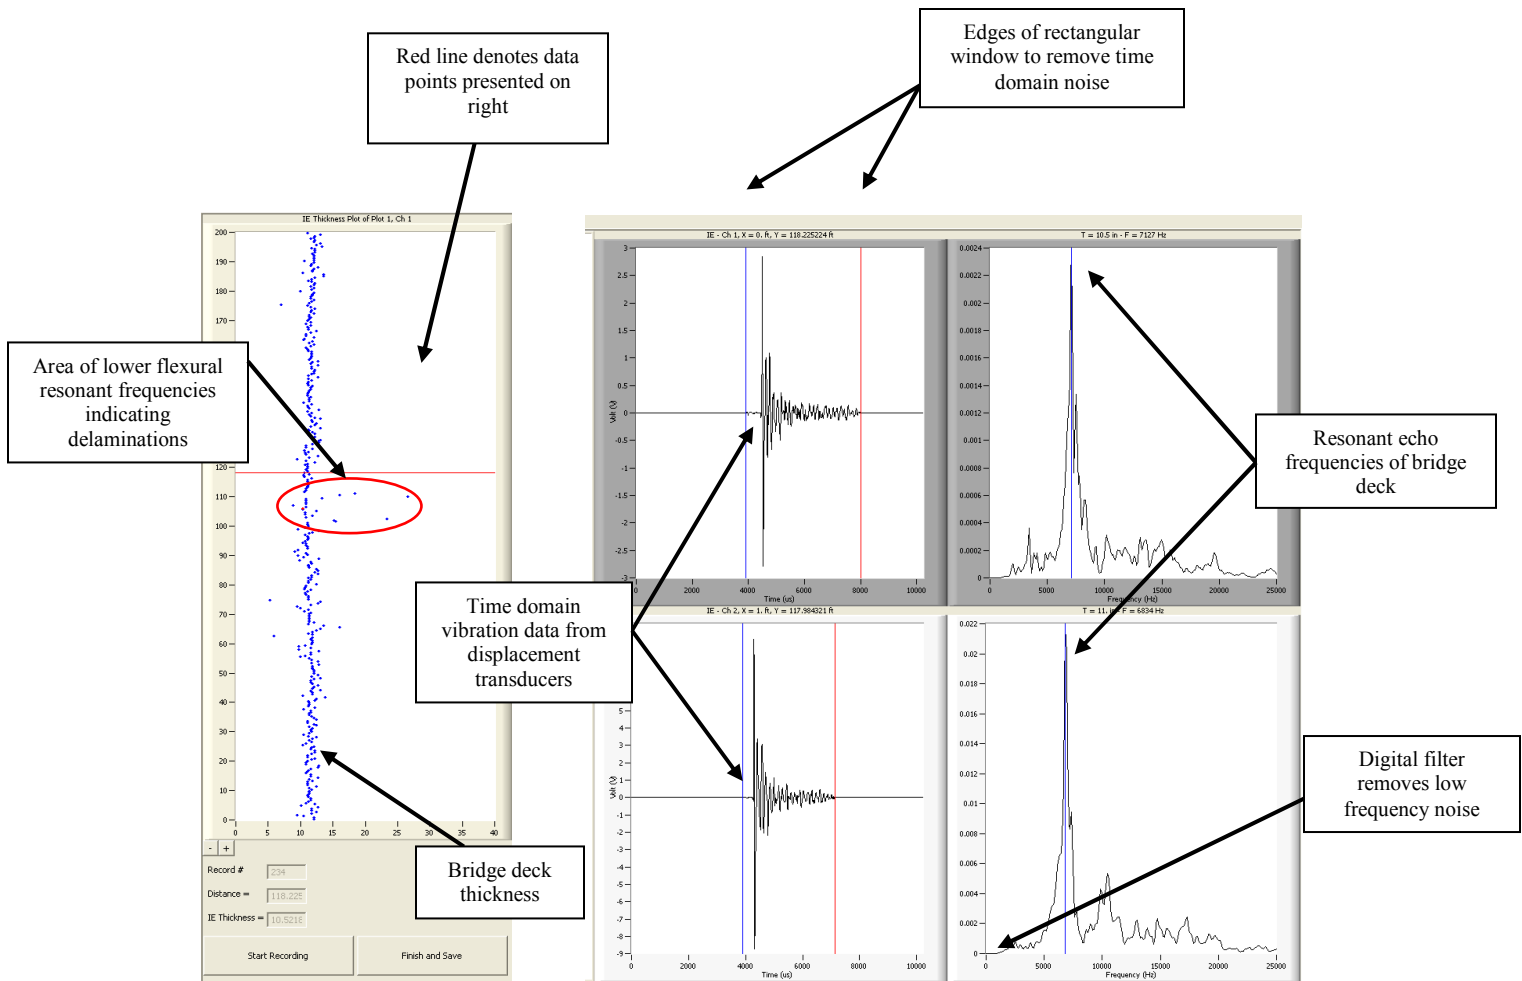
Figure 3: Example Impact Echo Results from a 50 ft long scan line for the Olson Instruments BDS-IE system.

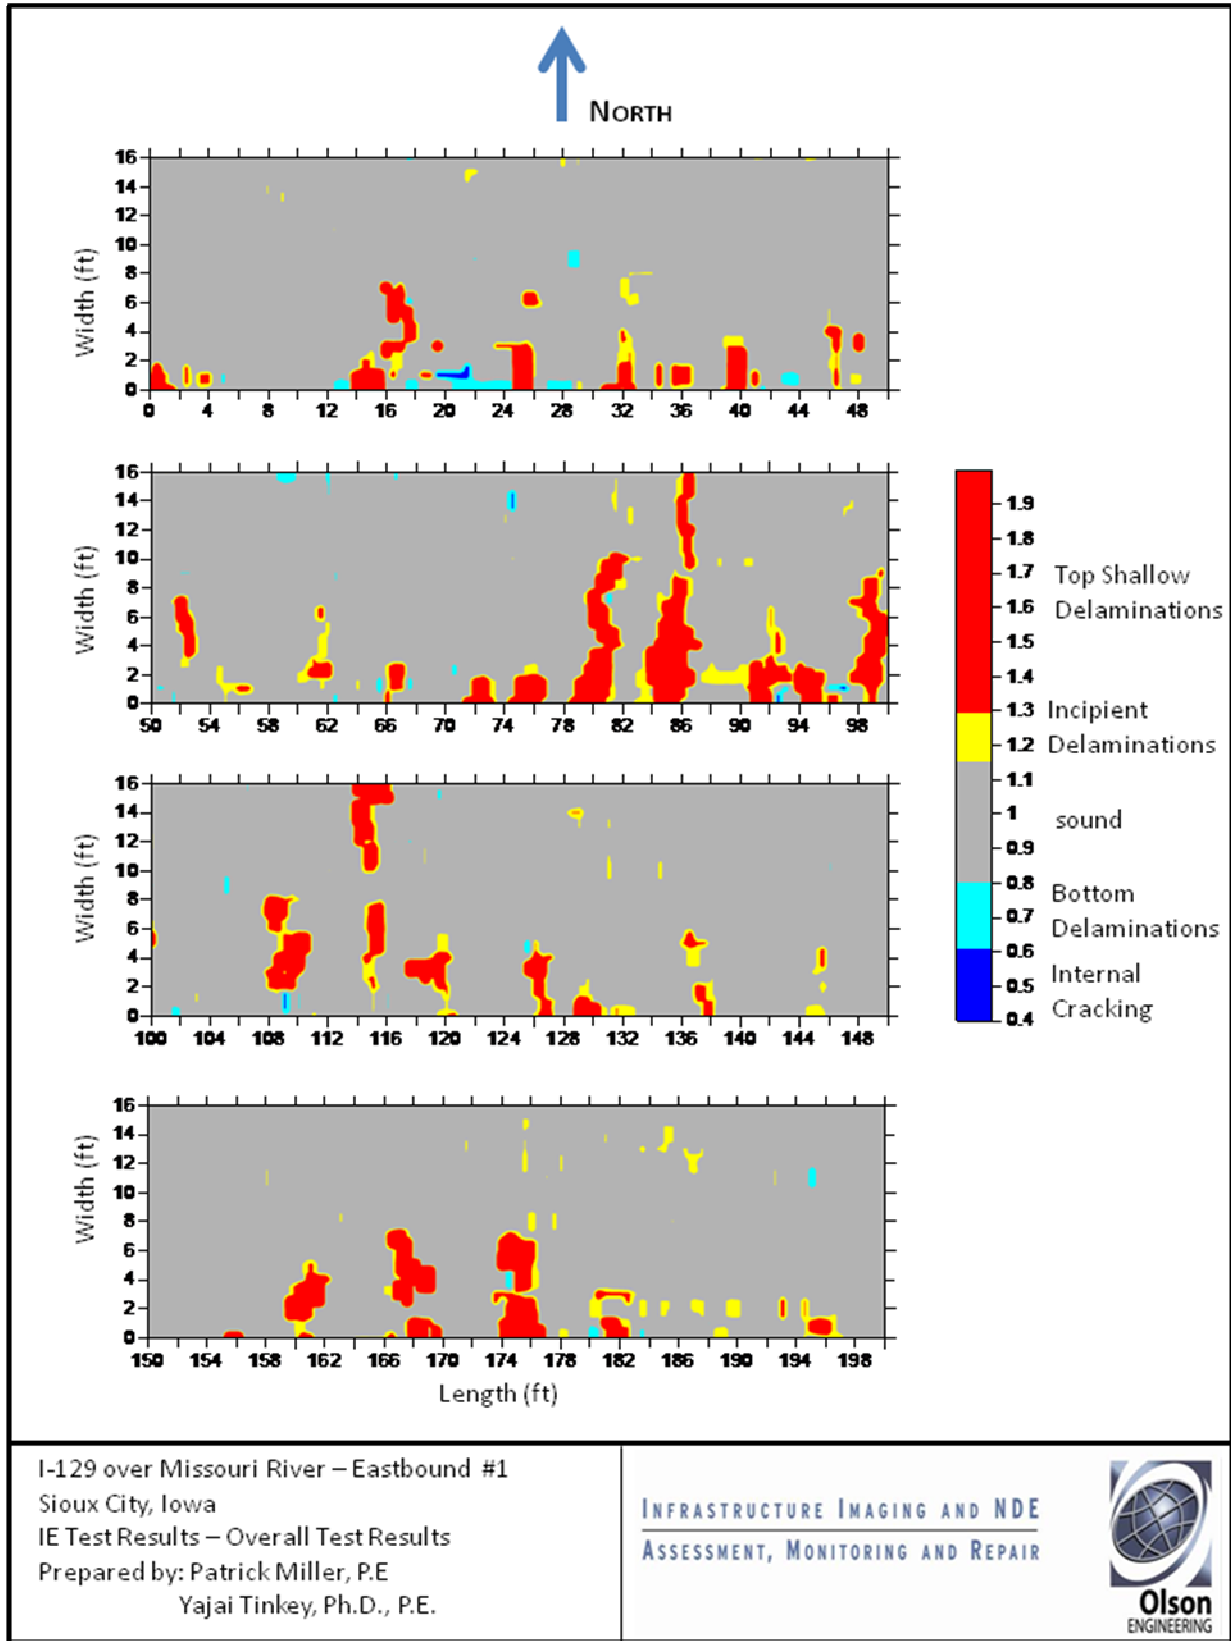
Figure A1: Eastbound Area 1, BDS-IE Results Image

The plan view color plots of the results representing the general conditions of the test section are presented in Appendix A. Top delamination maps are presented in Appendix B. The top delamination maps (Appendix B) indicate that there are several areas of delamination within each of the six test areas. The areas with the most delaminations are Eastbound Area 2, Eastbound Area 1, and Westbound Area 2. Olson Engineering's experience has shown that top delaminations (where it is audible when sounding) typically have calculated thickness values that are 30% higher than the expected echo thickness (purple and red areas). The yellow areas (15 – 30% higher) produced questionable results and may be due to developing/incipient delaminations. The blue areas have resonant frequencies which are notably less than the expected full thickness echo. It is possible that these areas are due to cracking at the bottom layer of rebar steel and may emerge in the future as bottom delaminations. Areas with resonances within approximately 20% of the expected resonance from a full deck thickness echo are considered sound. The variations in resonant frequency are attributed to small variations in actual thickness due to cast in place construction and resurfacing, as well as slight, natural variations in the concrete velocity. Table I in Section 1.0 presents the summary of the BDS-IE test results of the 6 deck areas.
