DIAGNOSTIC AND ANALYSIS OF SELECTED MASONRY RAILWAY BRIDGES ON SLOVAK RAILWAYS

Abstract. The paper presents an overview of the current state of railway masonry arch bridges that are in operation on Slovak Railways. The material of the vault is either stone or brick. It also presents the current possibilities of diagnostics, monitoring and evaluation of failures, the method of measuring selected material characteristics of masonry elements (especially the determination of compressive strength). Within the cooperation of our department and the Research and Development Institute of ŽSR, applications of diagnostic measurements and evaluation of the current state of these bridges are presented on selected bridge structures.

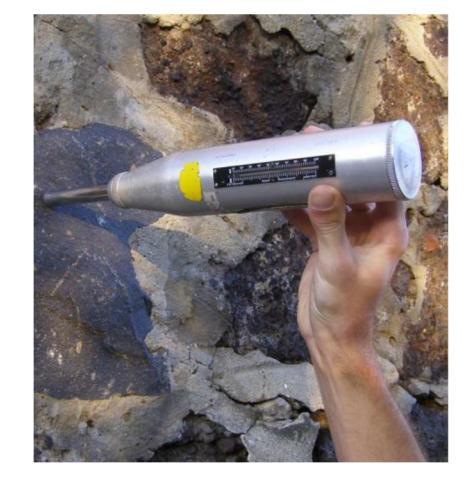
Fig. 1: Schmidt hammer strength tests.

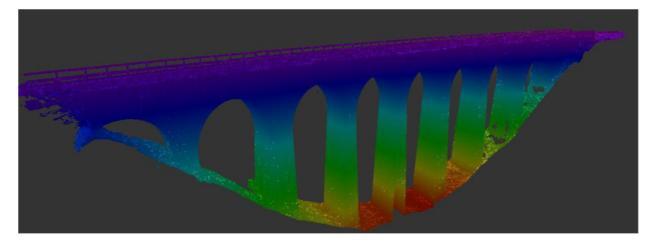
Fig. 4: The result of the scan is a processed 3D model of the Chmaroš Viaduct in the Leica Cyclone software, converted to the required dxf format.

In fig. 4 shows the output from 3D laser scanning. This method of geodetic observation is based on determining the spatial coordinates of detailed points by the spatial polar method.

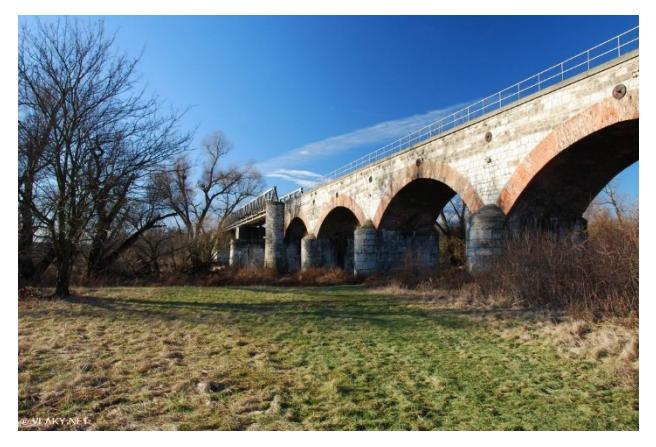
Fig. 5: View of the Marchegg Viaduct from the Slovak side.

On the bridge object in the vaulted part, the defects are mainly formed by longitudinal cracks in the vaulted ceiling. As part of the diagnostics, crack targeting and mapping were performed.

- operate a bridge with a maximum axle load of 20 tonnes (load category C3),
- operate the bridge at a maximum speed of 70 km / h,
- replace the expansion device (its vertical movement
