# Hydrogen Assisted Fracture of 30MnB5 High Strength Steel: A Case Study

Garikoitz Artola <sup>1,\*</sup>

and Javier Aldazabal <sup>2</sup>

<sup>1</sup> Azterlan, Research and Development of Metallurgical Processes, Aliendalde Auzunea 6, 48200 Durango, Spain<sup>2</sup> Tecnun, University of Navarra, Manuel de Lardizábal 15, 20018 San Sebastian, Spain; jaldazabal@tecnun.es

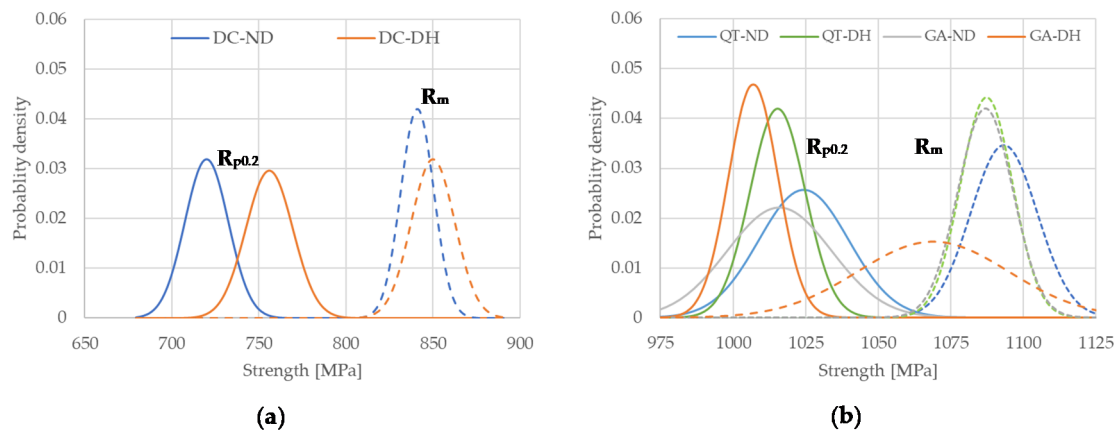
Figure 10 has been elaborated to help in visualizing this fact. It plots the average values in Table 6 with their standard deviation as the parameters of Normal probability distribution functions. Starting with the values of strength, the results have been divided first by class and then by condition. Figure 10a shows, that for the raw material in delivery condition,  $R_m$  distributions overlap by a high percentage, while  $R_{p0.2}$  coincide in about 50% of their dispersion. Accounting for the reduced number of repeats, this 50% overlapping has been enough to discard the existence of statistically significant differences between the averages of  $R_{p0.2}$  for DC-ND and DC-DH.

The plots in Figure 10b represent the averages for QT and GA specimen sets. These curves are similar to those of DC specimens in the sense that the curves overlap at a high percentage. This fact removes the possibility of affirming that the difference observed between the means is significant, even for the most disperse values such as  $R_m$  on GA-DH when working with three repeats.

**Figure 10.** Probability density plot assuming Normal distribution of average strengths and their uncertainties in Table 6 as mean and standard deviation values. (a) Plot for the DC Class 8.8 specimens. (b) Plot for the QT and GA Class 10.9 specimens.

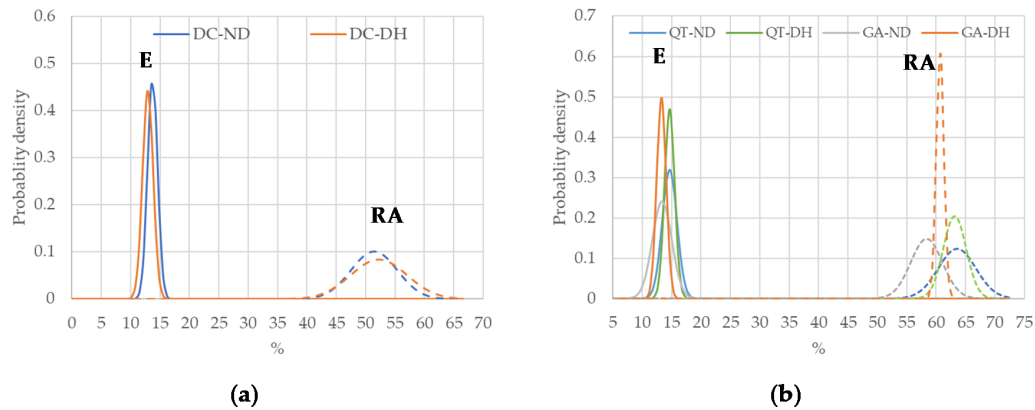
The same plotting approach for E and RA is shown in Figure 11. For these two properties, which are highly affected by HE and EAC, the curve overlapping is even higher than that for the strengths. This confirms that no major mechanical property decay due to production process-related internal hydrogen HE was produced in the original M52 fractured bolts that motivated this work. Major decays would have been detected even with three repeats.

**Figure 11.** Probability density plot assuming Normal distribution of average elongations and area reduction and their uncertainties in Table 6 as mean and standard deviation values. (a) Plot for the DC Class 8.8 specimens. (b) Plot for the QT and GA Class 10.9 specimens.

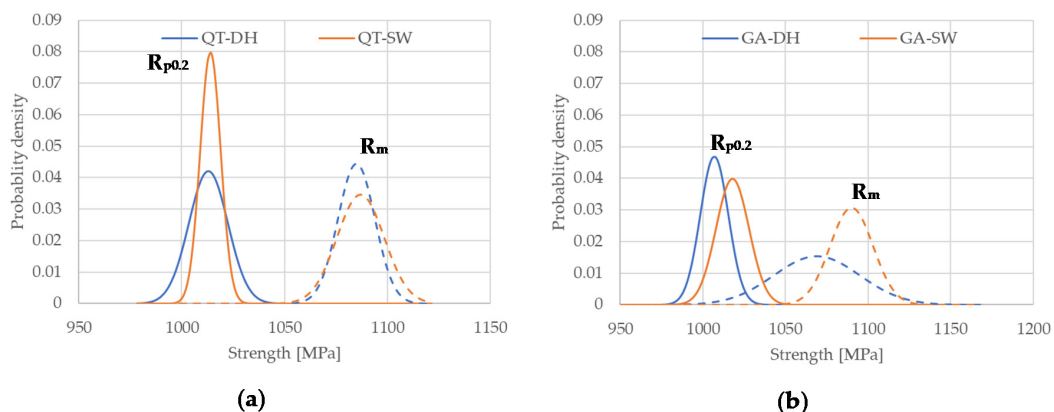
The outcome of the statistical analysis indicates that the effect of the immersion is not significant in terms of strength for either of the conditions; neither naked (QT), nor galvanized (GA). Figure 12 reflects this fact, as the gaussian curves overlap clearly for QT (Figure 12a) and slightly less so for GA (Figure 12b) specimens. The most doubtful result is observed for  $R_m$  in GA-DH and GA-SW, but again about 50% of the curve overlaps in the worst case and three repeats do not allow the conclusion that this is a significant variation.

**Figure 12.** Probability density plot assuming Normal distribution of average strengths and their uncertainties in Table 7 as mean and standard deviation values. (a) Plot for the QT specimens. (b) Plot for GA specimens.

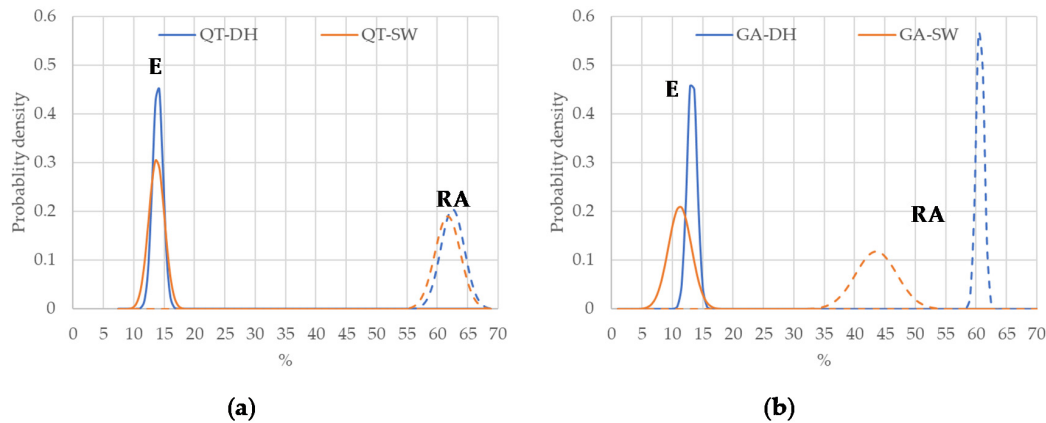
When the hypothesis tests are performed on the difference of averages of the ductility related properties, the scenario changes, not for the elongation, E, but for the reduction in area, RA. The outcome of the statistical analysis is that the drop in the average RA is significant for the galvanized specimens tested in submerged condition, with a level of significance of  $\alpha = 0.01$ . Figure 13 plots this: the RA curves of the graph in Figure 13a show that the Gaussian for GA-DH and the Gaussian for GA-SW do not touch each other. Consequently, it is statistically sound to affirm that an embrittlement process has

been developed in the GA-SW SSRT specimens and their differences in both E and RA can be considered as an actual effect of EAC and not a statistical artifact. This combination of hot dip galvanizing Zn coatings and water as the critical factor for the failure of bolts in the field has been reported by other case studies [26,34].

**Figure 13.** Probability density plot assuming a Normal distribution of average strengths and their uncertainties in Table 7 as mean and standard deviation values. (a)Plot for the QT specimens. (b) Plot for GA specimens.
